MARINE ACCIDENT INVESTIGATION BRANCH

## FLYER TO THE MERCHANT SHIPPING INDUSTRY

### **OUZO: ACCIDENT WITH THREE FATALITIES 21 AUGUST 2006**

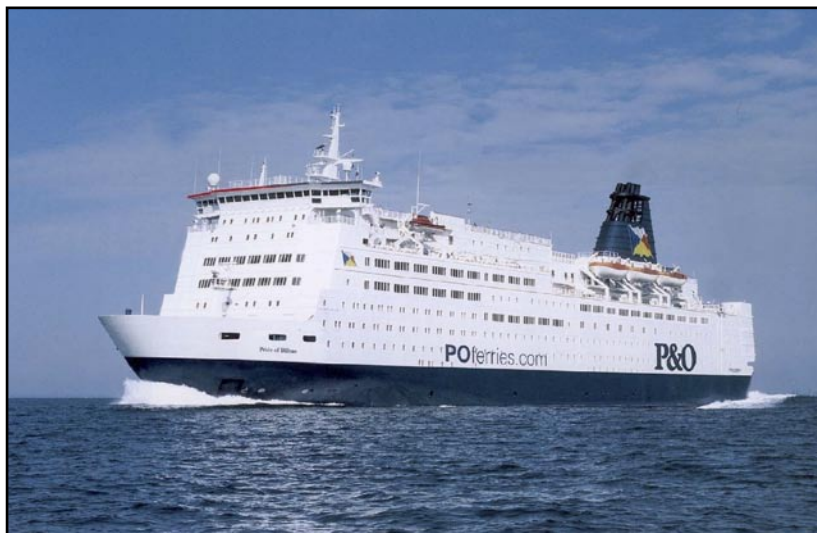
Voyage data recorder (VDR) records from ships that had been in the area during the night of 20/21 August were recovered and analysed by MAIB inspectors and it was discovered that the ferry *Pride of Bilbao* had been involved in an incident with a yacht 6 miles south of the Isle of Wight in the early hours of 21 August. The investigation concluded that she had either collided with, or passed so close to *Ouzo* at that time, and that the yacht had been swamped or capsized by the vessel's wash.

The watchkeeping officer and the lookout had seen the yacht at the last minute but had been unable to keep well clear. The sighting of a single red and then, possibly, a white light astern of the ferry after the incident was considered, by the watchkeeping officer, sufficient indication that the yacht was safe. The ferry continued to Bilbao without taking further action.
