Rail Accident Investigation Branch

Rail Accident Report

Derailment near Waterside, East Ayrshire 21 January 2006

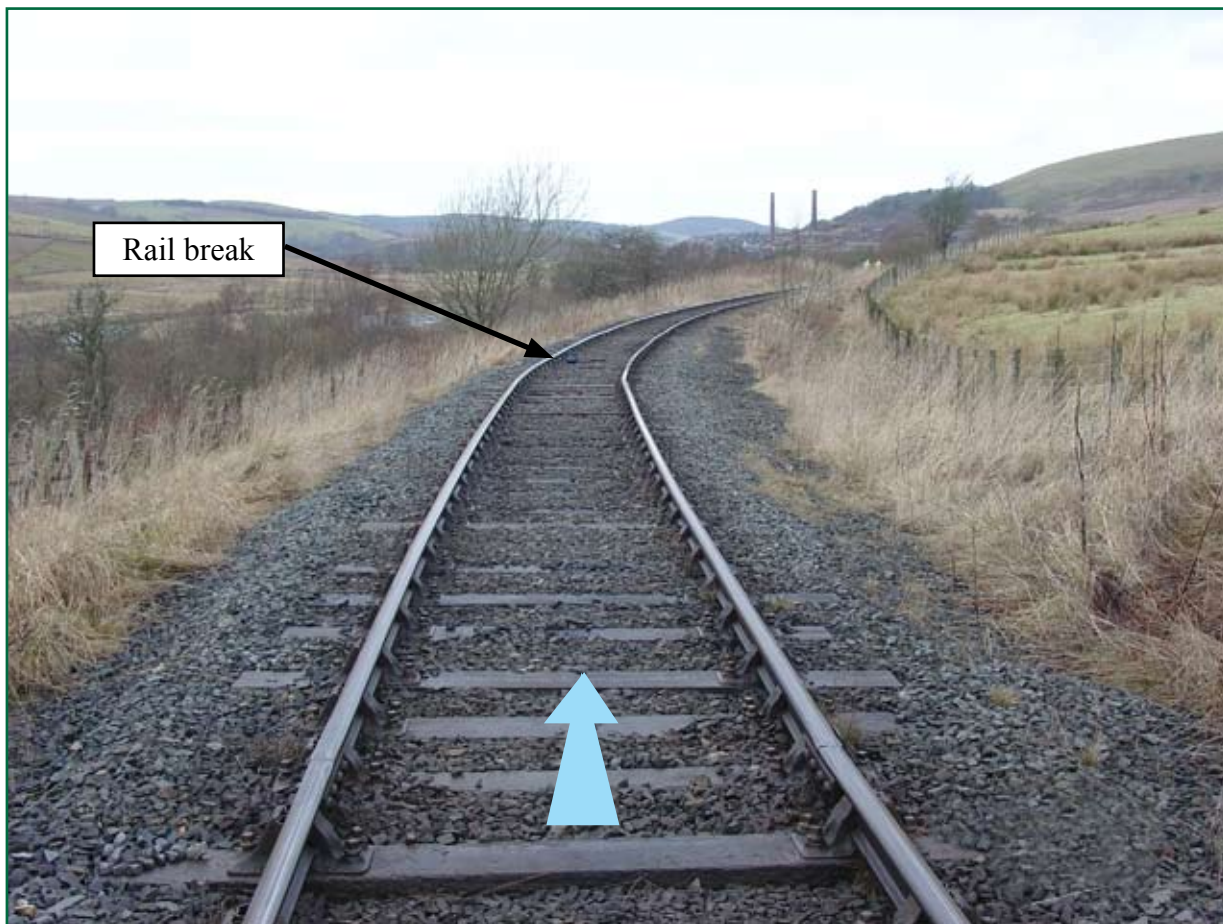
- 29 The derailment occurred at 03:19 hrs when the leading left wheel on wagon HTA310724 climbed onto the head of the left hand rail on encountering a transverse rail fracture located at 53 miles 889 yards, some 1130 yards (1034 m) before the Network Rail boundary. As the train negotiated a 200 metre radius right-hand curve on a 1:67 downhill gradient, the leading axle on wagon 310724, positioned 16th in the train of 21 wagons, became derailed to the left as it passed over a broken rail.

Figure 5: Overview of the point of derailment looking in the direction of travel.

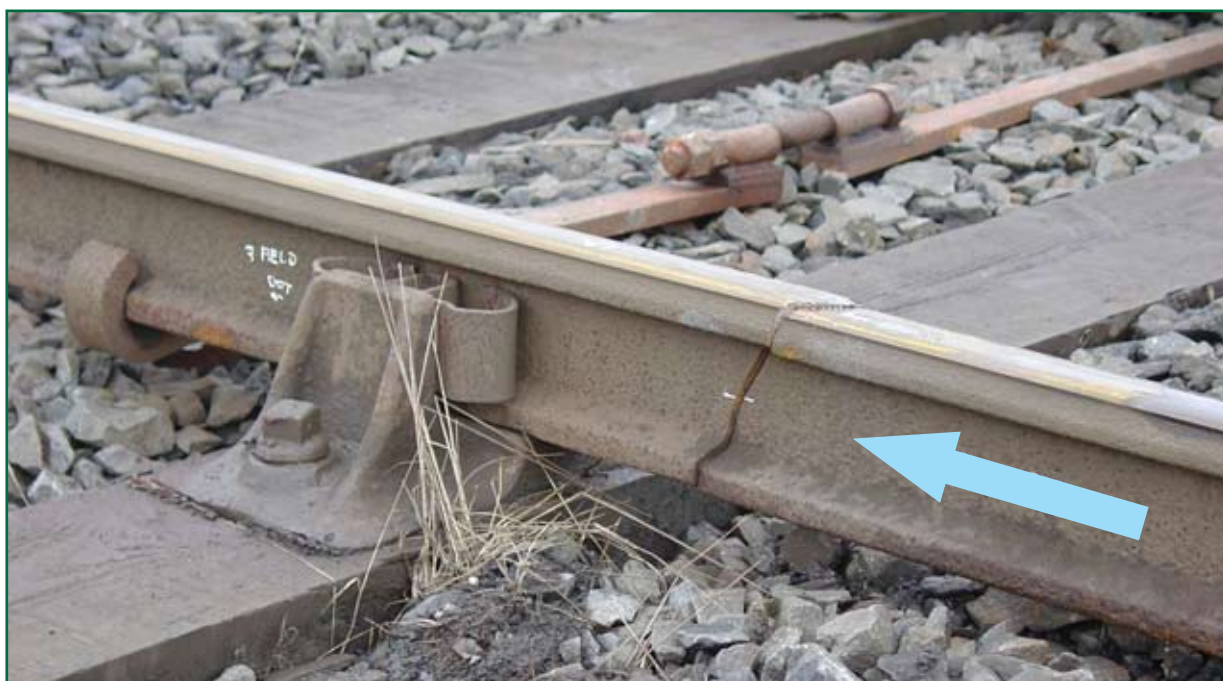
- 8 The immediate cause of the derailment was found to be a transverse fracture in the running rail within the section of track owned by Scottish Coal at 53 miles 889 yards. The break, located on the outside rail of a right hand curve, presented an obstruction which allowed the leading wheelset of wagon HTA 310724, positioned 16th in the train, to climb onto the rail head. It continued in this manner for a short distance before derailing to the left. The following five wagons making up the rear section of the train remained on the track and were derailed as the train came to a stand.

Figure 6: Rail break viewed from the field side.

- 68 Marks made by the chair on the seating faces suggested that rail creep of up to 65 mm had occurred.
- 69 Examination of the fracture face indicates that the rail failed from fatigue cracks that initiated from pitted areas on the underside of the rail on the field side. Multiple fatigue cracks had initiated from two pitted areas on the underside of the rail foot. These cracks had propagated by fatigue on a transverse path until they joined to form two single crack fronts on a slight plane to each other. Once the cracks had reached a critical size, the rail cracked rapidly upwards and stopped when the head section was reached. Based on an assessment of the impact damage due to wheels passing over the broken section and the amount of corrosion on the fracture surface, it is considered most likely that the final break occurred under train 6C64. This opinion is supported by the relatively rust free fracture surface of the head and the fact that if the previous train had broken it, then the running-on side of the fracture would be expected to have suffered more extensive damage.

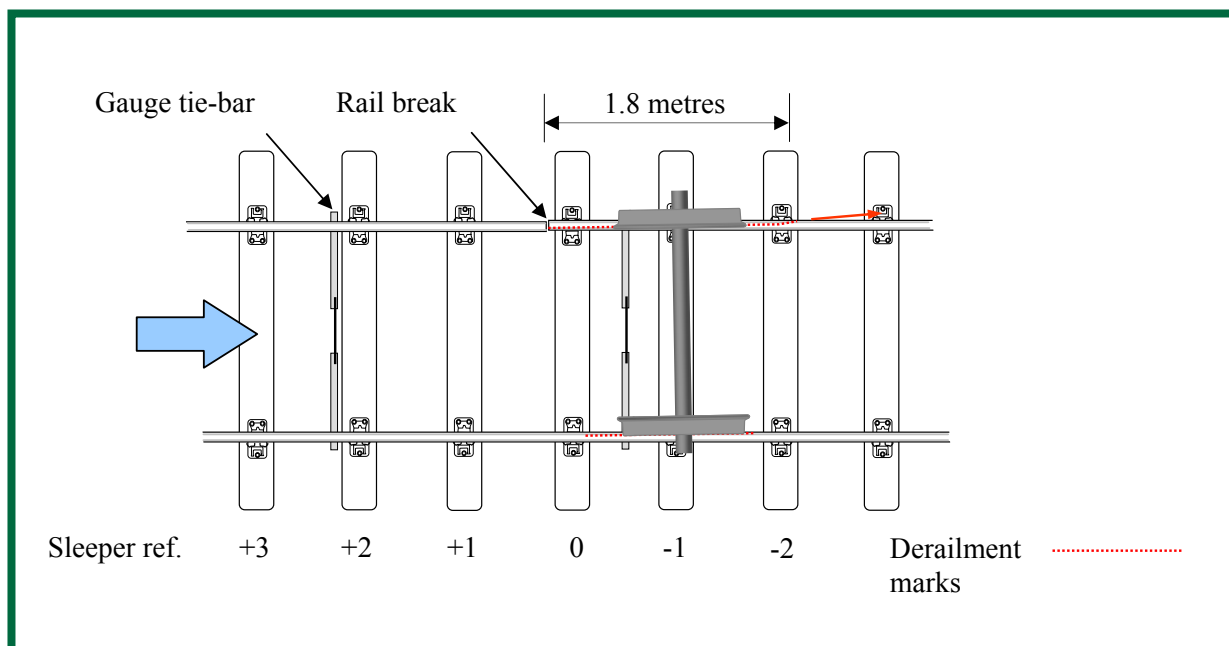
- 30 The derailed wheel continued to run on the rail head for a distance of 1.8 metres before becoming derailed to the left onto the *field (cess)* side, leaving a flangemark. A corresponding *tread corner* mark, created by the right hand wheel was observed on the opposite railhead (see Figure 7).

Figure 7: Sketch of rail break and point of derailment showing path of derailing wheelset.

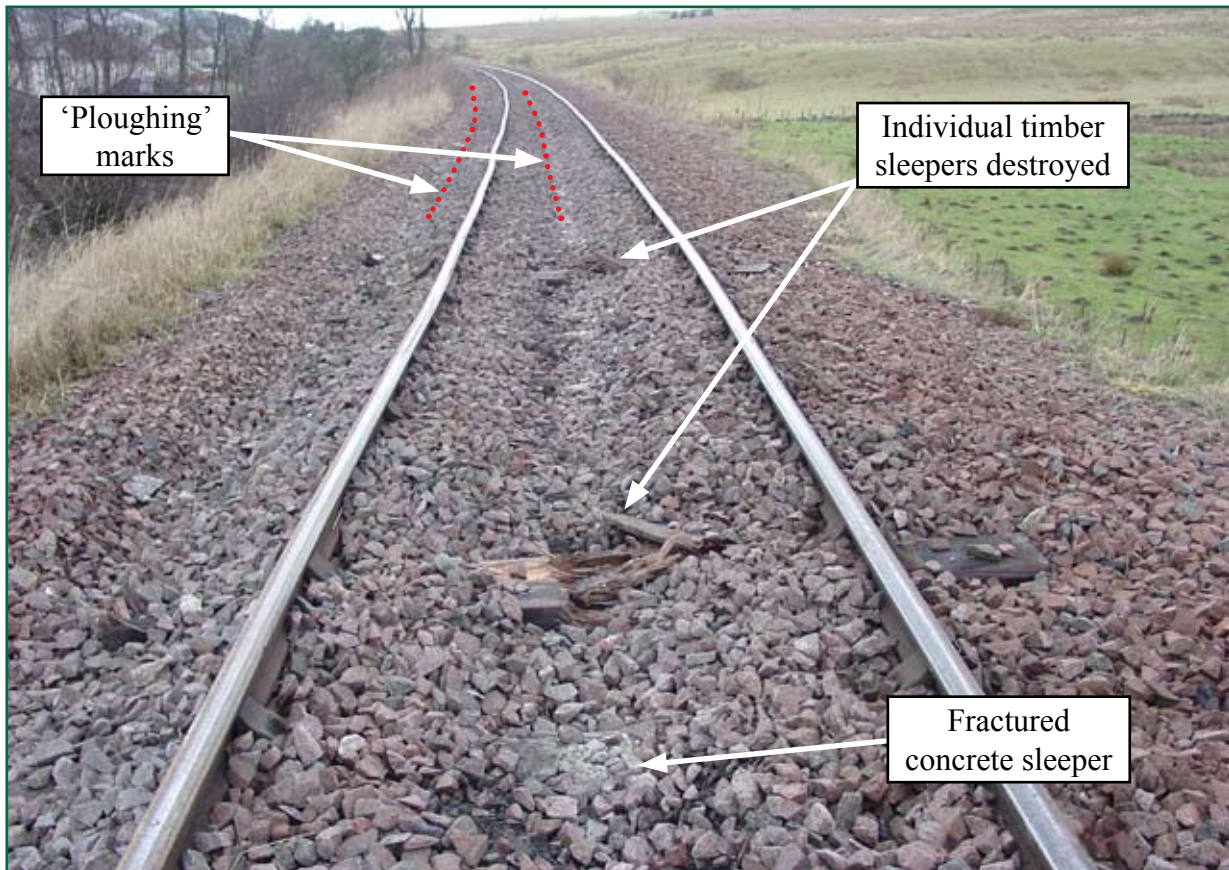
- 35 Between the 52 and 51½ mileposts, the derailed wheelset encountered deep ballast laid across the track (see Figure 8). This resulted in a ploughing action developing, forcing the bogie further to the left until a yaw angle estimated at 18° was realised, contrasting with a normal maximum of 5.2° (corresponding to the displacement when negotiating a 70m radius curve). At this angle, both right hand wheels on this bogie came into contact with the wagon's underframe causing damage and reducing their ability to rotate freely.

Figure 8: Track damage on the approach to Patna village near the 51½ milepost.

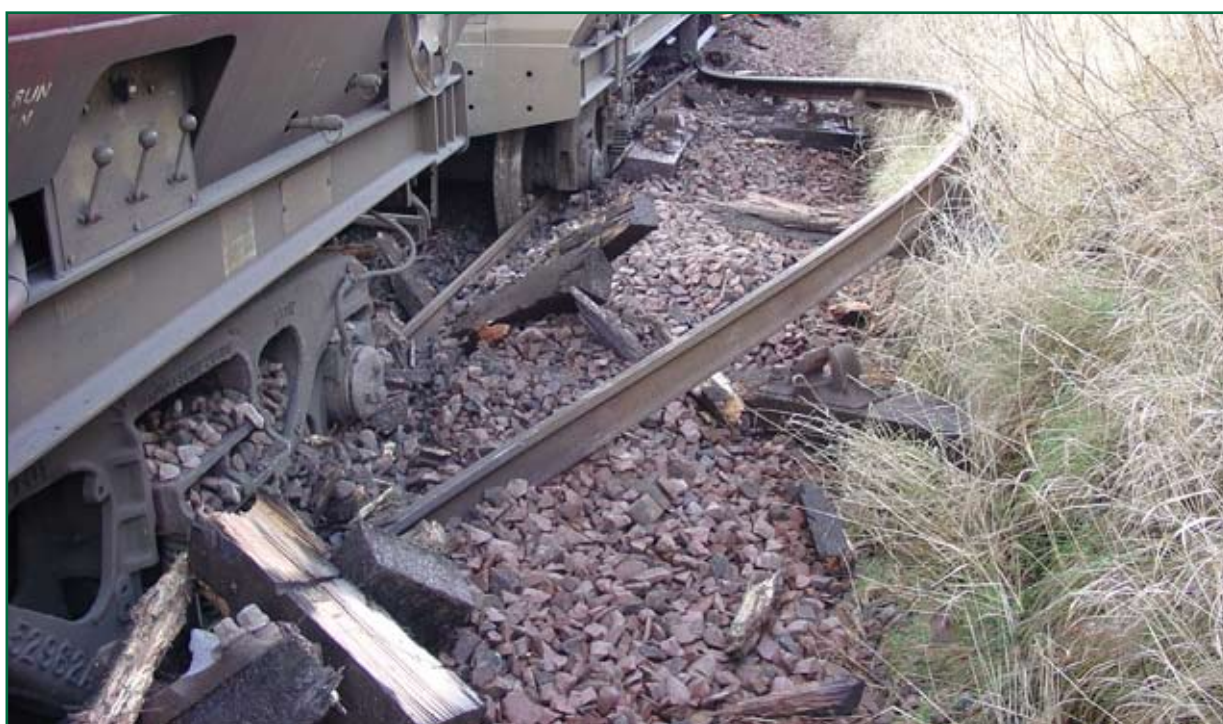
Figure 9: Derailed wagons and track damage viewed in direction of travel alongside the wagon positioned 3rd from the rear of the train. The buckled rail has been dragged forward with the train.

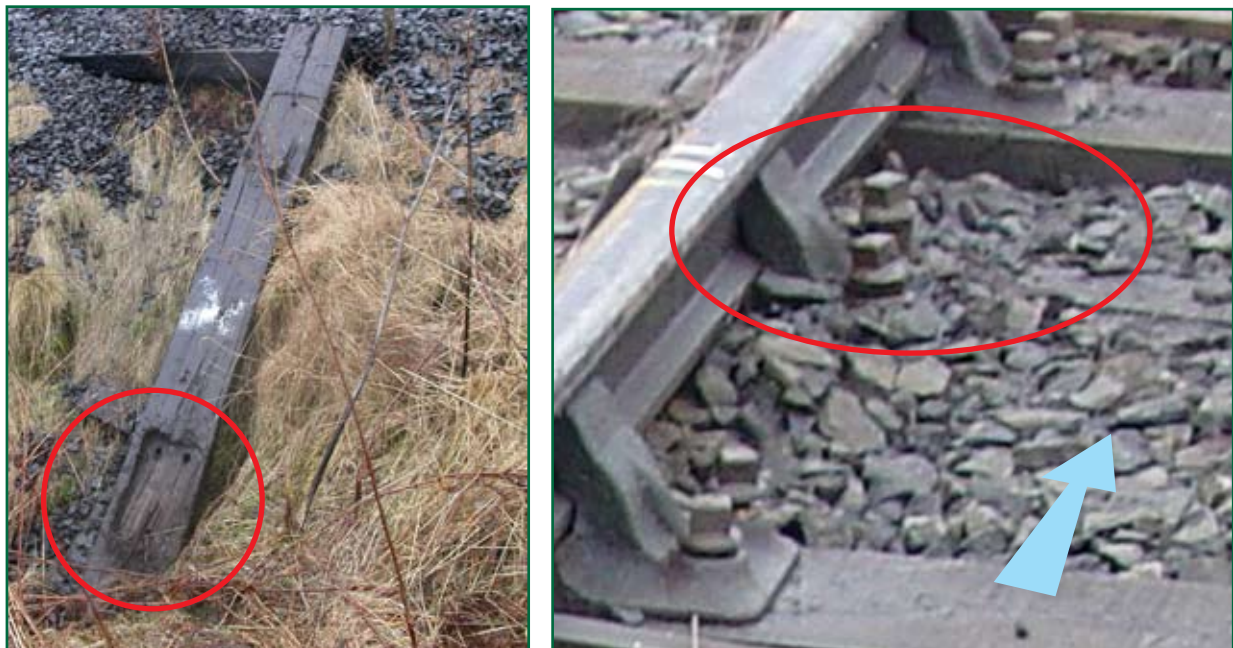
- 63 However, the wooden sleeper immediately before the rail break was not new. Whilst generally sound, inadequate ballast support had allowed movement to occur during loading by the passing of trains, but this went unrecorded in the 4-weekly inspection reports. This movement caused the chairscrews to ratchet upwards and become loose, allowing moisture to ingress beneath the chair and resulting in gradual loss of support due to softening of the wood. When removed from the track following the derailment, a 45 mm deep indentation was identified, together with evidence of up to 15 mm lateral movement (Figure 11). Whilst masked by the chair, the securing chairscrews had been partially ejected giving a visual clue as to the presence of this void and making it possible for track inspection staff to detect. When loaded by the weight of a train, the void would have caused the supporting chair to drop and move laterally. The reduced lateral and vertical support in this instance is a causal factor in the failure of the rail. There is no evidence that ballast under the old sleeper was packed when new sleepers were installed on either side of it during 2003. The November 2005 condition report recommended the renewal of ferrules throughout this section, which requires the removal of chairscrews and would have resulted in the sleeper defect being identified. However, as this section was not on the priority list, it is not known when this work would have been done.

Figure 11: 45 mm indentation in sleeper preceding rail break following its removal from the track. The lack of support offered by this sleeper was significant. The displaced chairscrews and broken rail can be seen in the right hand picture.

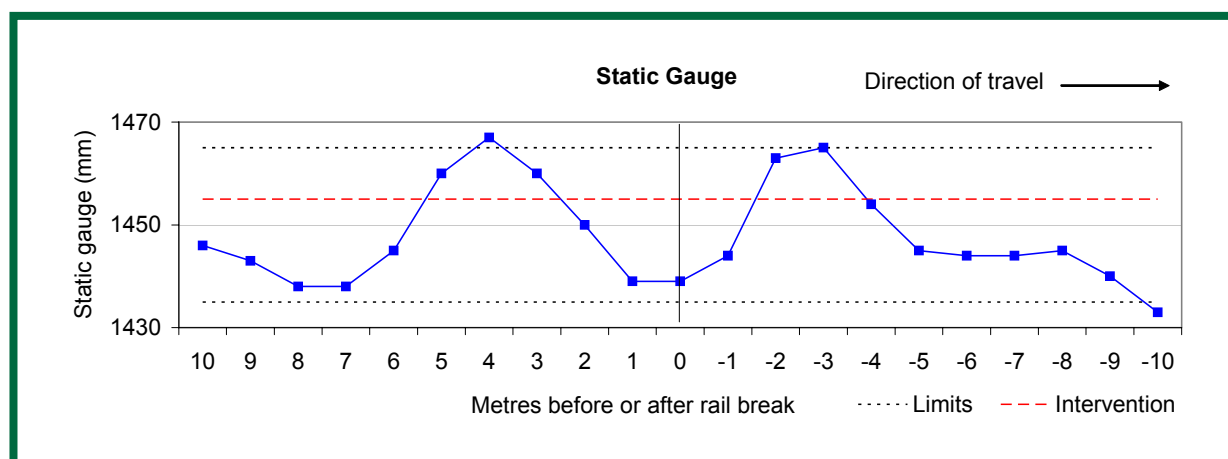
75 *Static* track gauge was found to be generally within the limits prescribed in the EWS Standard for maintenance; i.e. 1435 mm to 1465 mm as indicated in Figure 13. This Standard also requires corrective action to be taken when gauge exceeds 1455 mm. The maximum gauge on the Approach Road is given as 1455 mm in the most recent EWS 4-weekly reports which is 12 mm less than that recorded on undamaged track immediately after the derailment. Whilst some gauge widening may be resultant rather than causal, there is no record that the gauge had been checked in the five months prior to the derailment (see paragraph 53). The wheel-wear pattern, or running band, on the opposite rail gives a visual indication of the areas of wider gauge and highlights the presence of a long-standing track geometry defect.

Figure 12: Graph of static gauge showing that this remained largely within limits, but required corrective action where the limit for initiating intervention measures (1455 mm) was exceeded.

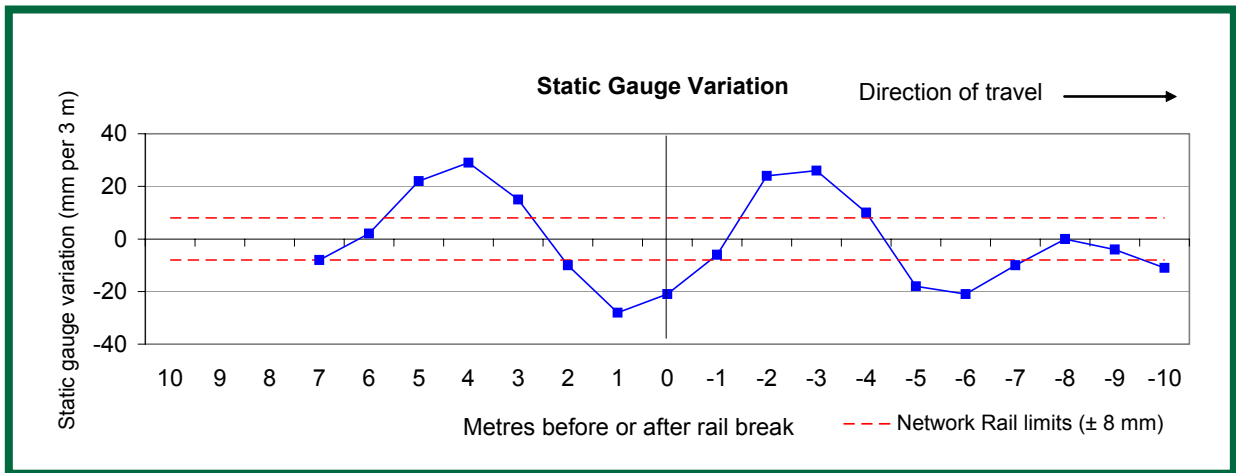
76 The variation in track gauge over a 3 metre length is not specifically addressed by the EWS Standard for maintenance. By comparison, Network Rail Standard NR/SP/TRK/001 Appendix E gives an intervention limit of 8 mm over a 3 metre length for a 10 mph line speed. Site measurements indicated gauge variation of up to 32 mm in 3 metres as illustrated in Figure 13. Gauge irregularities over short lengths of track can lead to bad riding and can develop into a state of cyclic *sidewear* increasing the stress imposed on the rails and the rate at which the asset dilapidates.

Figure 13: Graph of gauge variation over 3 meters. The Network Rail limit of 8 mm over a 3 m length is indicated by the dashed lines.

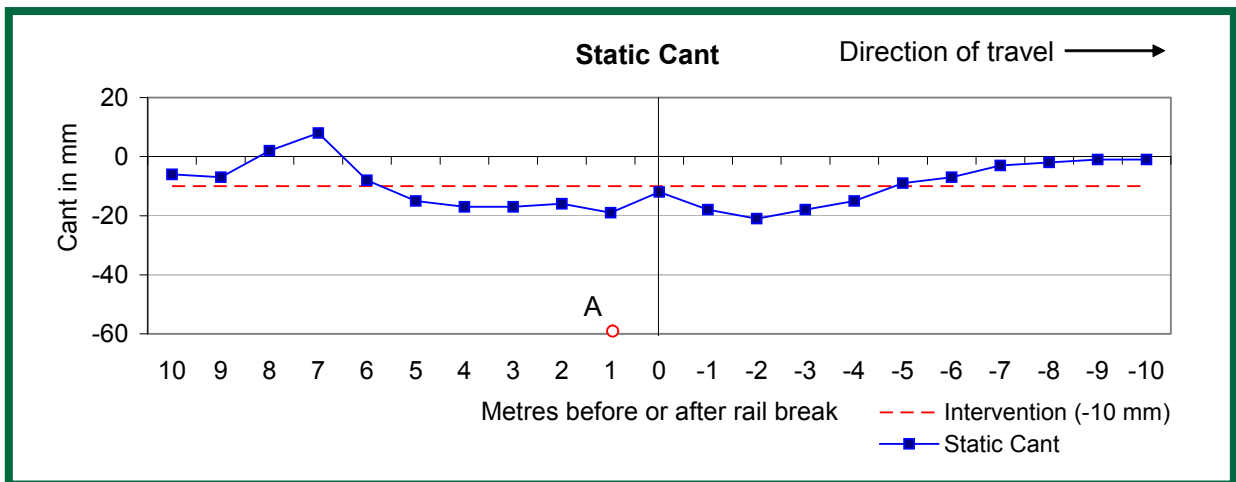
- 78 The cross-level (or cant) at the site was found to be predominantly negative, meaning that the outer rail was, unusually, lower than the inner rail of the curve. This will have had the effect of forcing vehicles to the outside of the curve. At 10 mph, this does not significantly increase the *dynamic loading* or *cant deficiency* but will have increased the rate of rail wear. Figure 14 shows the static cant for 10 metres either side of the break.
- 79 The EWS Standard for maintenance prohibits adverse cant on curves and requires negative values in excess of 10 mm to be rectified.

Figure 14: Graph of static cant showing negative values for the section leading up to the rail break.

- 80 Point A in Figure 14 represents a theoretical dynamic cant value that shows the effect of the 45 mm deep indentation discovered beneath the left-hand rail chair in the sleeper immediately preceding the rail break (see paragraph 63) when superimposed on the measured values. This assumes the left-hand rail deflected by the full 45 mm. The adjacent sleepers on both sides were installed new in 2003 and had no corresponding indentation marks.

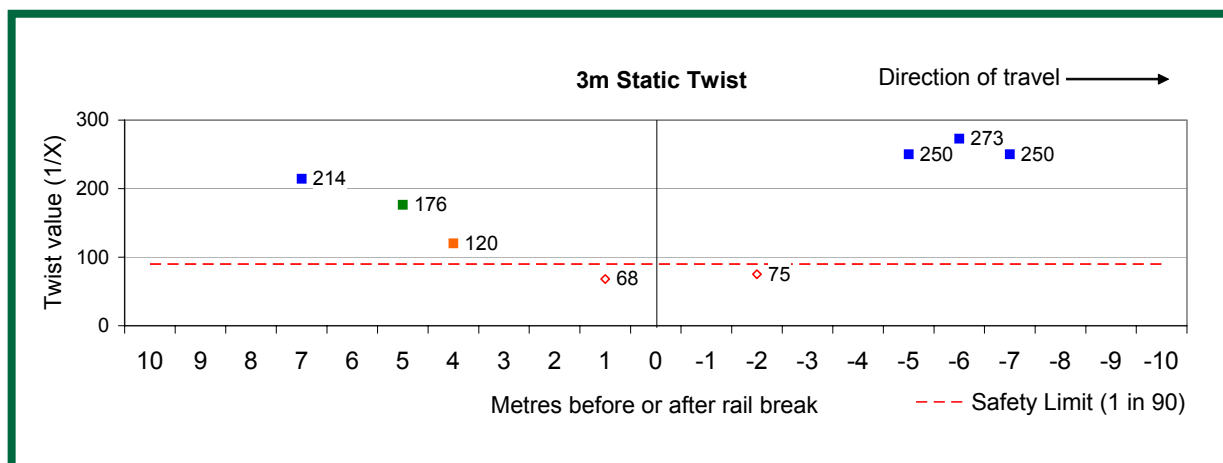
- 82 Figure 15 shows the static twist (solid markers) superimposed with theoretical dynamic twist values (hollow markers). The theoretical values assume the left-hand rail deflected fully into 45 mm deep indent in the sleeper preceding the rail break.

Figure 15: Twist measured over 3 metres showing values below 1 in 300.

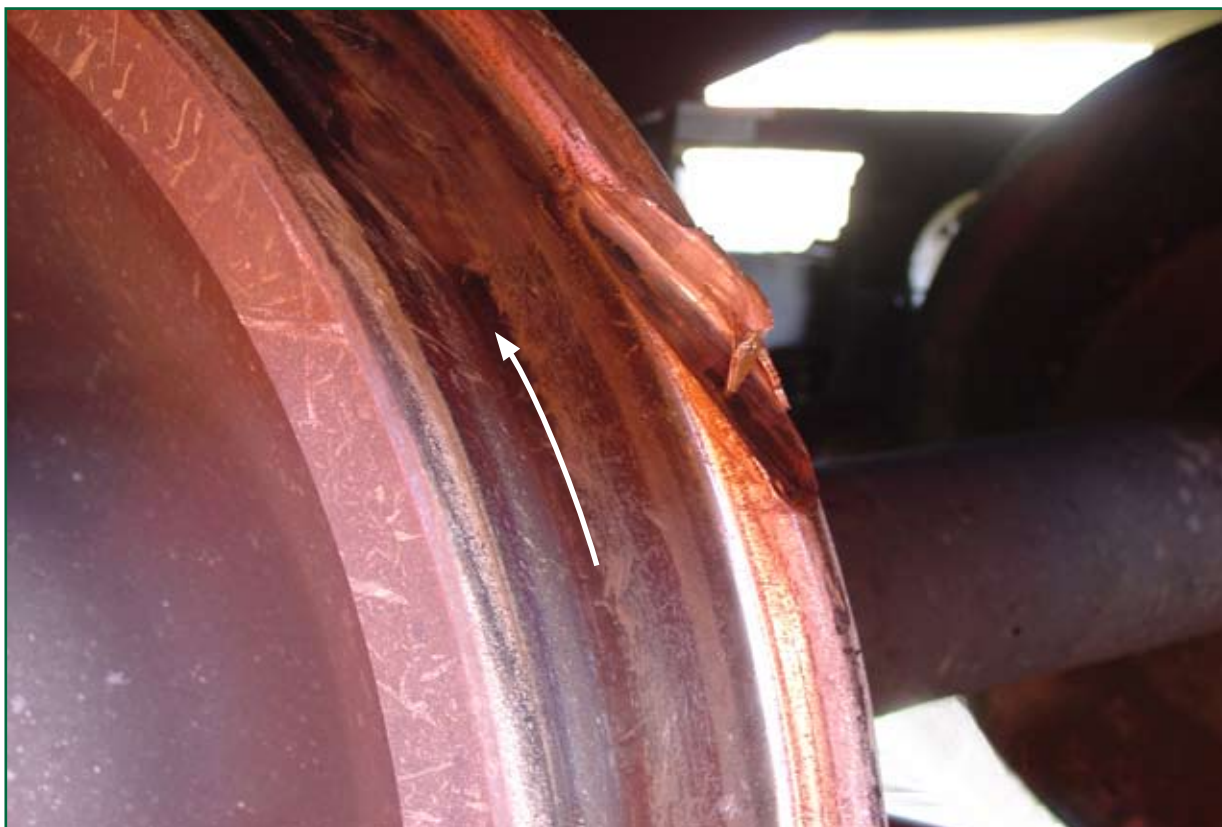
- 94 The final seven wagons in the train were examined by the RAIB following recovery. The inspection and weighing of the critical wagons involved in the derailment revealed no defects which could have caused this incident.
- 95 Wagon 310724 travelled for over 2¼ miles (3,800m) with the leading axle derailed to the left. As the bogie's rotation, or yaw angle, increased beyond the permitted maximum, both right hand wheels on the leading bogie came into contact with the wagon's underframe causing damage and reducing their ability to rotate freely. The trailing wheelset eventually became jammed, preventing rotation of this axle. The trailing left hand wheel, which remained on the track, suffered deep gouging to its flange as it was forced against the rail head at an angle but without being able to rotate. Figure 16 refers.

Figure 16: Left trailing wheel on leading bogie of wagon HTA 310724 showing deep flange damage.

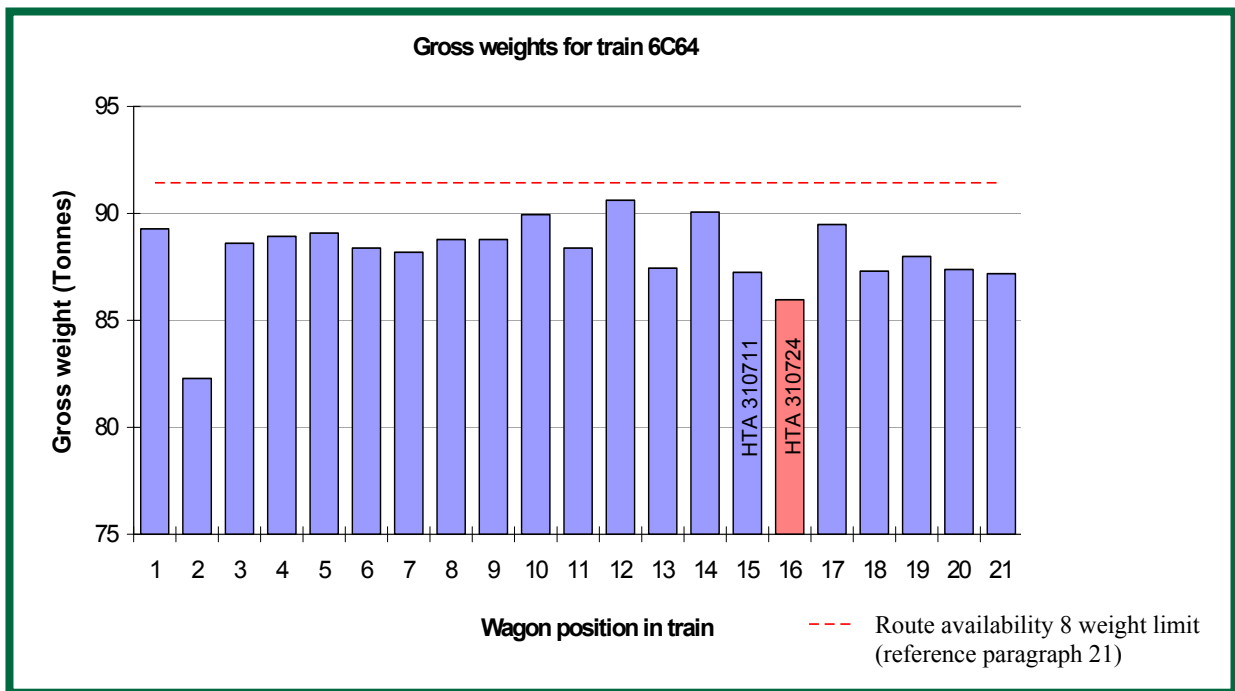
- 96 Loading records for all wagons forming the train have been examined (Figure 17). Wagons 310711 and 310724 were reweighed following the incident prior to transhipping their loads. There is no evidence that any wagon in this train was overloaded, although it was noted that wagon 310724 was relatively lightly loaded compared with most other wagons in the train. This is not considered to be a significant factor, however.

Figure 17: Gross loaded weights for each wagon forming train 6C64. The position of the first derailed wagon, HTA 310724, is highlighted.
