## CONTENTS

**(ALL TIMES IN THIS BULLETIN ARE UTC)**

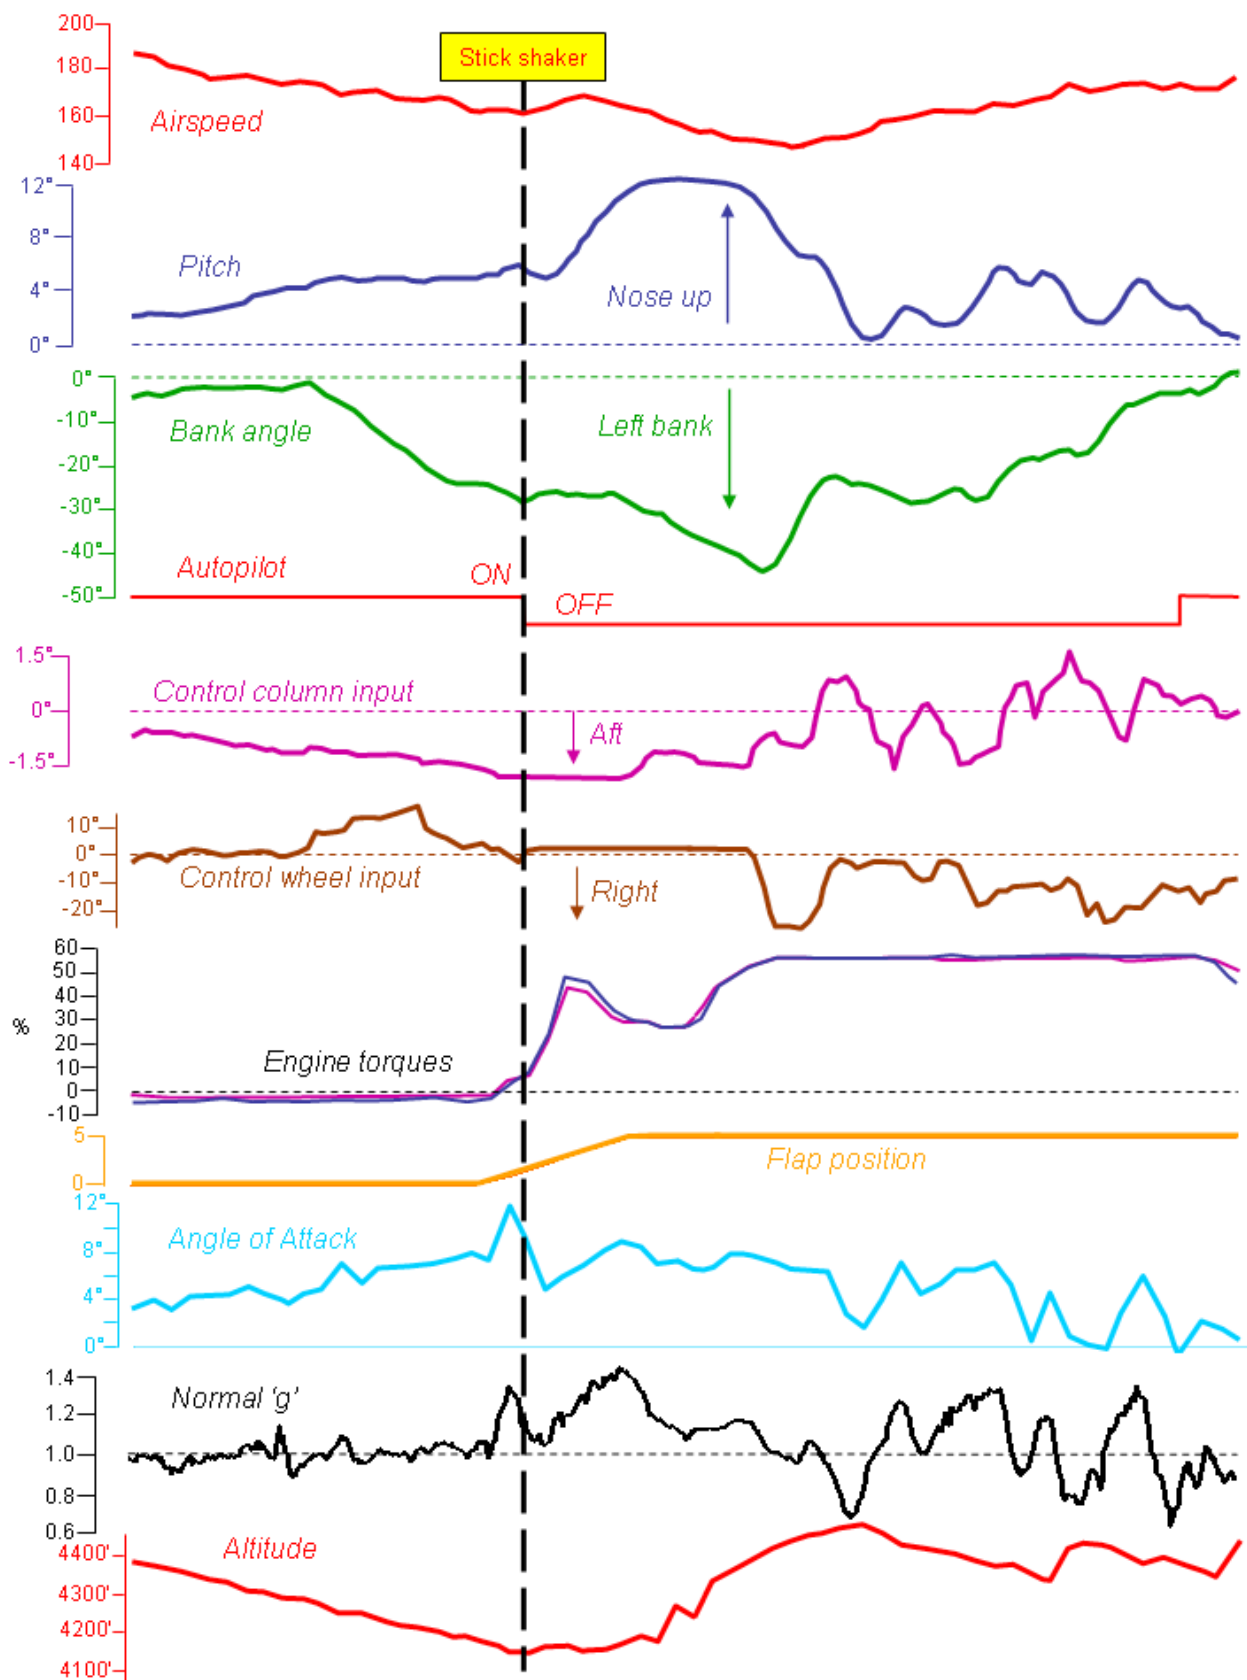
Figure 1

Relevant FDR parameters over a 65 second period surrounding the stick shaker event (simplified)

As the pitch approached its maximum value, about four seconds after autopilot disengagement, there was a small forward movement of the control column, which was soon removed, with no wheel displacement. Only when the bank angle increased beyond 40° was a large lateral control wheel input made, which corrected the overbanked condition. This was about 13 seconds after autopilot disengagement.

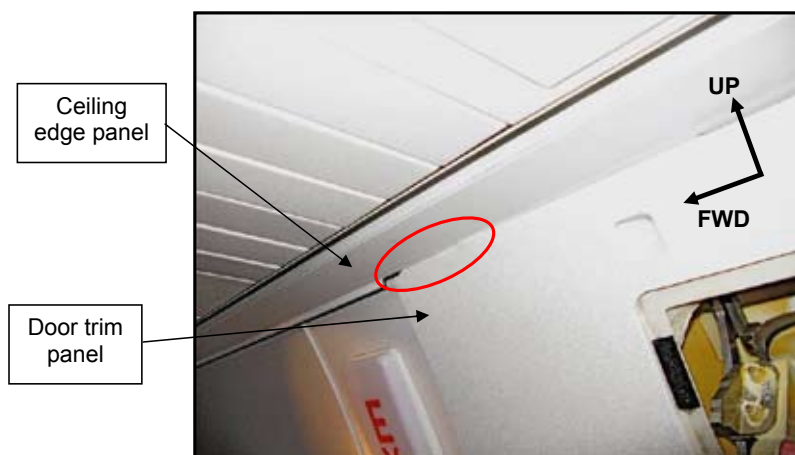
**Figure 2**

When the order to evacuate was made, passengers were able to open the left overwing exit door and evacuate onto the wing. Attempts to open the right overwing exit door proved unsuccessful, as the forward upper part of the door trim had become jammed under the ceiling edge trim panel, preventing the exit from being opened (Figure 2).

Right overwing emergency exit showing door trim partially jammed (circled) under ceiling edge panel

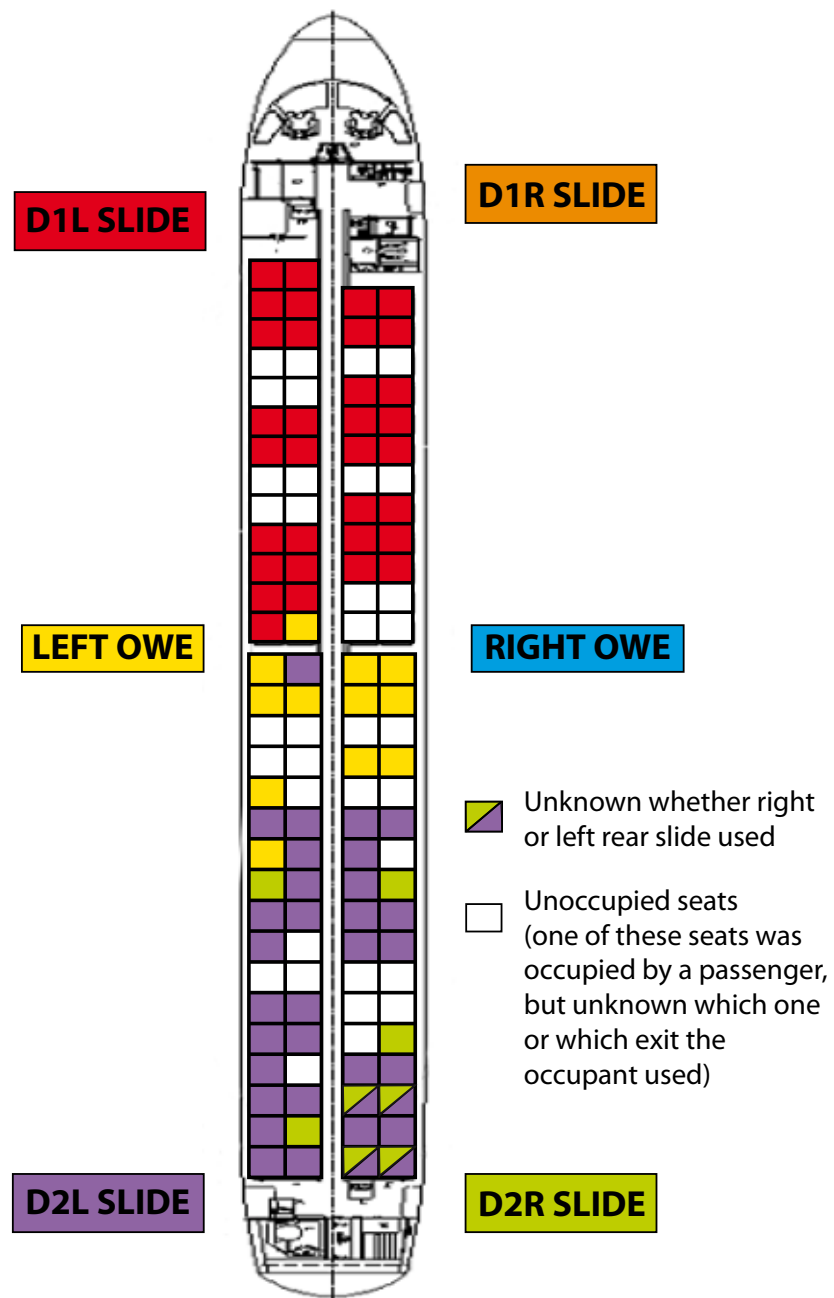
Figure 4 illustrates the exits used by the passengers, correlated by seat position. It shows that no passengers used D1R, despite this door being open with the slide

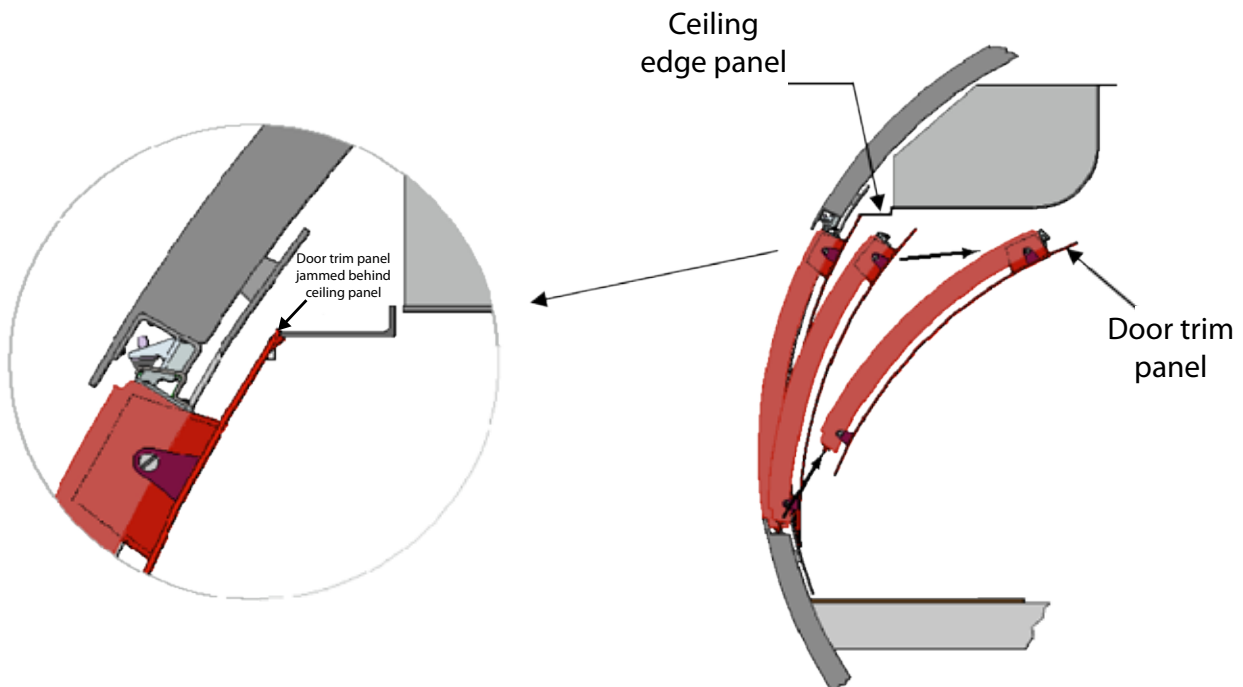
**Figure 5**  
Overwing emergency exit opening, showing location of jam

The overwing exit door is retained at its lower edge by spigots which engage in recesses in the bottom edge of the door aperture. Its top edge incorporates a locking mechanism operated by a handle at the top of the door, covered by a removable panel secured by Velcro strips. Pulling the operating handle disengages the lock at the top of the door and allows the door to pivot inwards about its lower edge. The spigots remain engaged until the door has pivoted inwards sufficiently for its top edge to clear the aperture, after which it is lifted clear of the aperture using a fixed handle near its base to support its weight. The door must then be thrown out of the aperture so that it does not cause an obstruction in the cabin to evacuating passengers. A compressible rubber bumper block limits the vertical displacement of the door during the initial phase of opening.

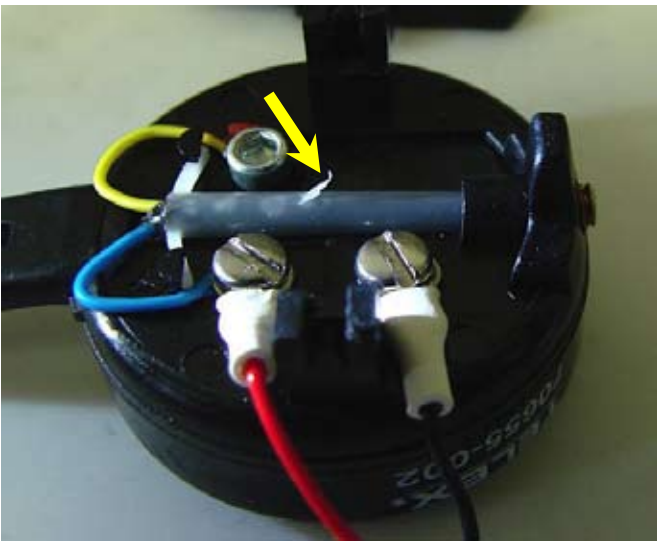
**Figure 6**

Disassembly of the captain's mask from the other aircraft identified a spurious whisker projecting from the plastic housing of the cut-out switch, the free end of which contacted the underside of the flow sensor pivot. The

whisker acted as a ratchet, tending to inhibit movement of the sensor vane in the direction required to reactivate the microphone, whilst leaving its motion in the direction required to cut out the microphone unaffected. Consequently, the mechanism tended to stick in the cut-out position, leaving the microphone open circuit. The whisker or spurious material appeared to be a ‘curl’ of the switch casing material (Figure 6), probably created either in the production of the switch itself, or during its assembly into the mask.

Whisker of plastic material on cut-out switch

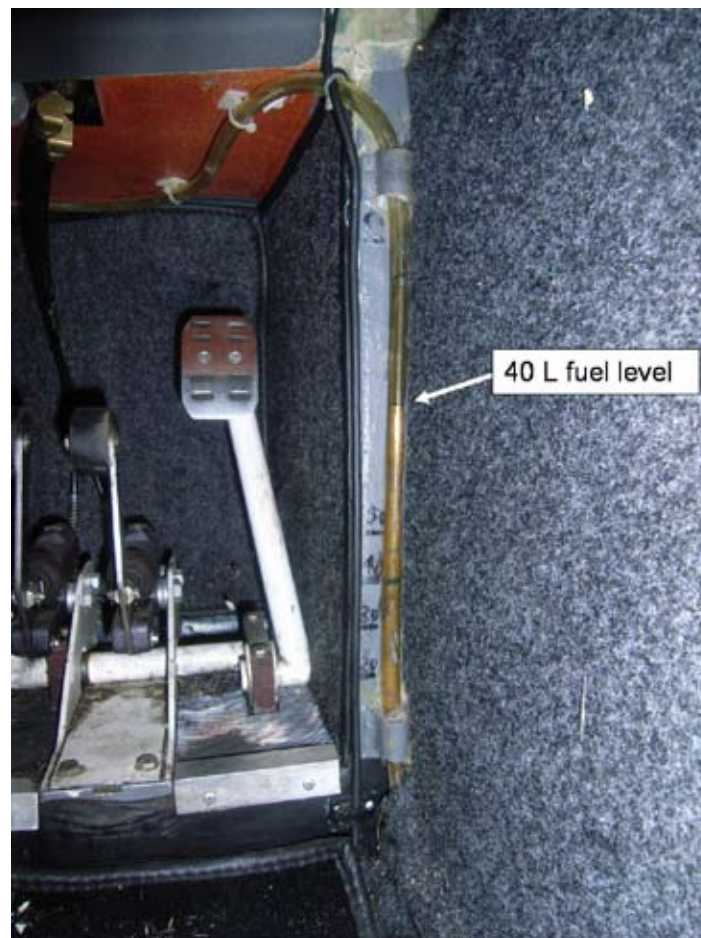
**Figure 2**

Fuel quantity indication was provided by means of a clear plastic sight tube mounted on the centre tunnel, close to the pilot's right lower leg (Figure 2). The sight tube must be calibrated during aircraft construction. The kit manufacturer's build manual suggests adding a card with dark and light stripes behind the tube to make the fuel level in the sight more visible; however, this was not used on this aircraft. Due to its location forward of the tank, the indicated fuel level is sensitive to changes in pitch attitude.
