## CONTENTS

**(ALL TIMES IN THIS BULLETIN ARE UTC)**

<b>Aircraft Type and Registration:</b>	Boeing 747-436, G-CIVB	
<b>No &amp; Type of Engines:</b>	4 Rolls-Royce RB211-524G2-T-19 turbofan engines	
<b>Year of Manufacture:</b>	1993	
<b>Date &amp; Time (UTC):</b>	11 July 2009 at 0310 hrs	
<b>Location:</b>	Phoenix, Arizona, USA	
<b>Type of Flight:</b>	Commercial Air Transport (Passenger)	
<b>Persons on Board:</b>	Crew - 18	Passengers - 300
<b>Injuries:</b>	Crew - 1 (Minor)	Passengers - some (Minor)
<b>Nature of Damage:</b>	None	
<b>Commander's Licence:</b>	Airline Transport Pilot's Licence	
<b>Commander's Age:</b>	55 years	
<b>Commander's Flying Experience:</b>	18,235 hours (of which 6,529 were on type) Last 90 days - 215 hours Last 28 days - 63 hours	
<b>Information Source:</b>	AAIB Field Investigation and operator's internal investigation

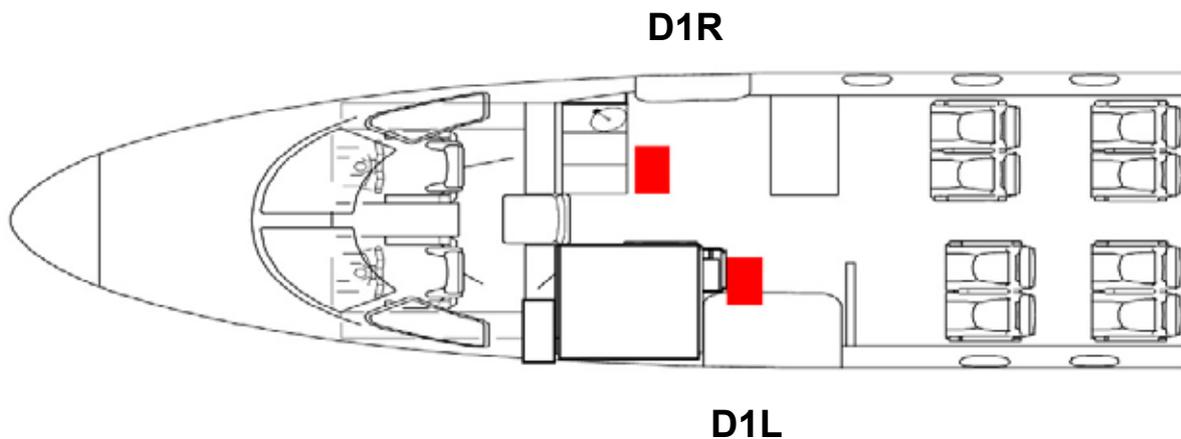
**Figure 1**

approximately midway up the cabin, over the wings. On hearing the order to evacuate, the cabin crew opened their allocated doors, the escape slides inflating automatically. The SCCM initially prevented passengers using Door 1 Left (D1L) as the slide had not fully inflated by the time the first passenger arrived there. Once it was fully inflated, the SCCM had to push himself past the flow of passengers to reach Door 1 Right (D1R) to open it. He commented that had he opened this door first, given the layout of the cabin, he would not have been able to push past passengers to get to D1L (Figure 1).

Forward cabin layout, showing forward exits (Doors 1 Left and Right)

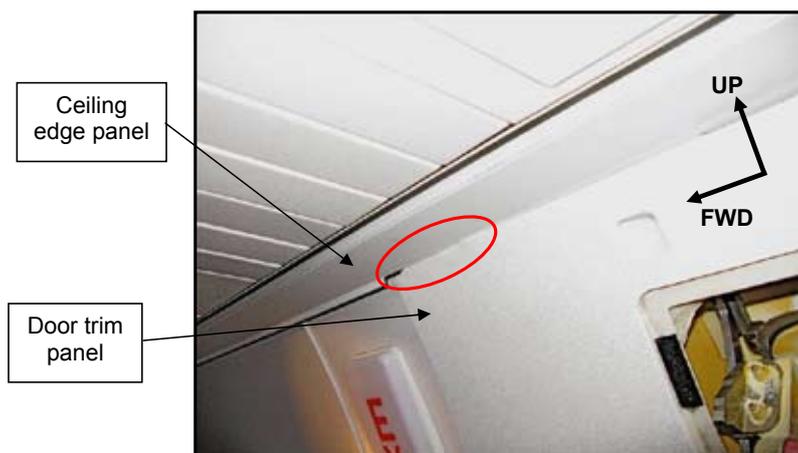
**Figure 2**

When the order to evacuate was made, passengers were able to open the left overwing exit door and evacuate onto the wing. Attempts to open the right overwing exit door proved unsuccessful, as the forward upper part of the door trim had become jammed under the ceiling edge trim panel, preventing the exit from being opened (Figure 2).

Right overwing emergency exit showing door trim partially jammed (circled) under ceiling edge panel

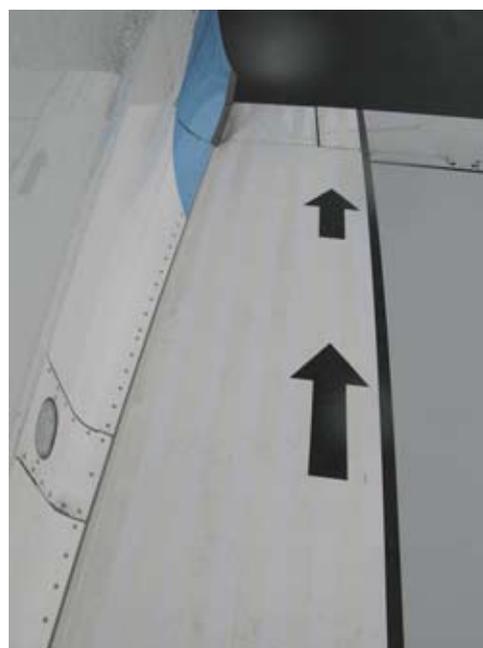
**Figure 3**

Two male passengers who evacuated via the overwing exit were able to jump down from the rear of the wing and assist other passengers to the ground. This included a mother carrying a baby. They believed that had they not been able to offer such assistance, it is likely that some of the passengers might have received serious injuries in attempting to climb off the wing. Passengers believed that the situation would have been worse had it either been raining or dark at the time of the evacuation.

Overwing exit evacuation route markings (left wing shown, view towards wing trailing edge)

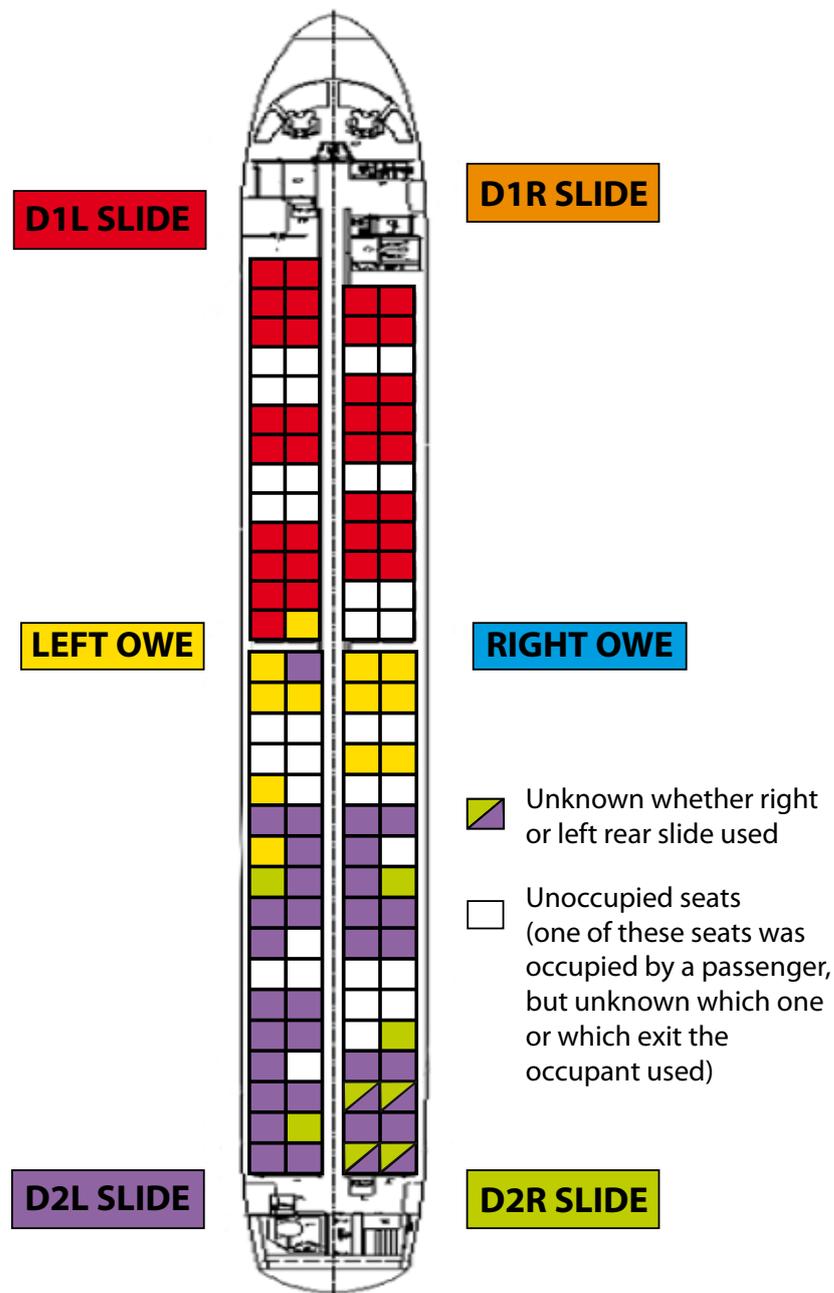
Figure 4 illustrates the exits used by the passengers, correlated by seat position. It shows that no passengers used D1R, despite this door being open with the slide

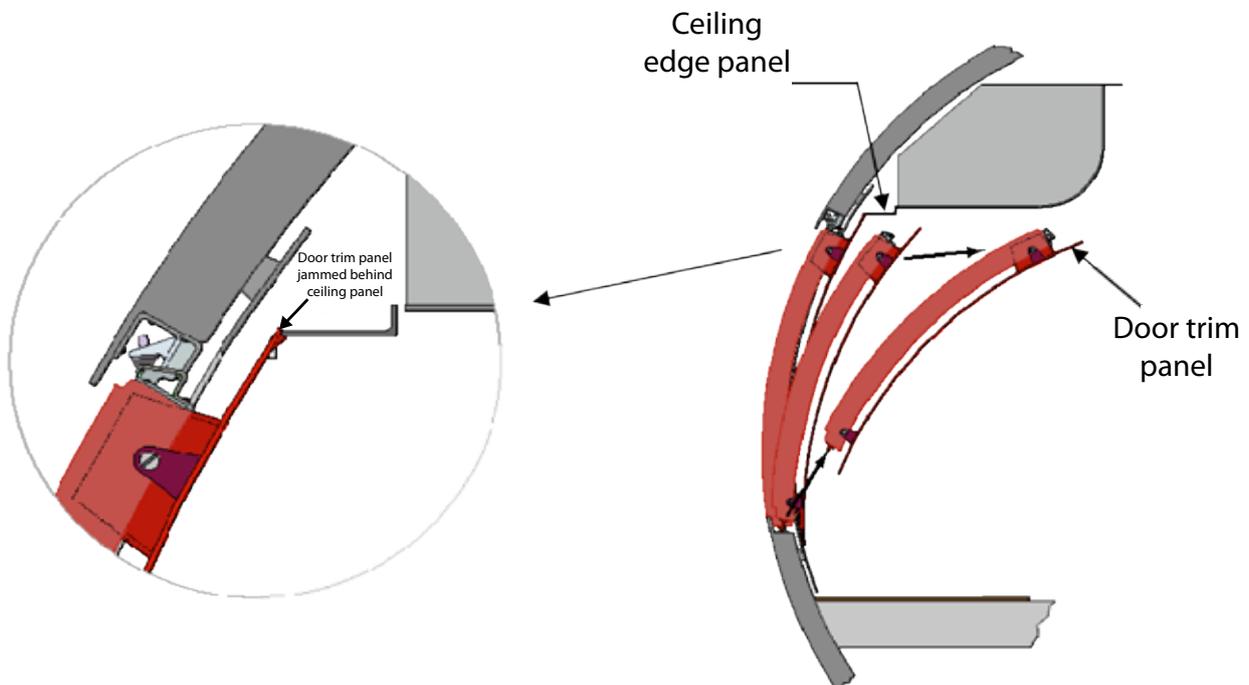
**Figure 5**  
Overwing emergency exit opening, showing location of jam

The overwing exit door is retained at its lower edge by spigots which engage in recesses in the bottom edge of the door aperture. Its top edge incorporates a locking mechanism operated by a handle at the top of the door, covered by a removable panel secured by Velcro strips. Pulling the operating handle disengages the lock at the top of the door and allows the door to pivot inwards about its lower edge. The spigots remain engaged until the door has pivoted inwards sufficiently for its top edge to clear the aperture, after which it is lifted clear of the aperture using a fixed handle near its base to support its weight. The door must then be thrown out of the aperture so that it does not cause an obstruction in the cabin to evacuating passengers. A compressible rubber bumper block limits the vertical displacement of the door during the initial phase of opening.

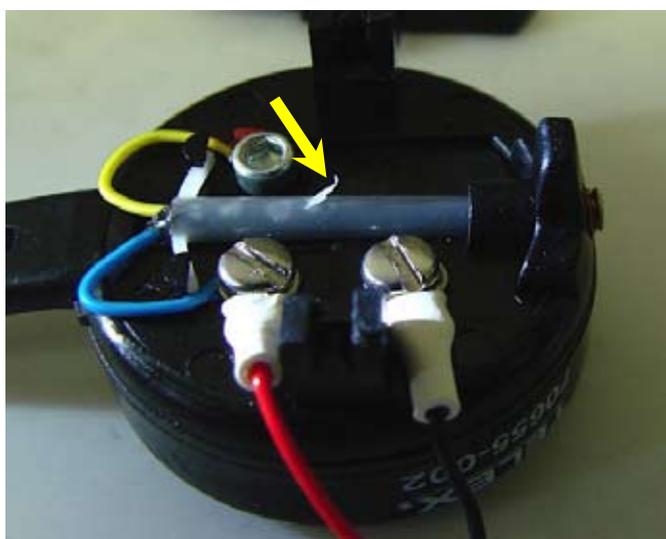
**Figure 6**

Disassembly of the captain's mask from the other aircraft identified a spurious whisker projecting from the plastic housing of the cut-out switch, the free end of which contacted the underside of the flow sensor pivot. The

whisker acted as a ratchet, tending to inhibit movement of the sensor vane in the direction required to reactivate the microphone, whilst leaving its motion in the direction required to cut out the microphone unaffected. Consequently, the mechanism tended to stick in the cut-out position, leaving the microphone open circuit. The whisker or spurious material appeared to be a ‘curl’ of the switch casing material (Figure 6), probably created either in the production of the switch itself, or during its assembly into the mask.

Whisker of plastic material on cut-out switch
