CONTENTS

SPECIAL BULLETINS / INTERIM REPORTS

AAIB Special Bulletins / Interim Reports

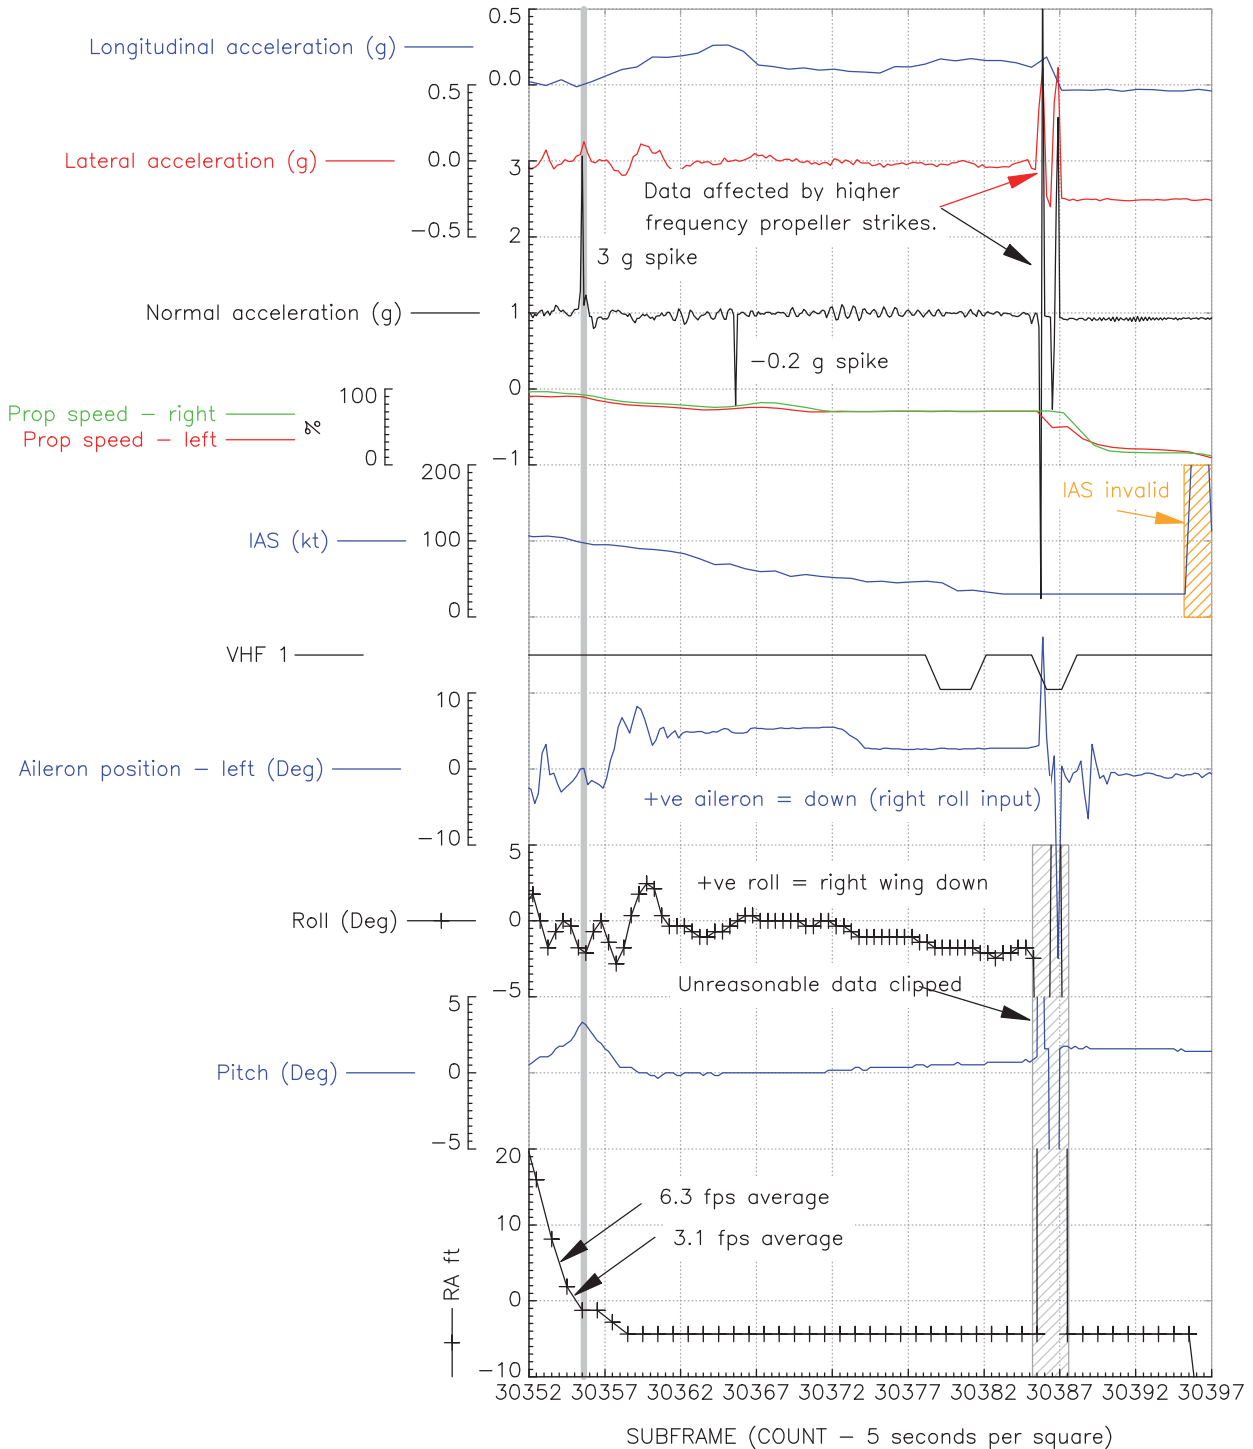
Figure 2
Pertinent FDR parameters

The FDR recorded a 3g normal acceleration spike on touchdown, significantly higher than would be expected during a landing. However, the recorded radio altitude profile indicated a descent rate averaging approximately 3.1 fps over the second just prior to touchdown which was only slightly higher than normal when compared to ten other flights recorded by the FDR. These calculated descent rate figures have limitations due to the low sample rate of once per second; the final height loss may have occurred within a shorter period than the one second between samples.

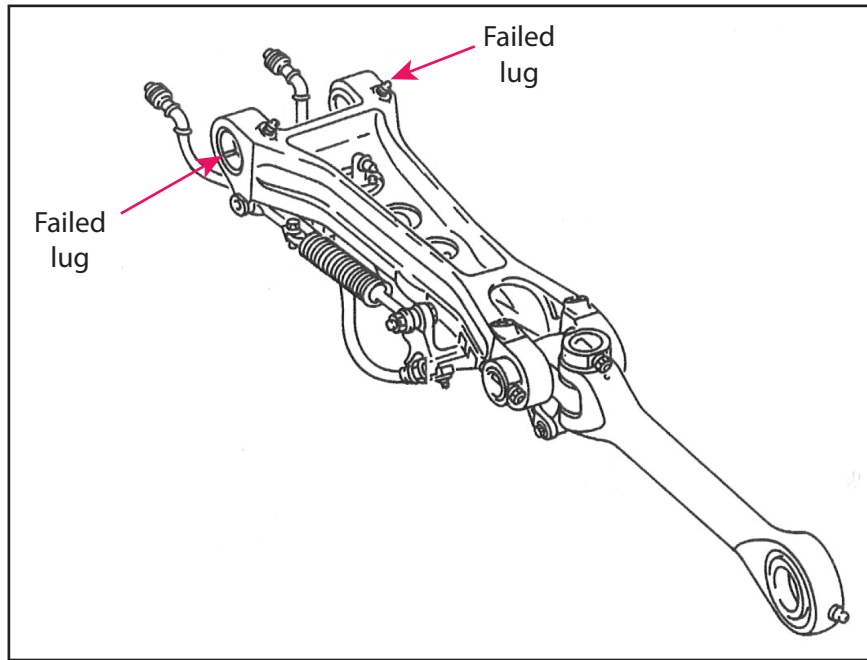
Figure 5

It was found that the side brace upper arm of the left main landing gear had suffered a structural failure. This had taken the form of a fracture of both lugs at their attachment to the through bolt in the fuselage-mounted pivot bracket (Figure 5). The failure

had rendered the side brace ineffective allowing the main leg to pivot outboard beyond its normal fully deployed position. This had resulted in non-design loading being transferred to the actuating cylinder and overload failure occurring in its attachment bracket to the fuselage structure. The unrestrained main trunnion had thus continued to translate outboard. Part of the lower fuselage had ultimately come into contact with the runway surface. The fractured lug recovered from the runway was found to be the forward of the two lugs of the side brace upper arm.

Side brace fracture locations

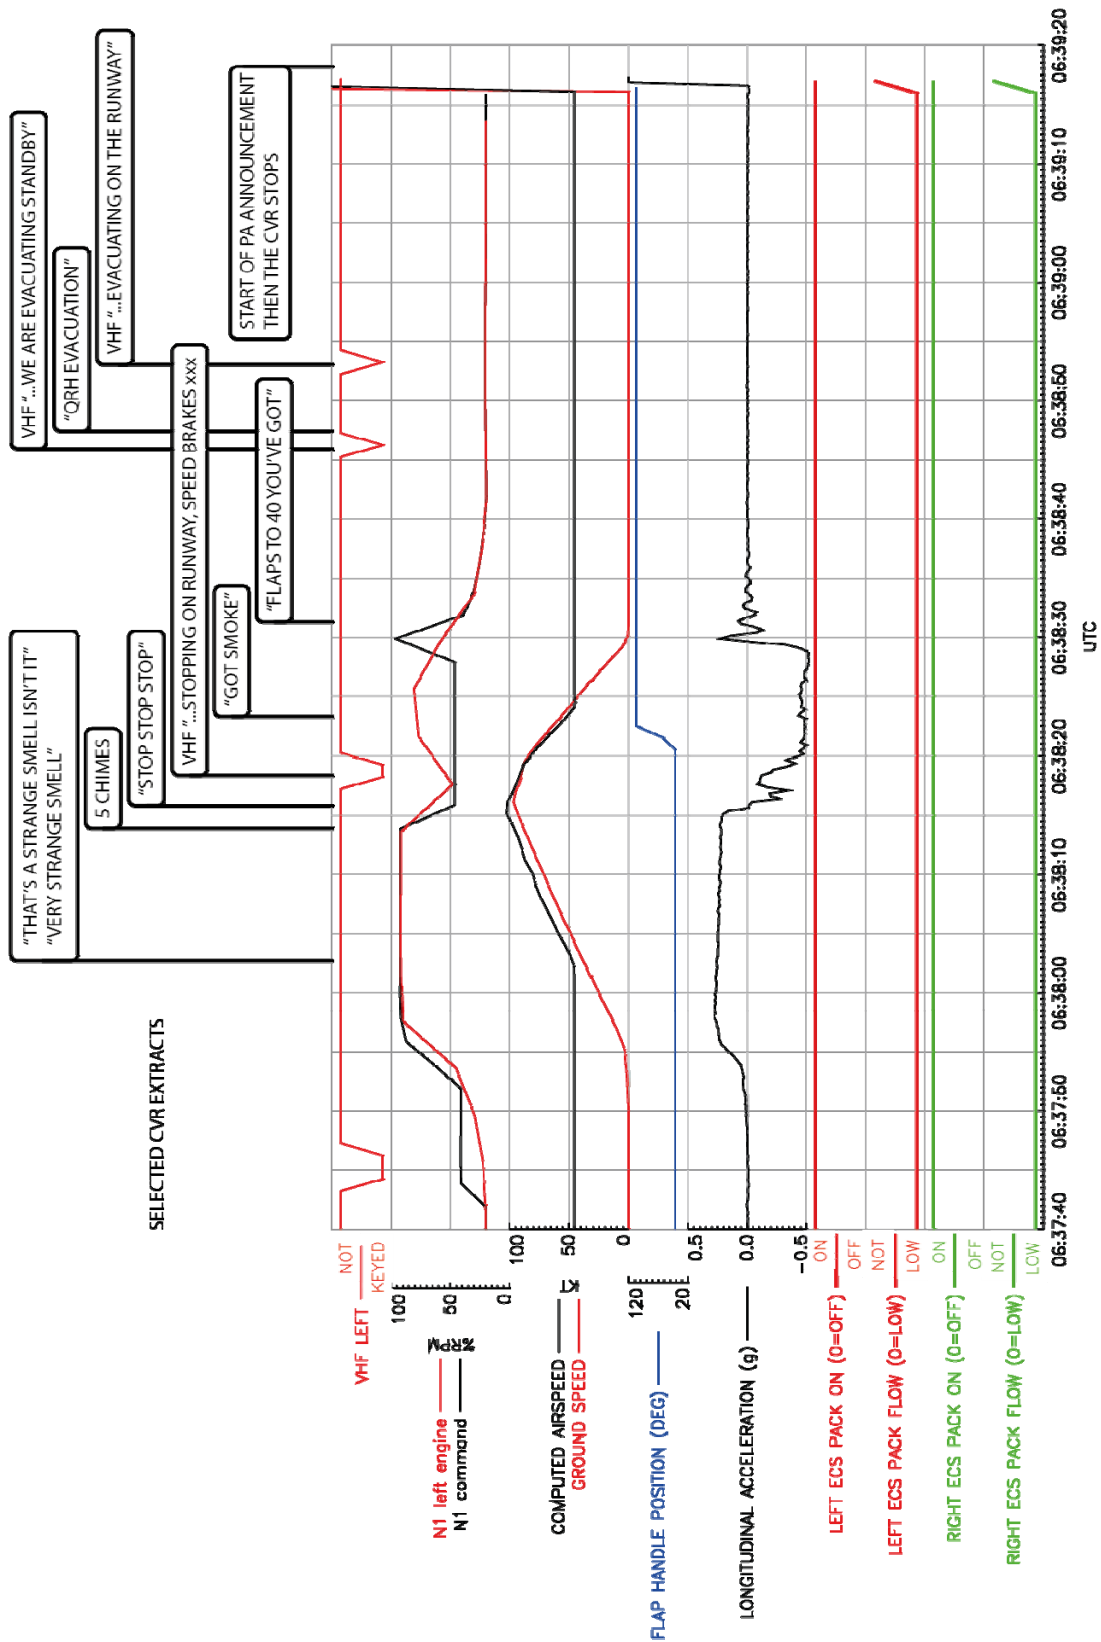
Figure 6

The recordings show that the pilots identified a "STRANGE SMELL" approximately five seconds after the engines reached their takeoff power. The flight crew did not make reference to any visual signs in the cockpit. Eleven seconds after the flight crew first commented on the smell, the cabin crew alerted the flight crew to a problem in the cabin. This was identified as smoke. There was no reference to heat or breathing problems.

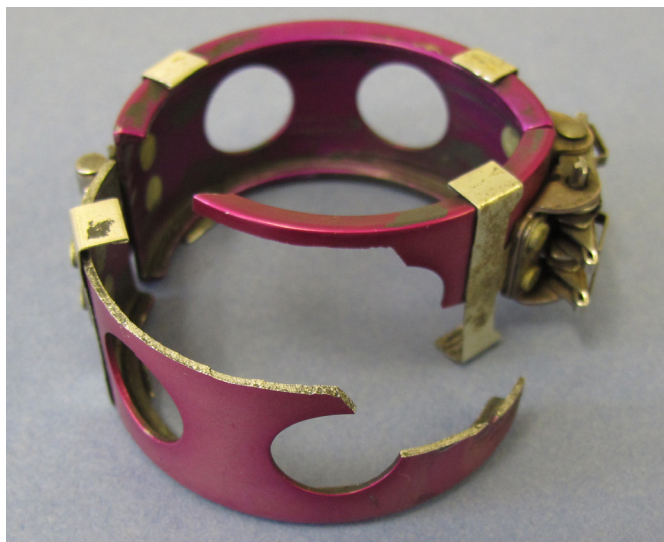
Figure 1

Failed Wiggins clamp from G-TLET

The metallurgist concluded that the clamp from G-TLET had separated due to fatigue fracture under the influence of engine vibrations. It was not possible to estimate the duration of the fatigue crack growth.

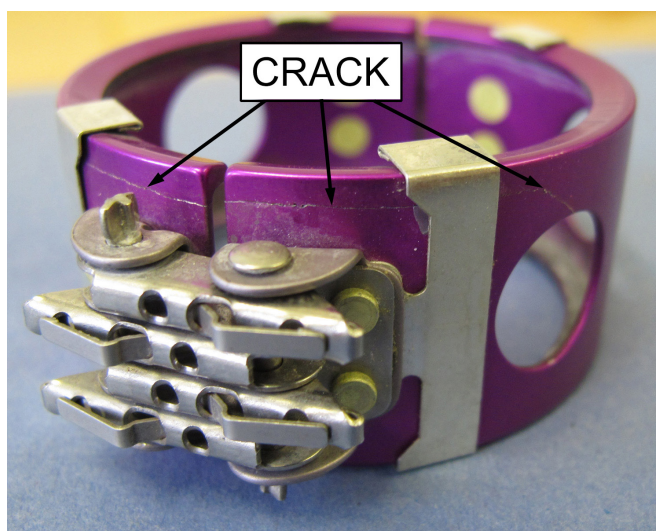
Figure 2

Cracked Wiggins clamp from another PA-28-161 with TAE 125-02-99 engine (G-BZLH)

wall thickness was measured as between 0.864 mm and 0.889 mm, which was within specification. There was evidence of significant fretting on the inner surface of the G-TLET clamp (Figure 4). There was also fretting wear on the inner surface of the G-BZLH clamp (Figure 5), although less extensive than on G-TLET. This indicated that both clamps had been subject to vibrations during operation.

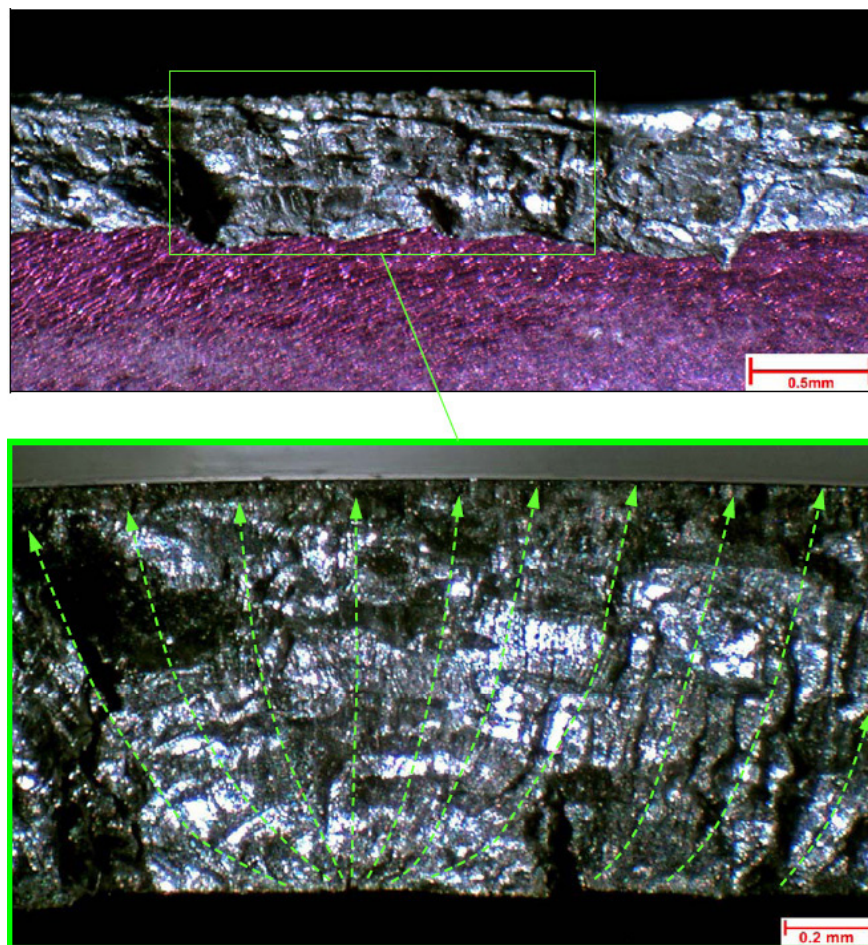
Figure 3

Radial outward fatigue crack growth on the main fracture plane of the failed clamp from G-TLET

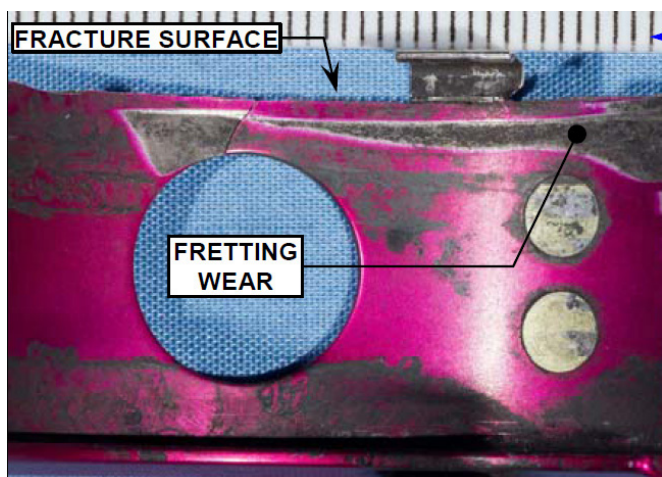
Figure 4

Fretting wear on the inner diameter of clamp from G-TLET

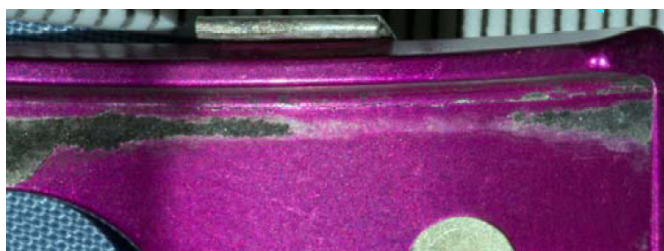
Figure 5

Fretting wear (dark areas) below crack line on clamp from G-BZLH

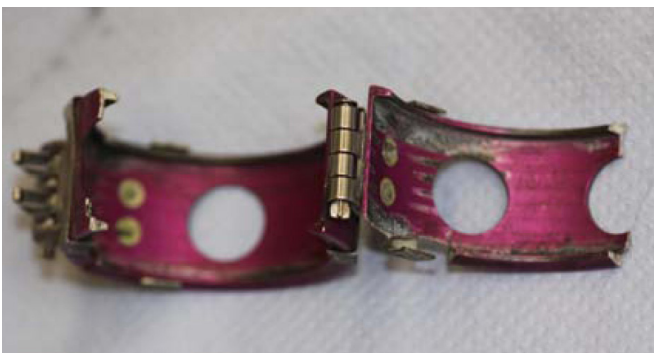
Figure 7

The engine manufacturer was aware of only one previous failure of a Wiggins clamp on a Centurion engine and that was on a Cessna 172R, registration SX-CCA, in 2010. During this incident the aircraft suffered a loss of power during the climb, but was able to turn back and land at the airfield. The clamp on SX-CCA was found to have cracked perpendicular to the main cracks found on the G-TLET and G-BZLH clamps (Figure 7). There was evidence of dark-coloured fretting damage on the inside of the clamp similar to G-TLET and G-BZLH. The engine manufacturer carried out an examination of the engine and noted that the mating section of the turbo charger compressor had a partially broken lip where the O-ring was fitted. Because the fracture surface was dirty they concluded

Failed Wiggins clamp from Cessna 172R (SX-CCA)
fitted with Centurion 2.0 engine

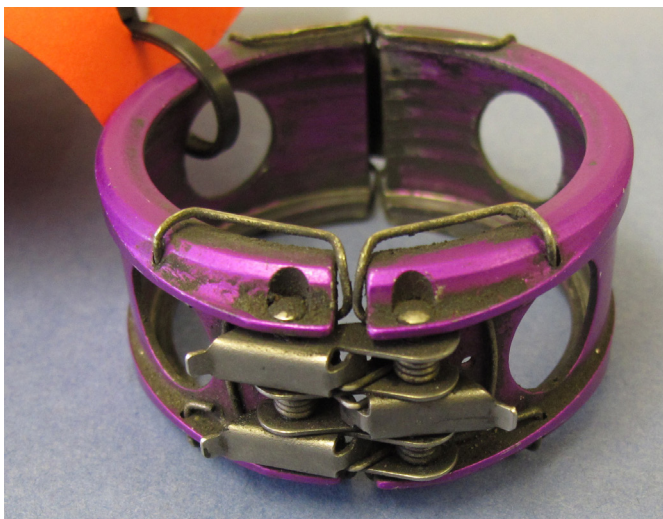
The TAE 125/Centurion engines were originally designed with a different type of clamp, part number 14C02-24A. An example of this clamp type is shown in Figure 8 – this clamp was removed from a Diamond DA40 D in 2012 due to excessive wear at the hinge. There was also evidence of fretting on the inner surface. This type of clamp is still in use today. The new clamp (P/N NM-0000-0024701), which was fitted to G-TLET, was approved in October 2003 and introduced into the field sometime thereafter but there was no requirement to retrofit, and therefore the total hours in service of the new clamp are not known. The engine manufacturer reported that the new clamp was introduced because of problems with excessive wear at the hinge of the old clamp and due to issues with its split-pin being out of position. There were, however, no reported occurrences of cracks and failures of the old clamp type. The wall thickness of the old clamp shown in Figure 8 was measured at 1.032 mm in the centre, with a region of thicker material at the edges of between 1.67 and 1.83 mm. This compares to a thickness of 0.864 to 0.889 mm for the newer clamp fitted to G-TLET.

Older style clamp (P/N 14C02-24A) which was removed from a Diamond DA40 D in 2012 due to excessive hinge wear
