Rail Accident Investigation Branch

Fire on board a freight shuttle in the Channel Tunnel - web site update and supplementary information

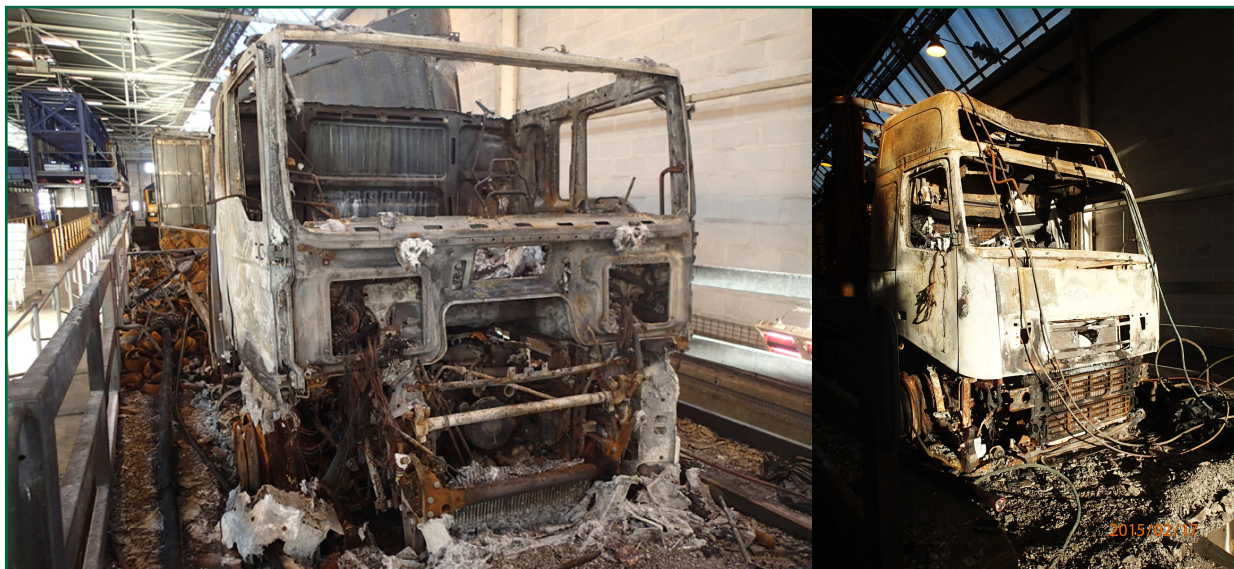
- 9 By 13:35 hrs, all other trains had left the tunnels and firefighting operations were commencing. The passengers and crew of shuttle 7340 departed from cross passage 4418 at 14:03 hrs and were taken by service vehicles to the French terminal of the Channel Tunnel system. Two lorries on the shuttle were confirmed to be on fire by the firefighting services. The fire was brought under control at 16:40 hrs but it still required several hours of dousing to cool the shuttle afterwards.

Figure 1: Images of the damage to the two lorries (both still located on the carrier wagons)

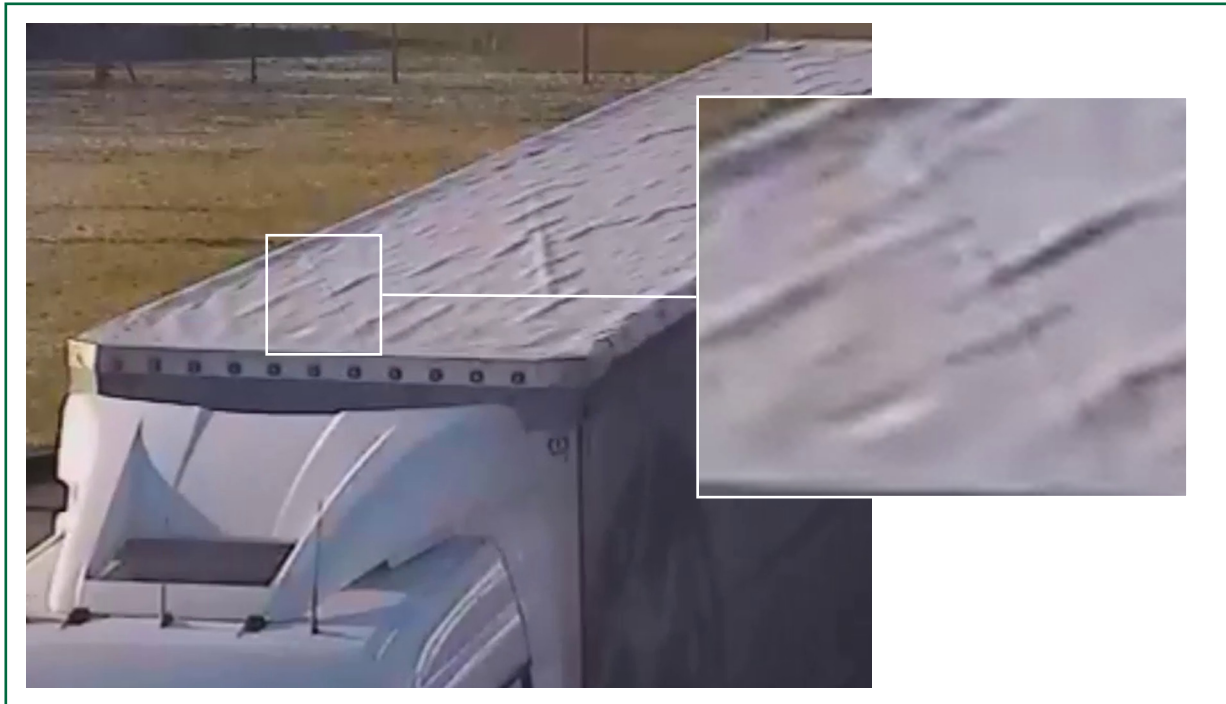
- 10 The CCTV footage of the lorry loaded on the 15th carrier wagon captured during the loading operations on the Folkestone terminal shows a whip aerial standing higher than the leading edge of the trailer. With the assistance of the lorry and trailer manufacturers, the RAIB established that this aerial was standing higher than Eurotunnel's height limit of 4,200 mm above road level and as a result came close to the overhead power line at the UK portal (a location where the height of the overhead power line reduces). The proximity of the whip aerial to the overhead power line almost certainly caused the electrical arc at the UK portal which initiated the fire.

Figure 2: CCTV image of the incident lorry during the loading operations showing the whip aerial fitted to the back of the lorry's cab

- 11 The RAIB studied the equipment and processes that are in place on the Folkestone terminal aimed at detecting over-height, thin aerials (about 1 mm in diameter). It concluded that, in order to detect over-height aerials, Eurotunnel relied solely on the integrity of sensors located at the bottom of the loading ramps referred to as the aerial detection system. This system had been in place since operations began on Eurotunnel's infrastructure in 1994. On the basis of tests organised by Eurotunnel after the incident, and using the data provided by the manufacturer of the sensors, the RAIB concluded that the aerial detection system was not sensitive enough to reliably detect thin aerials at typical lorry speeds when they passed in front of the system. This is a probable explanation of why the system did not detect the over-height aerial.

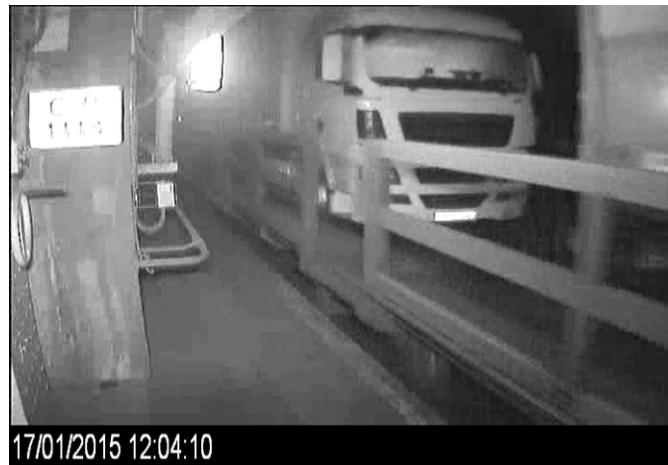
- 13 As the train came to a stand inside the tunnel following the initial power trip (12:00 hrs), smoke appeared to be developing inside the cab of the incident lorry (this can be observed from CCTV images taken from a camera located inside the tunnel). However, as there was no requirement for the train to be inspected, this early sign of a developing fire was not identified. It was 23 minutes later that the fire was detected. In the meantime, opportunities to stop the train within one of the two SAFE stations had been missed.

Figure 3: CCTV image of the incident lorry showing smoke inside the cab shortly after the power trip
