Rail Accident Investigation Branch

Rail Accident Report

Derailment of a tram on the Seaton Tramway 18 March 2007

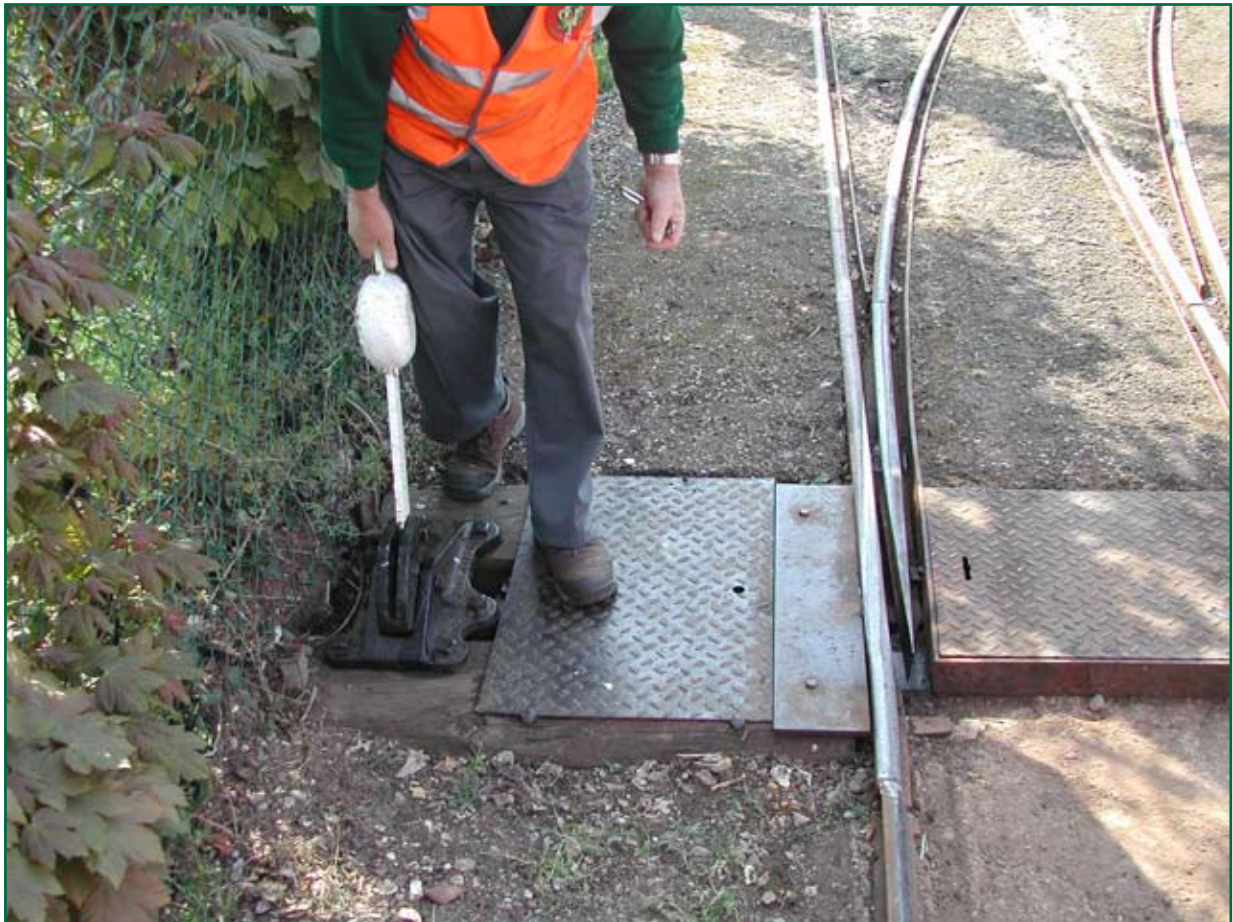
Figure 4: Points lever lifted and switch open with locking pin in position

10. Located at the entry to Seaton station is a pair of points, leading to a siding (Figure 3). These points are normally set so that trams run into the station platform. The points are operated by a weighted lever, which is secured by a pin; the pin, in turn, is padlocked in position, and are not *detected*. A tram can only enter the siding if the pin is removed and the points fully thrown to *reverse*. However, the pin allows sufficient movement of the lever for trams to *trail* the point when leaving the siding; the weight of the lever then ensures that the points then return to their normal position. As a result the lever can be manually lifted sufficiently that the *switches* partially open (Figure 4).

1. The Seaton Tramway should replace the weighted lever at the entry to Seaton station with a point lever that is capable of being locked when not in use, in order to prevent it from being used to move the points without authority. The points could be operated from the lever via a slotted joint, and be spring loaded, so that operational flexibility is not lost.
2. The Seaton Tramway should implement, so far as is reasonably practicable, the provision of visual indicators that show to drivers whether sprung and weighted points on the system that are used by trams carrying passengers are correctly set for the normal route.

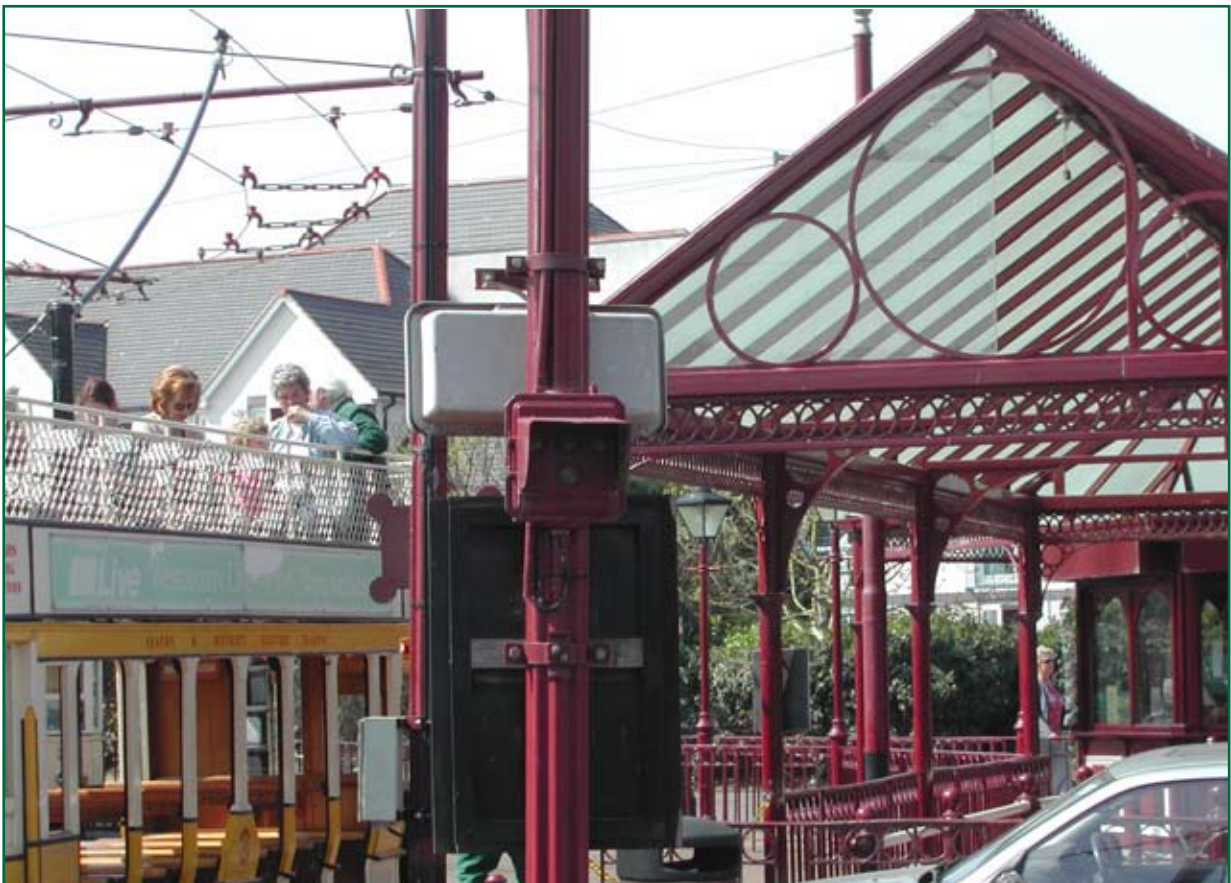
Figure 5: Trolley indicator

24. The trolley indicator is situated 22 metres after the points, and is over to the right relative to the approaching tram; it illuminates when the driver has travelled only 8.8 metres past the points. The requirement of Rule 81 to look at the indicator means that the driver of a tram may tend to look at the points, in accordance with Rule 60, some distance before arriving at them, and then look up for the indicator. If viewed from a distance, and in the absence of any other indication of the lie of the points it is possible that the driver may not notice if the points are slightly open.

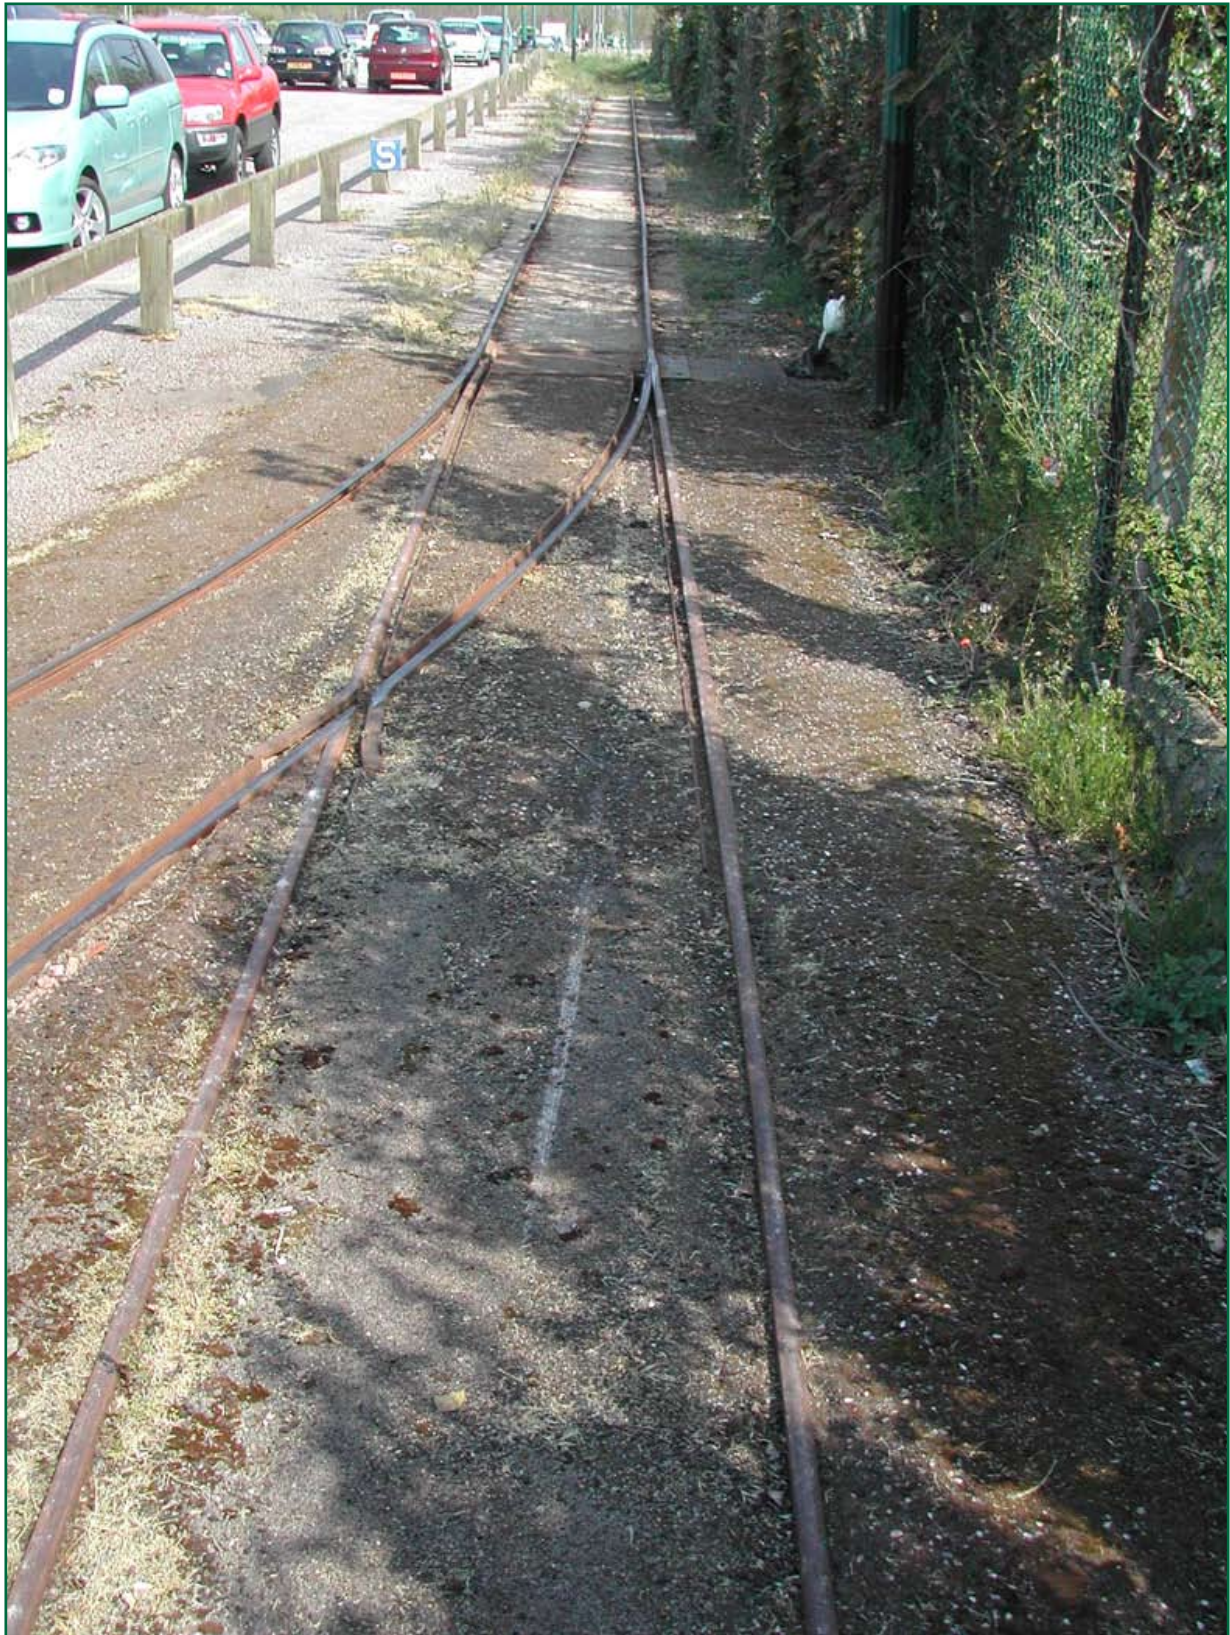
Figure 6: Marks from derailment

17. The incident was not immediately reported to the RAIB (paragraph 28). After the derailment the tramway company found marks between the switch and stock rails of the points. They concluded that these marks indicated that there was an obstruction between the two rails, such that the switch rail was held slightly open. There were several incidents of vandalism around Seaton station at the time of the derailment, and the tramway company concluded that the derailment was caused by someone placing a stone in between the switch and stock rail, with the switches being just sufficiently open to lead to the derailment, but not so far open that the driver could see the risk.

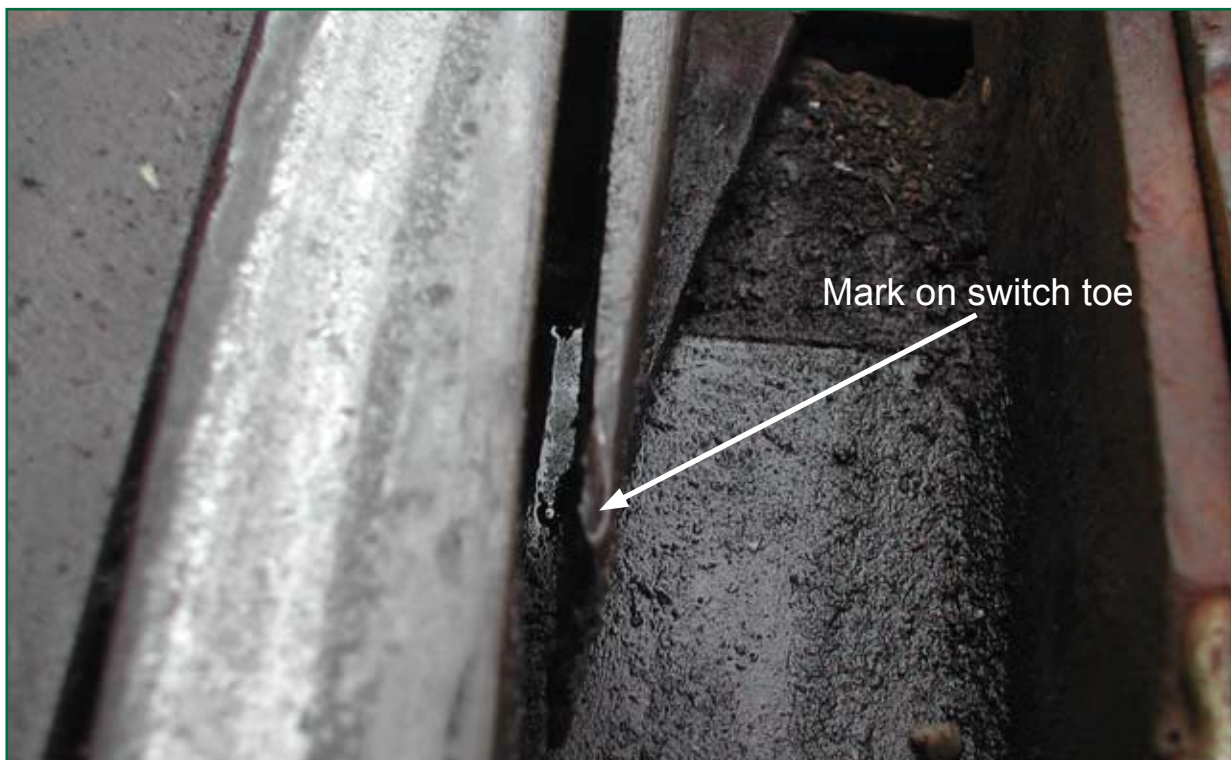
Figure 7: Mark on switch toe

19. Subsequent examination of the switches by RAIB showed a small mark on the switch toe, on the stock rail side, such as would have been made by a wheel striking the switch toe and going between the switch and the stock rails (Figure 7). The derailment marks on the switch toe, and on the ground, accord with the points lying very slightly open, so that they were struck by the tram's wheel, which went to the wrong side of the switch rail. The design of the point lever (paragraph 10) would allow the points to be opened sufficiently to let an object be placed between the switch and stock rails.

20. There have been no previous derailments at these points caused by the switches lying open, and they have functioned satisfactorily since the derailment, although no further maintenance has been carried out. The points operated satisfactorily when demonstrated to the RAIB in mid April. In view of these, and the relatively fresh state of the mark on the switch toes, the RAIB is satisfied that it is associated with the derailment on 18 March 2007.

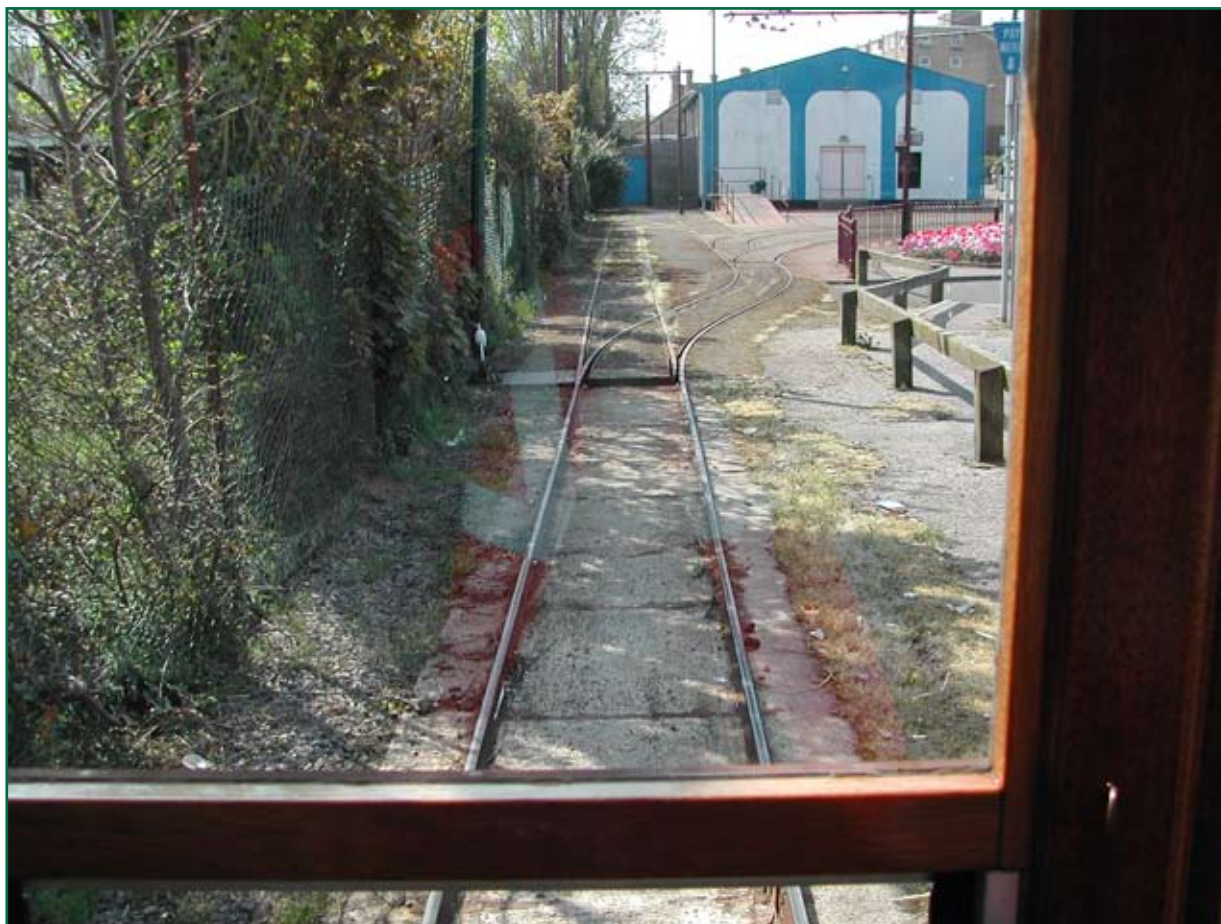
Figure 8: Driver's view approaching Seaton station

22. The safe operation of the points depends on the driver, as he approaches the points, being able to see whether they are set correctly (Figure 8). In this case the driver did not see the small opening of the points.
