Rail Accident Investigation Branch

Rail Accident Report

Dangerous occurrence at Lindridge Farm user worked crossing, near Bagworth, Leicestershire 22 March 2012

Report 11/2013
July 2013

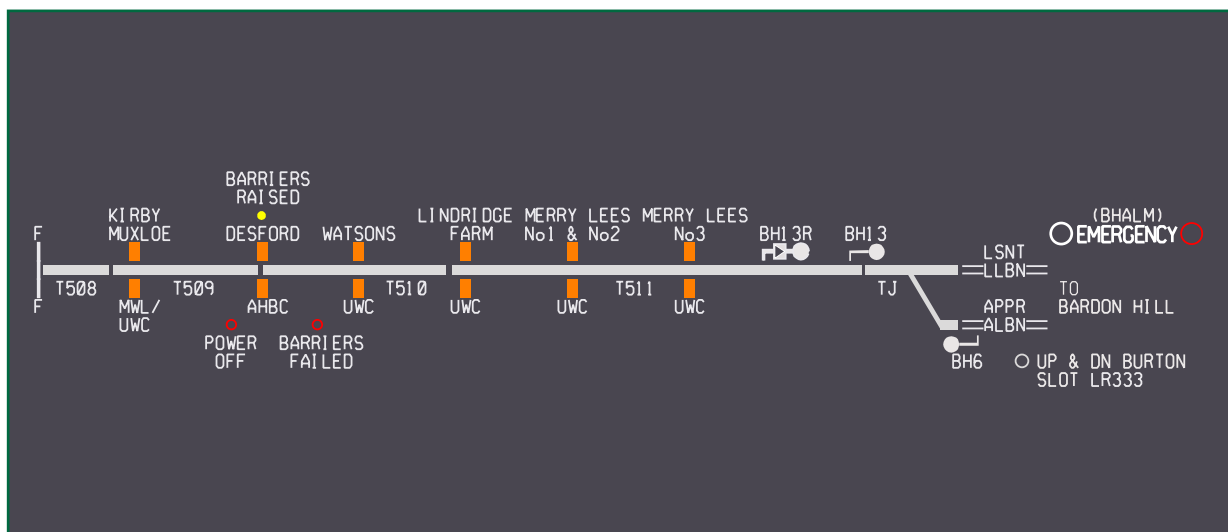
Figure 8: Track sections T510 and T511 as displayed on the Leicester workstation view at EMCC before the incident

- 35 Network Rail's technical and operations staff investigated and by 10:30 hrs they had found that Lindridge Farm user worked crossing and also Merry Lees No.1 & No.2 and Merry Lees No.3 user worked crossings were all shown in the wrong place on the signaller's workstation view. They identified that these crossings were shown on track section T511 when they should have been shown on track section T510 (figure 8).

55 The immediate cause of the incident was that the signaller believed that train 6Z75 had already passed Lindridge Farm user worked crossing when he gave the motorist permission to cross, because his workstation view showed the level crossing on track section T511 and the train on track section T510.

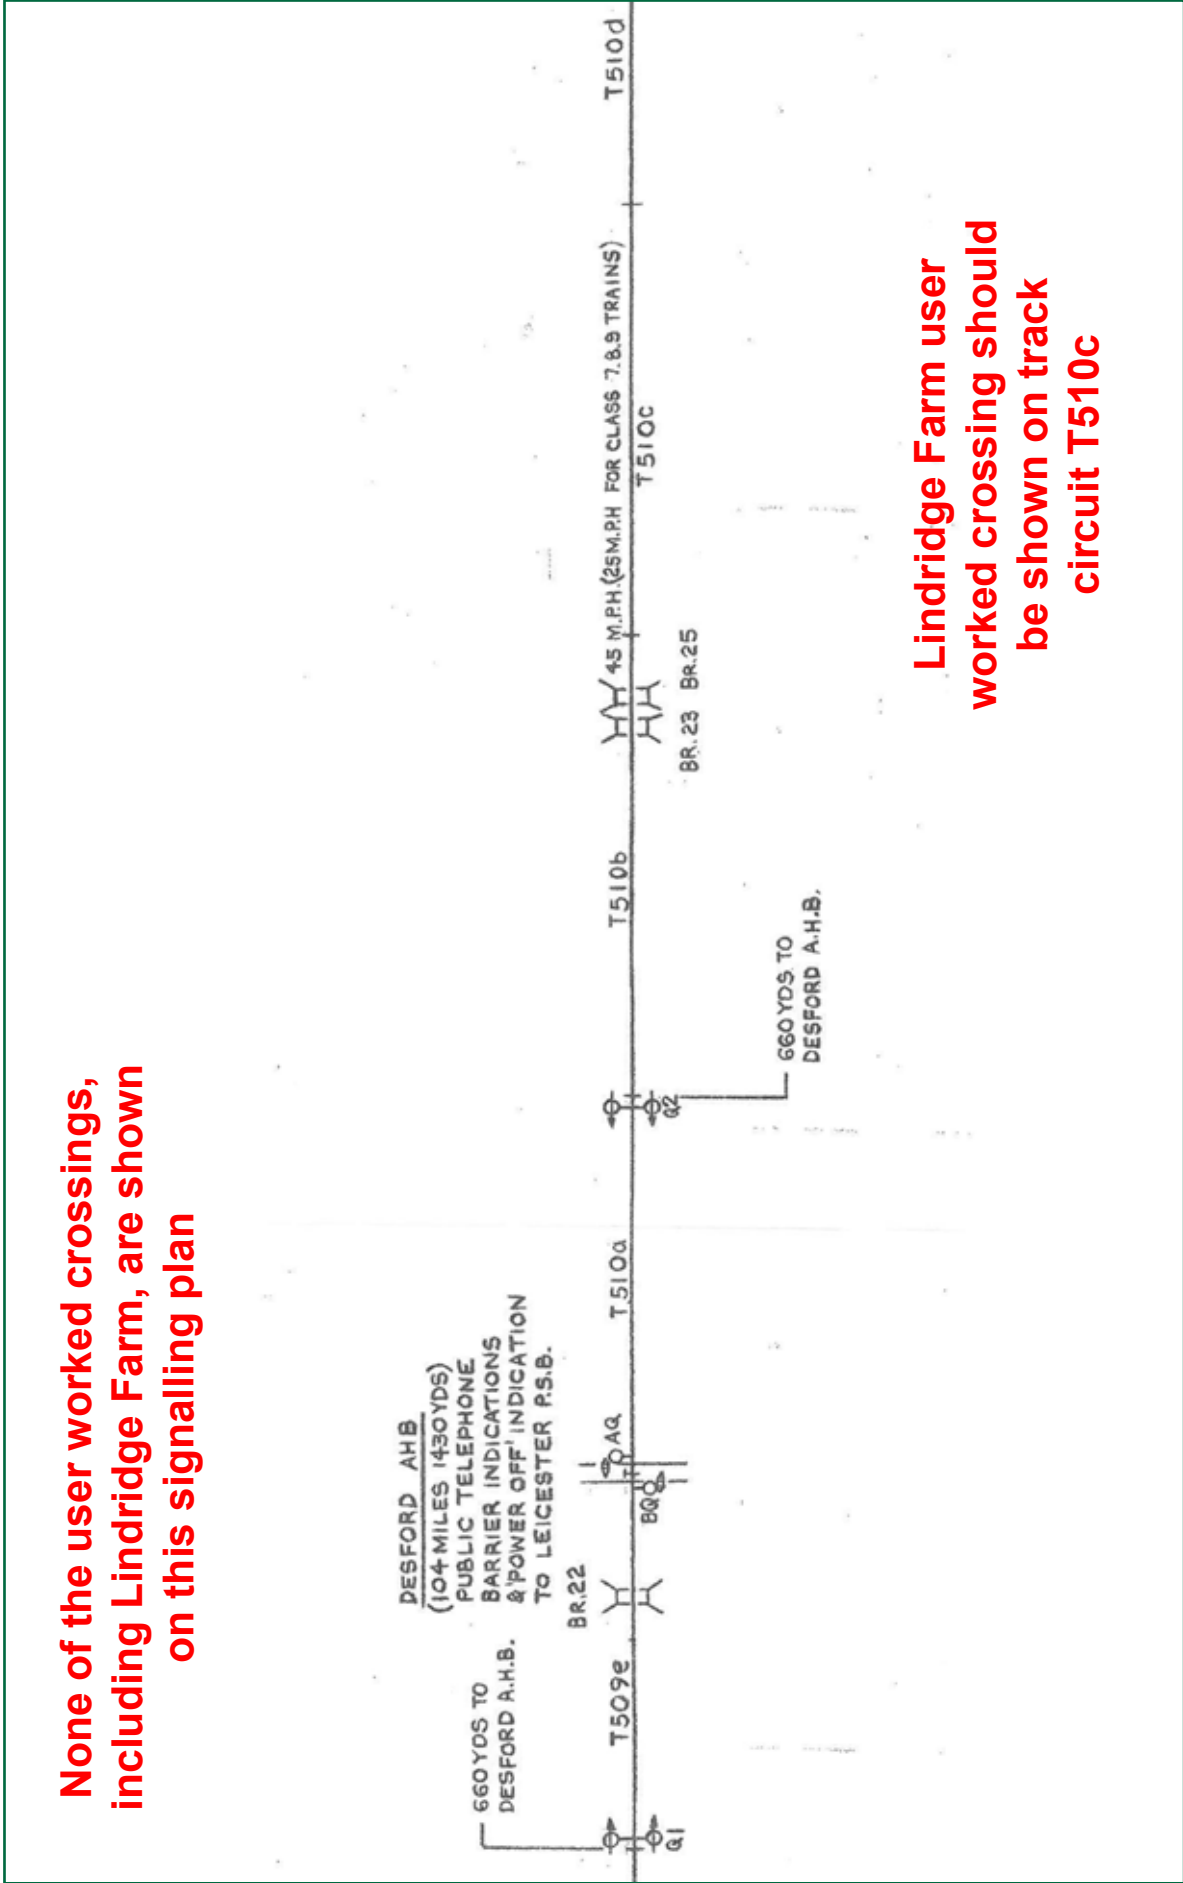
Figure 12: The Up and Down Burton line as shown on the existing signalling plan for Leicester, dated 1984

Lindridge Farm user worked crossing should be shown on track circuit T510c

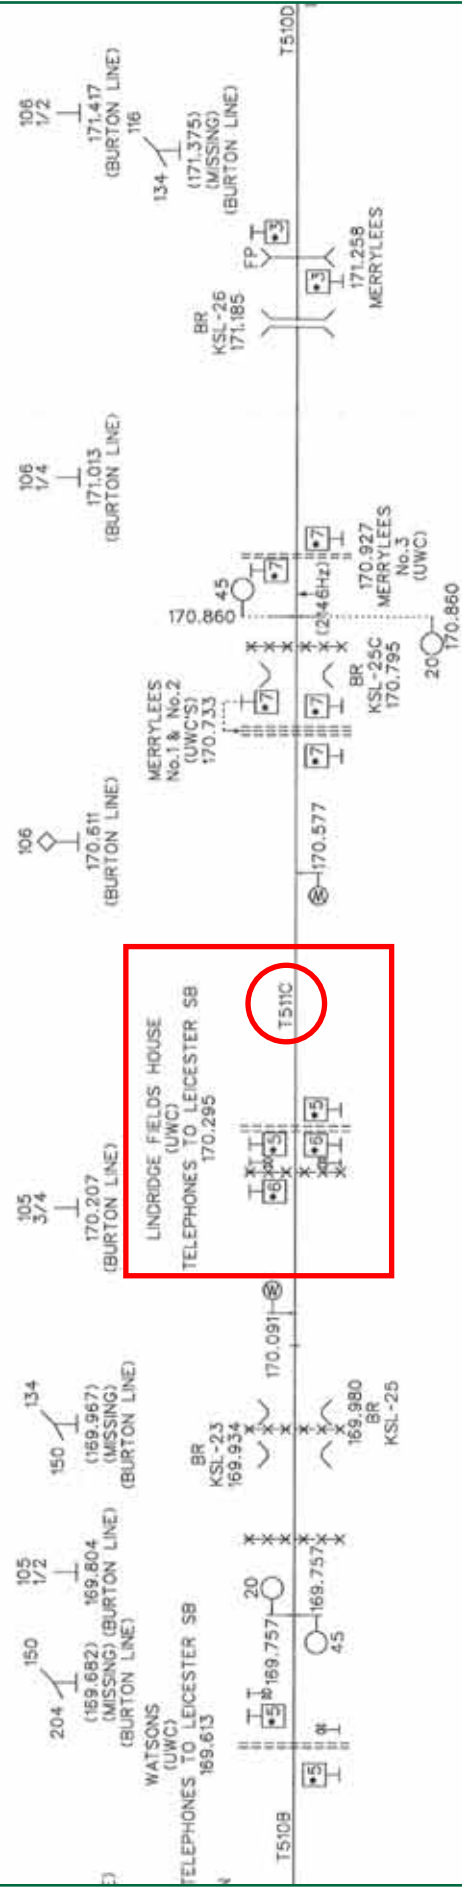
Figure 13: The error on the approved signalling plan for the Leicester area

Note: Lindridge Farm user worked crossing is incorrectly named as Lindridge Fields House user worked crossing on this plan

- b. The signalling plan for the Leicester interlocking renewal, which was redrawn by Network Rail SDG, contained an error that incorrectly named track circuit T510C as T511C (**paragraph 67, Recommendation 2**).

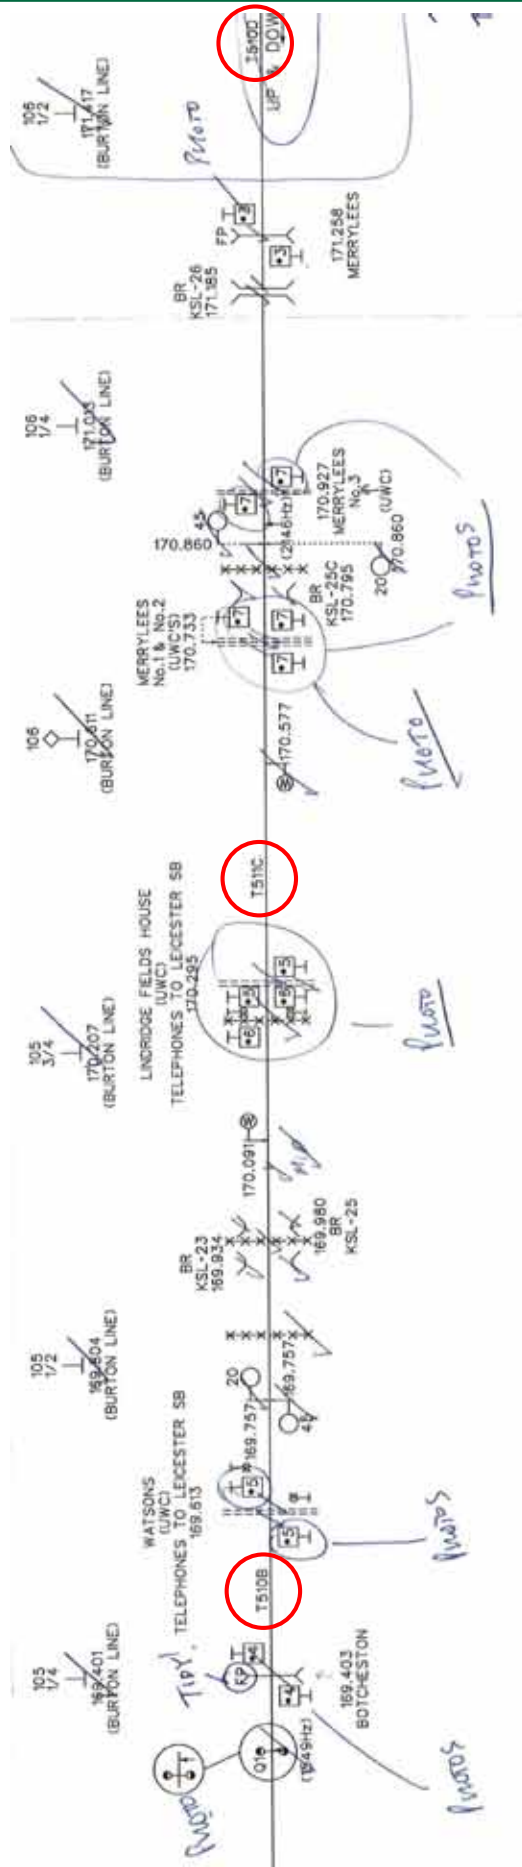
Figure 14: The tick marks and error on the copy of the signalling plan looked at by the checker

Note: Lindridge Farm user worked crossing is incorrectly named as Lindridge Fields House user worked crossing on this plan

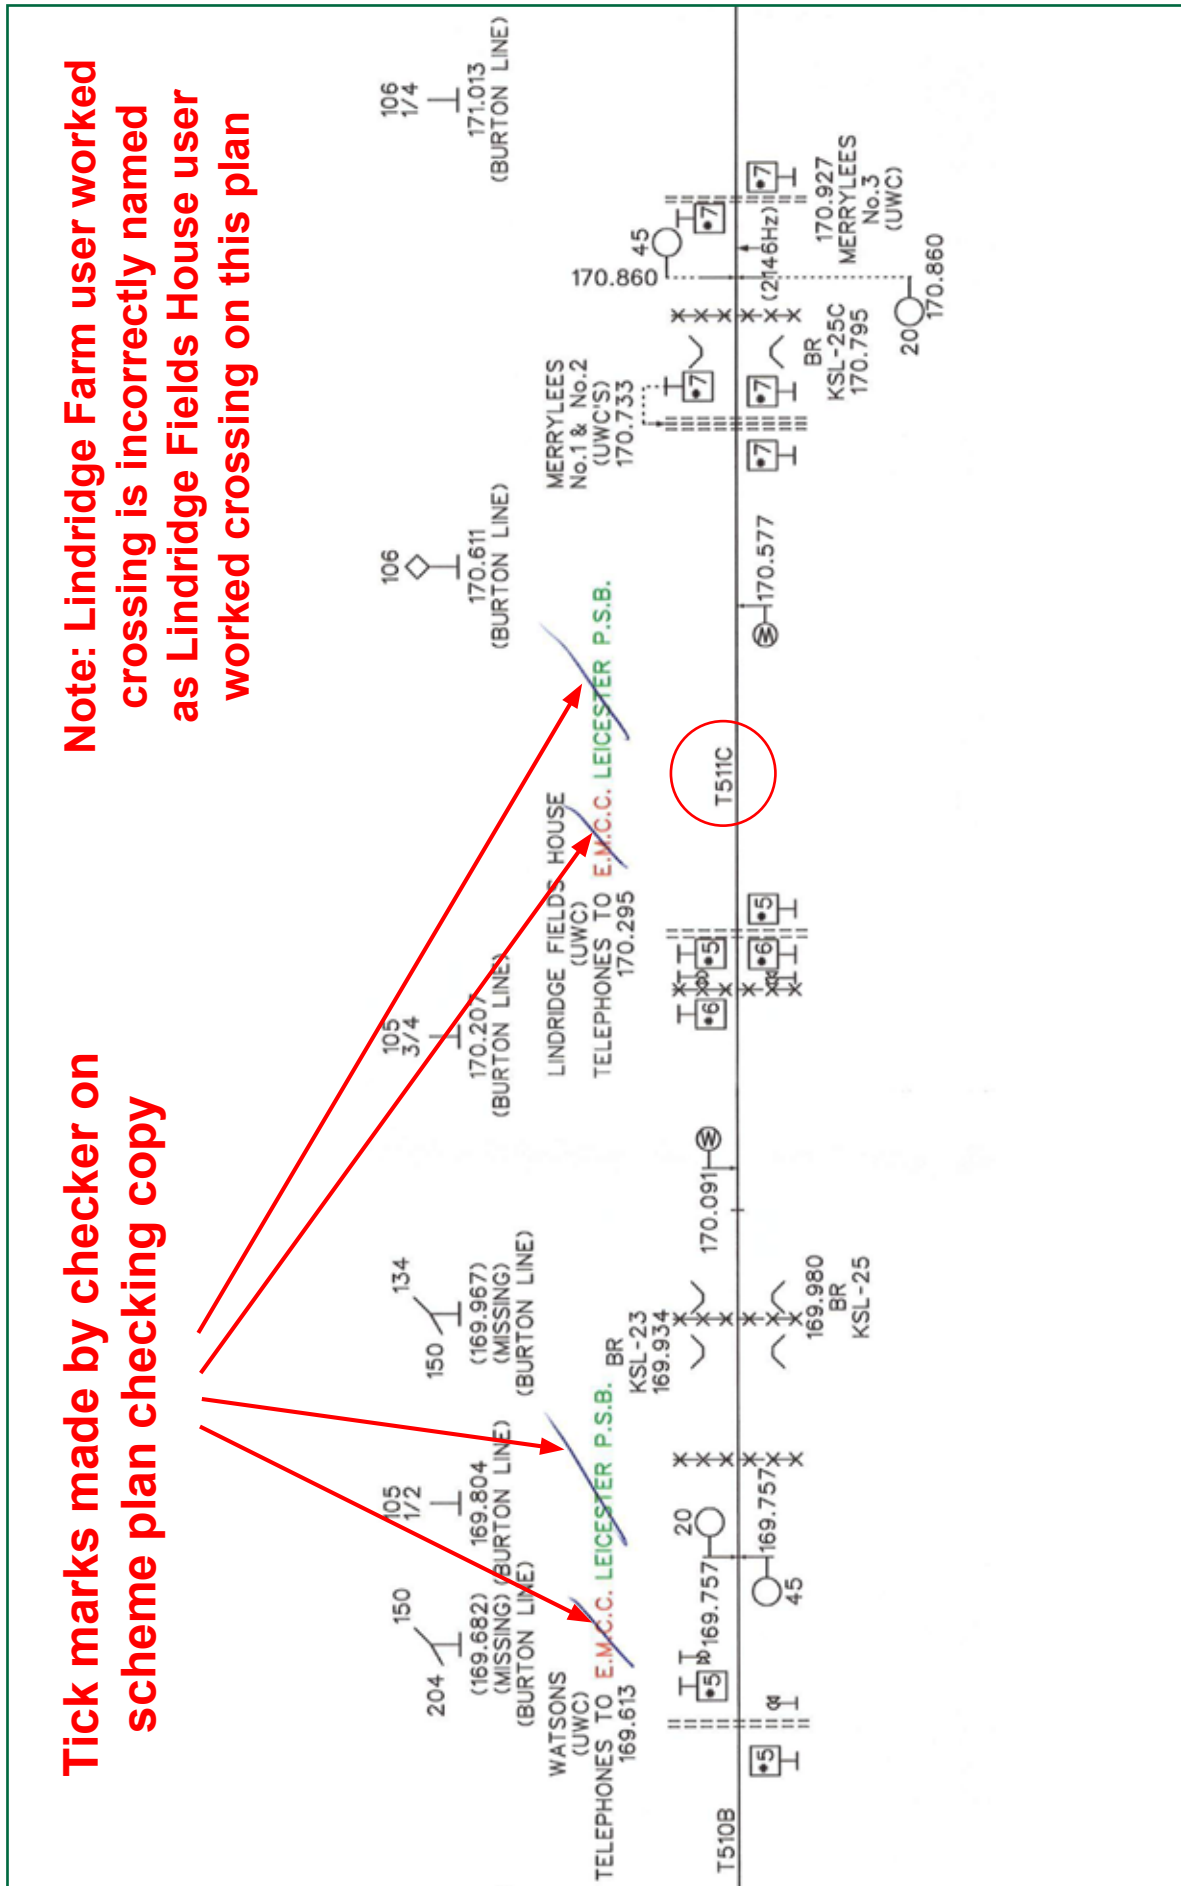
Figure 15: The tick marks and error on the checker's copy of the re-control scheme plan for Leicester

100 The error was not found during the production or checking of the re-control scheme plan for Leicester. This is a causal factor.

Tick marks made by checker on scheme plan checking copy

Note: Lindridge Farm user worked crossing is incorrectly named as Lindridge Fields House user worked crossing on this plan

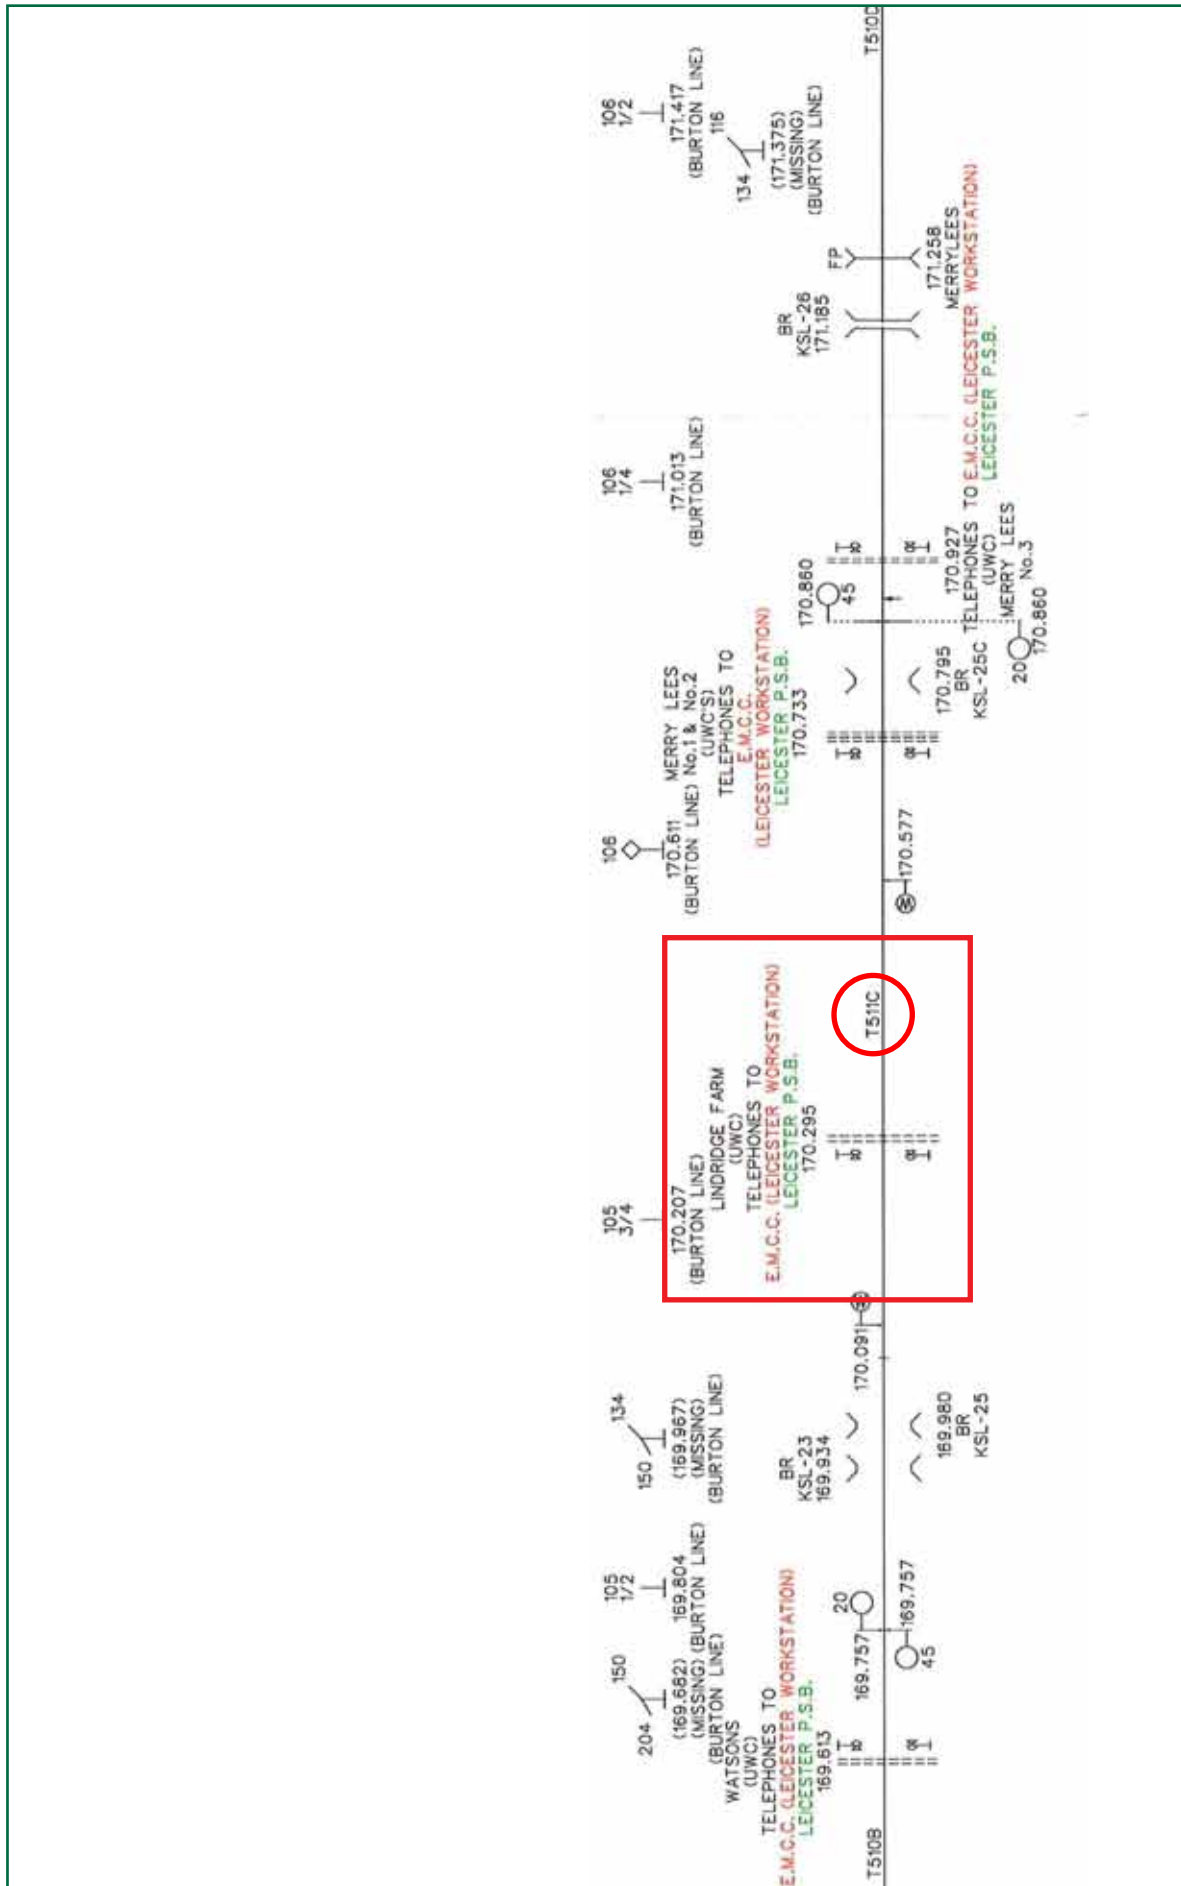
Figure 16: The error on the version D scheme plan for the Leicester area

- d. Versions D onwards of the re-control project scheme plan for Leicester, which were produced by Network Rail SDG, contained an error that incorrectly named track circuit T510C as T511C (**paragraph 95, Recommendation 2**).

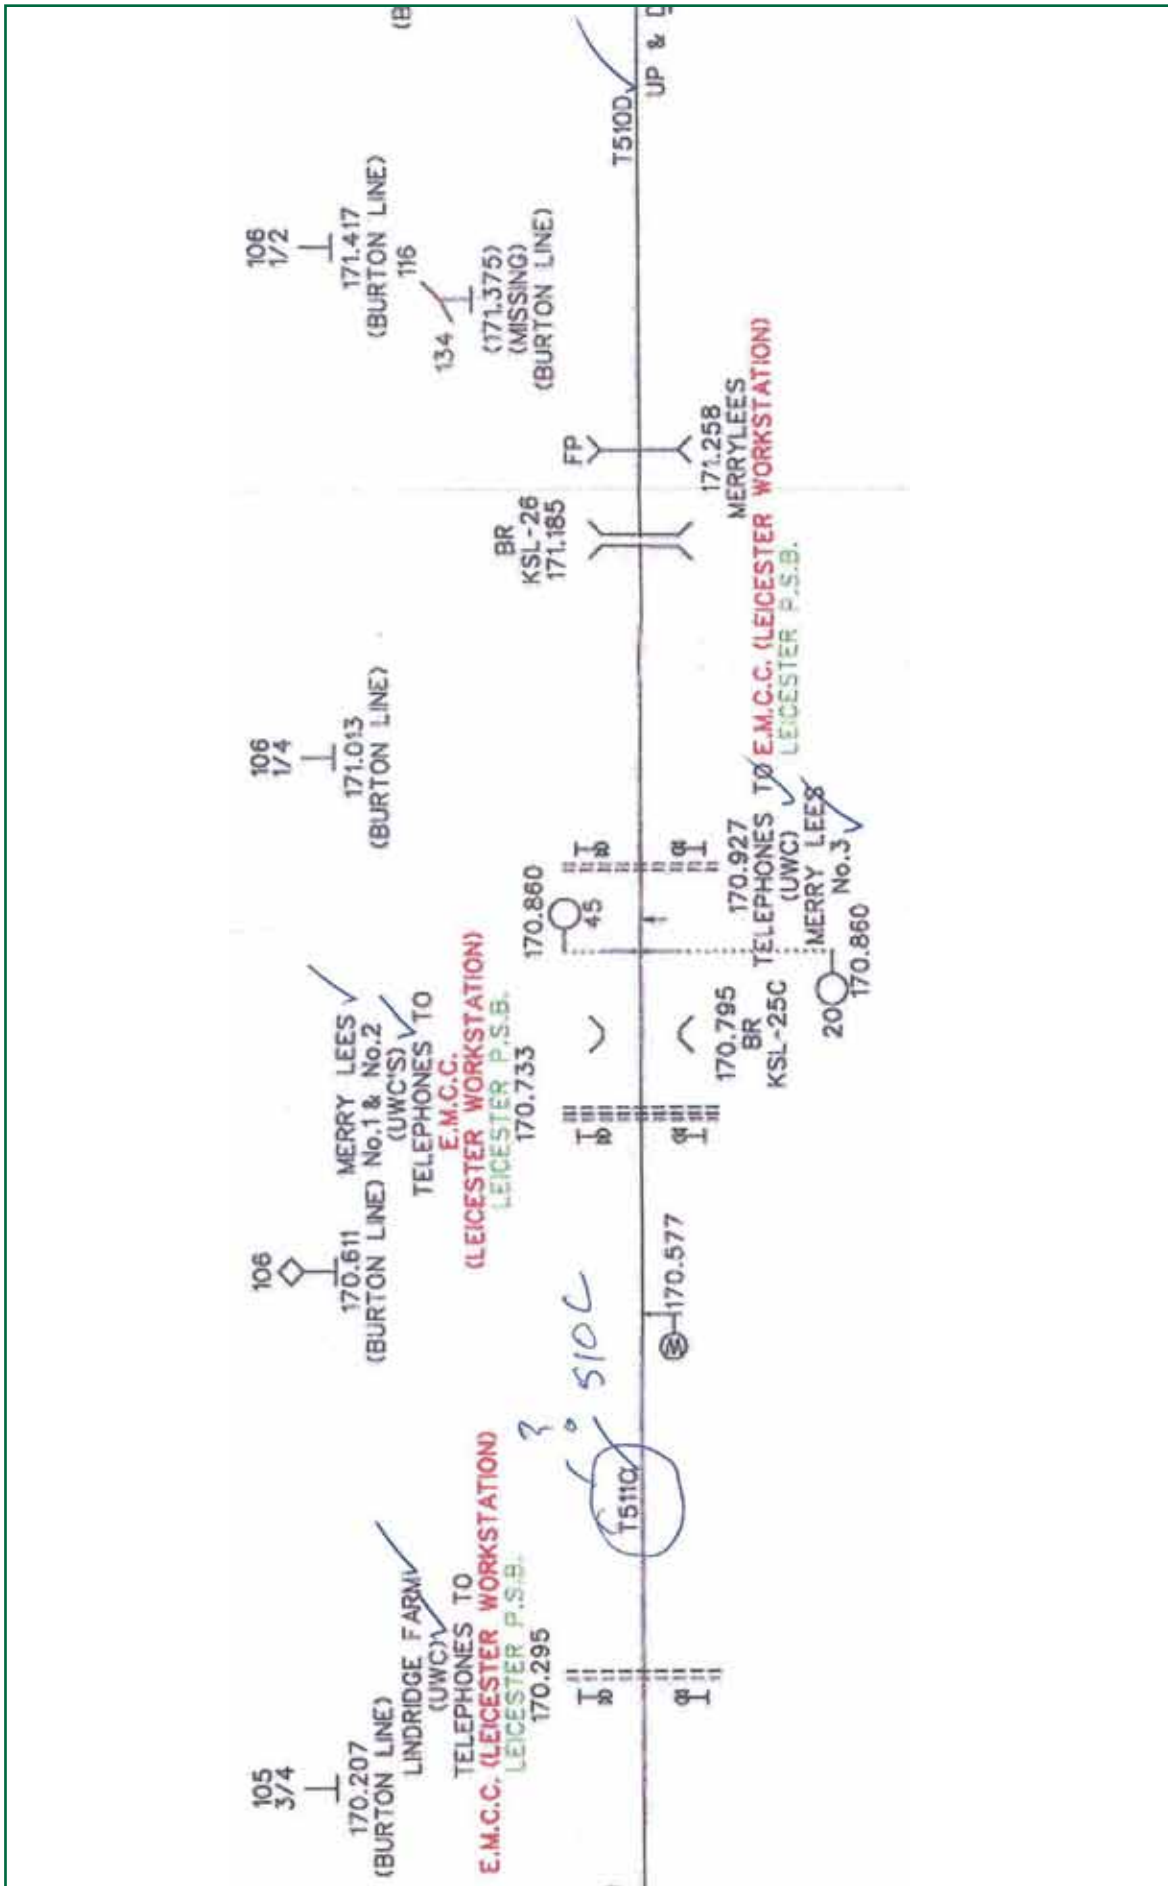
Figure 17: The tester's marks identifying the error on his copy of the re-control scheme plan for Leicester

- 120 Later on during 6 December, the tester noticed the error on the scheme plan when he logged that track circuit name T511C was shown twice on the scheme plan (figure 17). The tester recorded the error on a *test log*. It was the last item in a list of six scheme plan errors that the testers had noted during their checks that day.

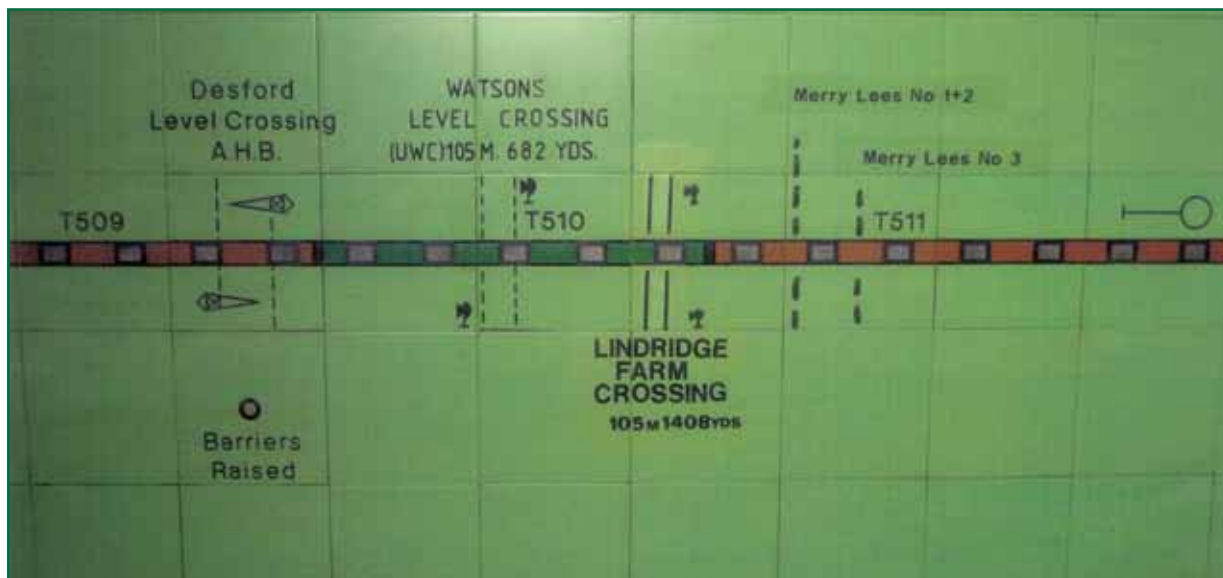
Figure 19: The signaller's panel at Leicester signal box with the Merry Lees user worked crossings incorrectly marked up on track section T511

131 The only track circuit name shown on this snapshot was T511C, so on 28 April, the Local Operations Manager marked the signaller's panel up with the Merry Lees crossings shown on track section T511 (figure 19). As explained earlier (paragraph 67), the signalling plan for the Leicester interlocking renewal contained an error with track circuit T510C incorrectly named as T511C. This led him to incorrectly mark the Merry Lees crossings on track section T511 instead of T510. The signaller's panel at Leicester signal box remained like this until it was decommissioned on 31 December.
