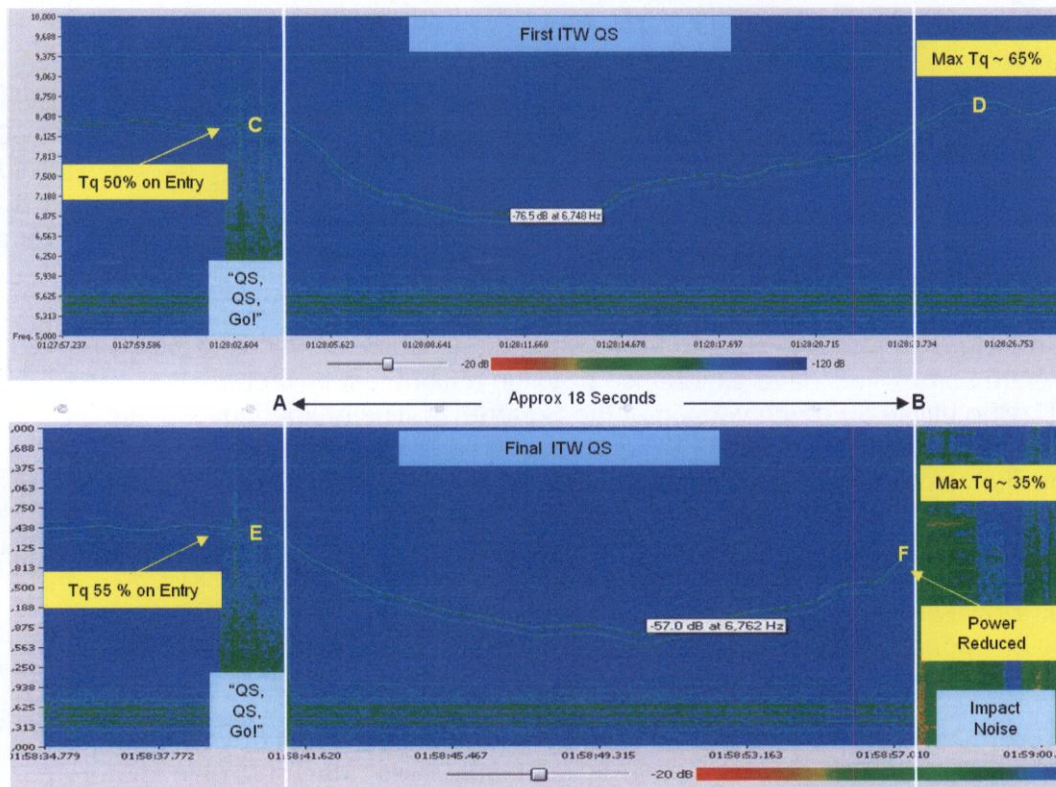
Figure 9 – Comparison Between First and Final ITW QS

a. The final QS took 18s from entering the manoeuvre until the aircraft impacted the ground (Line A-B). The 1<sup>st</sup> ITW QS took approximately 22s from entry until the aircraft came to a high hover. The point where max power is applied (point D) (aircraft in high hover) can be seen to occur past line B.

b. **Application of Power.** Fig 9 shows the variations of power during the ITW QSs based on the assertions made at 1.4.34.

i. Point C shows that the SP was applying approximately 50% Tq prior to entry on the 1<sup>st</sup> ITW QS. On entry, the power was reduced to near 0% Tq then increased gradually as the aircraft lost translational lift until he was established in a high hover pulling approximately 65% Tq (Point D).

ii. Point E shows that the SP was applying approximately 55% Tq prior to entry to the Final ITW QS. On entry, the power was reduced to near 0% Tq

then increased to a maximum of about 35% Tq (Point F). This figure was lower than the previous QSs and insufficient to prevent the aircraft from descending at that stage of the manoeuvre.

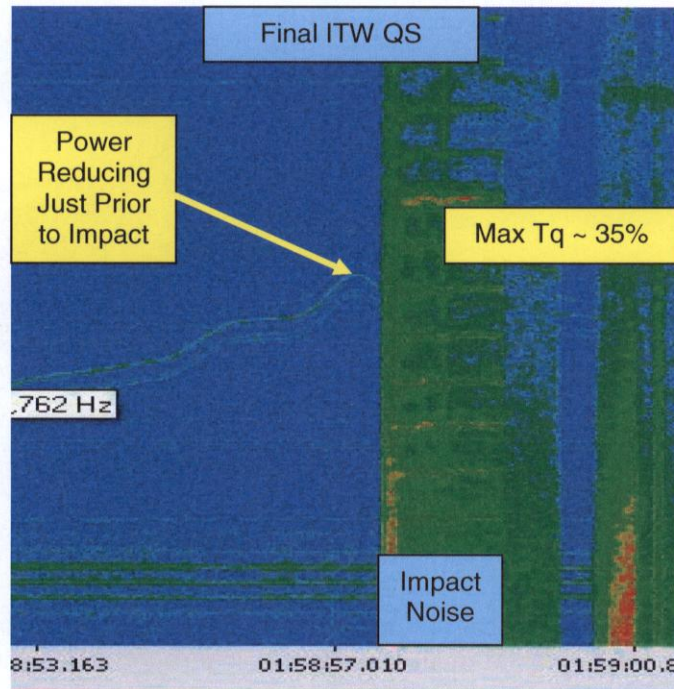
Figure 10 – Impact

- c. **Cushion of Impact.** The SP reports lowering the level and this was reinforced on the sonograph (Fig 10) indicating a reduction in power just prior to impact. The Panel was unable to positively determine why the SP did not cushion the impact but concluded that the following was the most probable:

- i. Given the SP's diagnosis of VR, he believed raising the collective lever would have exacerbated the situation.
- ii. The SP's significant fixed wing experience may have influenced his actions and caused him to 'revert to type'; therefore, it was not instinctive to pull in the collective.

The Panel concluded that the failure to apply sufficient power to arrest the RoD at the end of the final QS was the **cause** of the accident and that lowering the collective lever just prior to impact was an **aggravating factor**.

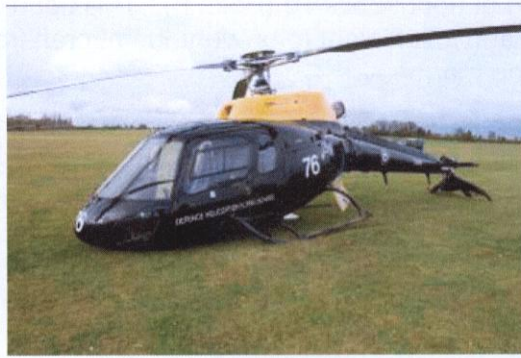
Figure 11 - ZJ276 Post Accident

1.4.52. **Final Impact.** The aircraft impacted the ground with considerable force in a near level attitude and slight forward speed. The aircraft came to rest in an upright position with the skid forward vertical struts sheared, resulting in the underside of the cockpit touching the ground. The tail pylon failed at the transportation joint causing the pylon to collapse, see Fig 11, below.

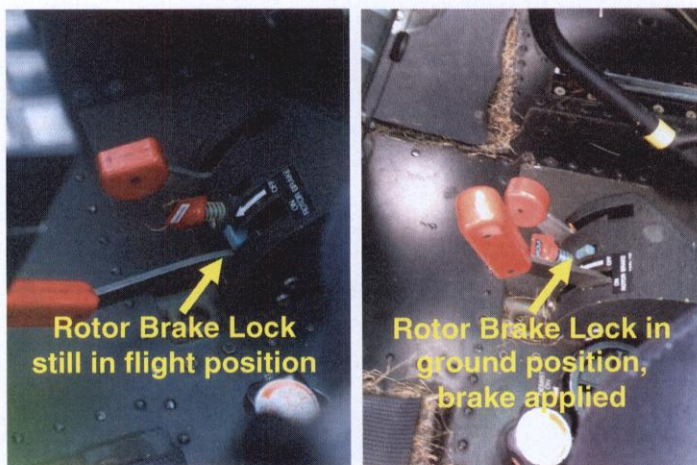
Figure 12 - Rotor Brake Lock

1.4.55. **Shutdown.** The pilot closed the throttle and operated the fuel shut-off lever. He attempted to apply the rotor brake and reports that the rotor brake lock was stuck; therefore, he waited until the rotor blades had slowed sufficiently before evacuating the aircraft. Post accident examination confirmed that the rotor brake lock was still in the flight position (Fig 12) and free to move.

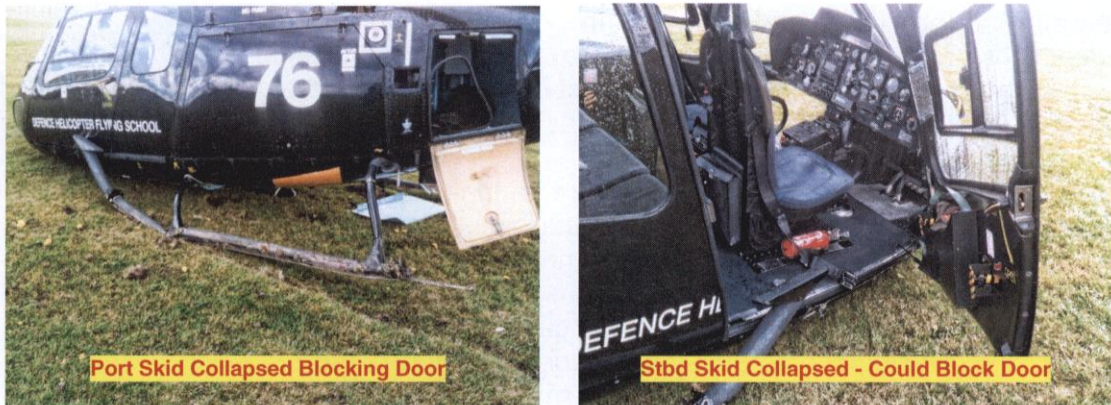
Figure 13 - Collapsed Skids

1.4.56. **Egress.** The SP unfastened his QRF and released his restraint harness without difficulty. He egressed the aircraft by the main starboard door, but does not recall opening it. The Panel determined that the door 'popped' open during the final impact. Given that both skids collapsed (Fig 13), and that the port door could not be

jettisoned, had the starboard door not 'popped' open the SP would have experienced considerable difficulty exiting the aircraft. The Panel conclude that the lack of an alternative egress method was an **other factor**.

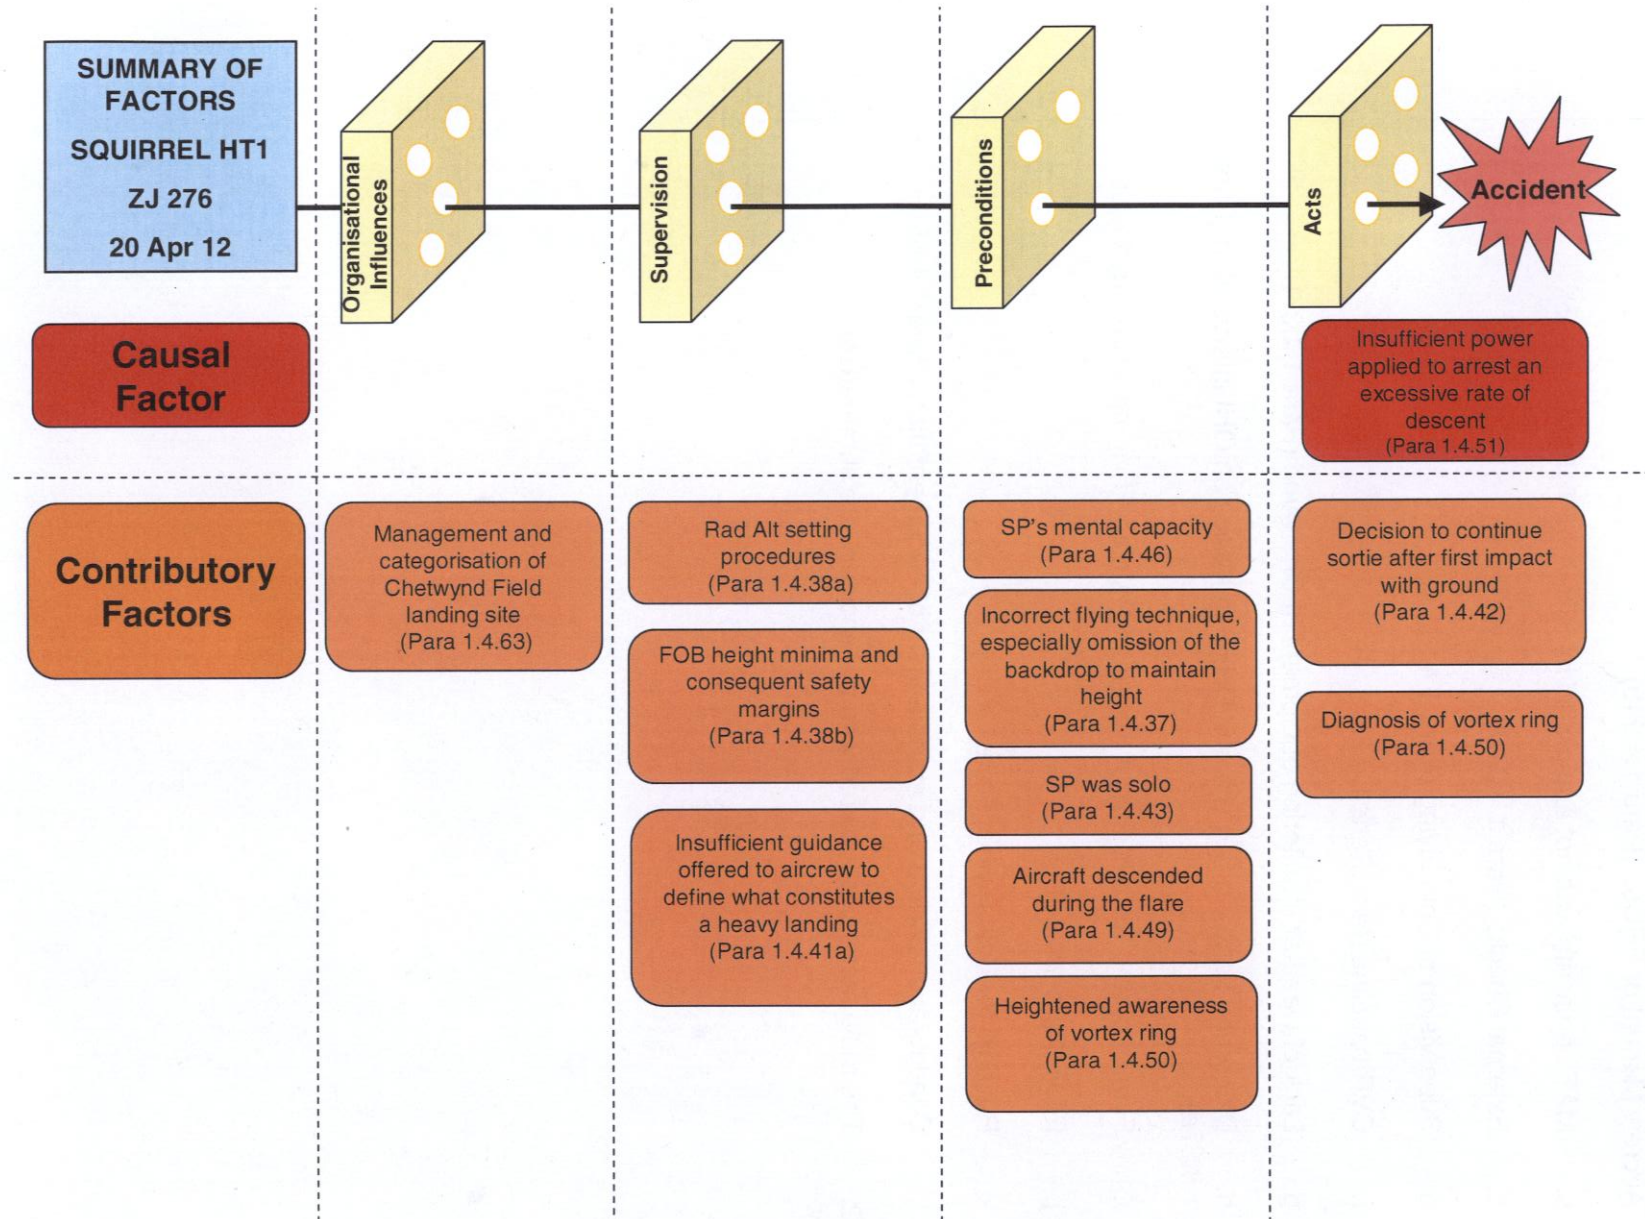
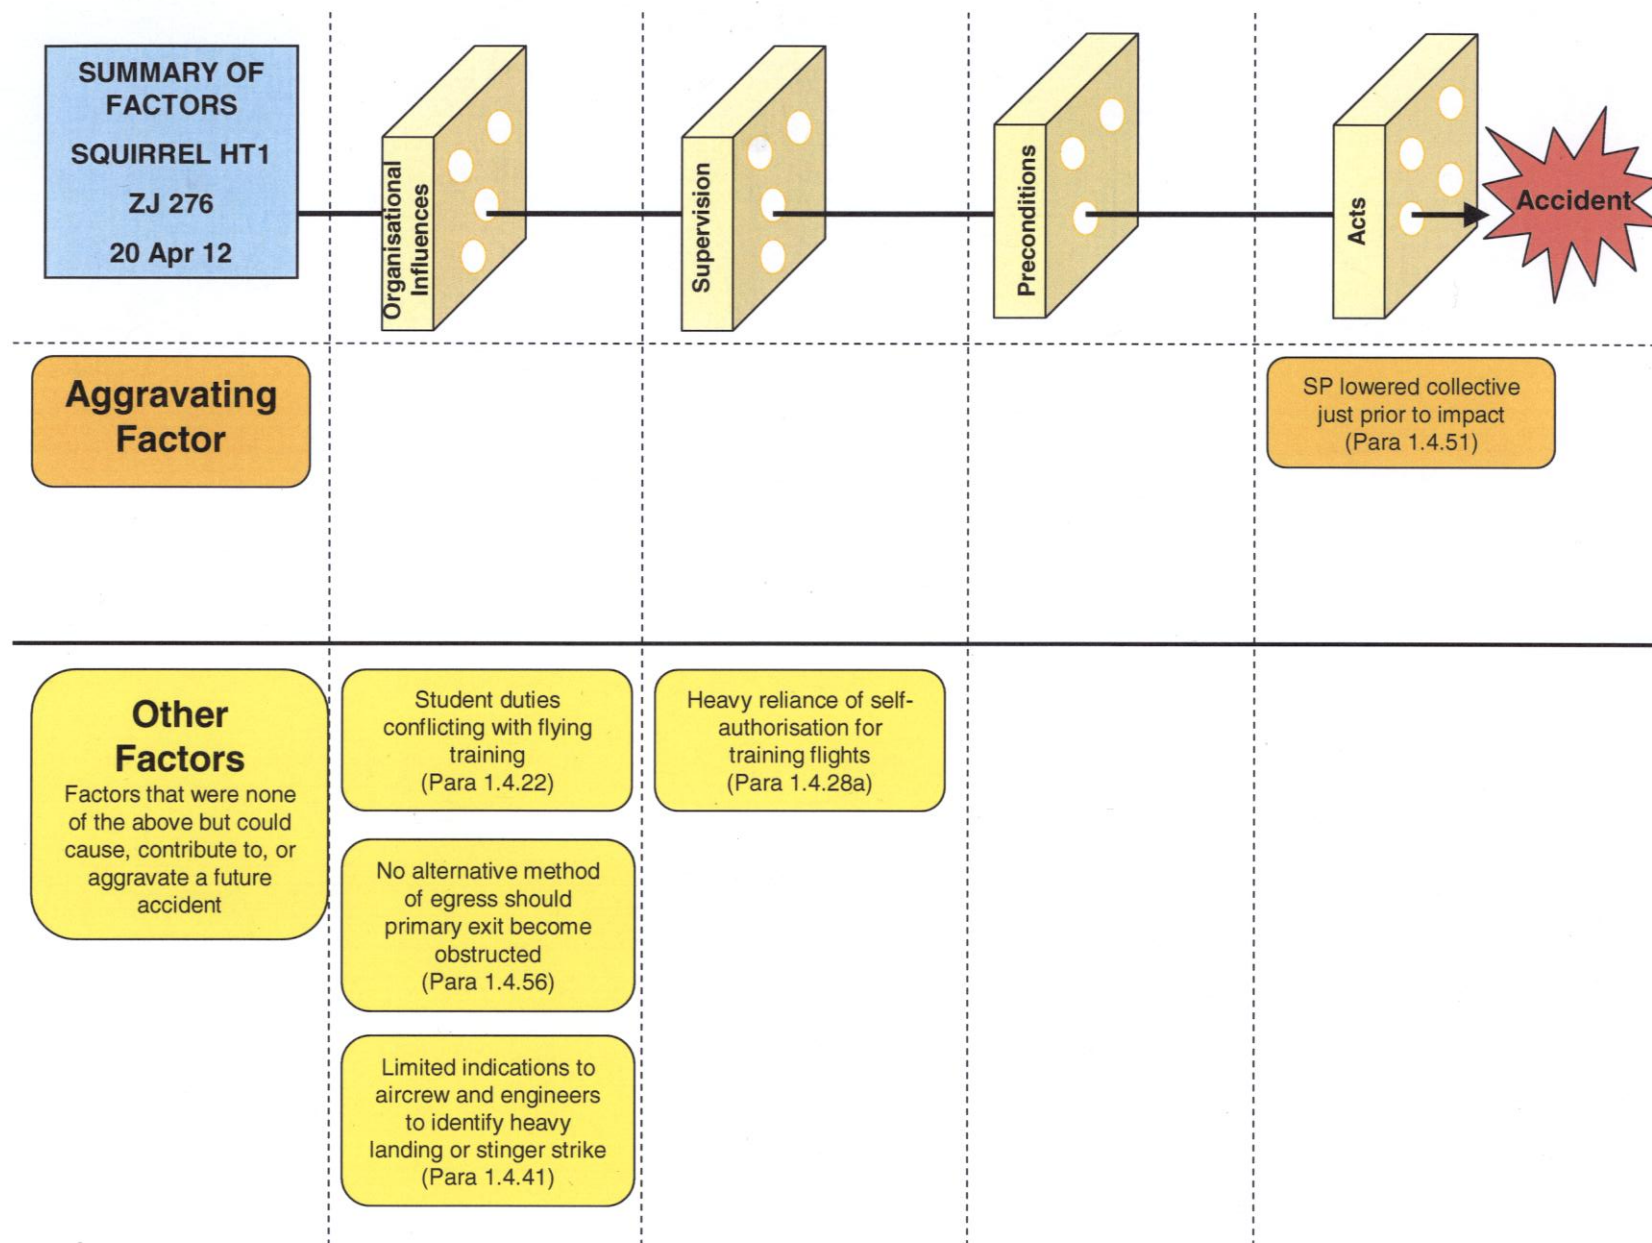
Figure 14 – Accident Factors Summary

1.4.72. The main factors associated with the accident are summarised in Fig 14 below.
