CONTENTS**SPECIAL BULLETINS**

COMMERCIAL AIR TRANSPORT**FIXED WING**

Airbus A319-131	G-DBCI	24-Jan-07	4
Airbus A321-231	G-MIDC	13-Nov-06	8
BAE Systems Jetstream 4100	G-MAJI	12-Jan-07	11
BAE Systems Jetstream 4100	G-MAJI	26-Feb-07	14

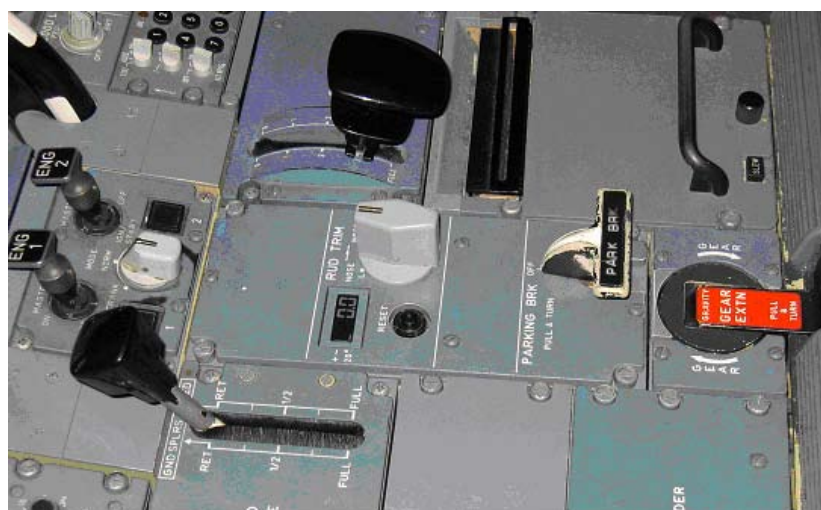
Figure 1

is selected by grasping the parking brake handle and rotating it clockwise. Despite these controls being of different shapes, requiring different methods of activation, their shapes allow both to be grasped in a similar manner prior to selection. An inspection of the aircraft’s flight deck showed that the identifying placard was missing from the parking brake selector.

Parking brake and flap selectors on an A320

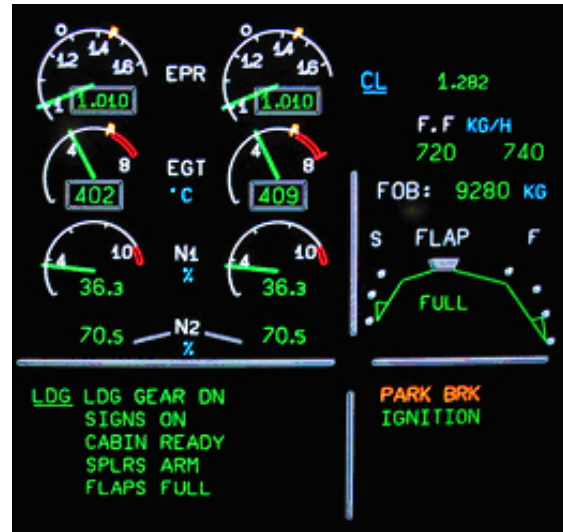
Figure 2

ECAM Display with parking brake selected

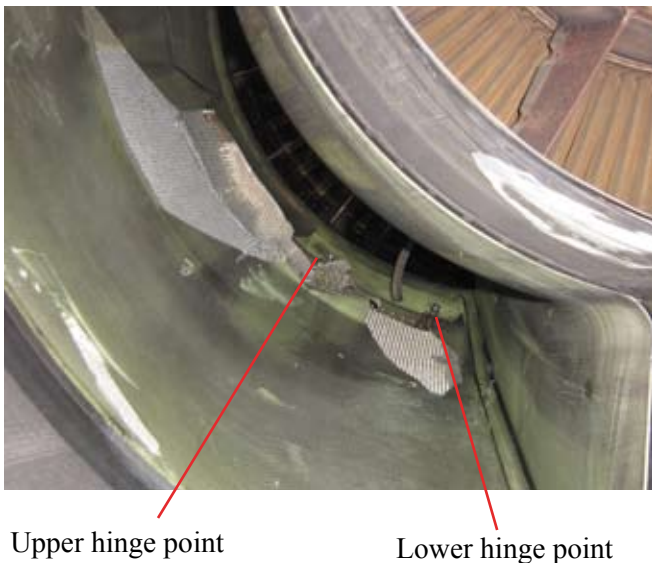
Figure 1

The aircraft had completed a flight from Dublin to LHR when, during a post-flight walk-around inspection, the flight crew observed that the acoustic panels lining the interior of the left engine by-pass duct had been damaged and that a thrust reverser blocker door was missing, Figure 1. No defects had been observed during the pre-flight inspection at Dublin, no unusual vibrations or noises were noticed during the flight and the aircraft had not recorded any defects in its fault monitoring systems. The remains of the blocker door were found adjacent taxiway E7 at Dublin Airport.

Damage to by-pass duct (view looking forward)

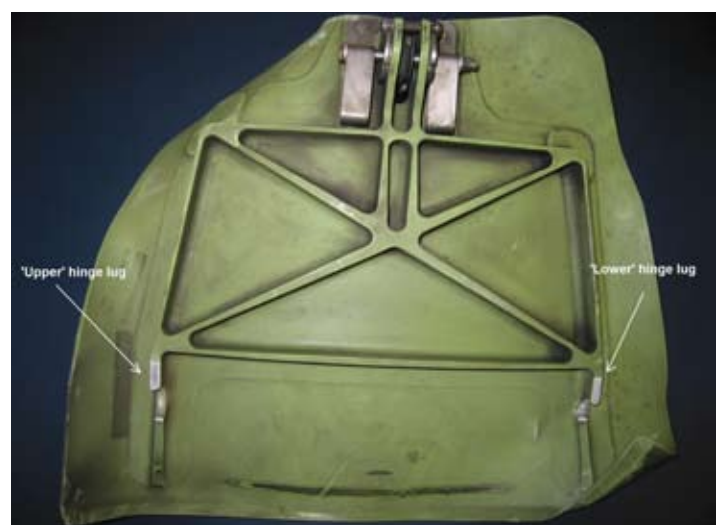
Figure 2

Examination of recovered material showed that the door actuation arm had failed due to an overload condition, and that the lugs on the forward edge of the door, into which the bearings had been located, had both failed, Figure 2.

The bearings had remained in their respective mounting brackets on the reverser translating sleeve. Laboratory examination of the fracture surfaces of both lugs showed areas of inter-laminar and inter-granular corrosion cracks, at the lug holes, suggesting stress corrosion. Overload failure areas towards the rear of each lug were also observed. The lower lug had also been distorted due to the application of a torsional load prior to failure.

Examination of the bearings showed that the upper bearing had seized in its race. Some evidence of corrosion staining was present between the bearing roller and race and it was noticed that evidence of primer residue was present between the inner surface of the lug holes and the spherical bearings.

Blocker door, showing failed hinge lugs

Deformation of the lower lug indicated that the upper lug failed first, which resulted in the failure of the lower lug and the actuation arm, which allowed the blocker door to be released.

The use of a stainless steel bearing in the aluminium lug would have provided a source of galvanic corrosion and, therefore, an initiator for the corrosion cracking

observed. In order to minimise this possibility, blocker doors are primed prior to the installation of the bearings; residue found in the lug holes confirmed that primer had been present. However, clear evidence of corrosion cracking in both lugs was present. This was probably as a result of galvanic corrosion between the steel bearing and aluminium alloy blocker door, and it is possible that the primer was of insufficient thickness to prevent this happening, or had become damaged during the installation of the bearings. The seized upper bearing would have introduced additional torsional loads in the door lugs, accelerating the rate of crack propagation.

The manufacturer is currently investigating several similar events and will, based on the results of these investigations, take action to minimise the possibility of additional failures of this nature. In view of this, no Safety Recommendations are considered necessary to be made at this time.

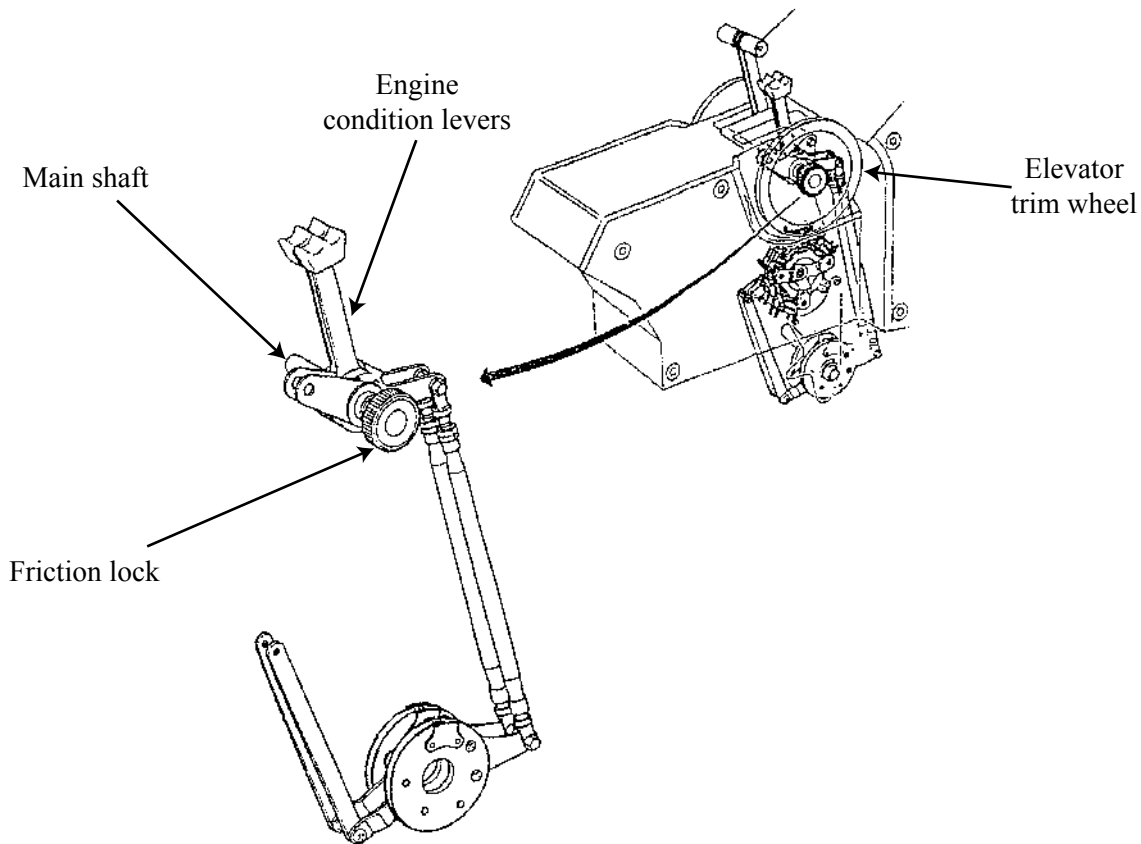
Figure 1

It was soon found that both the elevator manual trim wheel (see Figure 1) and the condition lever friction wheel had jammed and were immovable. The elevator electrical trim also did not work. Vectors were provided for a 10-mile final approach to the airport for an ILS landing on Runway 23 in order for the crew to assess handling. The decision was made to keep the flaps at their takeoff setting of 9° in case further

Investigation by the company’s engineers found that the condition lever friction wheel, which rotates about a common shaft with the elevator manual trim wheel (Figure 1), had made contact with the trim wheel such that application of nose-down elevator trim also caused rotation of the friction wheel in the ‘tighten’ sense until the two had jammed together. When the two wheels were freed, both mechanisms worked correctly. The aircraft manufacturer provided the information below

Jetstream 41 centre console, showing relationship between engine condition lever friction lock and elevator trim wheel

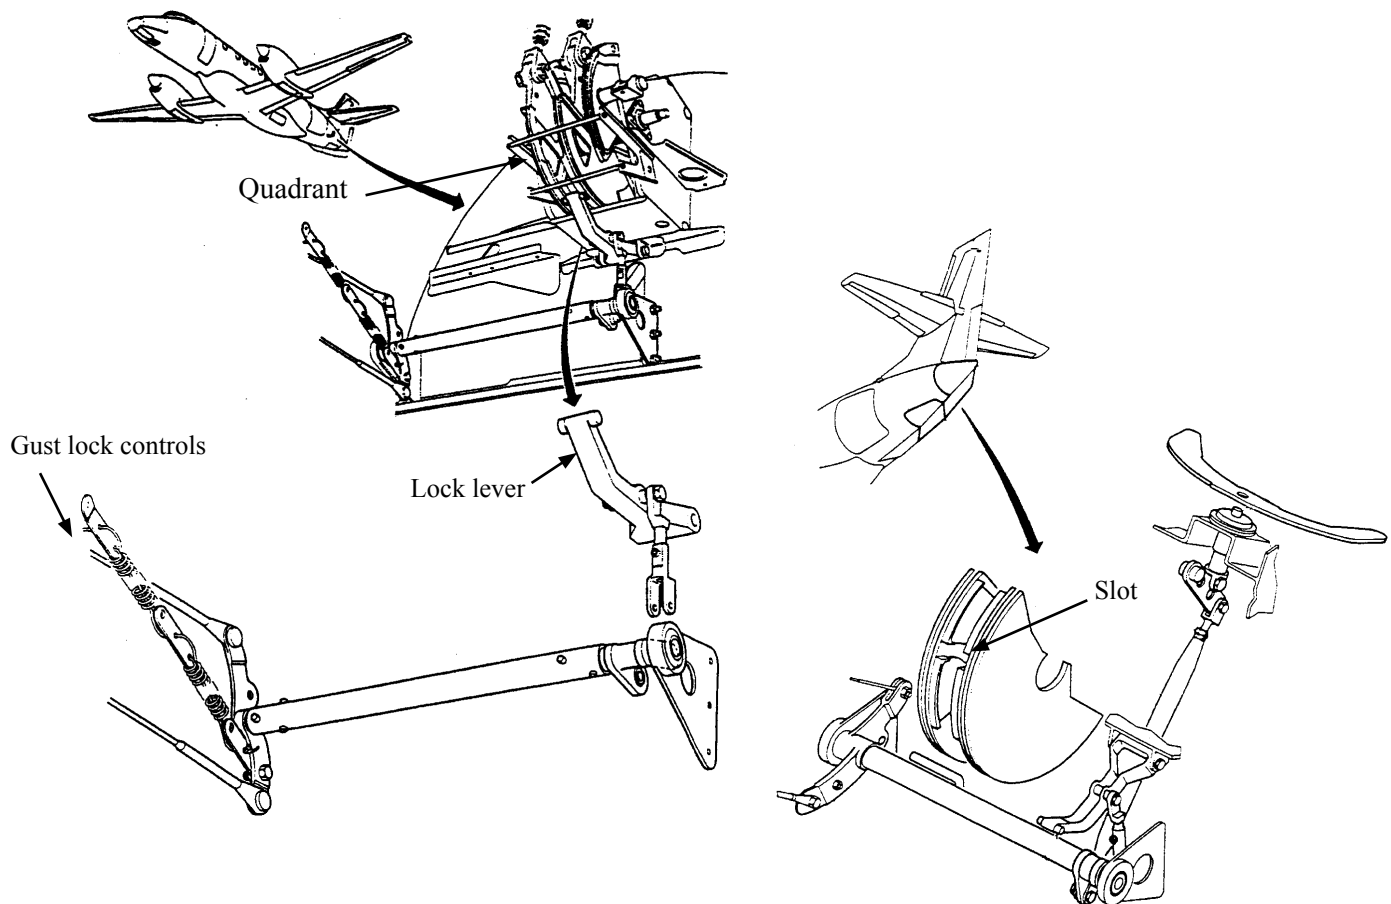
Figure 1

Operation of the gust lock control lever, with respect to the elevator circuit, causes a lock pin to engage in a slot cut into a cable quadrant located in the rear fuselage, Figure 1.

In this case, an apparent lack of lubrication was causing the pin to 'hang up' in the slot, thus keeping the elevators in a locked condition. When the operating lever on the flight deck was moved to the unlocked position, the 'lost motion' was taken up by the compression of a spring within the locking mechanism. The operator, who has a fleet of 25 Jetstream 41 aircraft, has stated that they have experienced 19 similar occurrences involving the gust lock system, although many of these were the result of

Details of elevator gust lock controls in rear of fuselage

The Maintenance Schedule required that the gust lock system components be lubricated every 6,000 flight hours which, with this operator, occurred approximately every four years. Since this incident the operator has adopted a policy of applying lubrication every year. Also, the aircraft manufacturer is in the process of changing the Maintenance Schedule to increase the frequency of gust lock system lubrication. Since this will take some time, they are considering raising the matter in an All Operators Message (AOM) to be published in the shorter term.

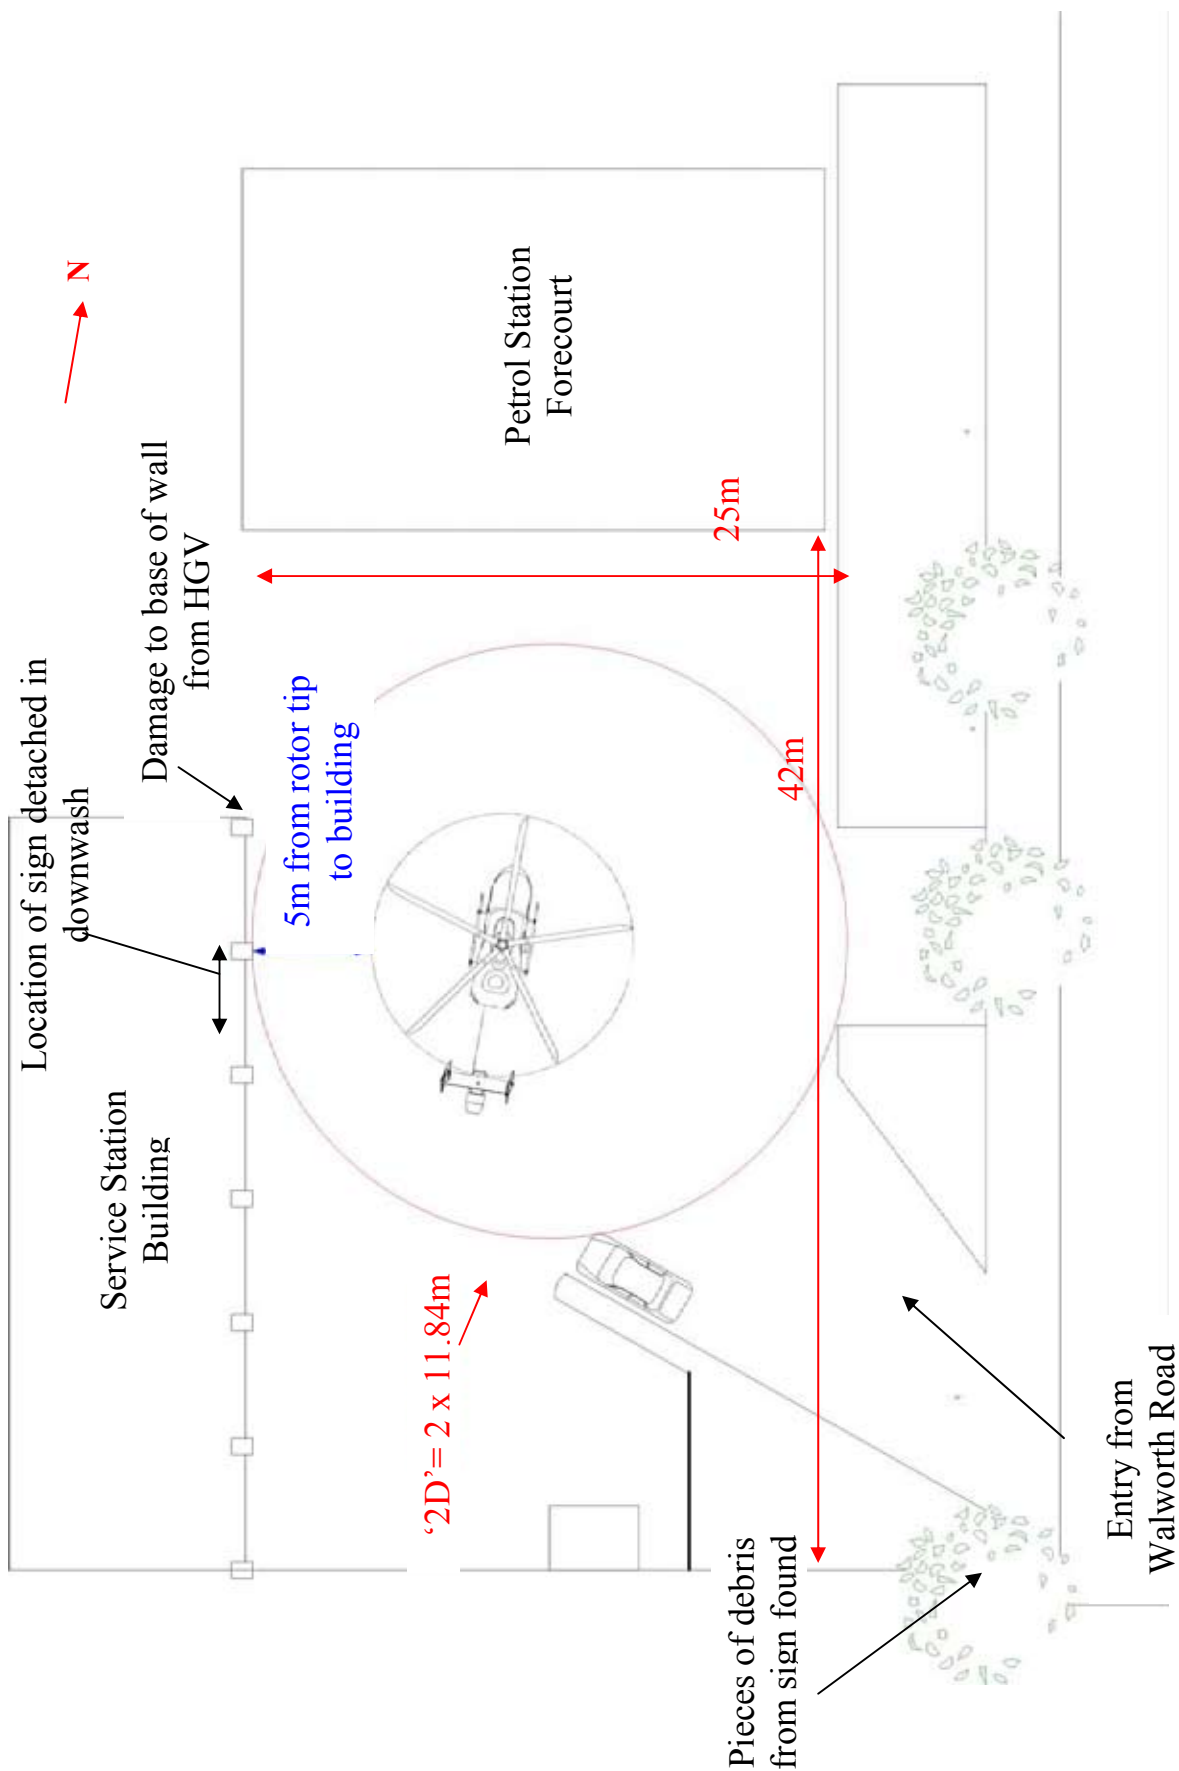
The helicopter had come to rest on a northerly heading with the rotor disc approximately 5m from the front of the garage building. Numerous impacts with the rotor blades had shredded the metal sign, pieces from which had been flung to the edge of the garage forecourt. The remains of fixings on the fascia board indicated that the sign had been attached prior to the helicopter landing. The metal bracket connecting the fascia to the end brick wall had been dislodged so that the fascia was no longer attached to the wall. There was also damage to the brickwork at the base of the side wall. The garage manager stated that the base of the wall had been hit by a Heavy Goods Vehicle (HGV) at some time prior to the accident. It was not possible to determine whether the detachment of the fascia board had occurred in the HGV impact, or was part of the damage caused by the helicopter downwash.

All the main rotor blades, which were of fibreglass/epoxy construction, had suffered damage to their outer sections. The leading edge abrasion strips were smeared with blue paint from the sign and the blades had suffered multiple impacts. An aerial from the top left side of the helicopter had detached and the left vertical stabiliser had suffered impact damage from the sign fragments.

Figure 1
G-EHMS at Walworth Road, 4 June 2006

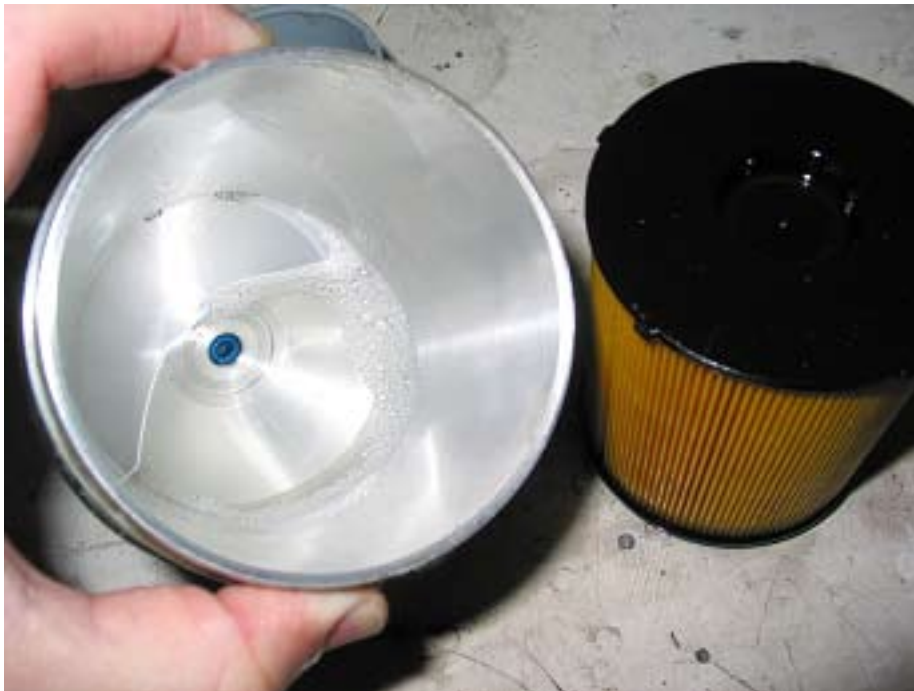
Figure 2

Fuel filter canister showing small amount of fuel present, as found

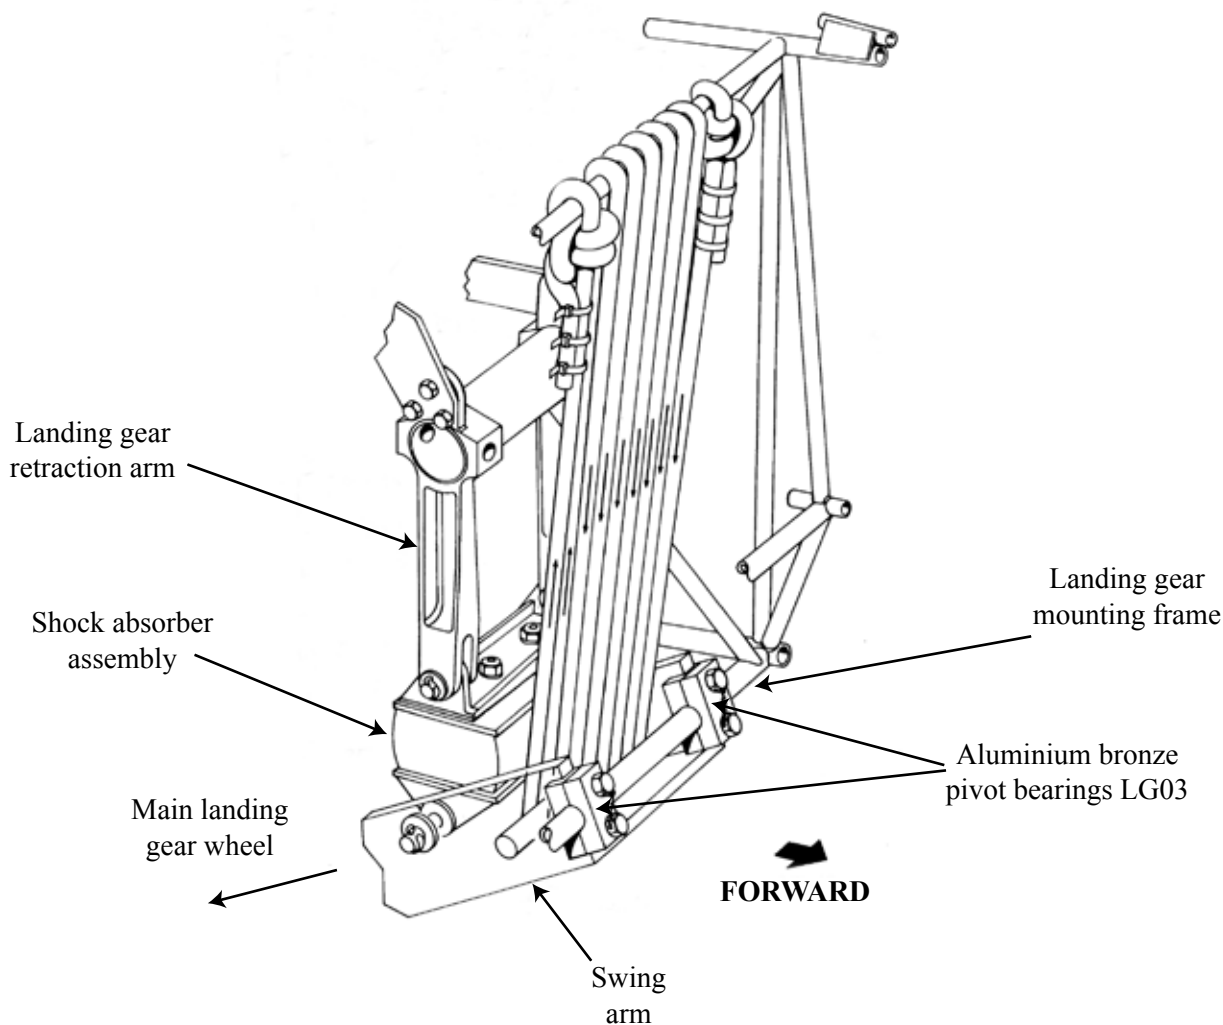
Figure 1
Main landing gear pivot

The pilot, who was also a PFA Inspector, carried out a detailed examination of the landing gear system and found that the aluminium bronze pivot bearings, part number LG03 (Figure 1), that allow the main landing gear swinging arm to rotate around the landing gear mounting frame, had seized onto the steel shaft of

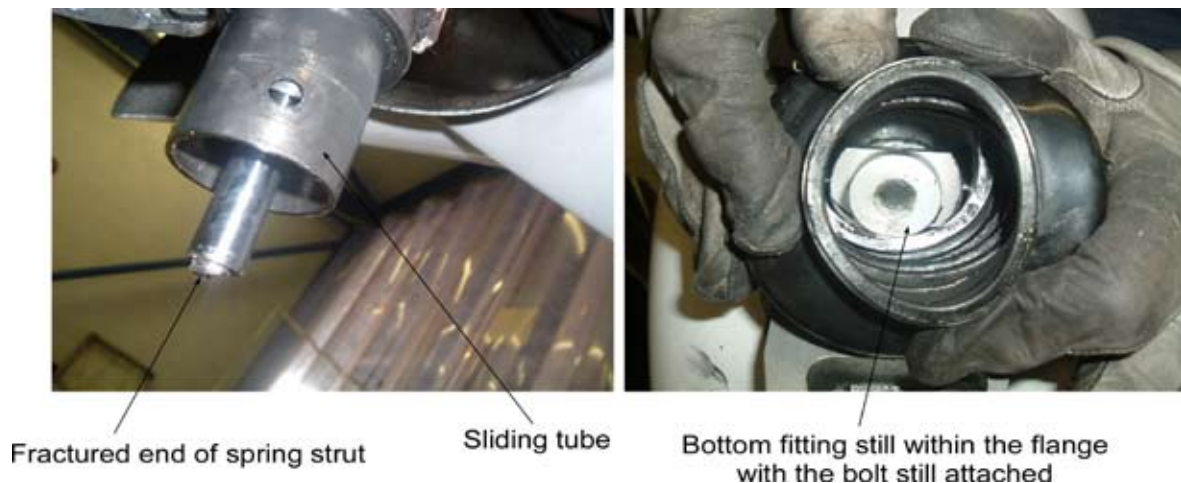
Figure 2

An examination of the aircraft by the maintenance organisation found that the gas spring strut had failed at its lower end where it screws into the bottom fitting. The sliding tube was found to have been incorrectly assembled

- it had not been secured to the flange, with the attaching bolt only passing through the flange and bottom fitting (see Figure 2). This failure to secure the sliding tube had allowed it to float freely. It had migrated upwards out of the lower flange and induced high bending loads on the lower end of the gas spring strut. Eventually this had led to its fracture, and the ultimate collapse of the nose leg.

Fracture of the spring strut

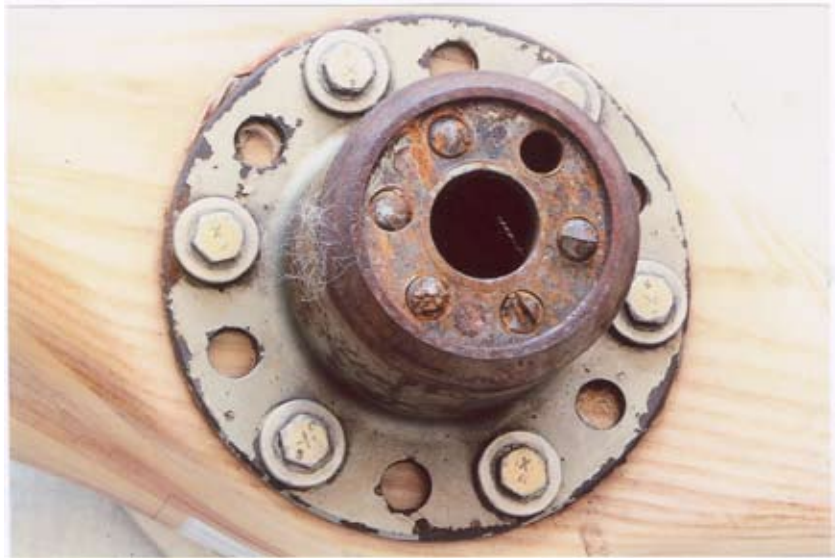
Figure 1

On the Kolb Twinstar, the engine and propeller act in a 'pusher' configuration. The propeller is mounted on an extension fitting which in turn is bolted to the end of the crankshaft, using six bolts. The propeller does not require removal of the extension fitting when it is installed. The propeller had detached due to failure of the bolts holding the extension fitting to the crankshaft – one was missing completely (see Figure 1). Metallurgical examination showed that the five remaining bolts had fractured in long-term high-cycle bending fatigue. This was caused by progressive slackening of the bolts due to fretting of the holes in the fitting. The six bolts are normally wire locked in pairs and it was noted that the wire locking of two of the pairs had broken due to high-cycle fatigue. Also noted was that the bolts, which are threaded along their entire length, had cut 'threads' into the holes in the fitting. This was considered to have exacerbated the fretting, as may the presence of a relatively high level of surface corrosion on the crankshaft fitting.

Detached crankshaft extension showing fatigue fractures of five bolts with sixth missing. (Note surface corrosion)

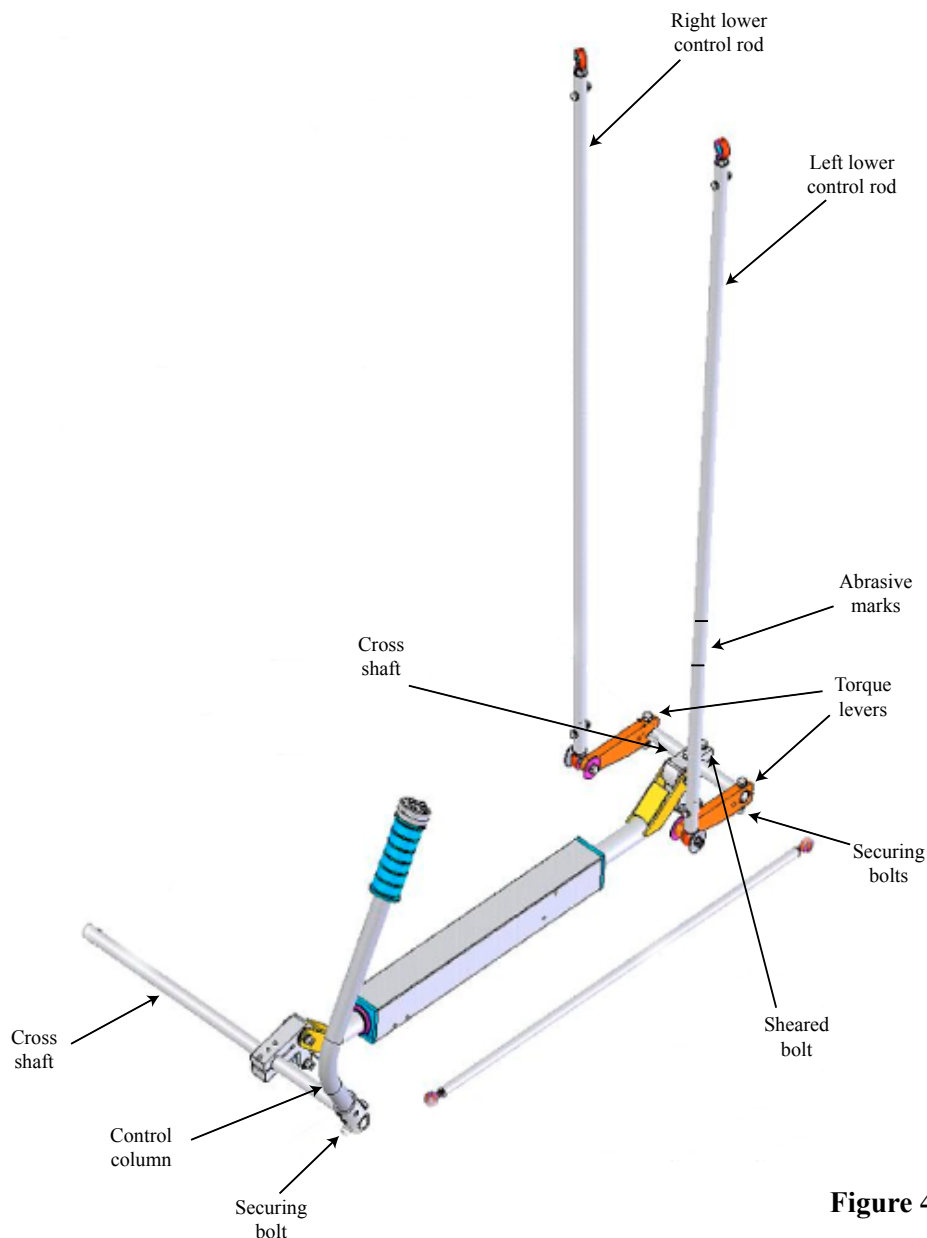
Figure 4
RAF 2000 flying controls

The pilot's left rudder pedal had broken off and the right rudder pedal layshaft had popped out of the right mounting bracket, which had distorted during the impact. The rudder hinge rod, which was still connected to the cables, was distorted and had a dent similar to the profile of the leading edge of a main rotor blade at a position just above the upper hinge point. Continuity of the rudder cables was established between the rudder pedals and the rudder attachment point.

With the exception of the torque levers, continuity of the cyclic control was confirmed between the control column and the gimble activation arm. Both torque levers, which are mounted at the base of the mast, had failed at the point where the bolts secure the levers to the cross shaft (see Figure 4). The left lower control rod was badly bent during the impact and broke during the recovery of the gyroplane. At 34 cm from the bottom of the rod there were deep abrasion marks along the rod for approximately 40 mm. The lock nut on the lower fitting on the left upper control rod had been

fully wound off and the fitting was loose. Abrasion marks were also discovered at 80 mm and 35 cm from the bottom of the right lower control rod. The lock nut on the fitting on the right upper control rod was found to be loose. The bolt used to secure the pilot's control column to the cross shaft had four washers between the column and the nut. The bolt which secured the torque lever to the cross shaft had failed in shear. Both trim springs were still connected to the control rods. The trim indicators were in the fully down position and the trim cables were unwound from the barrels inside the trim mechanism, so that there was no tension in the trim springs and no trim force applied to the control system.
