# ***AAIB Bulletin***

***2/2016***

Published 11 February 2016

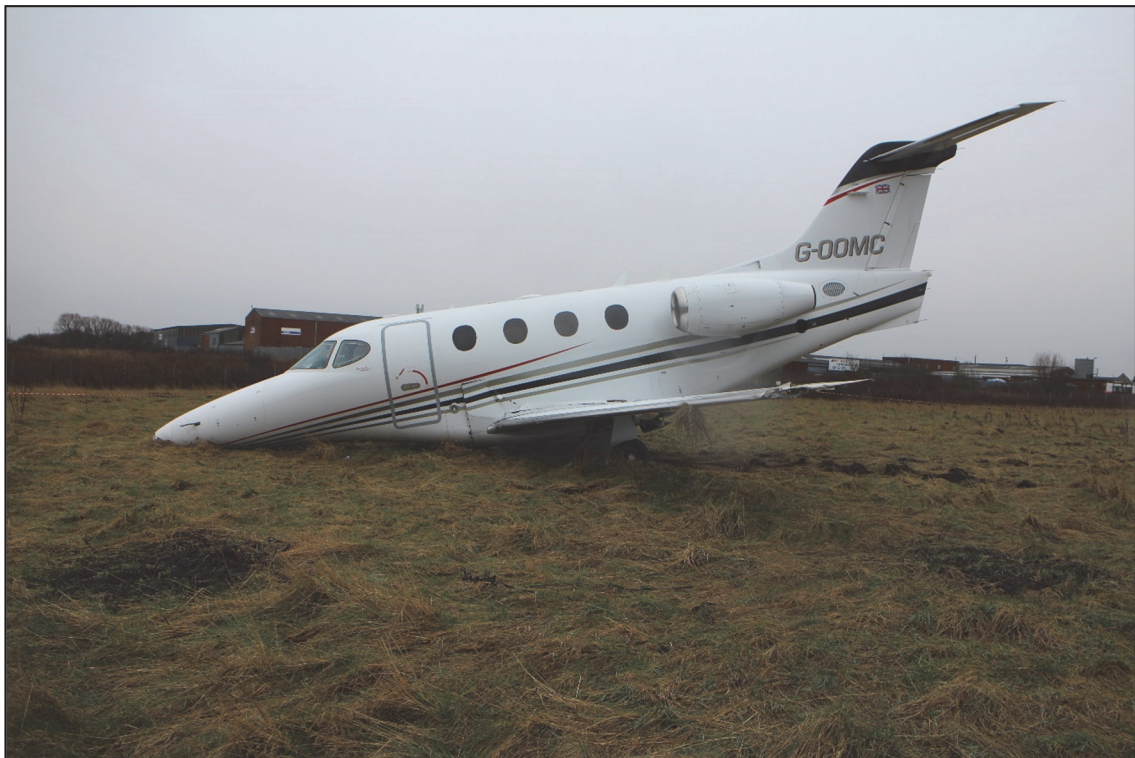
**Figure 1**  
G-OOMC post-accident

Marks on the runway showed that the main landing gear (MLG) inboard doors remained extended throughout the landing, suffering edge abrasion damage as a result. The aircraft travelled approximately 123 m beyond the runway paved surface, during which the nose landing gear collapsed and the nosewheel detached.

Prior to coming to a halt, the left wingtip was driven into the ground, deflecting the aircraft from its path. The four wing-to-fuselage mounting forgings were damaged and, in three cases, had fractured. The wing was displaced to the right, indicated by extensive root fairing and inboard flap track damage.

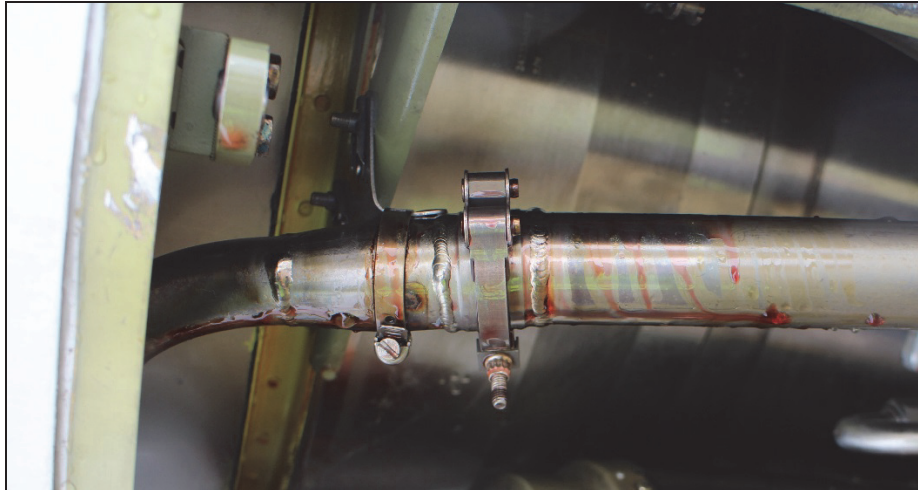
**Figure 3**

Subsequent examination found evidence of a hydraulic fluid leak within the left engine nacelle, in the vicinity of the hydraulic pump. Hydraulic fluid had congealed and accumulated on the engine bleed air pipe, on surrounding pipes and surfaces, and at the bottom of the lower panel. The engine casing and components attached to the lower portion of the engine were covered in a thin film of hydraulic fluid (Figure 3). The hydraulic reservoir was empty, but a small amount of residual fluid was present in the filter housings and the bottom of the assembly. The filter blockage indicators had not 'popped' and the fluid and filters were found in a clean and uncontaminated condition.

Hydraulic system leak spray dispersion within the left engine nacelle

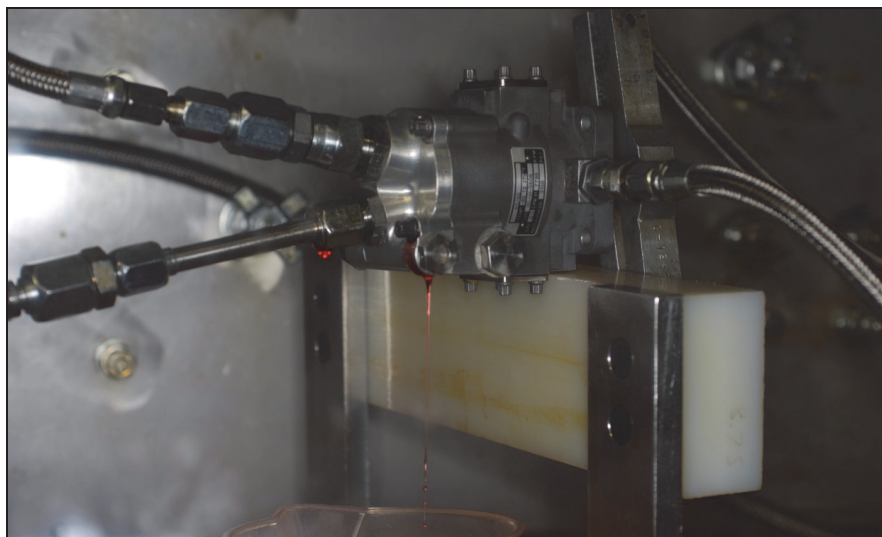
**Figure 4**

The left hydraulic pump and associated pipework were tested at the system working pressure. During the test a constant leak was visible in the vicinity of the pressure compensator<sup>7</sup> assembly chamber plug on the port cap of the pump.

Hydraulic pump leaking under high pressure (3,000 psi) test  
(Photo courtesy of the NTSB)

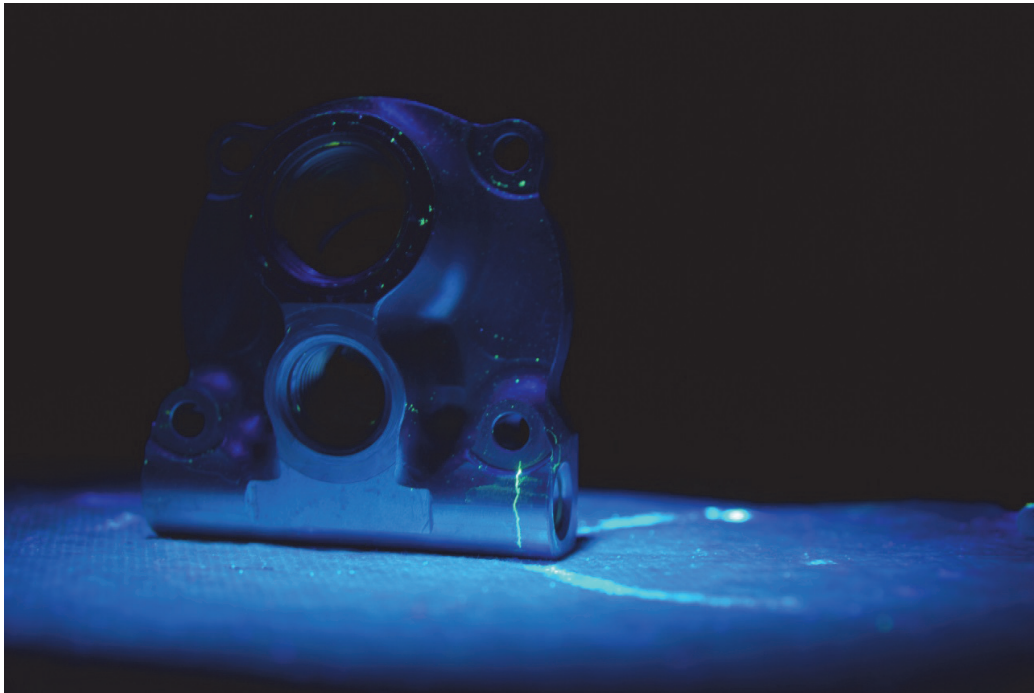
**Figure 5**

The investigation determined that, irrespective of the omission to apply the emergency brakes, the Landing Distance Available (LDA) at Blackpool was insufficient for the aircraft to land with a hydraulic failure. A fatigue crack in the port cap<sup>1</sup> of the left hydraulic pump had caused a hydraulic leak which eventually resulted in the total loss of the hydraulic system.

Crack in the port cap shown with dye penetrant under UV light  
(Photo courtesy of the NTSB)

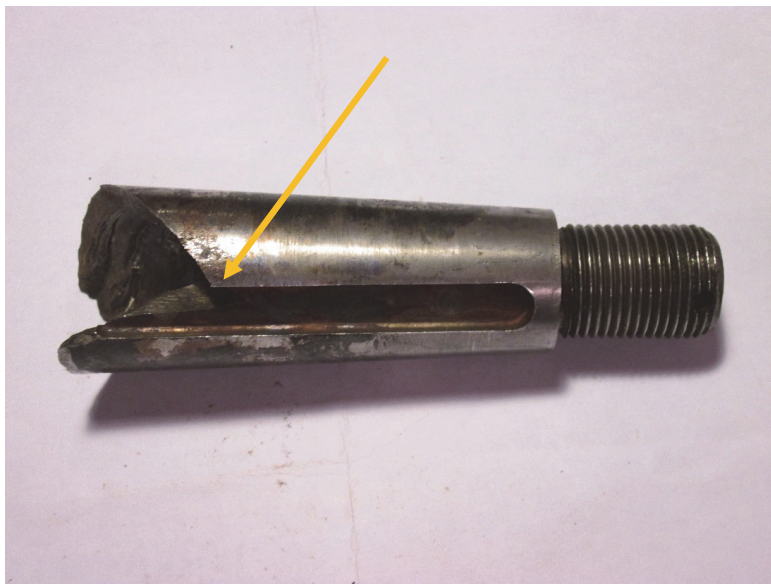
**Figure 1**

it had detached because the tapered end of the crankshaft on which it was mounted, had fractured (Figure 1). He also recognised that the fracture was almost identical to one he had seen in an AAIB Bulletin concerning another JAP J99-engined aircraft in 2012 (G-EBJI, Bulletin 10/2012).

Failed crankshaft showing corrosion pitting in the area of the fatigue crack origin (arrowed).

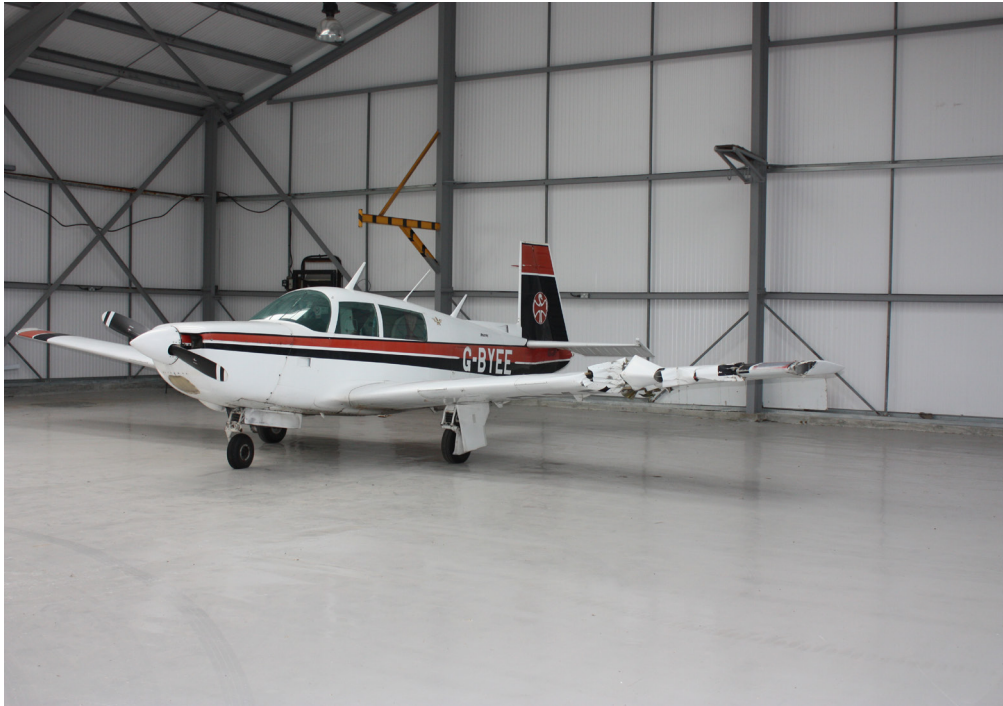
**Figure 1**

G-BYEE showing the severely damaged left wing

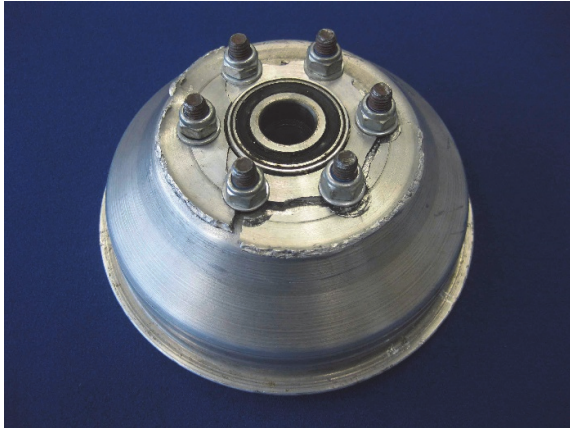
**Figure 1***Photo: LAA*

The right wheel was constructed from two aluminium halves which were bolted together. It was found that the outer half had failed circumferentially, which had allowed the outer rim to separate.

G-CHHD right main wheel

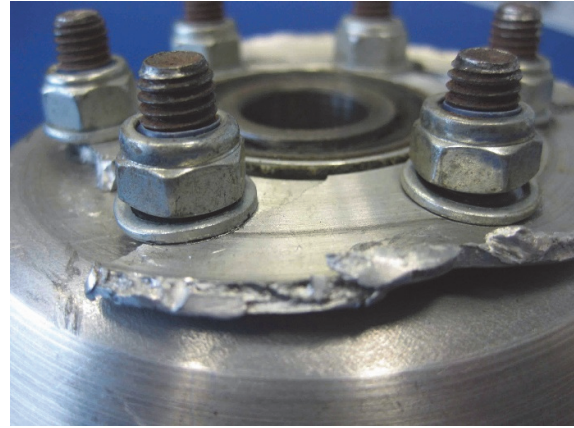
**Figure 2***Photo: LAA*

G-CHHD right main wheel - detail

The LAA's examination revealed that two of the six attachment bolts were not fully tightened down, which left a gap of around 1.5 mm (see Figure 2), with another bolt noted as being loose. Corrosion products were observed near one of the loose bolts (see Figure 3), with evidence pointing to fretting that occurred as a result of relative movement between the two halves in service.

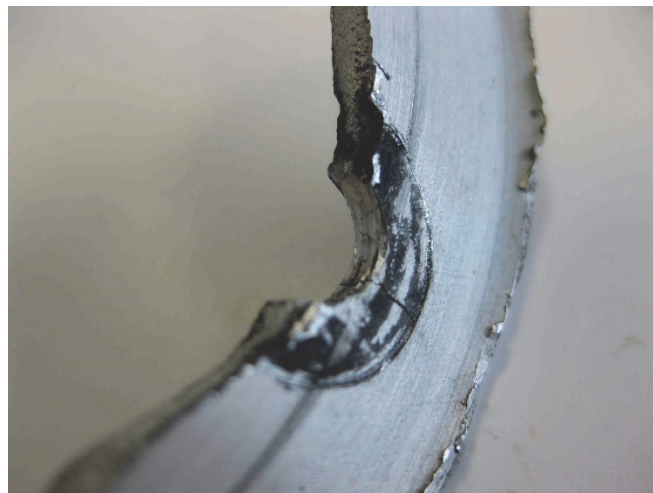
*Photo: LAA***Figure 3**

Showing corrosion products and radial crack

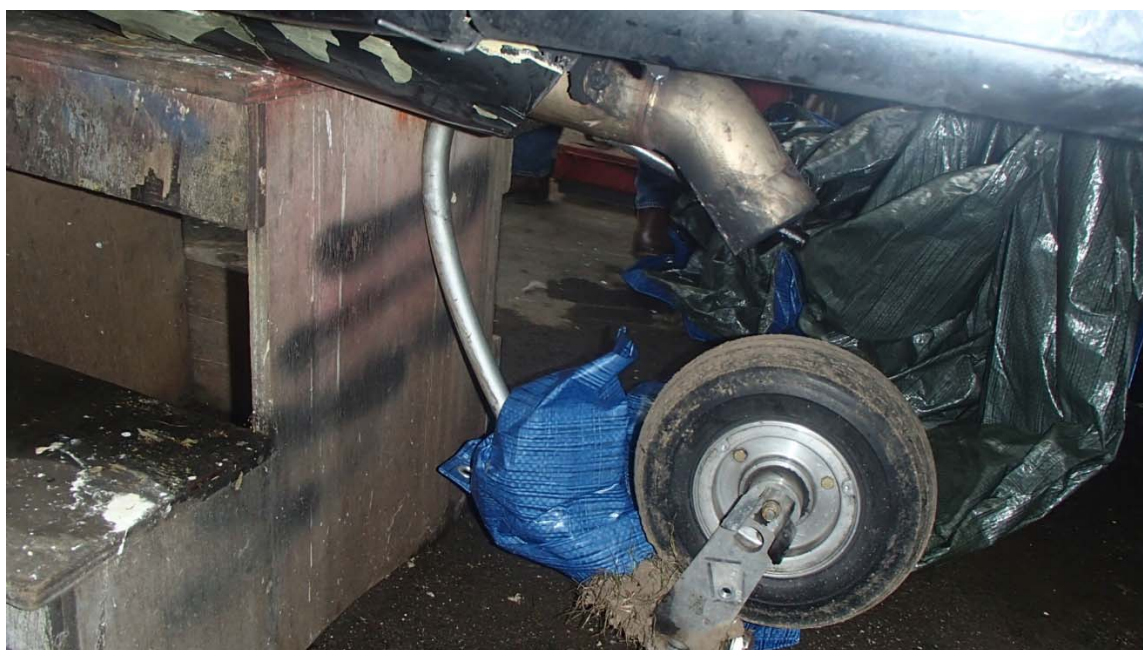
**Figure 1**

Examination of the aircraft showed that the nose landing gear leg had folded backwards and there was distortion of the nosewheel fork relative to the leg. Previous experience of collapses on this type of nose gear suggests that this kind of damage is typical when the

nose landing gear is subjected to high loads which can cause the nosewheel fork to bend and dig into the ground – the resulting drag on grass runways then typically causes the leg itself to collapse backwards in bending near its mounts (Figure 1).

Nose landing gear of G-XSAM showing distortion of nosewheel fork and tubular leg

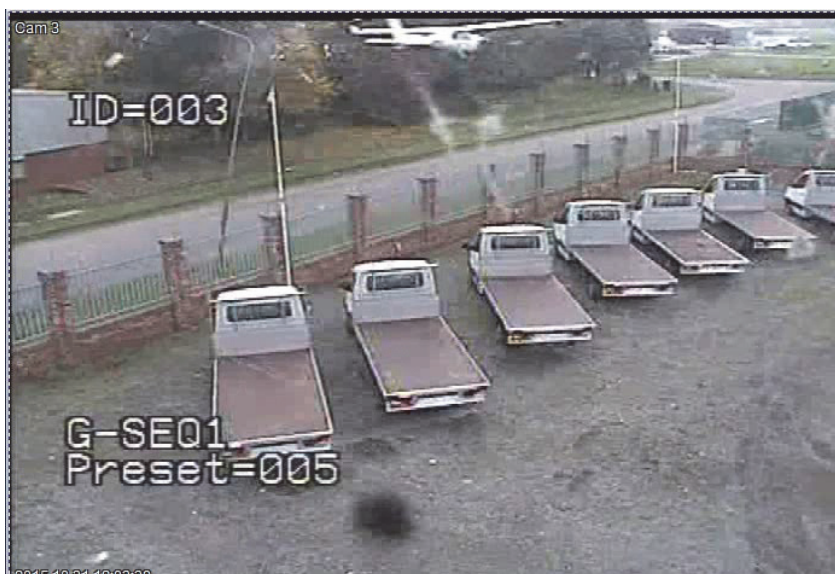
**Figure 2**

CCTV snapshot of the moment after the aircraft's tailplane hit the lamp post
