Defence Infrastructure Organisation

SAFETY ALERT

Subject: STRUCTURAL INSPECTION OF DOOR HEADER STEELWORK IN "L" TYPE HANGARS.

Number: 06/11

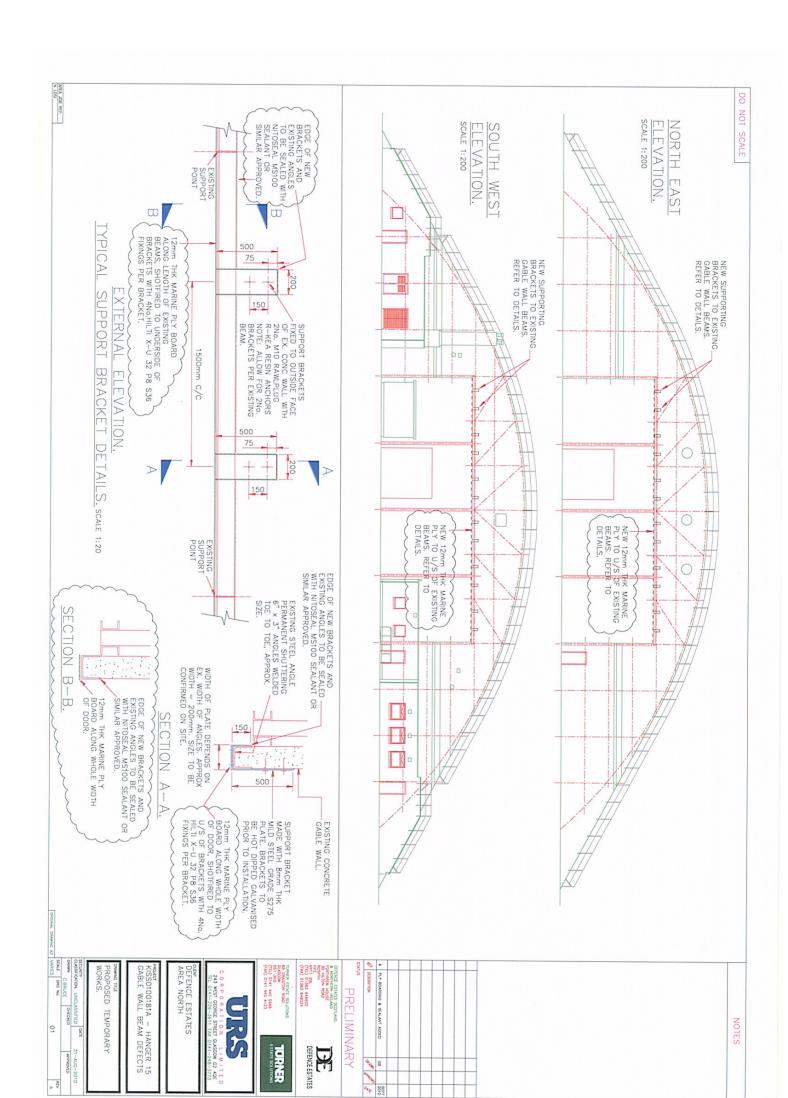
In recent months RAF Lossiemouth and RAF Kinloss have reported significant deterioration to the structural steelwork of the soffit of the main door headers on their "L" type hangars. These were in poor condition and had corroded and delaminated to the extent where there was the potential for structural failure and collapse. Consequently there is a risk that personnel in the vicinity of these doors could be injured by falling structural elements.

The attached drawing can be used to identify the affected areas and is also a suggested method of applying a temporary repair. It should be noted that this drawing may be subject to third party rights.

- a. All establishments are to determine if they have any "L" type hangars in their inventory. If none exit on the respective establishment then no further action is to be taken.
- b. Any establishment having "L" type hangars in their inventory are to immediately conduct a structural survey to determine the severity and extent of any deterioration of the soffit steelwork of the door headers.
- c. Any steelwork identified as being in an immediately dangerous condition is to have the hazard removed by immediate temporary repairs. See attached drawing.
- d. <u>All</u> results of the above inspection shall be passed to the Subject Contact Point given below, irrespective of the findings.
