CONTENTS

INCIDENT

Aircraft Type and Registration:	Boeing 767-300 ER, V8-RBH	
No & Type of Engines:	2 Pratt & Whitney 4060 turbofan engines	
Year of Manufacture:	1993	
Date & Time (UTC):	3 March 2007 at 1630 hrs	
Location:	London Heathrow Airport	
Type of Flight:	Commercial Air Transport (Passenger)	
Persons on Board:	Crew - 11	Passengers - 189
Injuries:	Crew - None	Passengers - None
Nature of Damage:	Failure of No 1 wheel hub	
Commander's Licence:	Airline Transport Pilot's Licence	
Commander's Age:	56 years	
Commander's Flying Experience:	16,635 hours (of which 7,654 were on type) Last 90 days - 162 hours Last 28 days - 60 hours	
Information Source:	Aircraft Accident Report Form submitted by the pilot, and metallurgical examination of components

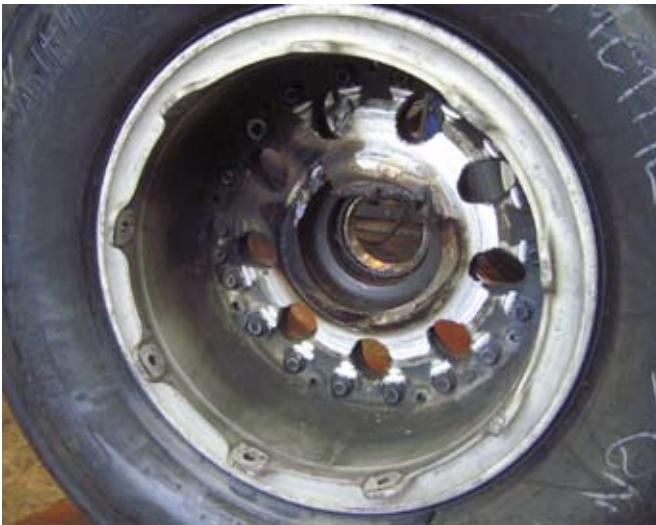
Figure 2

A large, almost-cylindrical section of the inner hub had become detached (see Figures 2, 3 and 4). The approximate location of the separation of the inner hub into two parts is also shown in Figure 1. The wheel was disassembled into its inner and outer hub parts and subjected to a detailed metallurgical examination. The conclusions from the examination were:

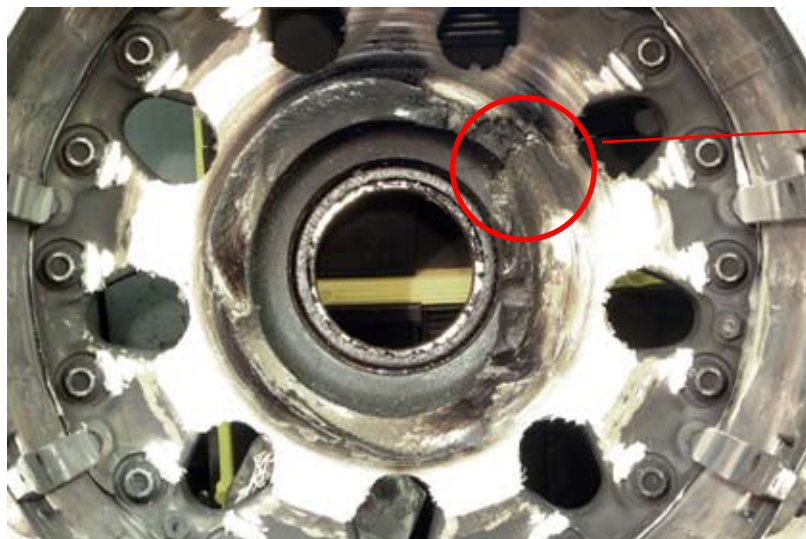
Figure 4

Region of
initial failure

- a) the inner bearing housing had become detached and had severely overheated during contact with the main part of the inner hub. This was likely to have been the cause of the temperature warnings;
- b) the initial failure of the inner hub had taken place in the region shown by the in Figure 4;
- c) the likely cause of the failure was probably fatigue, or stress corrosion, or a combination of both;
- d) a precise assessment of the failure to the hub was impossible due to the extensive heat and

mechanical damage. The assessment was also made more difficult by the rapid cooling of the hub that occurred as a result of the water applied by the fire service;

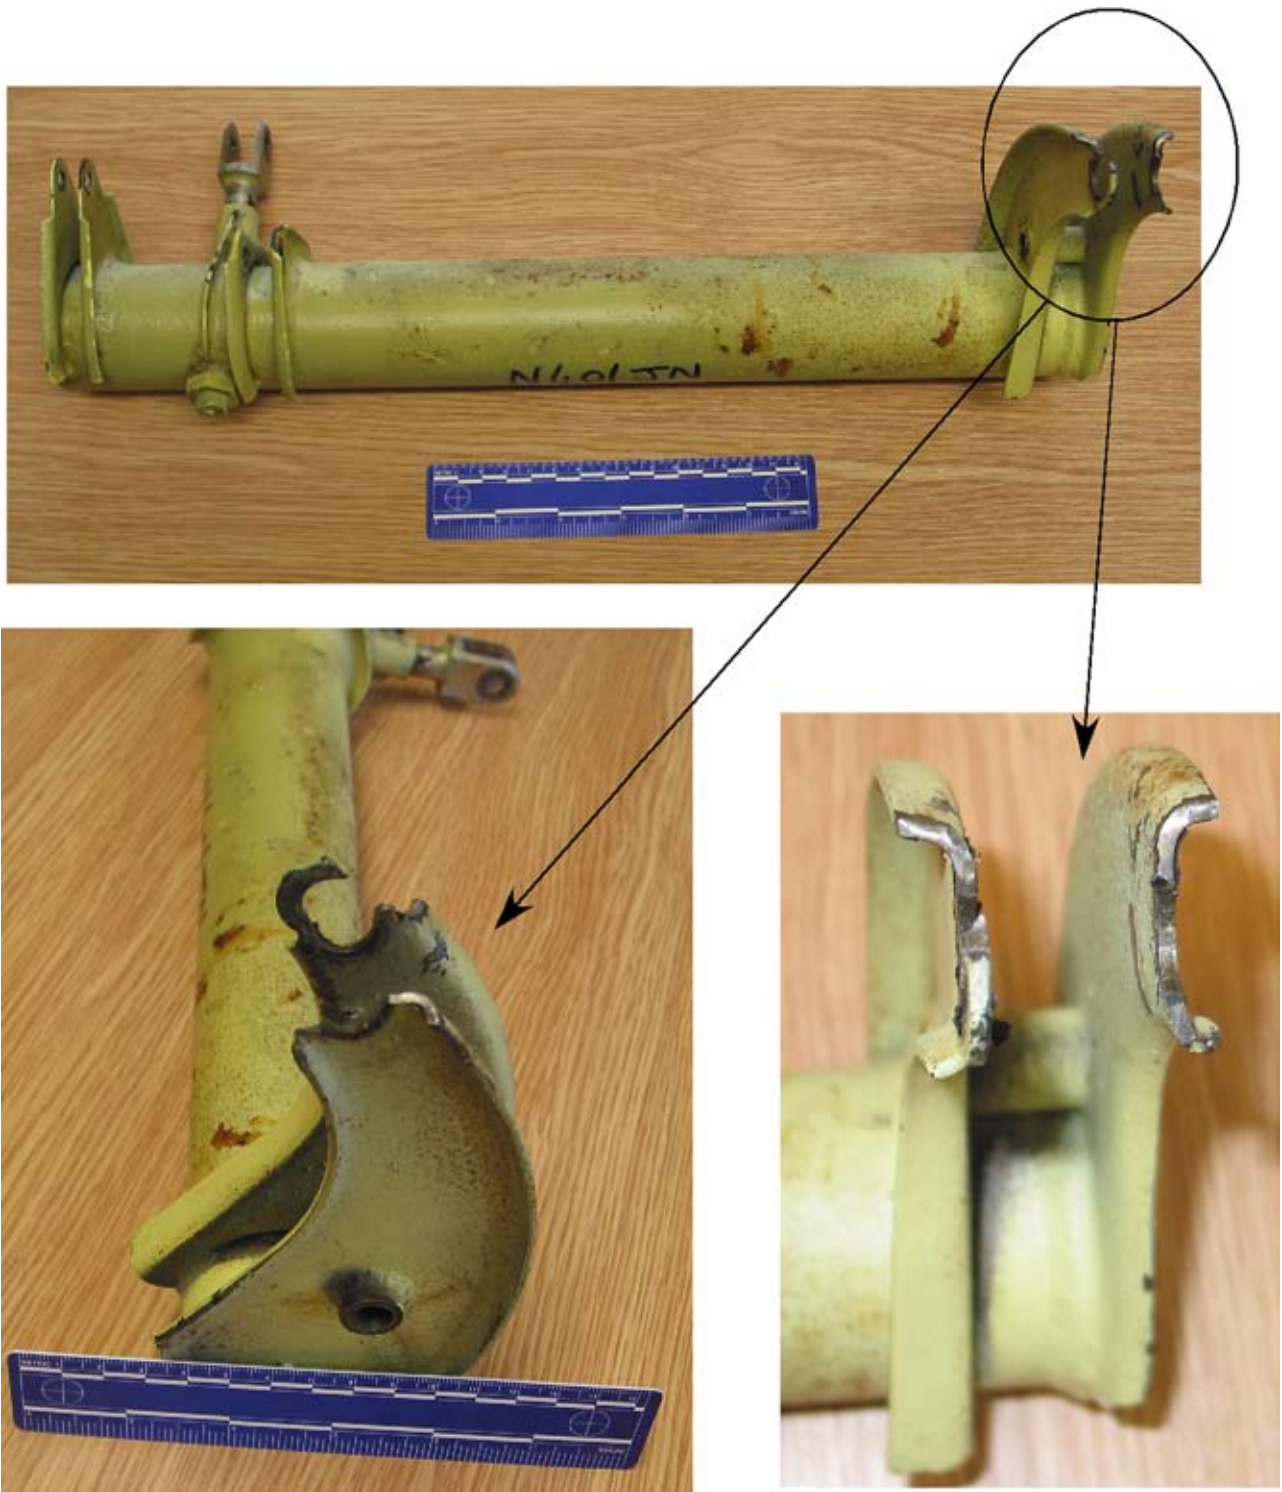
The aircraft was recovered from the runway and taken to a local hangar where it was found that the right main landing gear torque attachment holes had failed, (see

Figure 2). The failure was such that the pushrod that provided drive to the torque tube from the electrical retract/extend actuator had disconnected.

Figure 2
Failed right MLG torque tube removed from N401JN

The torque tube was removed from the aircraft and sent for detailed metallurgic examination. This revealed a slow progressive fatigue failure, followed by a rapid overload, (see Figure 3). The fatigue crack striations indicated that it had suffered up to 250 cycles before the final overload. Each cycle was probably related to an extension/retraction cycle of the landing gear.

It is recommended that the Federal Aviation Administration mandate Cessna SID 32-10-05 for the Cessna 401/402 main landing gear torque tube, and mandate similar Cessna SIDs relating to main landing torque tubes of similar design.

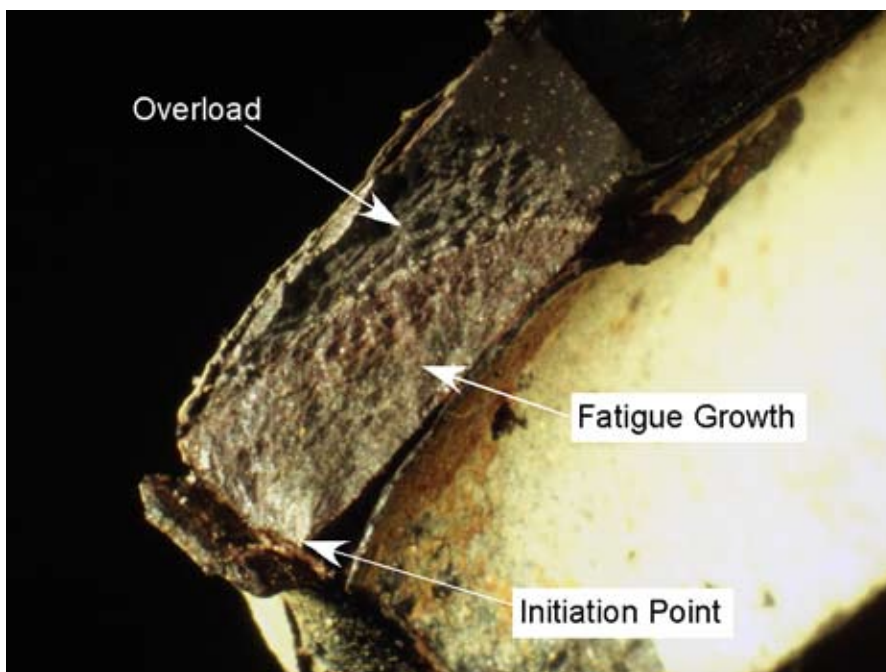
Figure 3

Microscopic image of the initiation and fatigue crack growth

It could not be determined what caused the initiation of the crack in the arm attachment holes, although, it had been present and growing for a considerable time. The fatigue striations indicate that the crack had been present over 250 cycles, estimated as being since May 2001. There was no specific mandatory requirement to inspect the torque tube and its location on the aircraft made it difficult to carry out a visual inspection. To detect the crack would have required removal of the torque tube and an NDI.

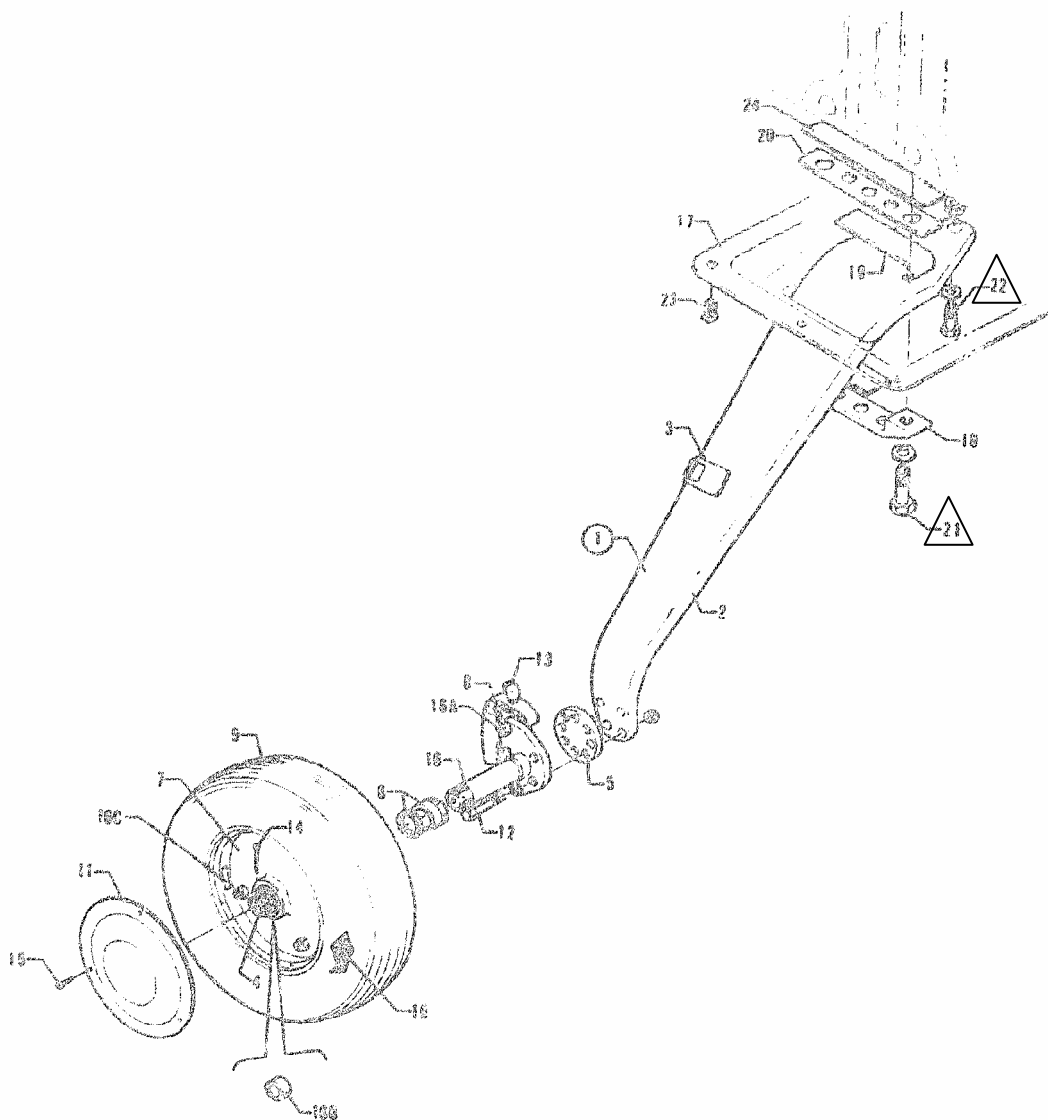
Figure 1

Examination of the detached left main landing gear indicated that one of the three bolts (Figure 1, item 22), part number 401 511, that attach the landing gear to the aircraft, was missing. The other two bolts (Figure 1, items 21), part number 401 462, were attached to the landing gear with locking wire and exhibited very good
