## CONTENTS

**(ALL TIMES IN THIS BULLETIN ARE UTC)**

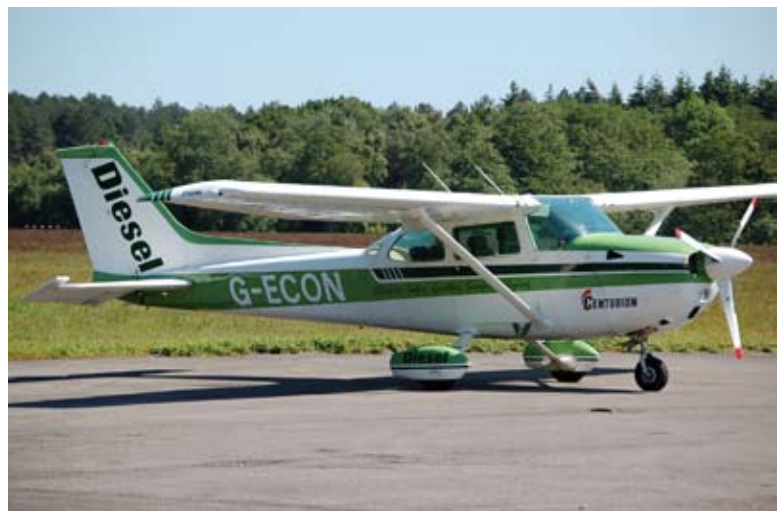
**Figure 1**  
G-ECON

The condition of the bolts and threads in the inner hub suggests that either the bolts were not fitted correctly, or the torque on all the bolts released and vibration caused them to unwind until there were only two to three threads on two of the bolts clamping the hub together. G-ECON has a very distinctive colour scheme and it is highly likely that the pieces of wheel spat found at Dunkeswell came from this aircraft. This evidence is consistent with the pilot's account of feeling a bump through the landing gear during the takeoff run, which was probably the point at which the left wheel hub started to come apart. The pilot commented that it was difficult to inspect the wheels with the spats fitted (Figure 1).

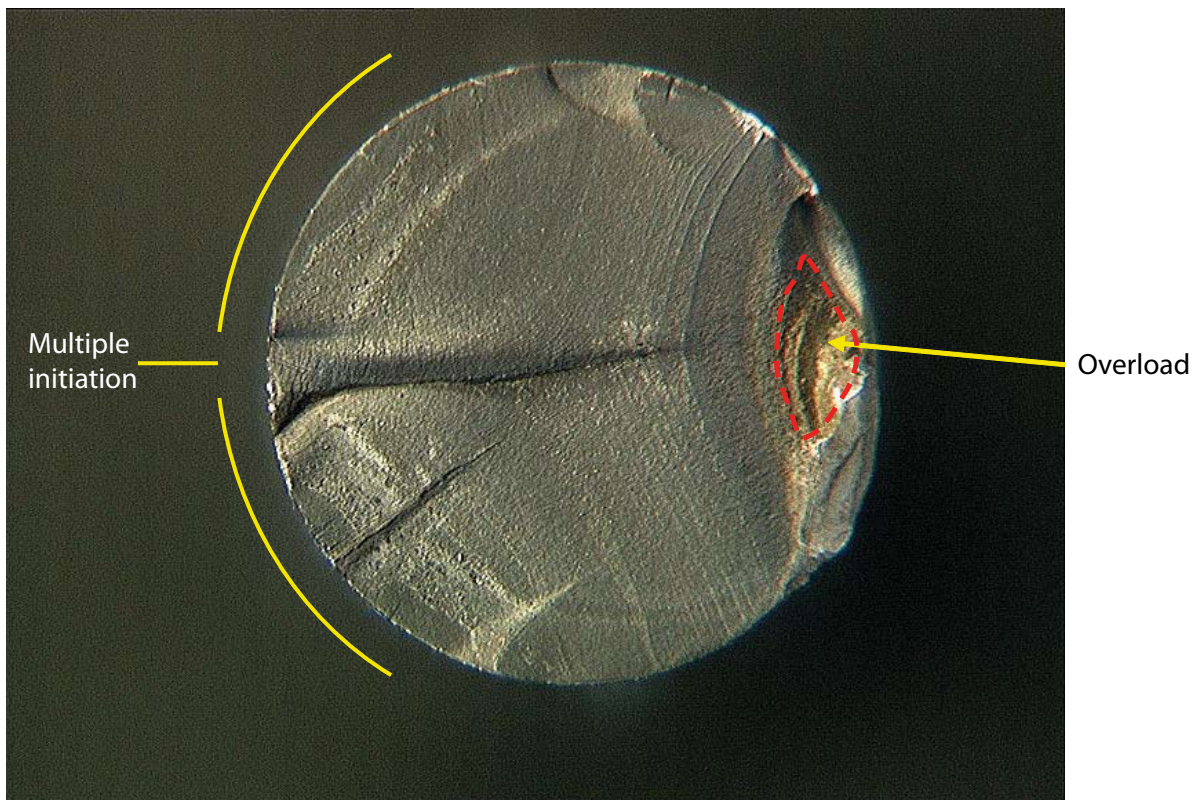
**Figure 1**  
Fracture surface of No 3 exhaust valve from G-JAAB after cleaning

the head radius. It was noted that the stem-side fracture was coated with a dark deposit unlike the head-side, which was relatively clean. Detailed examination of the stem-side deposit under high power optical microscopy revealed the presence of bright discrete globular metallic particles amongst the deposit. The particles were soft and could be smeared, which suggested that they could be particles of lead. After cleaning, the fracture surface of the stem side was examined and seen to exhibit beachmarks, which are characteristic of failure due to fatigue crack growth (Figure 1). Multiple fatigue crack initiation sites were present around the majority of the valve circumference, although crack growth appeared to have been predominantly from one side of the valve. A small area of overload was present at the end of the fatigue.

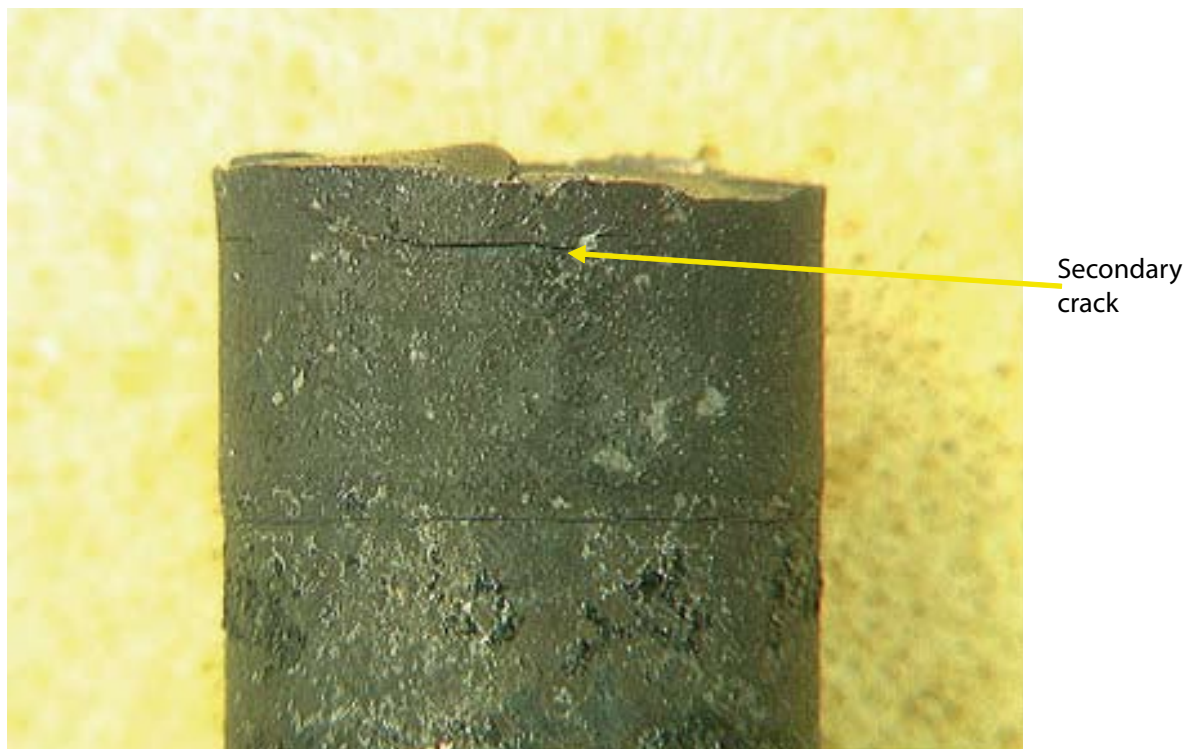
**Figure 2**

Visual examination of the remaining section of the exhaust valve stem revealed secondary cracking adjacent to the fracture surface (Figure 2).

Stem of No 3 exhaust valve from G-JAAB adjacent to fracture showing secondary cracking

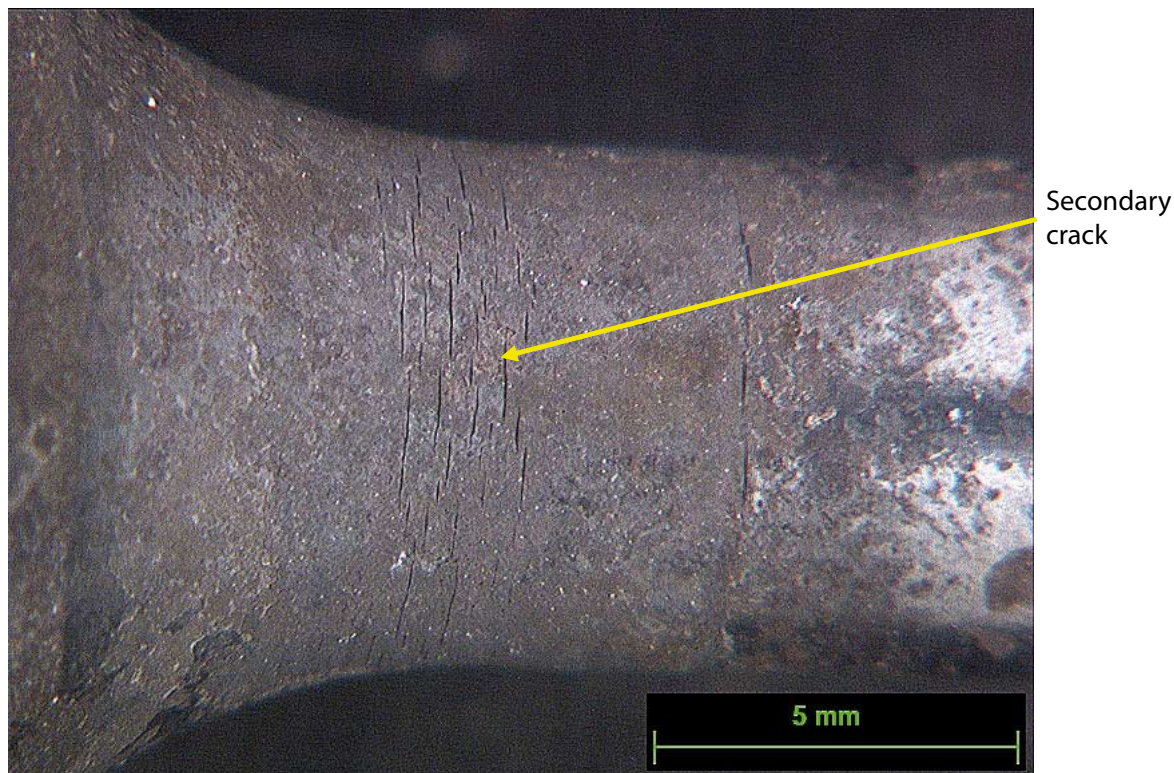
**Figure 3**

Exhaust valves 1, 2 and 4 exhibited small transverse cracks (Figure 3) at the edge of the head radius, in a position similar to the fracture point of the exhaust valve from cylinder No 3, indicating that all the cylinders had experienced similar high temperatures.

No 4 cylinder exhaust valve from G-JAAB showing secondary cracking

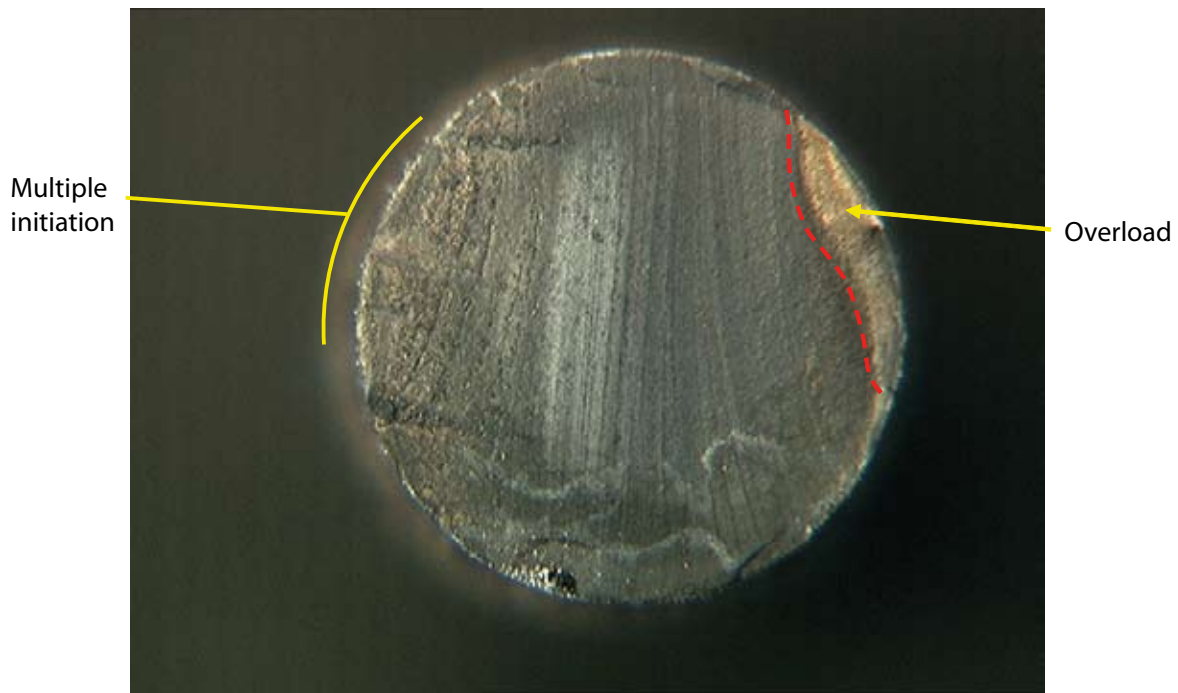
**Figure 4**

Fracture surface of No 1 exhaust valve from G-CBIP

within the exhaust port. Figure 4 shows beachmarks clearly visible on the fracture surface, characteristic of fatigue crack growth. The fatigue appeared to have initiated from multiple points on one side of the valve and propagated across the majority of the valve stem before final overload failure occurred.

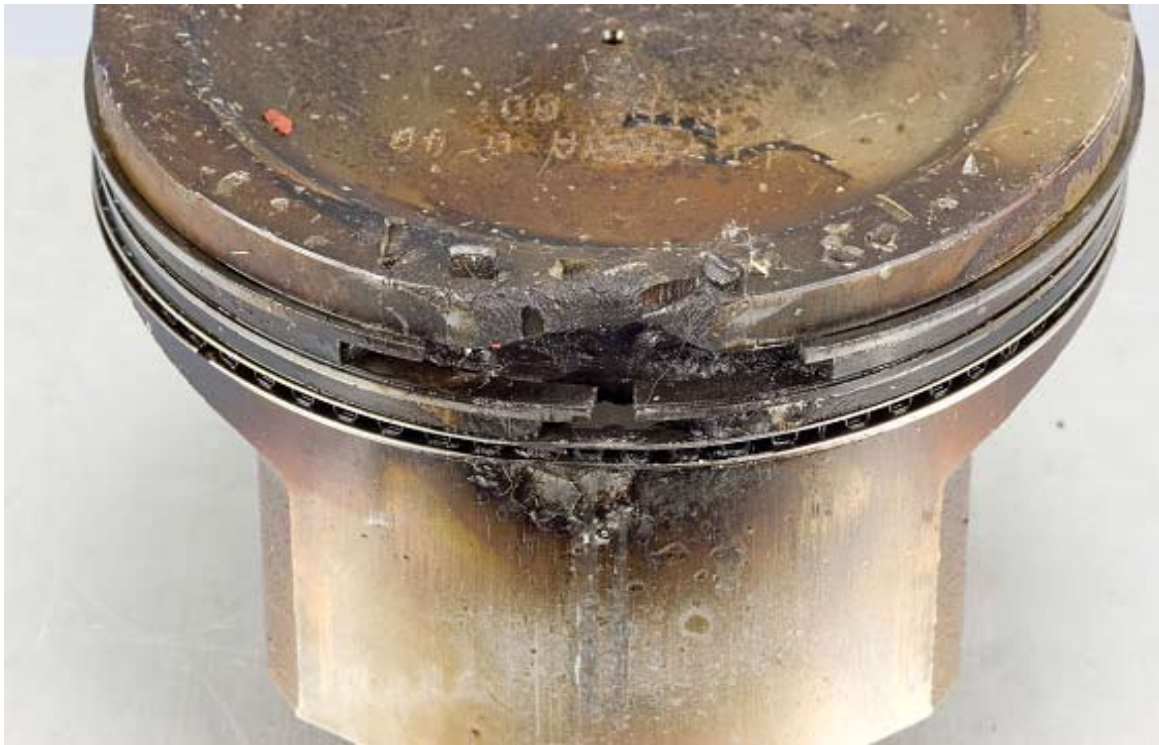
**Figure 2**

Three cylinders and their associated pistons were taken to the Materials Department at QinetiQ for detailed metallurgical examination. Examination of the three cylinders showed that No 3 piston and cylinder exhibited characteristics similar to the No 3 piston and cylinder from G-CEED. The piston/cylinder head interface exhibited sooting on one side of the cylinder, with the corresponding edge of the piston exhibiting burn-through (Figure 2). The internal surface of the cylinder showed evidence of minor wear and material pick-up from the piston at the point of the piston burn-through. Skirt wear was observed on the piston similar to that observed in the examination of the engine from G-CEED. Minor wear was observed below the burn-through with the opposite skirt exhibiting more severe wear. The other two pistons both exhibited skirt wear similar to the No 3 piston. One of the pistons showed evidence of damage to the edge of the piston crown with reciprocating wear and material pick-up on the internal surface of the cylinder. The damage appeared to be purely mechanical, with no evidence of burn-through as seen in the No 3 piston.

Examination of the piston rings and oil scraper rings showed that the lower piston ring was seized in the closed position on one of the pistons and on another the upper ring was seized at the area of the damage, so that it was flush with the piston edge. The other end of the piston ring was free to move. On the No 3 piston both the lower piston ring and oil scraper ring were seized in the closed position.
