## **Service Inquiry**

1 Rifles Parachuting  
Accident

29 Sep 15

**SERVICE INQUIRY INVESTIGATION INTO THE DEATH OF LCPL ALI JOHN WOODFORD ON 29 SEP 15**

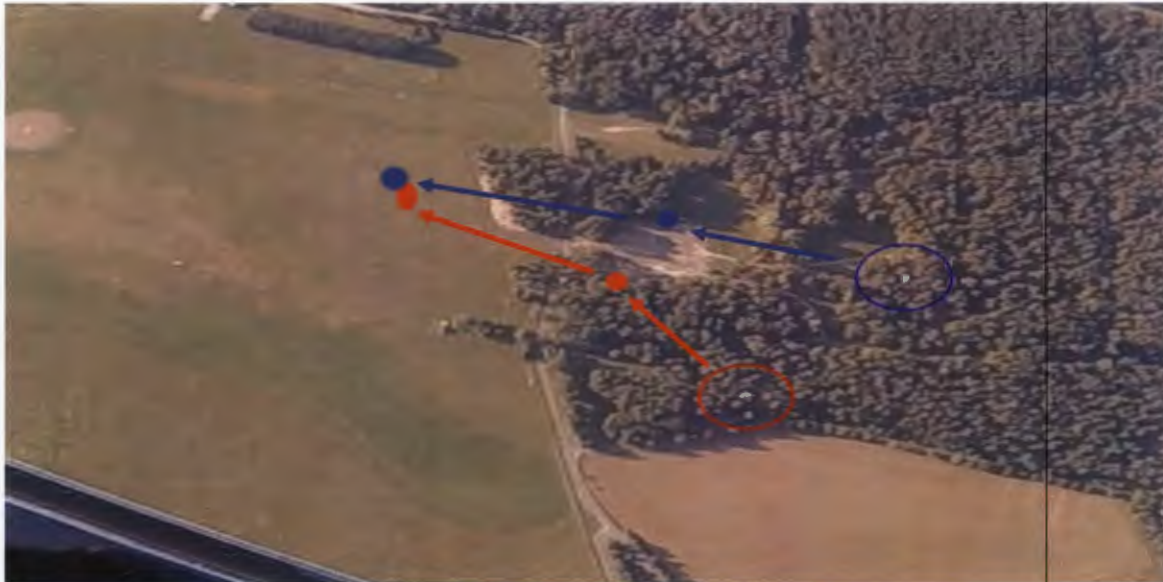
Fig 1.3.5 – Collision Course.

1.3.29 Approximately 14s after initiating their downwind legs LCpl Woodford and Student A collided and became entangled at a height of 780ft agl. Fig 1.3.5 provides a depiction of the collision course taken by Student A and LCpl Woodford. They were entangled in the air for approximately 8s. LCpl Woodford carried out his main parachute cut away and reserve canopy deployment drills at a height of 460ft agl. LCpl Woodford was seen to be falling backwards as he cut away his main parachute. LCpl Woodford's reserve canopy started to deploy but did not fully open before he impacted the ground 359m (1180ft) from the control tower. Exhibit 22  
Exhibit 24  
Exhibit 25  
Exhibit 23  
Witness 12

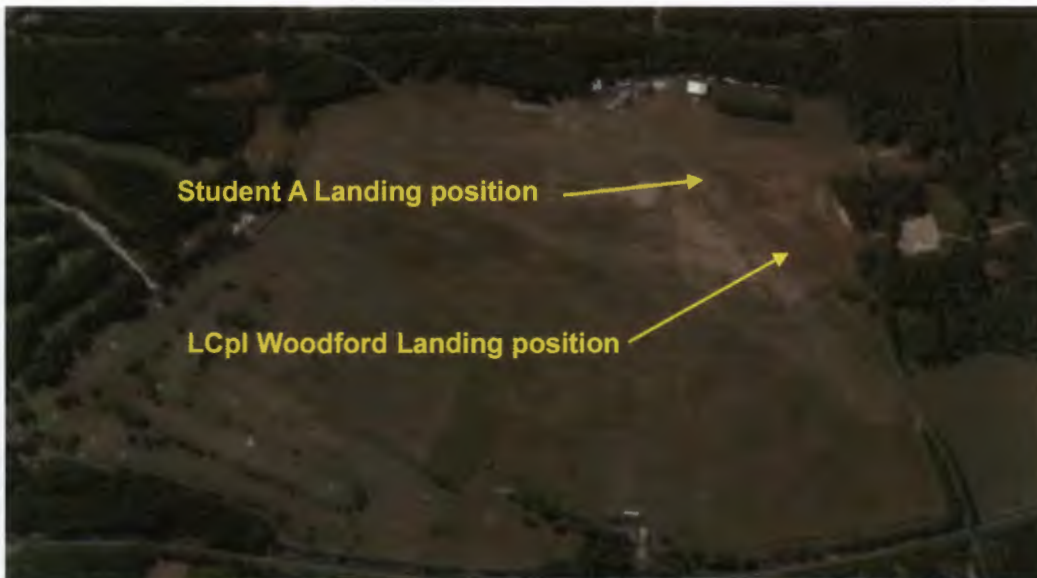
Fig 1.3.6 – Landing Positions.

1.3.30 Student A cut away his main canopy and pulled his reserve handle at a height of 279ft agl approximately 14s after the collision. Student A's reserve canopy fully deployed just before he landed 200m (656ft) from the control tower. Fig 1.3.6 details the approximate landing positions of LCpl Woodford and Student A.

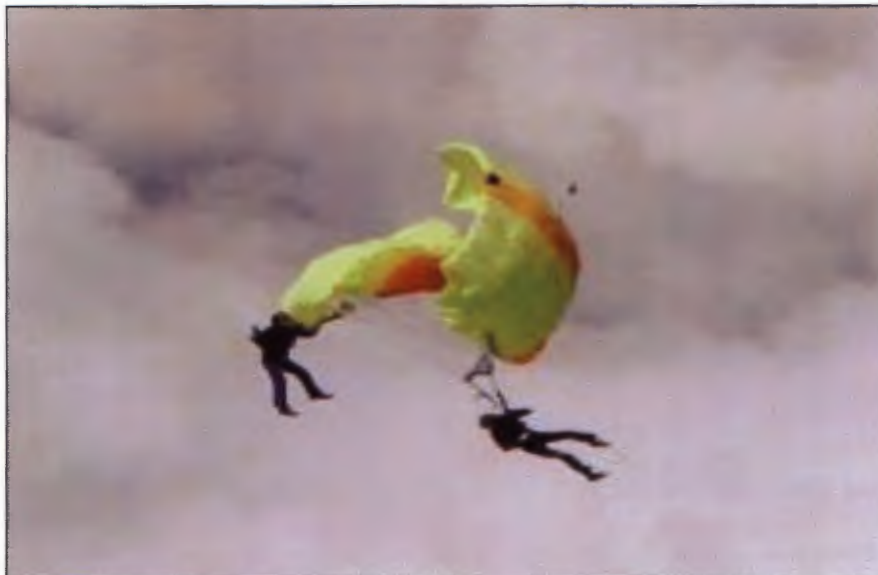
Fig 1.4.3 – Example of Body Position Change Due to Entanglement.

1.4.23 LCpl Woodford and Student A were at a height of 238m/780ft agl when they collided. They were entangled for approximately 8s. During this time the AAD data depicts fluctuations in air pressure immediately prior to the point at which the reserve drill was completed by LCpl Woodford. The Panel was provided with evidence that these fluctuations were likely due to erratic changes in body position as a result of the entanglement. Witnesses stated that LCpl Woodford was falling backwards when he conducted the reserve drill.

1.4.25 The Panel concluded that it is more likely than not that LCpl Woodford's body position caused a delay in the full deployment of the reserve parachute and his rate of descent could not be arrested within the height available. LCpl Woodford's body position was an aggravating factor.

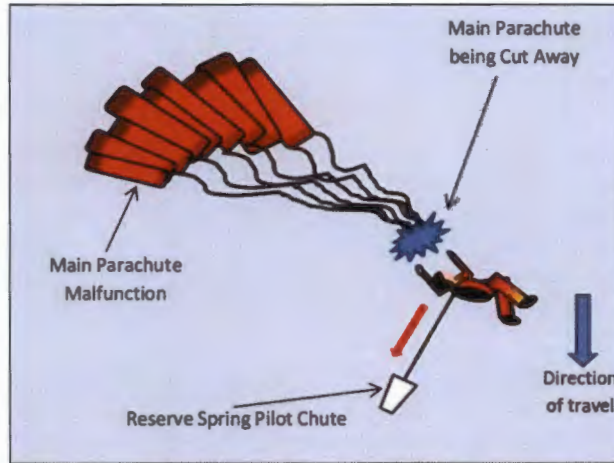
Fig 1.4.4 – Spring Loaded Pilot Chute Ejection Direction.

1.4.24 According to the PIA standards, when LCpl Woodford conducted his reserve drill, he was at sufficient height for the reserve parachute to fully deploy. However, the Panel noted that if LCpl Woodford was falling backwards when he conducted the reserve drill, deployment of the reserve parachute could be delayed because in theory the spring loaded pilot chute would have ejected towards the ground (Fig 1.4.4). The Panel assessed that LCpl Woodford would have had to fall below his pilot chute before it could inflate to initiate the deployment of the reserve parachute.

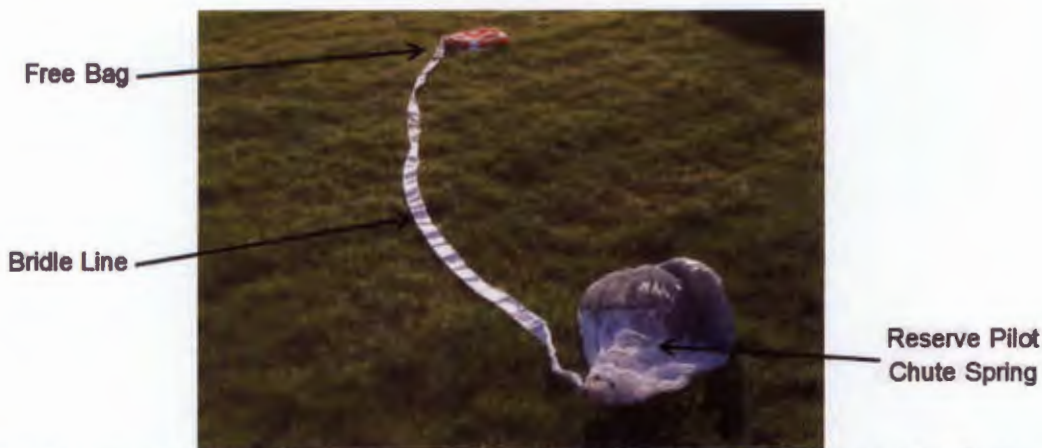
Fig 1.4.6 – LCpl Woodfords Reserve Pilot Chute Spring, Free Bag and Bridle Line.

1.4.27 Photographs taken immediately after the accident of LCpl Woodford's spring loaded pilot chute, bridle line and free bag by Staff C and D indicated that LCpl Woodford's pilot chute spring had initiated the deployment of his reserve parachute. RAF CAM examined LCpl Woodford's and Student A's pilot chute springs and found them to be intact and functional. Based on the evidence the Panel concluded that the reserve pilot chute spring was **not a factor**. However, the Panel **observed** that although there is evidence of spring tension/compression tests on other parachute systems there is no minimum spring compression force stated either in published documentation from Rigging Innovations or the spring manufacturer for the system used in the accident. In contrast, military parachute systems have standards applied to each equipment item and tests are conducted periodically once fitted.

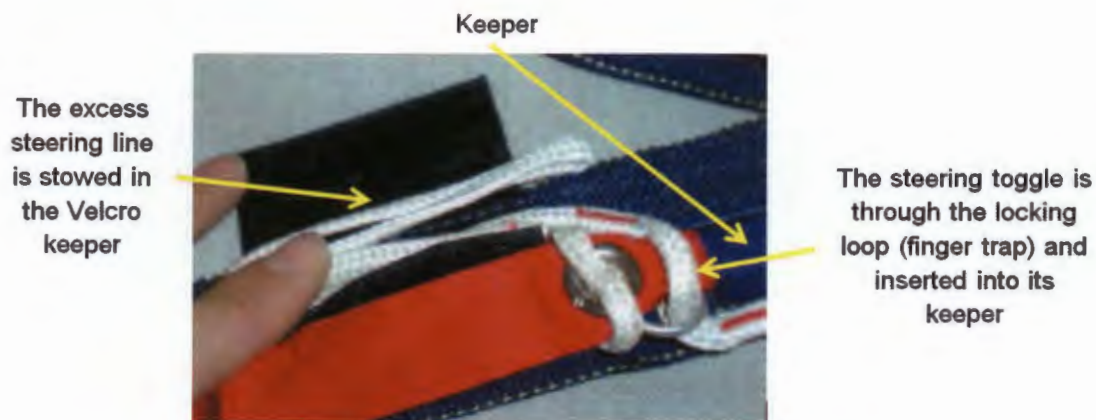
Fig 1.4.12 – Steering Toggle Set at Half Brake.

1.4.36 **Reserve Steering Toggle.** The Panel reviewed photographic evidence of LCpl Woodford's equipment taken at the accident site as part of the post-accident procedures and subsequently during the equipment inspection by the SIB, BPA and Defence AIB. The Panel identified from the post-accident photographs that LCpl Woodford's right hand reserve steering toggle was not set at half brake<sup>6</sup>. Fig 1.4.12 depicts a steering toggle set correctly at half brake according to the manufacturers' guidelines.

1.4.42 In light of the documentation oversight coupled with not being able to identify the cause of LCpl Woodford's reserve steering toggle not being set correctly in the half brake position, the Panel recommended to DG DSA that all reserve parachutes held at RAPA be inspected prior to the recommencement of parachuting activities. This recommendation had been enacted by RAPA and confirmed with DG DSA.

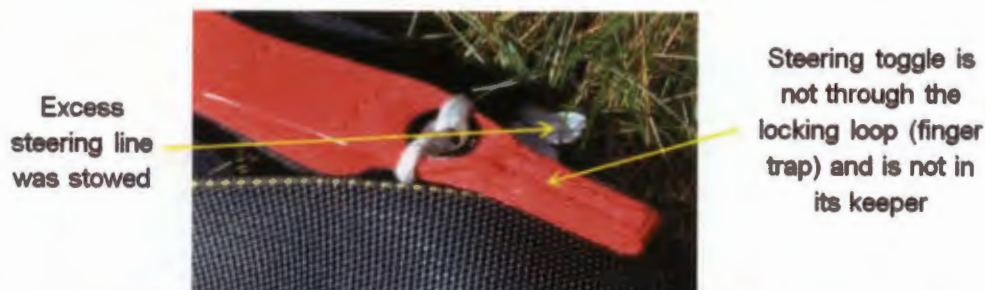
Fig 1.4.13 – LCpl Woodfords right hand Steering Toggle.

1.4.37 The locking loop/finger trap was not in place nor was the finger stowed into its keeper shown in Fig 1.4.13. After further investigation the Panel were unable to determine whether this anomaly had occurred when the reserve parachute was packed, on impact with the ground, or during the recovery process after the accident.

1.4.38 The Panel was advised by a Subject Matter Expert (SME) from the BPA that the steering toggle not being stowed correctly would not have impeded the deployment of LCpl Woodford's reserve parachute. The Panel concluded that the reserve steering toggle

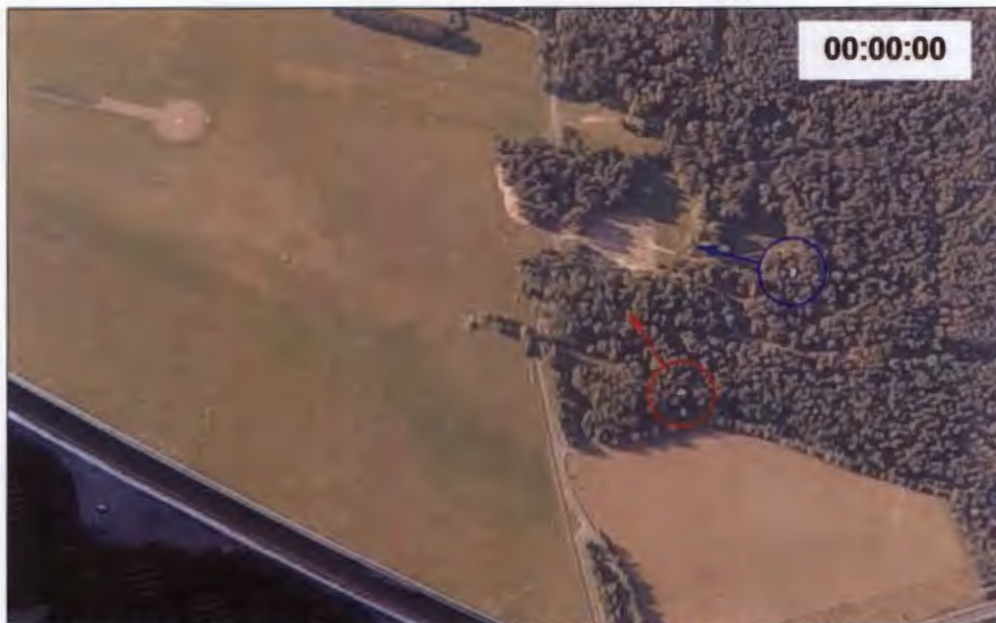
**Fig 1.4.14 – LCpl Woodford and Student A approximately 180m apart.**

1.4.65 LCpl Woodford and Student A attained similar heights, with LCpl Woodford the last to perform a significant turn manoeuvre, which concluded approximately 12s before the collision. Both students initiated their Landing Pattern (LP) downwind legs on a convergent path. Fig 1.4.14 through to Fig 1.4.16 depict the respective flight paths of LCpl Woodford (circled red) and Student A (circled blue) with an elapsed time in seconds in the top right hand corner.

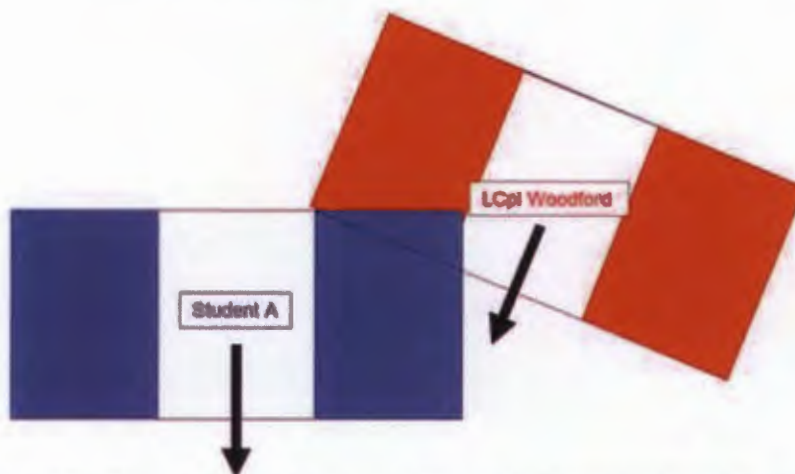
Fig 1.4.17 – Direction and Angles of the Main Parachutes at Collision.

flown by Student A, on the left side mid-way down the blue canopy's left steering lines. Fig 1.4.17 provides a pictorial representation of the relative direction of travel and angles of the main parachutes at the moment of collision. The 1710 NAS report described damage to the right quarter of the red canopy and that red residue, most likely from the red parachute, was on the rear left steering lines of the blue canopy.

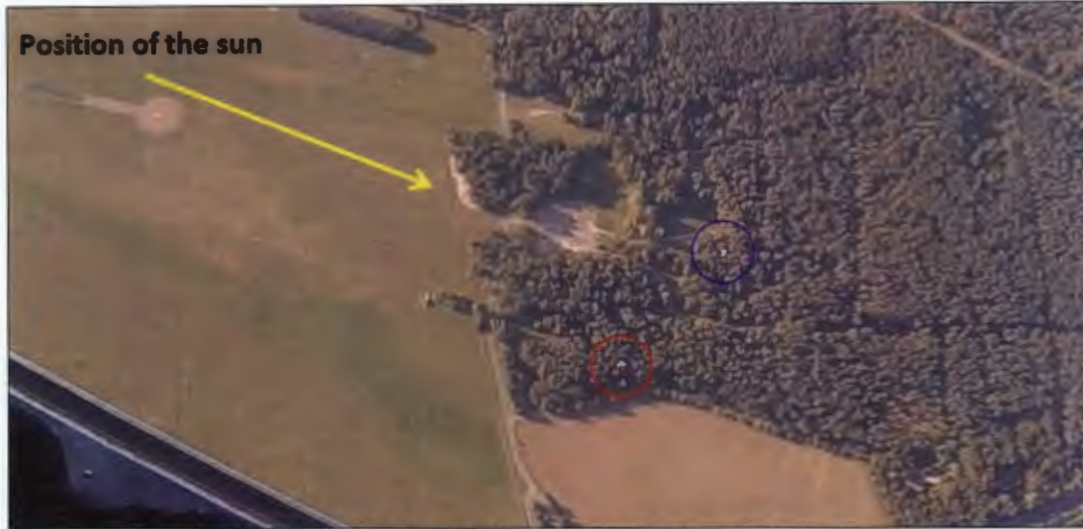
Fig 1.4.18 – Orientation of the Sun at the Time of the Accident.

1.4.70 **Position of the Sun.** Given the general MET conditions on the day and the evidence of the headcam footage, the Panel identified that the sun was not obscured at the time of the accident. The position of the sun was in the west at 240 degrees. The time of day would have placed the sun at an elevation of 18 degrees. The sun would have been in the eye-lines of Student A and LCpl Woodford when looking ahead as their general flight paths were towards the west (see Fig 1.4.18). However, it would not have impeded their ability to see each other as they would have had to look left (Student A) or right (LCpl Woodford) to locate the other parachutist. All round observation conducted by LCpl Woodford and Student A should have enabled detection of one another. The sun had not affected Student A. The Panel was unable to determine if the sun had affected LCpl Woodford's vision but considered it unlikely. Accordingly, the Panel concluded that the position of the sun was probably **not a factor** in the accident.

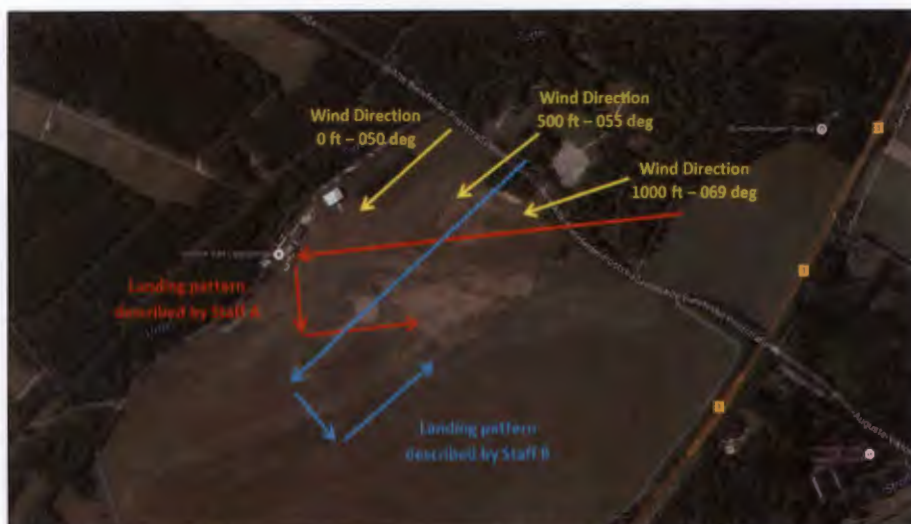
Fig 1.4.21 – Landing Patterns briefed by the CI and SI.

1.4.79 **Conflicting LP.** Prior to embarking the aircraft the SI briefed students on the specific direction of the LP to be used. This was in accordance with the MET conditions at the time. The CI briefed the LP for that lift differently. Fig 1.4.21 illustrates the LPs briefed by the CI and SI and describes the wind direction at 3 separate heights in accordance with the MET. The CI acknowledged during interview that the SI instructed the LP with a downwind leg towards the golf courses. However, when the students were descending they were informed to head towards the control tower for their downwind leg. The CI gave these instructions because the wind had changed and was now in the direction of the control tower (Fig 1.4.22). Instructions were given to the first two student parachutists on the lift as they descended and to LCpl Woodford and Student A. The description of Student A going towards the control tower for his downwind leg was incorrect as the headcam footage shows he conducted his downwind leg towards the golf courses. A number of other students reported that the downwind leg was towards the golf courses.

1.4.80 The Panel assessed that the SI briefed a LP commensurate with the MET. Student A was on a downwind leg as briefed by the SI. LCpl Woodford's downwind leg was orientated towards the control tower as instructed by the CI. This indicated that LCpl Woodford followed the instructions given by the CI to conduct a downwind leg towards the control tower although there is no other evidence to substantiate this possibility.

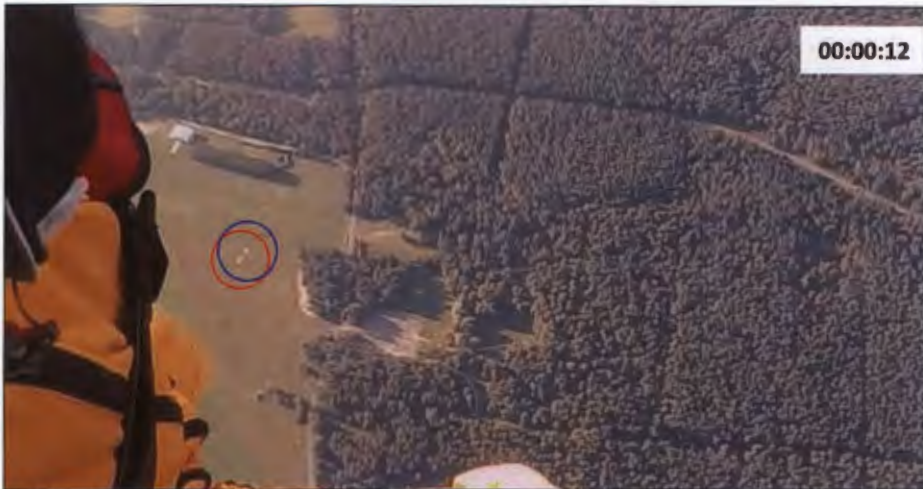
Fig 1.4.23 – Student K Exiting the Aircraft - LCpl Woodford and Student A Circled.

1.4.87 **Supervision – Division of Attention.** The third lift of the day occurred at 1658 hrs. The first pass was conducted at 1701 hrs, the second pass at 1704 hrs (LCpl Woodford and Student A) and the third pass at 1707 hrs. The CI watched the exits of Students K and L on the third pass. The headcam footage showed that as Student K sat in the doorway of the aircraft, LCpl Woodford and Student A were approximately 20m apart (Fig 1.4.23) at 12s elapsed time of the headcam footage.

1.4.88 LCpl Woodford and Student A collided as Student K exited the aircraft between second 13 and 14 of the headcam footage. The actual collision was not visible on the headcam footage as they were obscured by Student K. LCpl Woodford and Student A became visible again during second 14 by which time they were entangled.

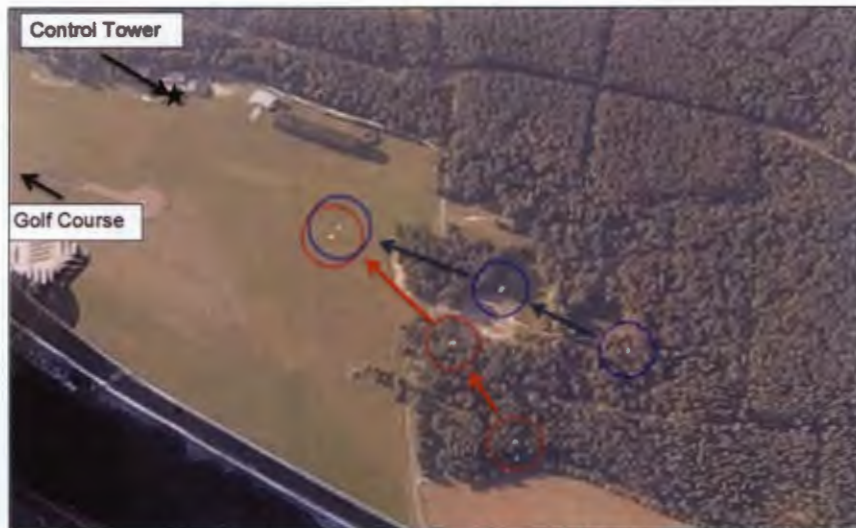
Fig 1.4.24 – Converging Down Wind Legs.

1.4.94 The Panel found evidence that a left turn was not taken by the blue canopy flown by Student A which, according to the headcam footage illustrated at Fig 1.4.24, continued

on a straight flight path towards the golf courses. The red canopy can be seen to be heading towards the control tower with a slight deviation to the left at approximately second 5 of the headcam footage.
