Rail Accident Investigation Branch

# Rail Accident Report

## The derailment of a freight train at Washwood Heath 8 September 2006

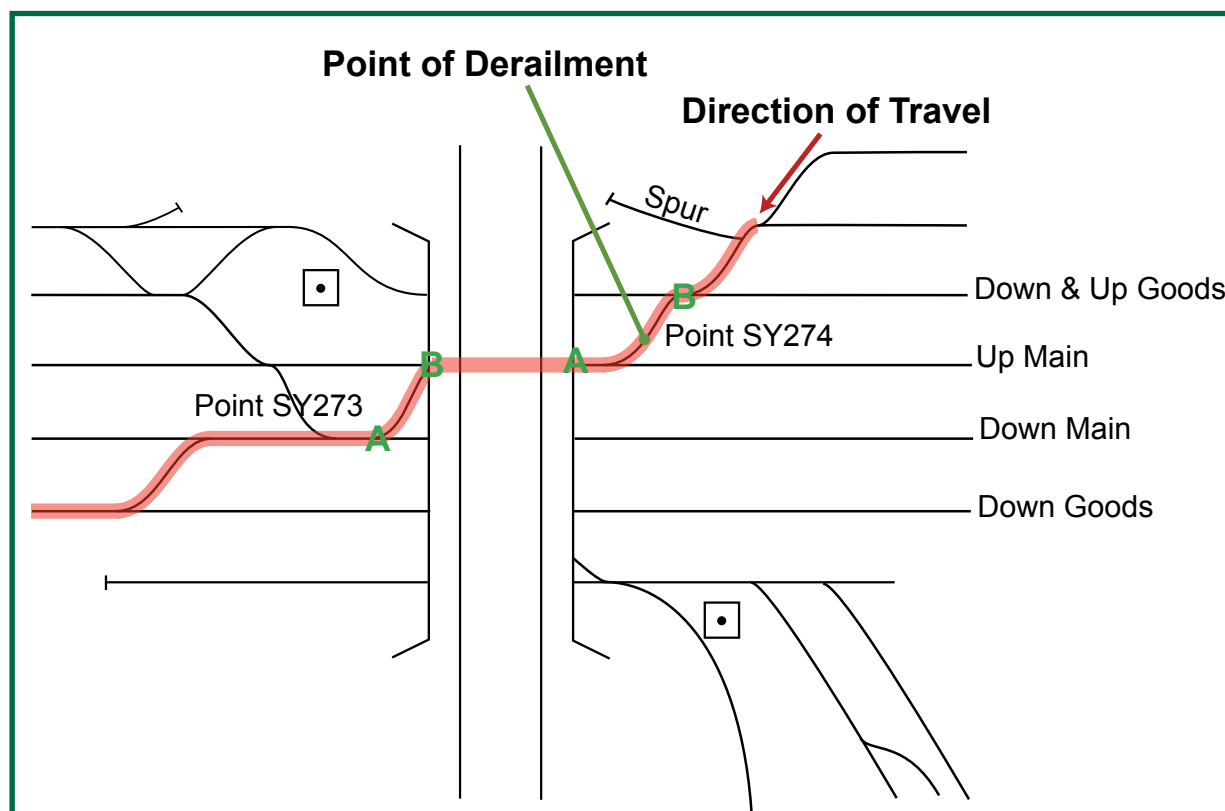
Figure 2: Diagram of SY274 crossover showing point of derailment

- 29 The derailed bogie was dragged through SY724A, SY273B and SY273A points (see Figure 2) causing damage to each. At some position, shortly after passing over point SY273A, the derailed bogie rerailed and continued to run normally.

- 33 The derailment mechanism was *flange climbing*. This was evidenced by distinct marks on the gauge corner of the left-hand *closure rail* followed by marks on the top of the rail indicating that the two left-hand wheels on the leading bogie had run along the railhead before dropping off the *field corner* of the rail.

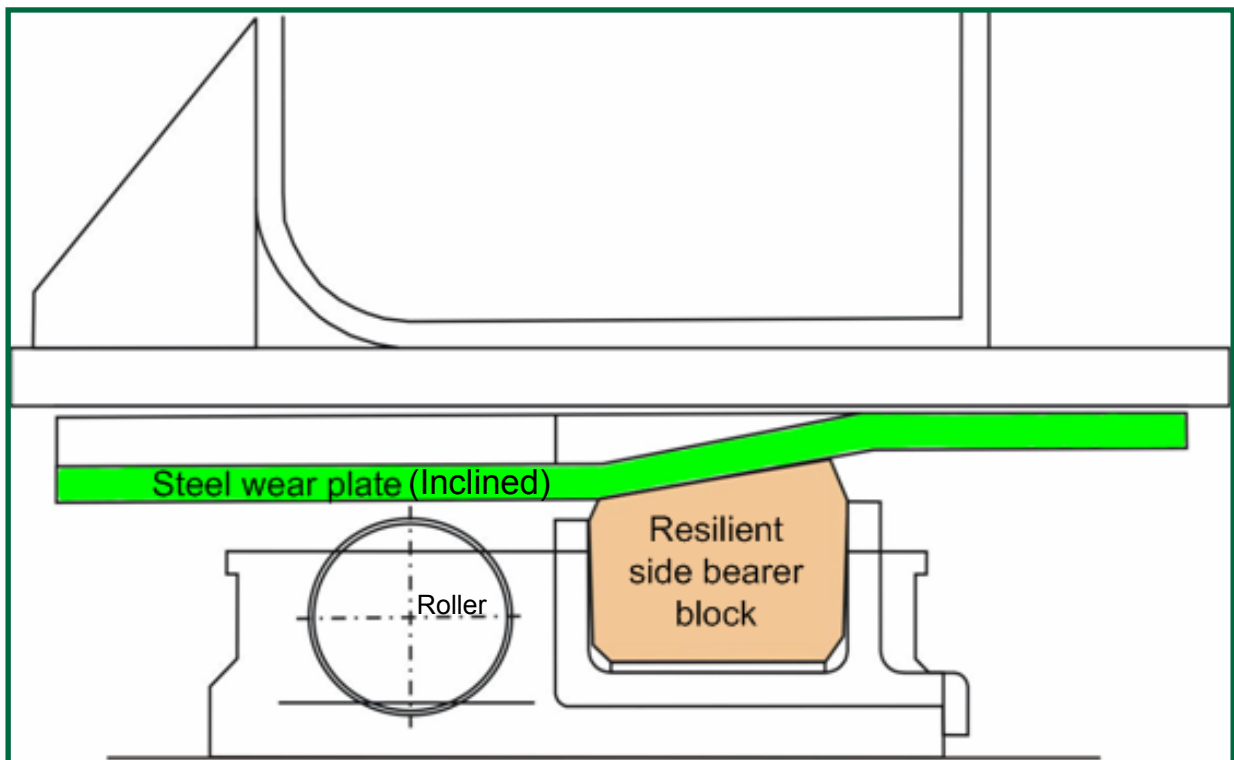
Figure 5: Diagram of the original side bearer assembly with inclined wear plate

- 45 When delivered to EWS in 1999 the FAA wagon's side bearer assembly incorporated:
- an inclined *underframe wear plate*; and
  - a resilient *side bearer block* and roller (see also Figure 5).

- 48 EWS concluded that the propensity to derail was linked to the inclined underframe wear plates on the wagon. They reasoned that when these wagons traversed reverse curves these plates caused the two ends of the wagon to tilt in opposite directions (so generating a twist force). EWS considered that this twist force at the wagon ends, combined with the wagon's structural stiffness, would be sufficient to cause one or more wheels to become unloaded so increasing the risk of derailment.

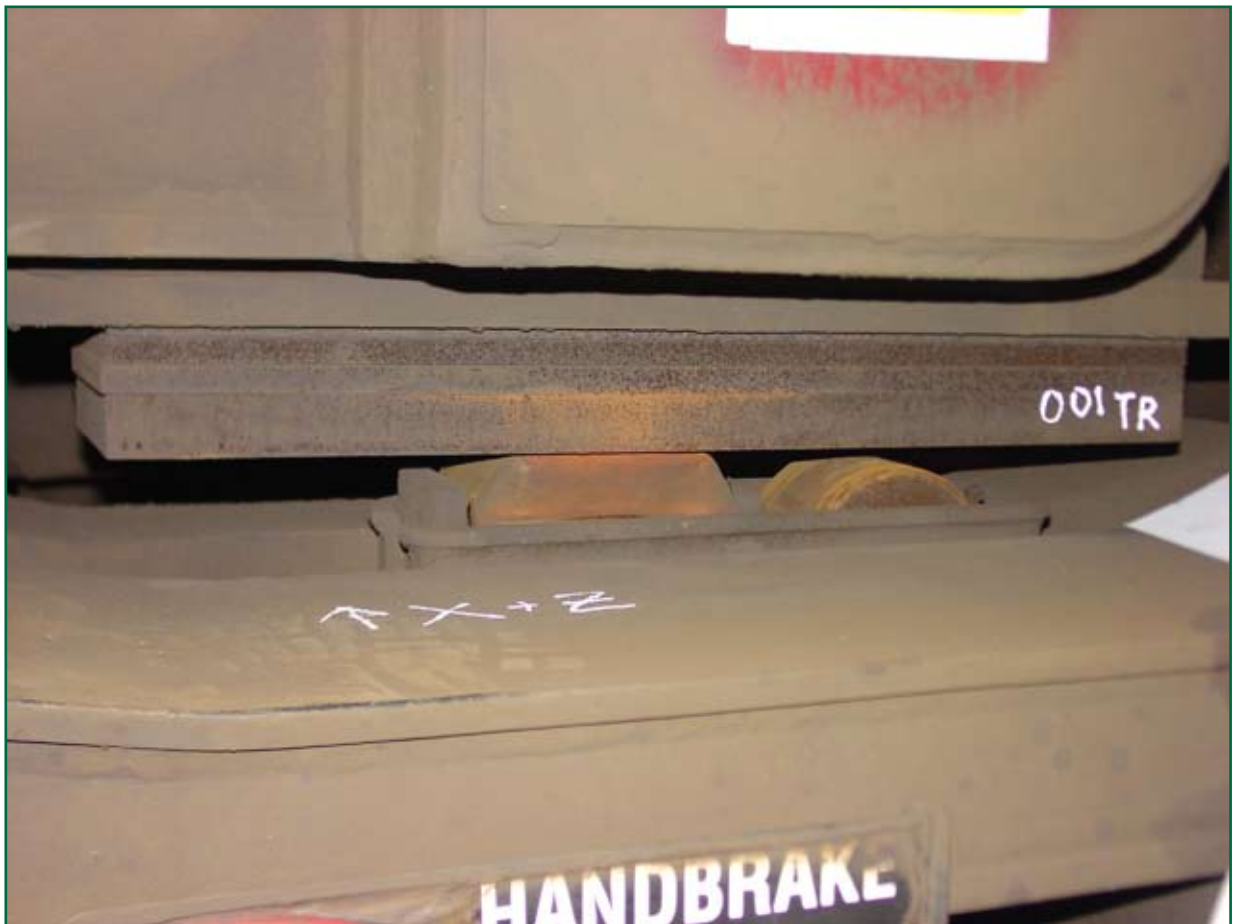
Figure 7: Photograph showing condition of a side bearer assembly

- 58 Some days later the vehicle was subjected to further visual examination at a Bombardier facility. During this further examination it was noted that the outer surfaces of the four steel underframe wear plates on both bogies were showing signs of corrosion, as shown in Figure 7.

- bedding down of the assembly after initial installation;
  - degradation of the side bearer block; and
  - corrosion or pitting on the steel wear plate.

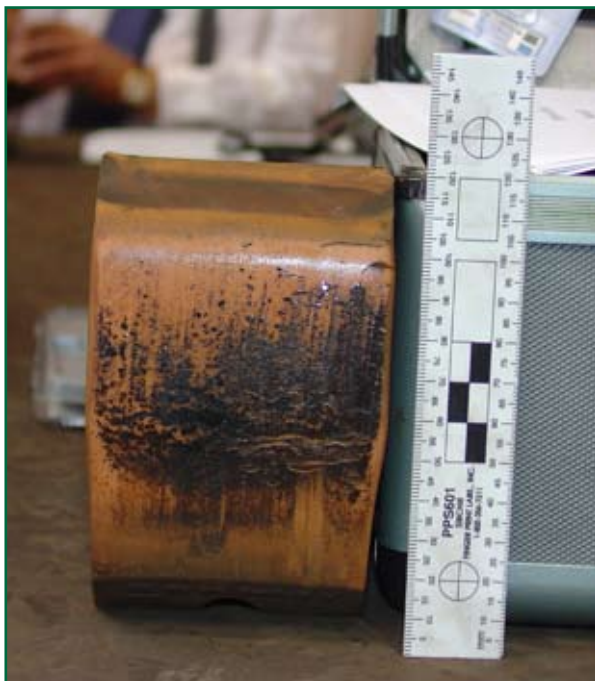
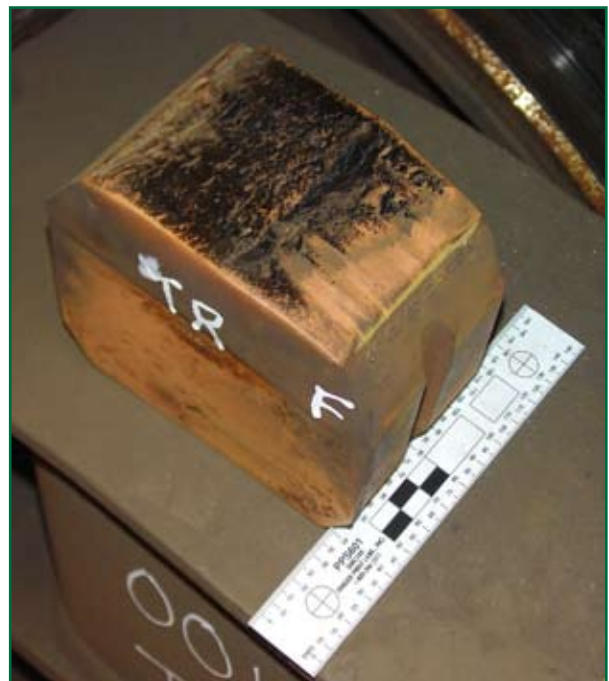
Figure 8: Condition of leading and trailing side bearer blocks

- 59 On lifting the wagon body the side bearer blocks, for both the leading and trailing bogies, were showing signs of surface abrasion and lateral cracking/tearing. The condition of the leading and trailing side bearer blocks can be seen in Figure 8. The surfaces of the trailing bogie's side bearer blocks showed indications of more abrasion and damage than those on the leading bogie.

- 61 In addition to the above, it was found that the side bearer blocks had been compressed by 4.5 mm which indicated that a significant proportion of the vehicle body weight had been carried by the four side bearer blocks.

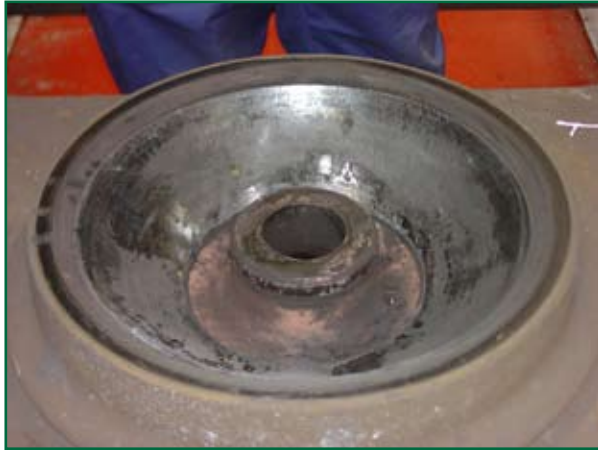
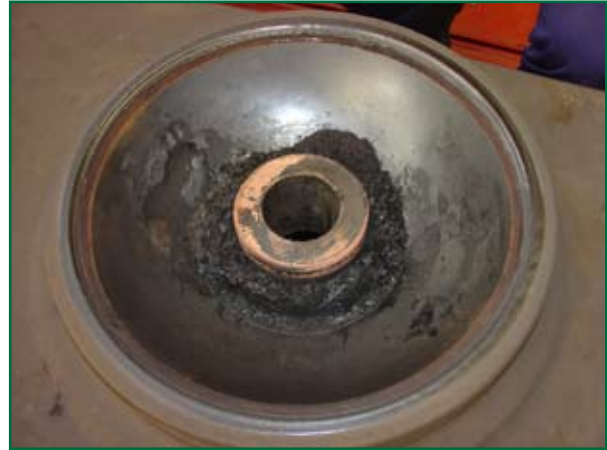
Figure 9: Condition of leading and trailing centre pivot socket liners

- 60 The centre pivot concave bearing surfaces on both bogies were also examined. Both showed signs of wear with the trailing bearing having shaved off an appreciable amount of material (see Figure 9). The surfaces of the centre pins were scored but did not show signs of significant damage (see Figure 10).

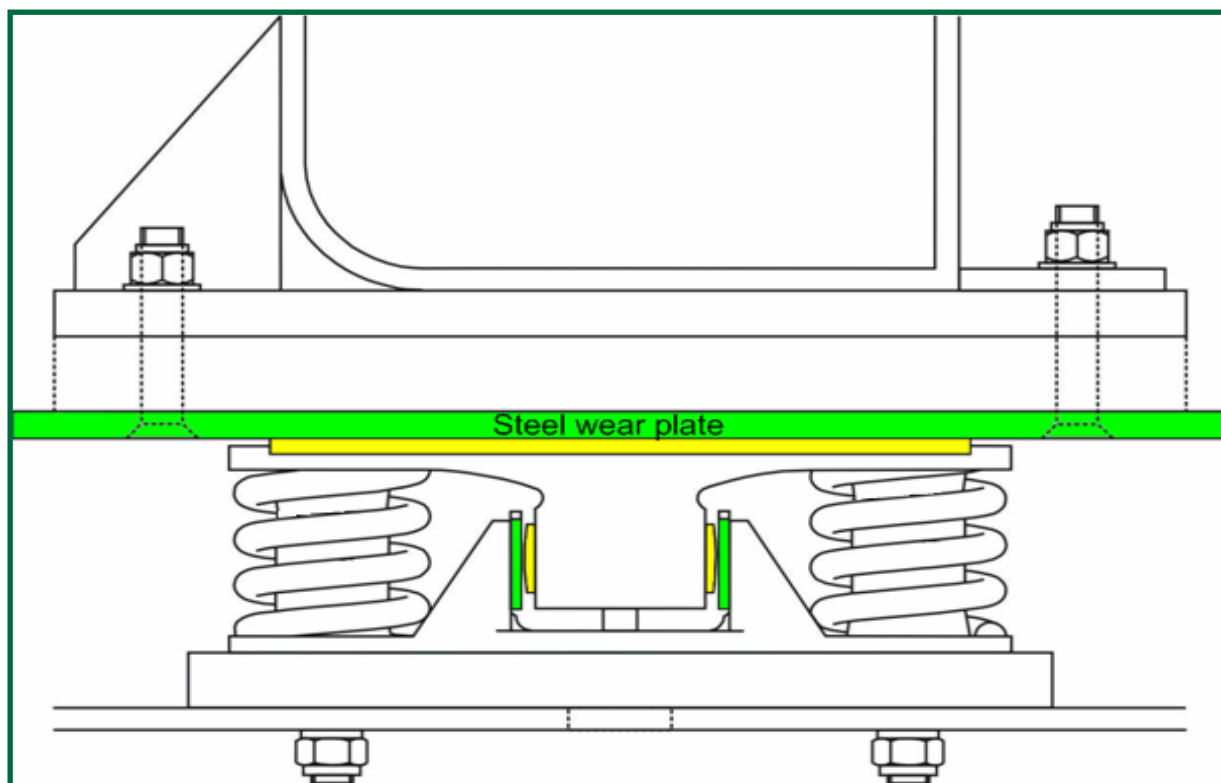
Figure 11: UIC design of side bearer

70 On a sixth FAA wagon, 609052, the existing side bearer block/roller was replaced by a UIC sprung bearer (Figure 11). The values obtained for this modified configuration of side bearer was as follows:

- bogie rotational stiffness = 0.104 (the original approved value was 0.119)
- average wheel unloading = 45 % (as compared to the specified limit of 60 %)

- 82 Tests carried out on wagon 609052 showed that both bogie rotational stiffness and wheel unloading would be comparable with the original values measured with the approved design if the resilient block was replaced by a UIC standard sprung side bearer (see Figure 11).

- 95 In addition to the above EWS are undertaking a programme to remove resilient block side bearers and replace them with a UIC standard sprung side bearer (see also paragraph 70).

- 1 EWS should complete its programme for installing UIC sprung side bearers in FAA wagons in order to overcome the known deficiencies with the existing arrangement (paragraph 90).
- 2 EWS, pending the replacement of all existing side bearers, should test a representative sample of the unmodified fleet of FAA wagons in order to confirm that the values obtained for bogie rotational resistance and torsional stiffness remain acceptable once the central pivot and side bearer components have been subject to wear and to measure any change in the performance of the side bearer lubrication between PPM (paragraphs 90 and 91).
