## CONTENTS

### SPECIAL BULLETINS

**SERIOUS INCIDENT**

<b>Aircraft Type and Registration:</b>	Boeing 737-73V, G-EZKG	
<b>No &amp; Type of Engines:</b>	2 CFM56-7B20 turbofan engines	
<b>Year of Manufacture:</b>	2004	
<b>Date &amp; Time (UTC):</b>	11 August 2010 at 1640 hrs	
<b>Location:</b>	West of Nantes, France	
<b>Type of Flight:</b>	Commercial Air Transport (Passenger)	
<b>Persons on Board:</b>	Crew - 5	Passengers - 144
<b>Injuries:</b>	Crew - None	Passengers - None
<b>Nature of Damage:</b>	None	
<b>Commander's Licence:</b>	Airline Transport Pilot's Licence	
<b>Commander's Age:</b>	60 years	
<b>Commander's Flying Experience:</b>	17,950 hours (of which 13,430 were on type) Last 90 days - 236 hours Last 28 days - 82 hours	
<b>Information Source:</b>	Aircraft Accident Report Form submitted by the pilot and further enquiries by the AAIB

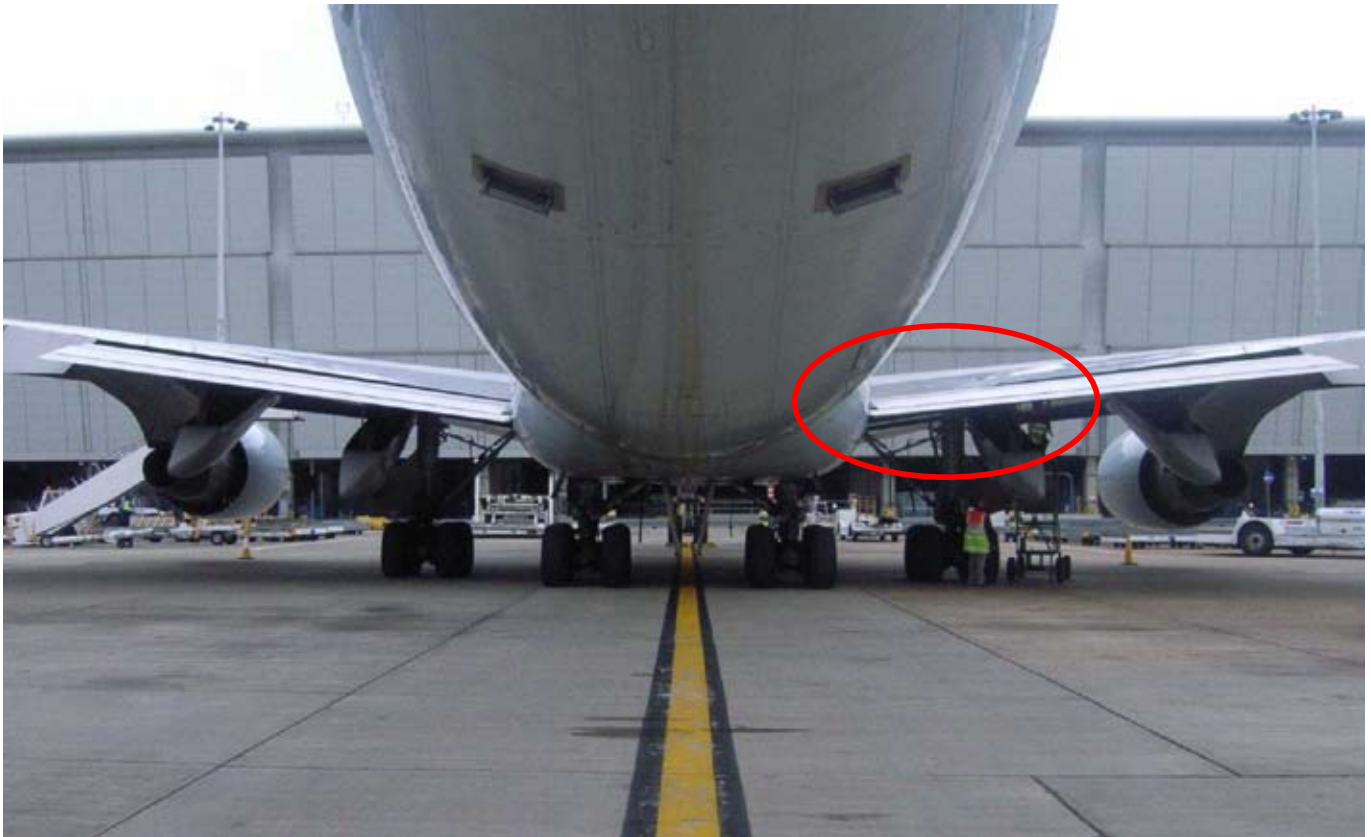
**Figure 1**

During post-flight inspections by an engineer, damage was identified to wing panels above and below the inboard flaps on the right wing and the flaps appeared out of alignment (Figure 1). Further investigation showed that the outboard end fitting of the wing landing gear support beam had failed. The aircraft was withdrawn from service for further inspection and repair.

Rear view of aircraft, showing misalignment of inboard flaps

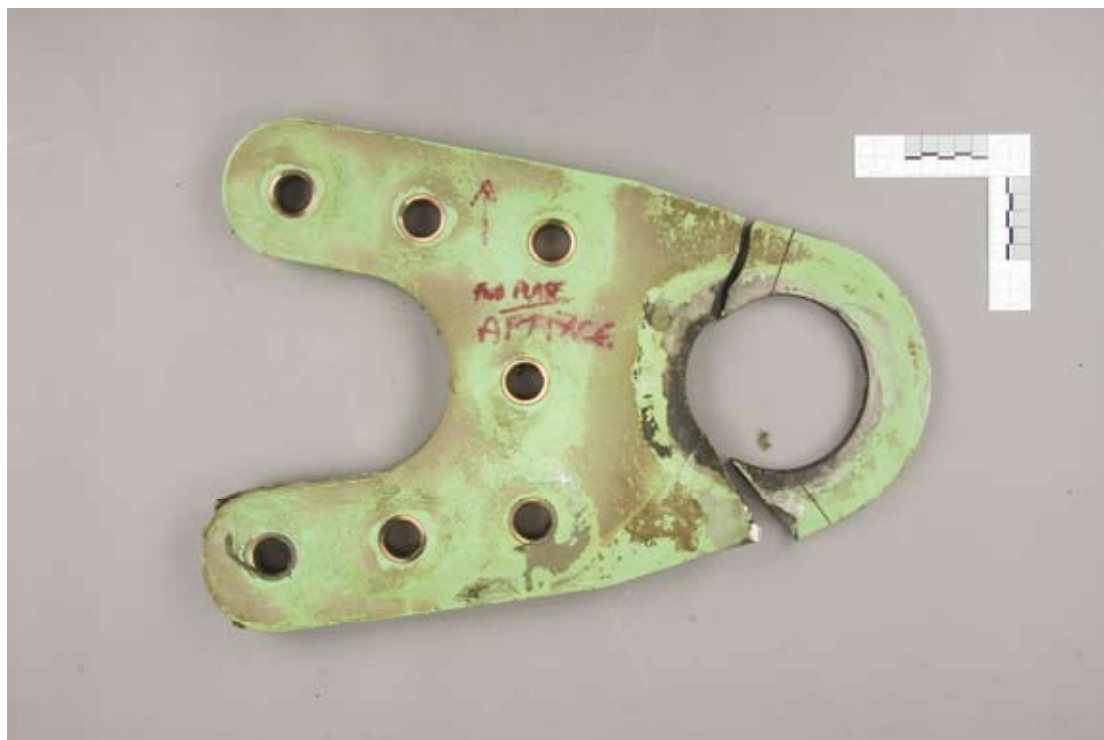
**Figure 3a**

Both fittings on the right wing had failed due to cracks radiating from the main bore of the fittings (Figure 3a and 3b). Significant areas of corrosion were apparent in the bore close to the cracks.

General view of failed forward fitting, right wing

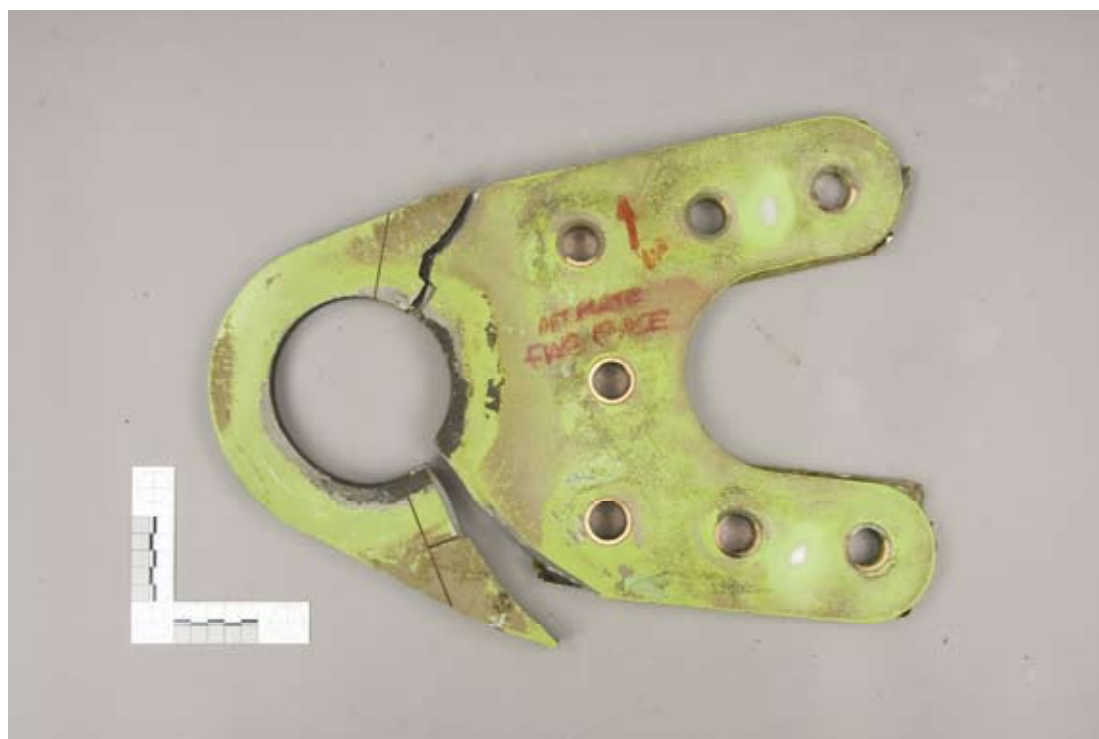
**Figure 3b**

General view of failed aft fitting, right wing

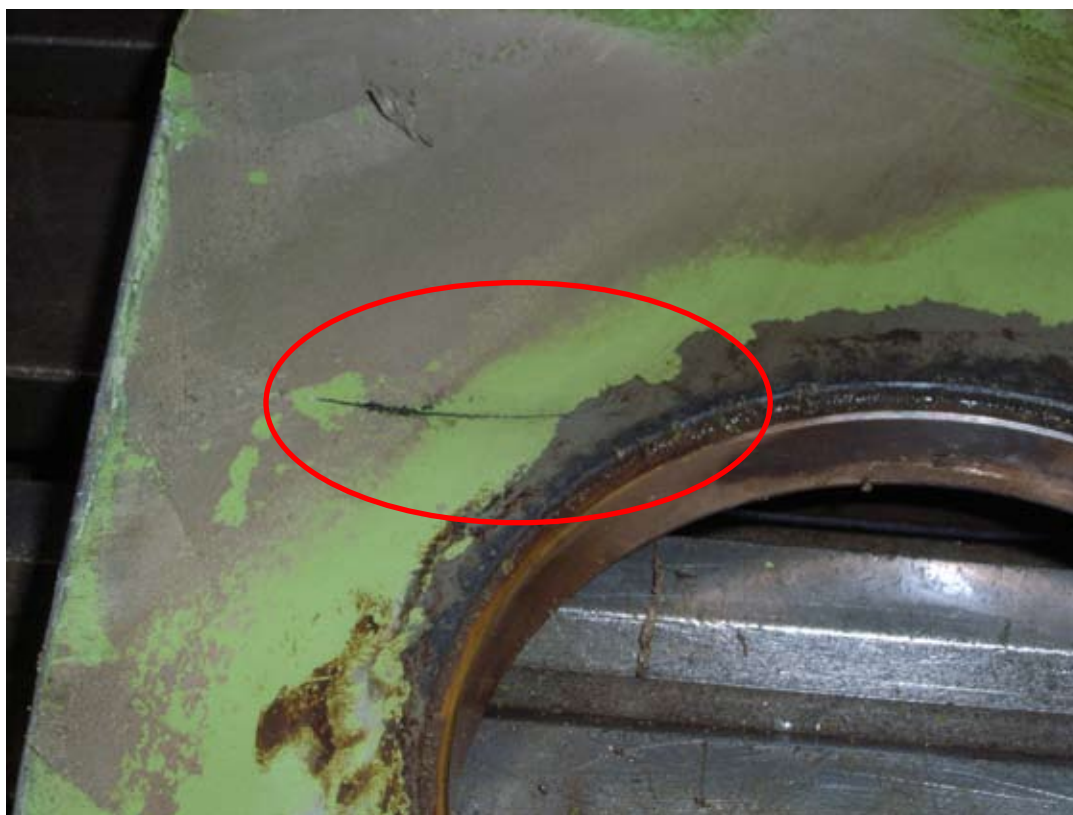
**Figure 4**

The fittings on the left wing were inspected using the inspection technique detailed in the manufacturer's Alert Service Bulletin (747-57A2331) and the forward fitting was found cracked (Figure 4).

Close up of forward fitting, left wing,  
showing bushing, corrosion around main bore and crack

manufacturing records that would have confirmed this had not been retained. Evidence did show that the large bushing had rotated in the fitting and as a result the sealant was dislodged allowing moisture ingress into the joint.

The manufacturer's current Service Bulletin (747-57A2331) details inspection procedures and either rework or replacement schemes to remedy and upgrade any deteriorated fittings that are identified.

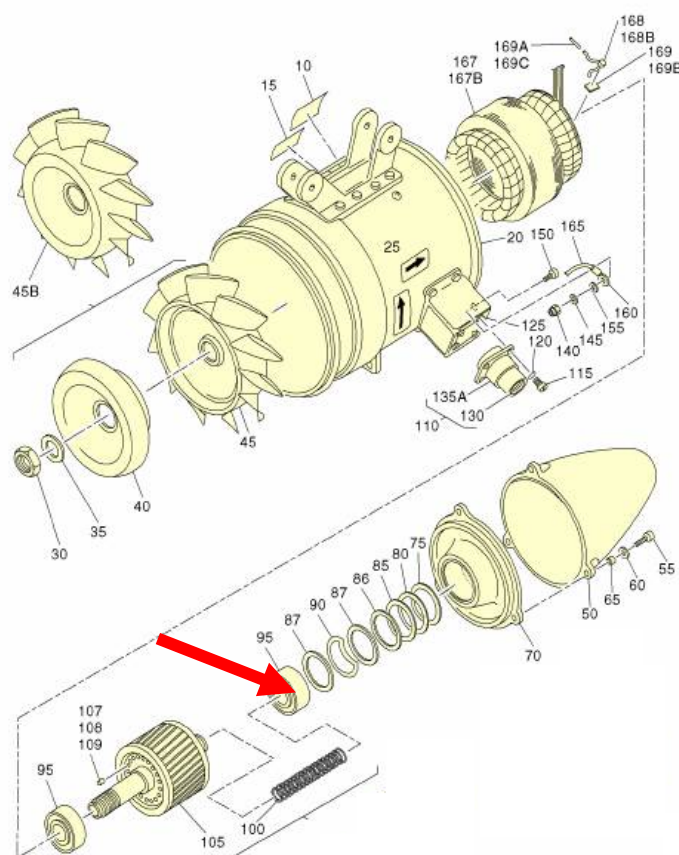
**Figure1**

Exploded view of the recirculation fan; position of failed bearing indicated

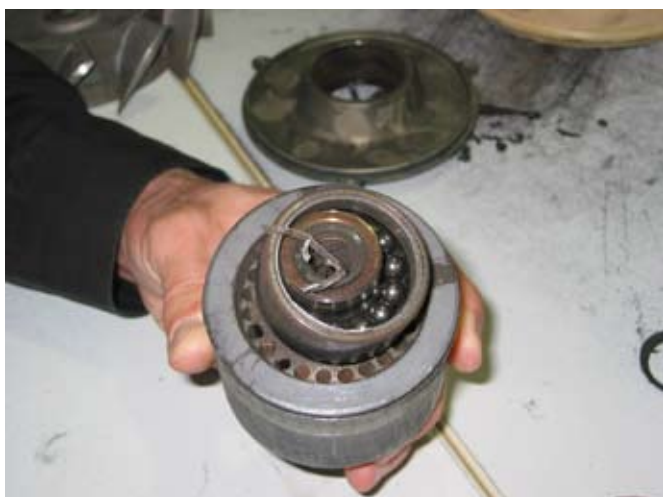
**Figure 2a**

Initially, the unit was placed on a test rig but the fan turned only briefly before the 68 amp rig circuit breaker tripped. The unit was disassembled and it was clear that the rear rotor bearing had failed (Figure 2). The radial play that had occurred at this end of the shaft had resulted in contact between the rotor and stator, which had resulted in smearing of the segments and the consequent generation of debris, mostly in the form of black dust.

Examination of the bearing components indicated that the fibre bearing cage had disintegrated and that there was no evidence of grease with which the bearing had been packed. Fragments from the bearing grease shield were found, which suggested that this may have come loose, leading to the escape of the grease and the subsequent bearing failure. Circumferential score marks on the external surface of the bearing outer race indicated that it had been spinning within its housing; this may have occurred as a result of friction generated within the bearing during the break-up process. It was also noted that grease had started to run out from the otherwise intact front bearing (ie fan end), indicating that the unit had been running in a hot condition.

View of rotor and failed bearing

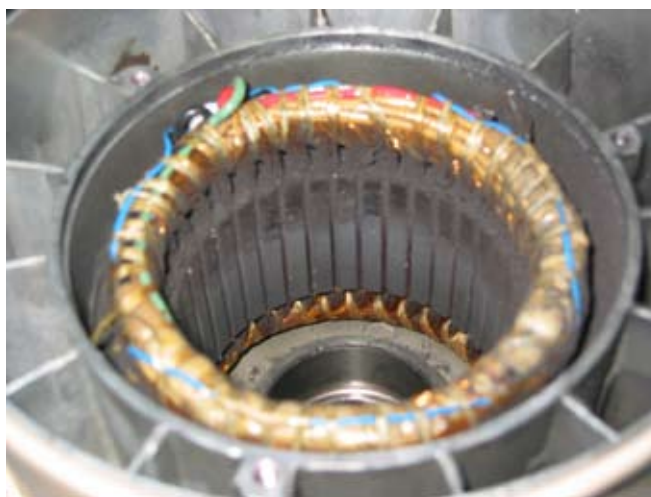
**Figure 2b**

View of contact damage from rotor

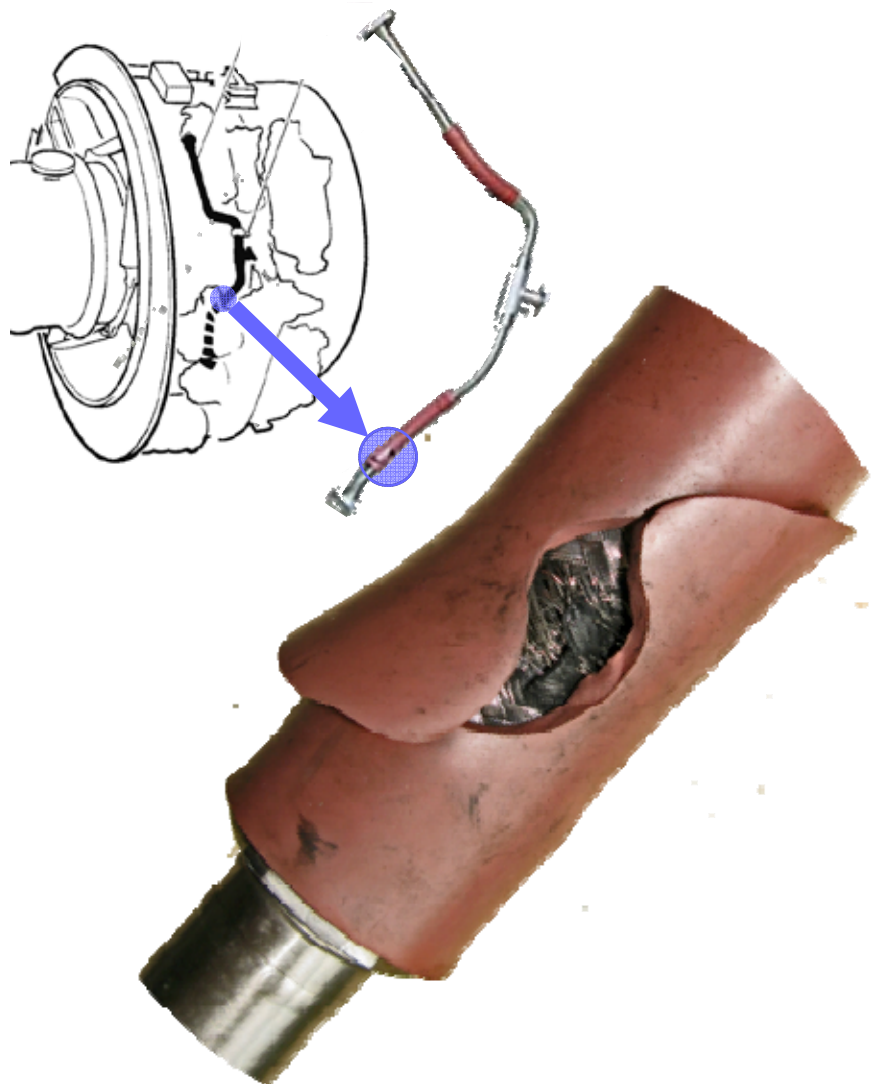
**Figure 1**

Post-flight examination revealed a rupture of a Low Pressure (LP) fuel pipe between the FCOC and the HP engine-driven fuel pump.

LP fuel pipe failure – G-OOOZ

There is a repair approved by the engine manufacturer, Field Repair Scheme (FRS) 6887, which involves replacement of both flexible hose sections.

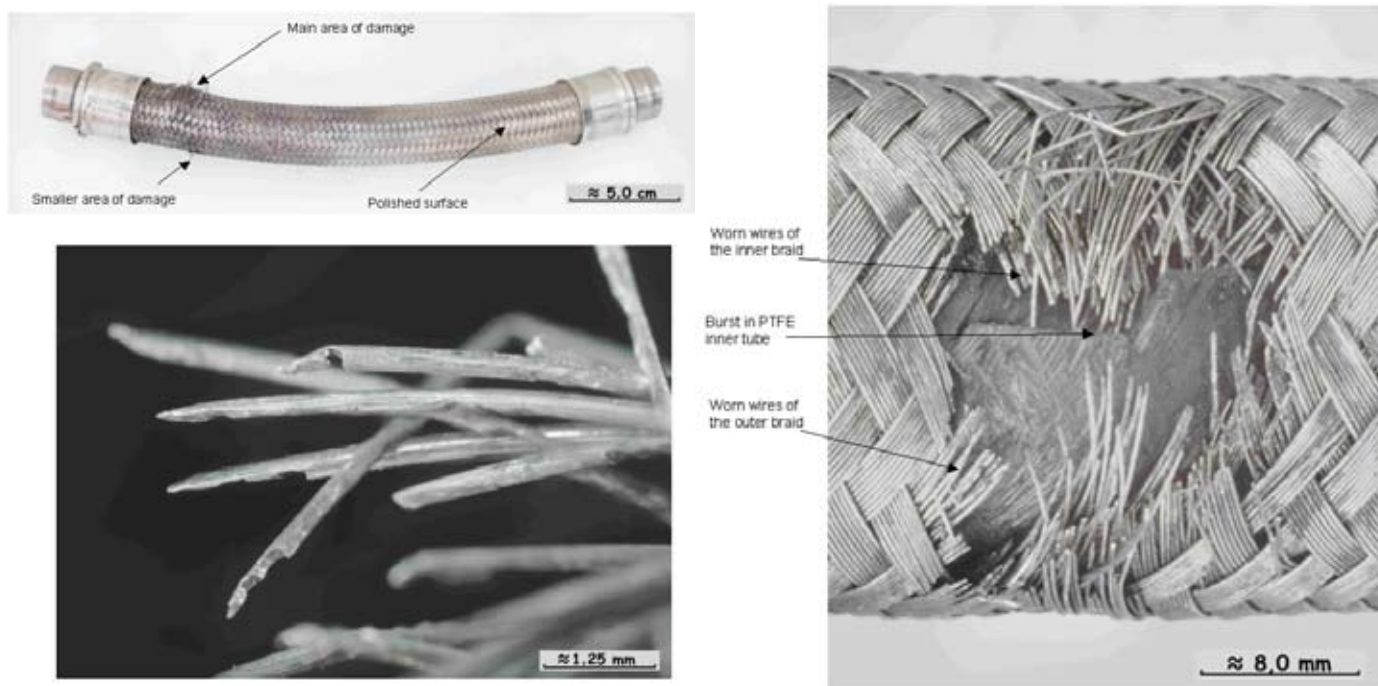
**Figure 2**  
Detail of fuel pipe failure

Microscopic inspection of the rupture site revealed a pattern of localised but extensive inter-braid fretting in both the inner and outer braids. The stainless steel braid wires were worn and notched; the damage had been caused by relative movement between overlaying strands. In many cases this process had completely severed the wire strands (Figure 2). It was evident that the resulting loss of hoop integrity had left the inner core of the pipe unsupported, allowing the inner tube wall to rupture and burst through the compromised region of braid. Damage, probably caused by relative movement of the braid, was apparent to the outer surface of the PTFE core tube, sufficient to cause significant weakening.

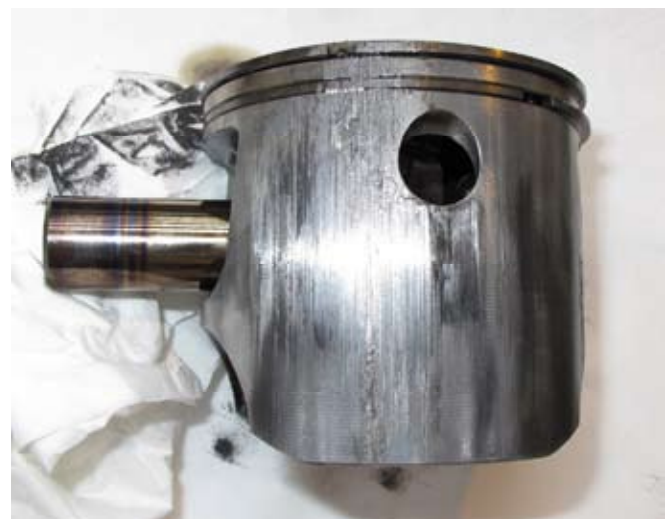
**Figure 1**

‘Power takeoff’ piston showing vertical scoring marks consistent with piston seizure

The evidence from the scored 'power takeoff' piston was indicative of the piston having seized due to overheating. This evidence was consistent with the pilot's report that the engine stopped suddenly after a rapid rise in coolant temperature. The pre-impact coolant level quantity in the radiator could not be positively established due to multiple leaks suffered following impact, but the coolant level quantity in the overflow bottle was below the minimum required. This may have been an indication that the radiator was suffering from a leak, because if the

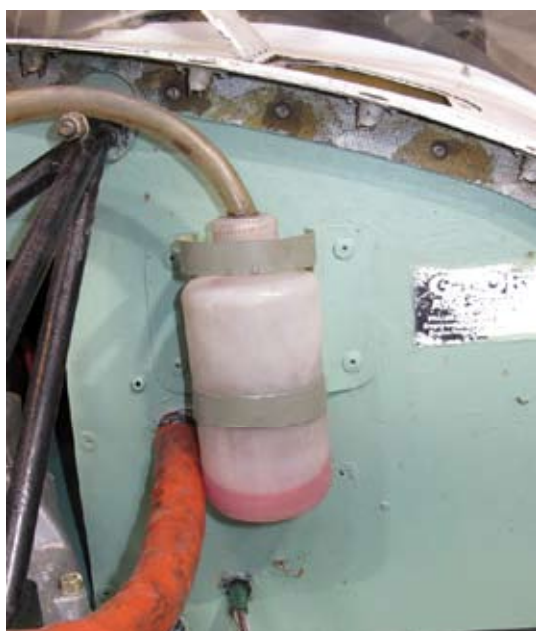
**Figure 2**

Radiator overflow bottle in the as-found position  
with the as-found coolant quantity

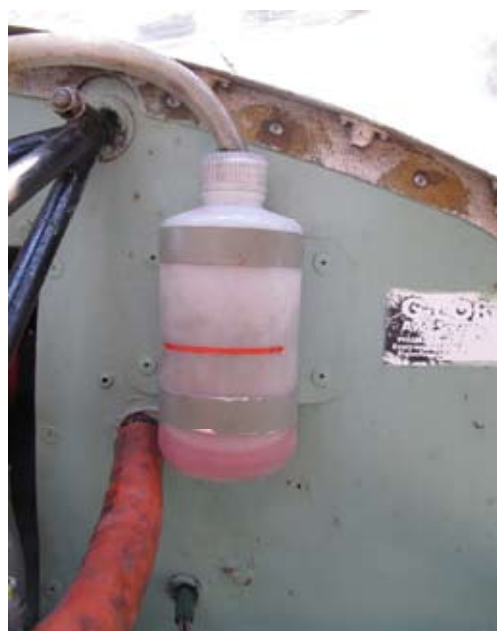
**Figure 3**

Radiator overflow bottle after being pushed up  
into its correct seating position  
(red 'minimum cold' line visible)

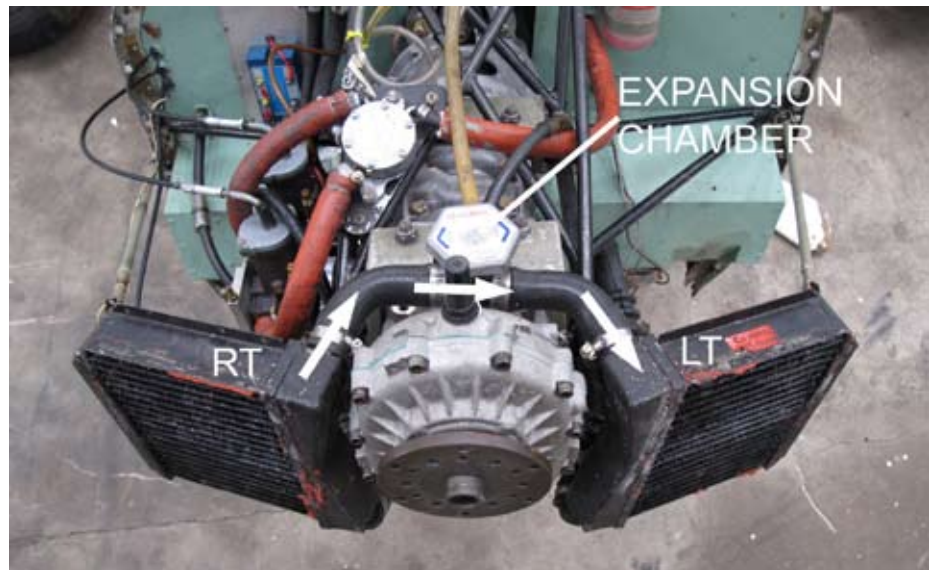
**Figure 4**

with the build manual for the Avid Speedwing Mk4<sup>2</sup>, but was different to the installation described in the Rotax installation manual. The Rotax installation manual describes an installation with a single radiator and does not describe how to install a dual radiator system. The Rotax manual also depicts an expansion chamber that is significantly larger than the one fitted to G-LORT (Figure 4). In the G-LORT dual-radiator installation the coolant flows from the top of the right radiator ('RT') to the top of the left radiator ('LT') as depicted in

Dual radiator installation on G-LORT; white arrows show direction of coolant flow

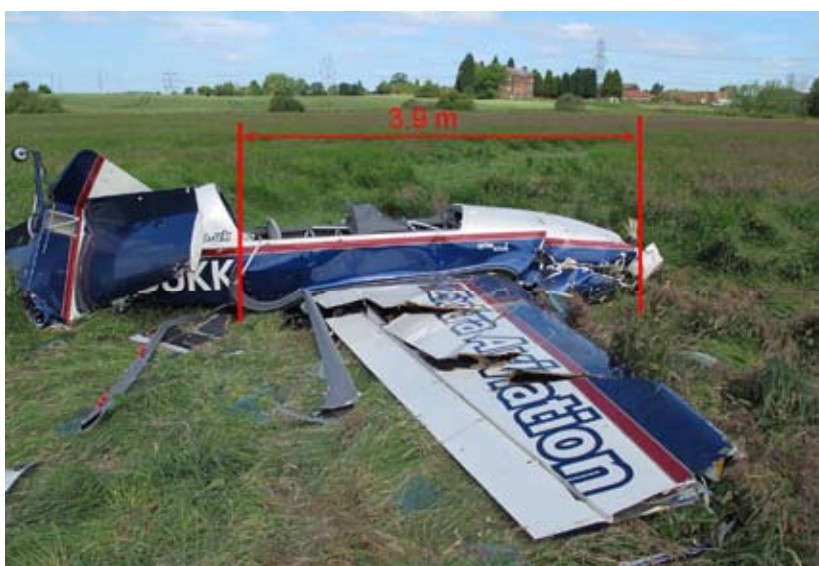
**Figure 3**

The wreckage of the aircraft was found upright in a flat field of tall grass, approximately 200 m north-east of Methley Bridge, Castleford (Figure 3). The aircraft had travelled a distance of just 3.9 m from its initial impact point to its final resting point, indicating a steep nose down impact, consistent with the video and still imagery. All three propeller blades had separated near their roots indicating that they had a high rotational energy at impact. The steel-tube airframe had sustained numerous overload failures, and the composite wing upper and lower surfaces were destroyed. The empennage had failed in bending overload due to the inertial forces at impact. There was no evidence of any pre-impact separations.

Aircraft wreckage – the distance from nose impact point to nose resting point was 3.9 m.

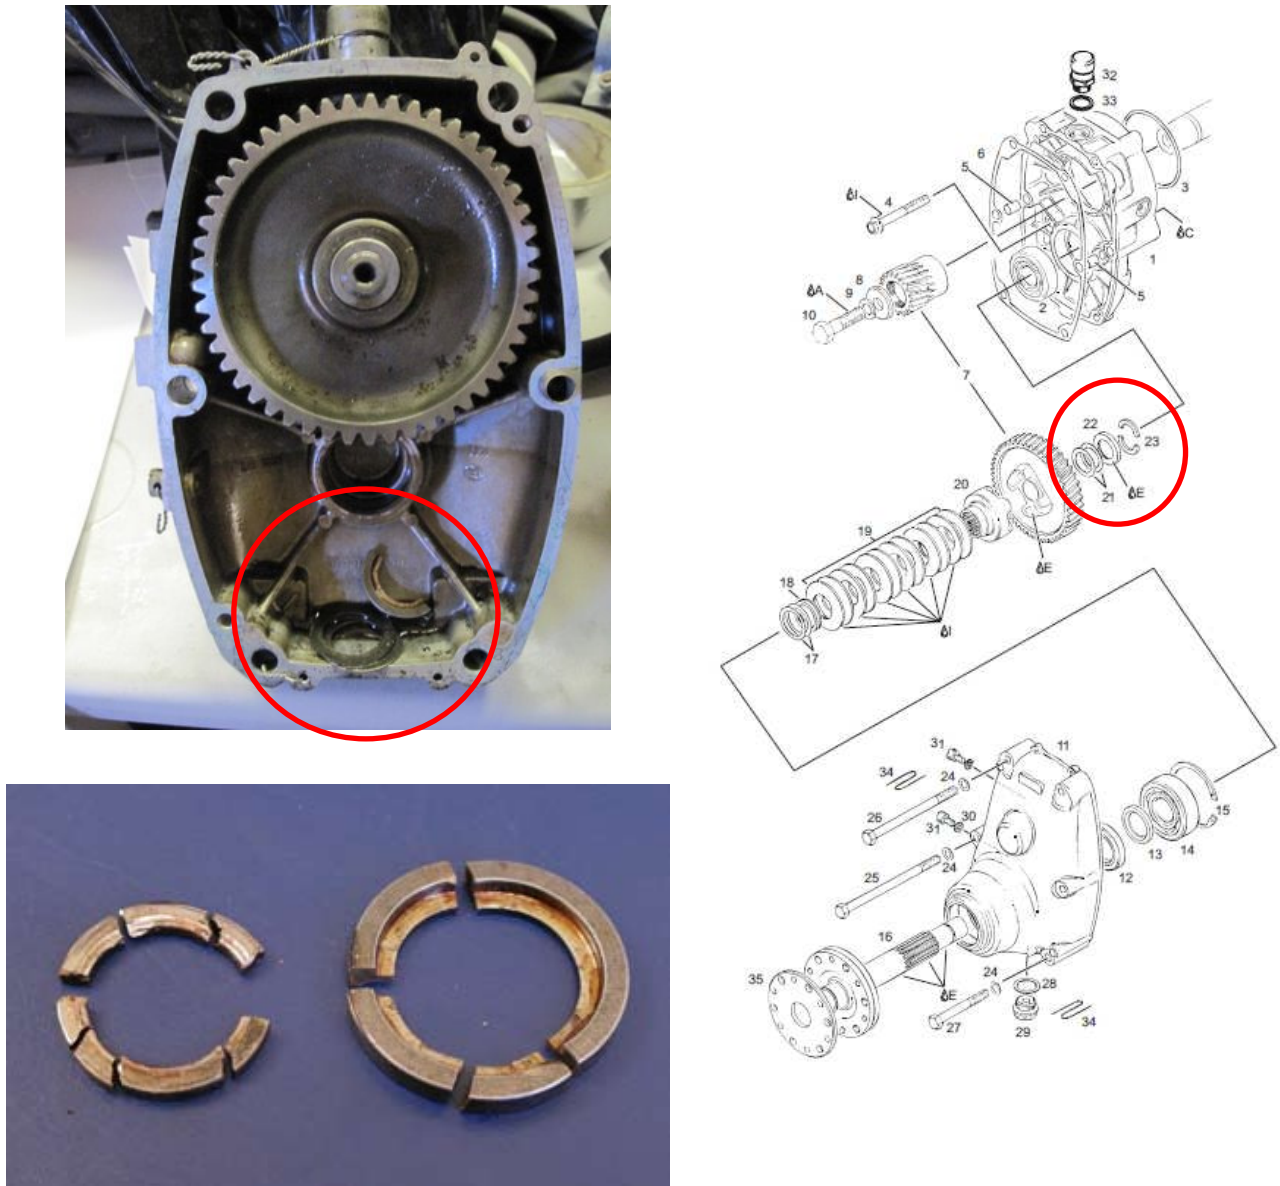
**Figure 1**

The pilot/owner reported that a strip inspection of the gearbox revealed that the secondary gear angular ring and the two retaining half rings had broken into several pieces (Figure 1). It is most likely that the failure of this retaining mechanism allowed the gear to move axially causing the overload dog-clutch to disengage, thereby removing drive to the propeller. The engine had completed 446 hours since new, but had been recently inspected. The gearbox had completed approximately 90 hours since an inspection and overhaul.

Failed gearbox components
