CONTENTS

SERIOUS INCIDENT

Aircraft Type and Registration:	Airbus A330-243, G-OJMC	
No & Type of Engines:	2 Rolls-Royce RB211 Trent 772B-60 turbofan engines	
Year of Manufacture:	2002	
Date & Time (UTC):	28 October 2008 at 0426 hrs	
Location:	Sangster International Airport, Montego Bay, Jamaica	
Type of Flight:	Commercial Air Transport (Passenger)	
Persons on Board:	Crew - 13	Passengers - 318
Injuries:	Crew - None	Passengers - None
Nature of Damage:	None	
Commander's Licence:	Airline Transport Pilot's Licence	
Commander's Age:	47 years	
Commander's Flying Experience:	14,500 hours (of which 3,000 were on type) Last 90 days - 170 hours Last 28 days - 40 hours	
Information Source:	AAIB Field Investigation

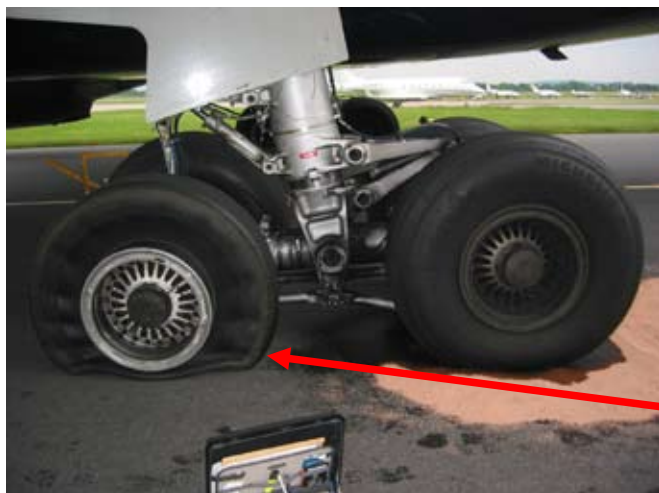
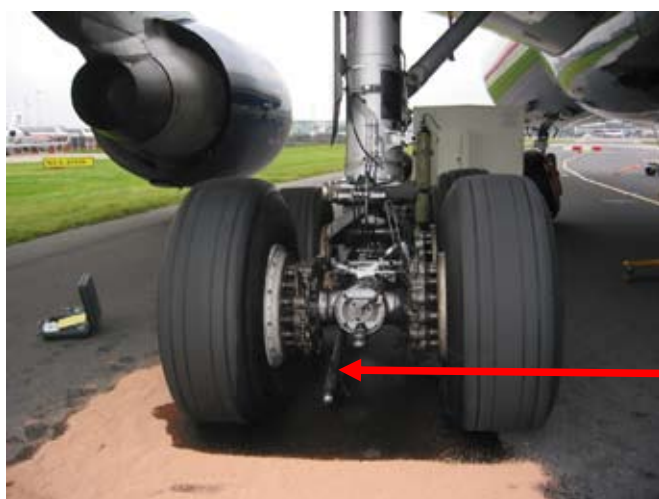
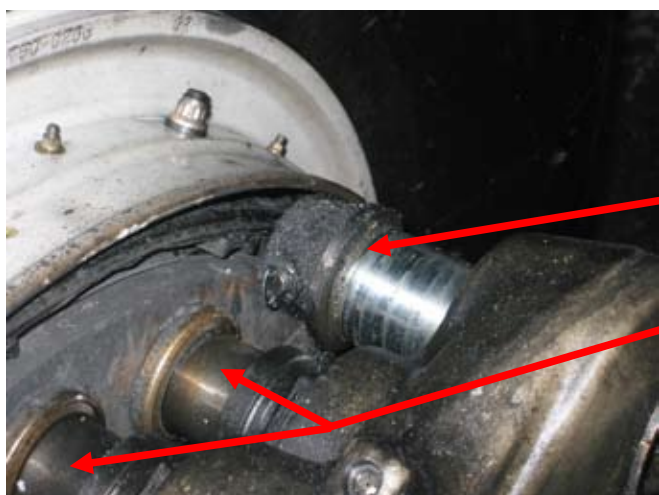
Figure 2

Deflated No 1 tyre

Disconnected brake reaction rod

Torque pin migrated into wheel rim following flange failure

Views of the left landing gear. Note hydraulic fluid spillage

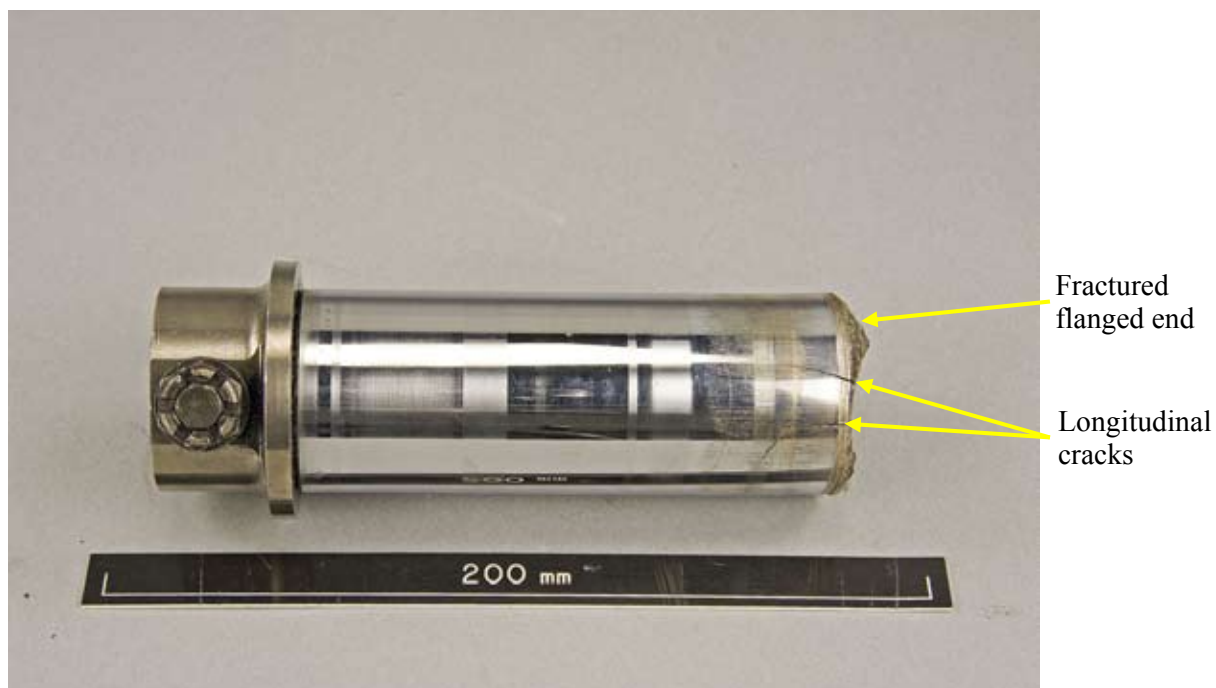
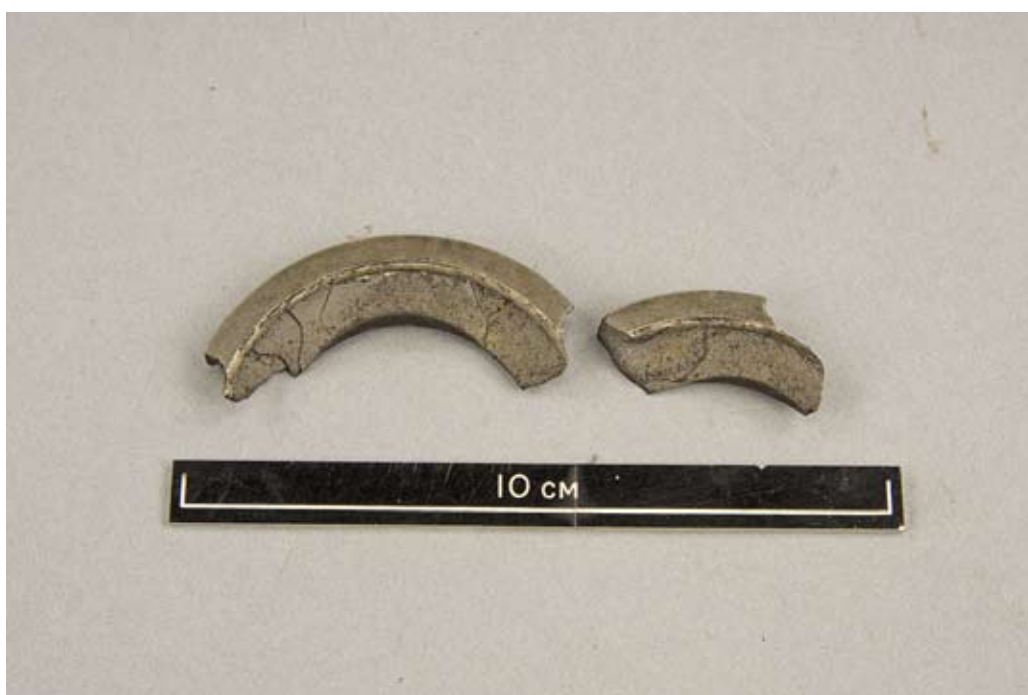
Figure 4

The runway debris included fragments of the flange, from the head of the pin, amounting to about 50% of the circumference. The remainder was not recovered. Photographs of the pin and flange fragments in their 'as received' condition are shown at Figure 4.

Batch markings on the recovered portion of the flange indicated that the pin was among those potentially susceptible to hydrogen embrittlement and machining irregularities, and which had, according to the manufacturer, led to previous cases of in-service flange failure. This had resulted in changes to the pin manufacturing processes and the issue of related service

No 5 torque pin together with flange fragments that were found on the runway

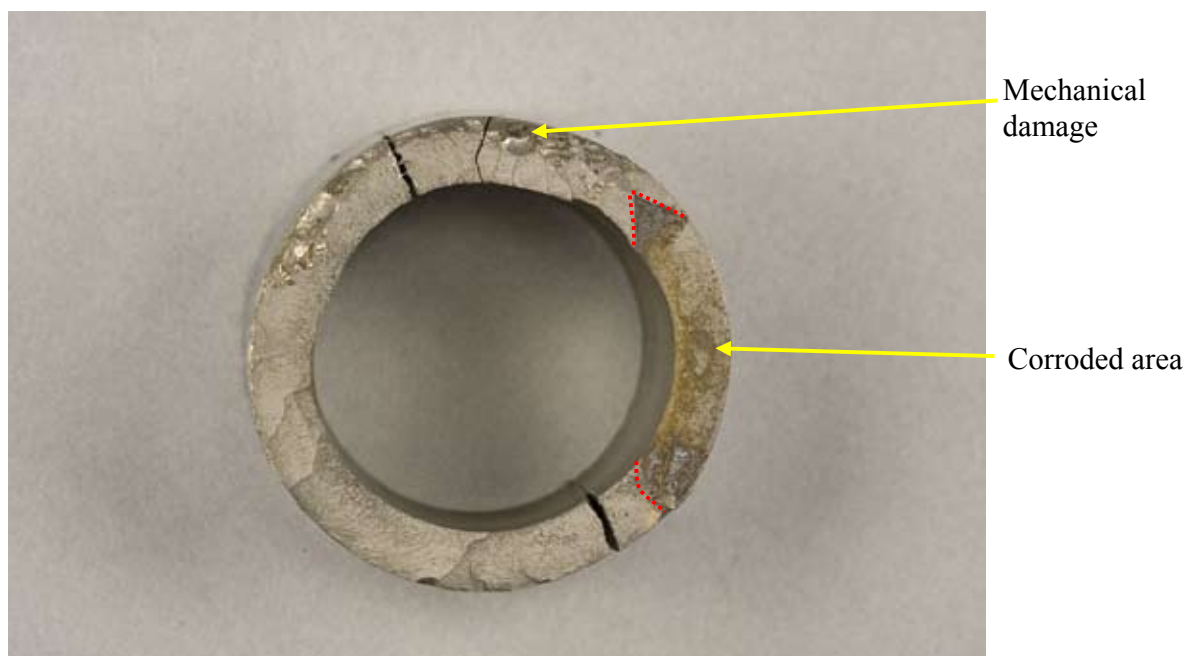
Figure 5

The pin was manufactured from 300M steel, heat treated to 275-300 KSI (the ultimate strength, in thousands of pounds per square inch). The material was found to comply with this specification.

View of torque pin fracture face

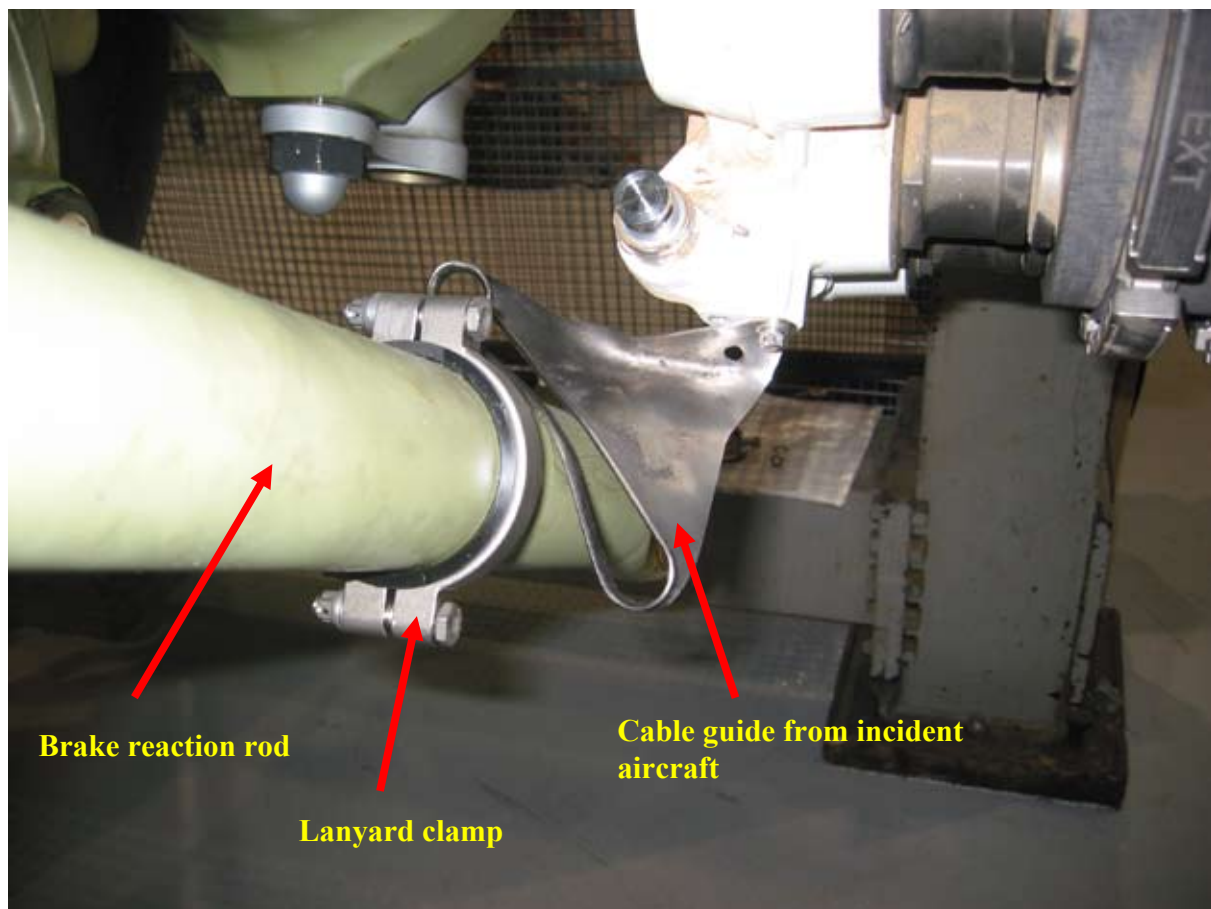
Figure 6

View of test showing how cable guide on brake housing may have contacted the brake reaction rod

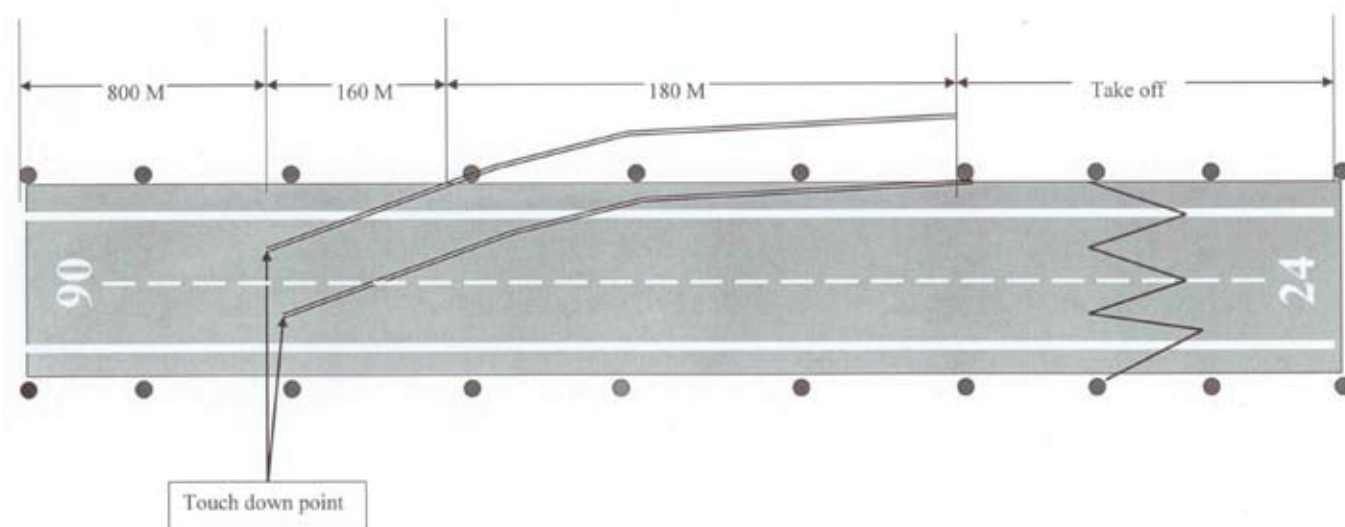
**Figure 1**

Diagram depicting ground marks

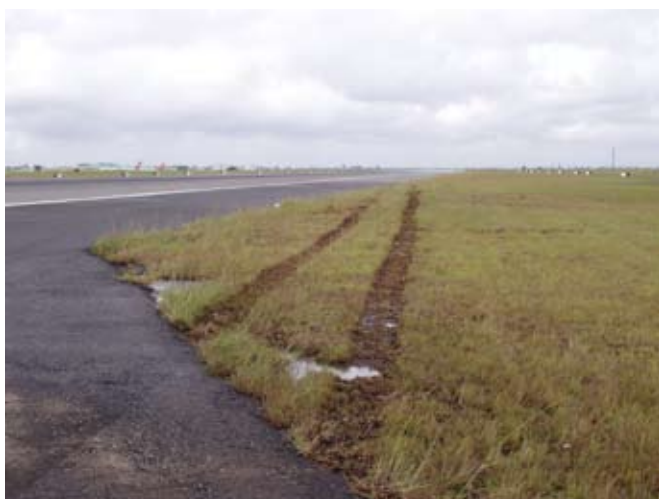
**Figure 2**

View towards the touchdown point

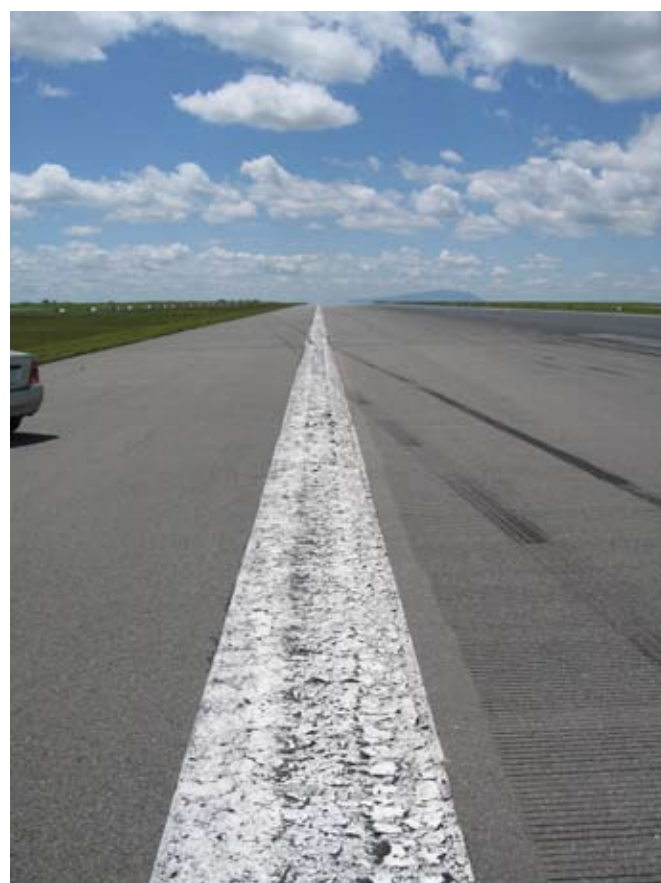
**Figure 3**

Left hand runway edge markings for Runway 06 with G-VAIR left main gear tyre tracks visible

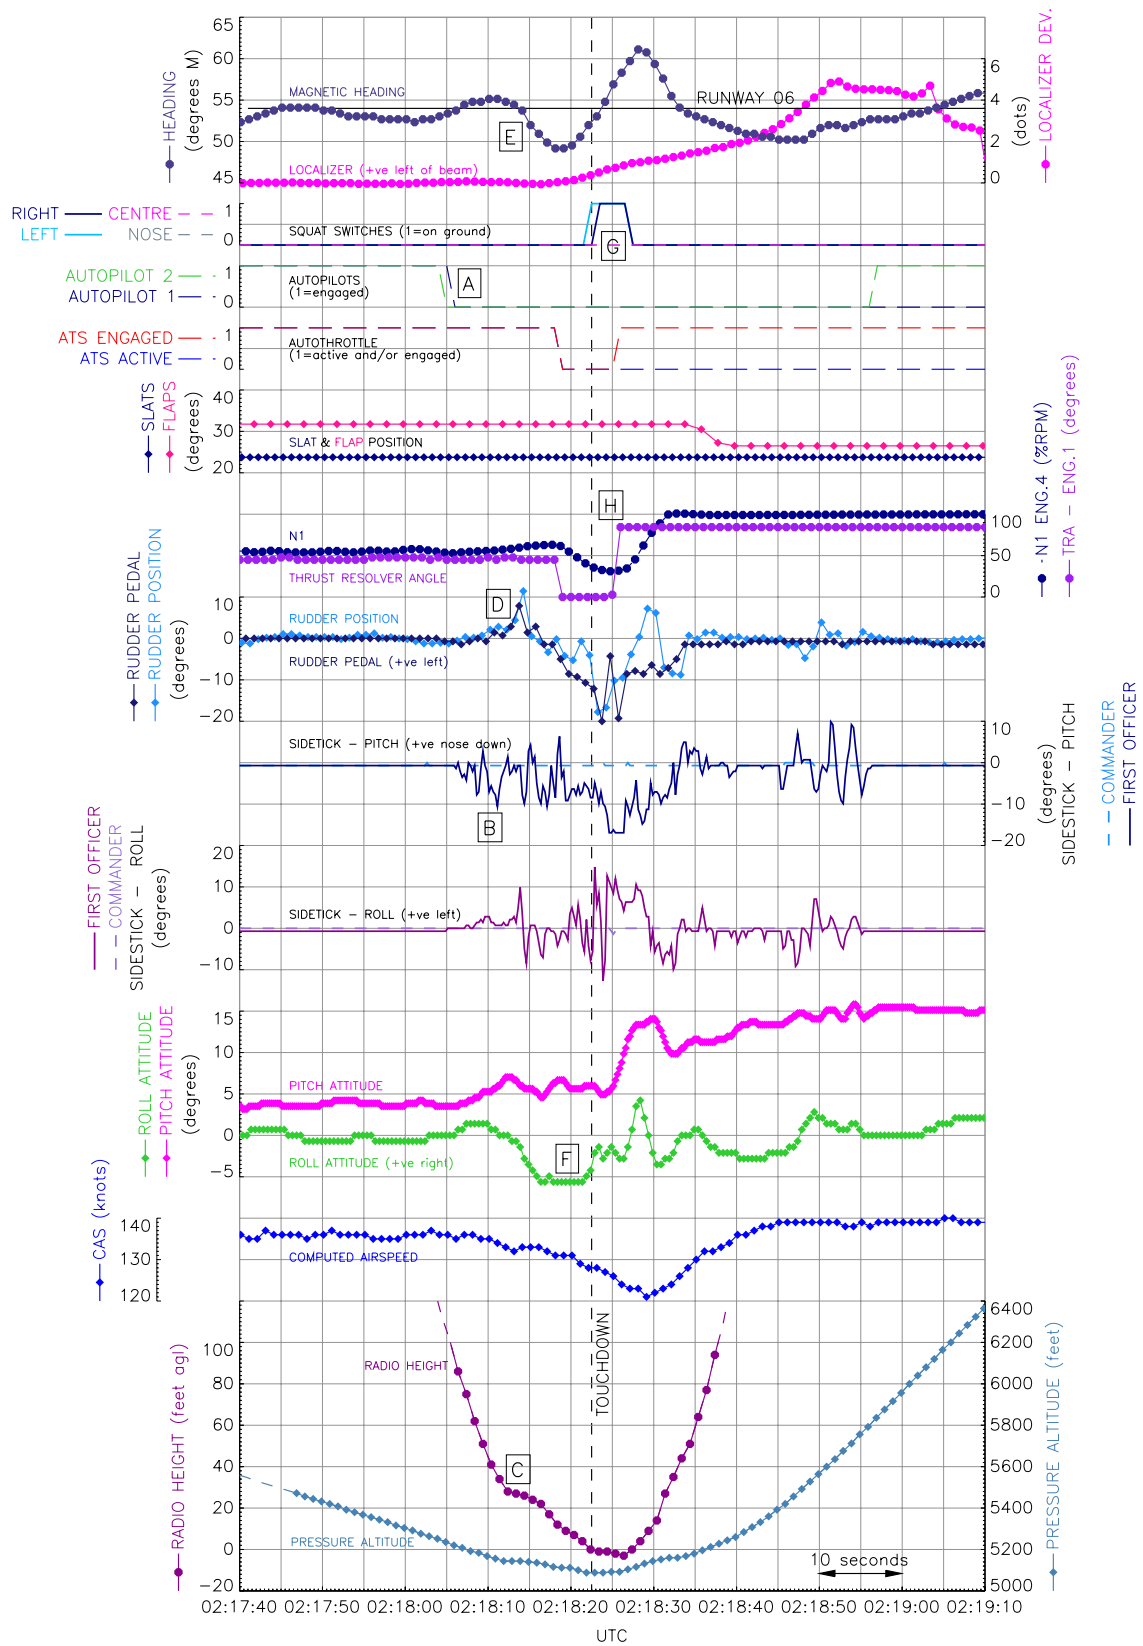
Figure 4
Salient FDR Parameters
 (Serious Incident to G-VAIR on 27 April 2008)

Between 40 and 50 ft agl, the PF initiated the flare by briefly pulling back on the side stick (see Point B).

This momentarily pitched the aircraft to 7° nose up, and reduced the rate of descent to about 60 feet/minute as the aircraft passed through 30 ft agl (Point C). The FO then put in a 10° left side-stick¹ input followed by an 8° right input, during which the FDR recorded an 8° left rudder pedal² input being made (Point D), causing G-VAIR to roll left and drift to the left of the runway centreline (Point E).

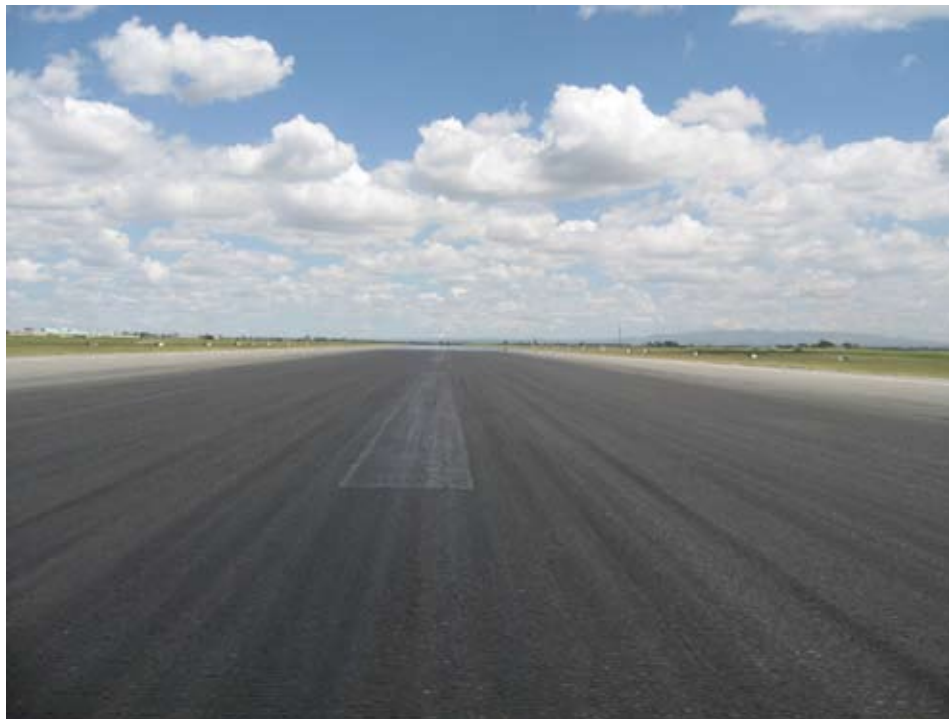
Figure 5

Contamination in touchdown zone area of Runway 06

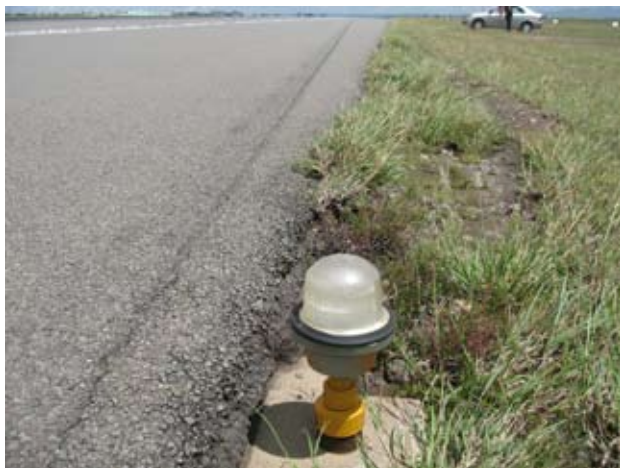
**Figure 6**

“Frosted” edge light

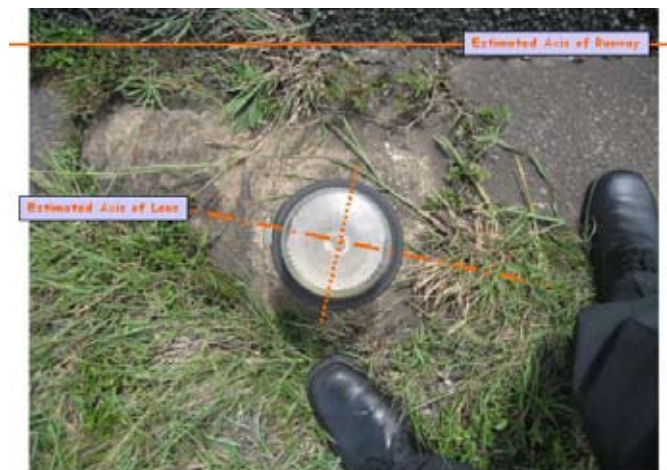
**Figure 7**

Example of edge light misalignment

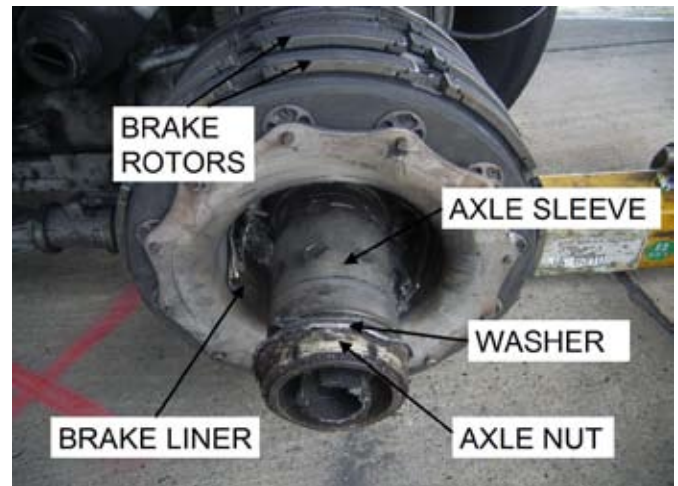
Figure 3
Damage to wheel axle

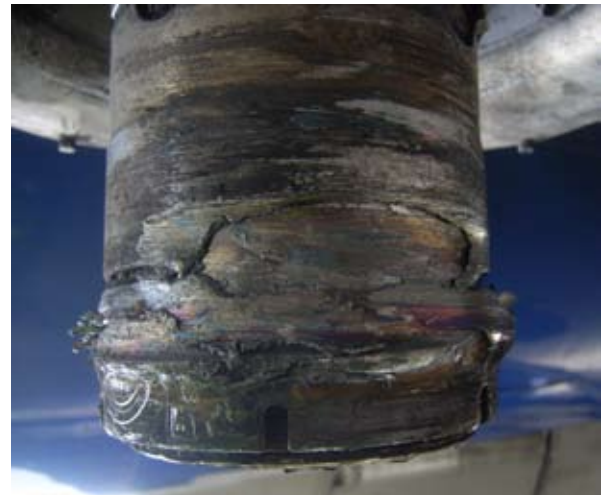
Figure 4
Damage to wheel axle underside (6 o'clock position)

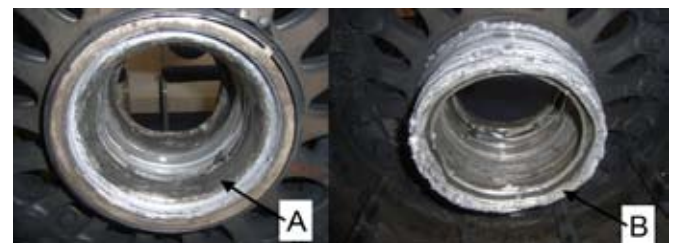
Figure 5
Left: Outer wheel hub showing remains of outer bearing cup (A).
Right: Inner wheel hub showing that at (B) the inner bearing hub support and inner bearing cup are missing.

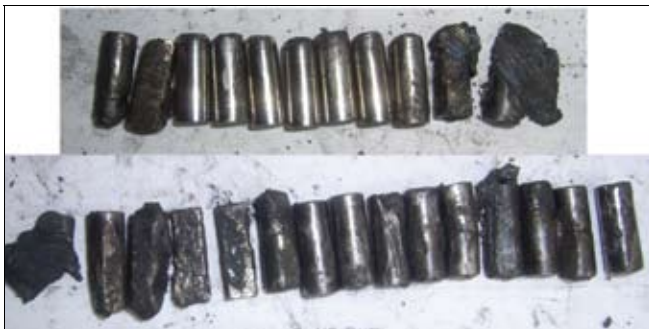
Figure 6

and the outboard bearing had the same part number, but it was possible to separate the rollers into two groups on the basis of a batch mark indentation (shaped like a house) present on some of their ends. This indentation revealed that the rollers were from a batch manufactured in 1995. The rollers without the indentation mark were blackened, and exhibited evidence of high temperature exposure and some minor plastic deformation (the lower row in Figure 6). Some of the rollers with the indentation mark were relatively undamaged and had not been exposed to high temperatures; others exhibited crushing damage (the upper row in Figure 6). The sliding ends of both sets of rollers were in good condition, which is an indication that lubrication was present. Also, the roller bodies had not elongated, which is an indication that failure occurred rapidly and at relatively low rotational speed.

Some of the recovered rollers from the outer bearing (lower image) and inner bearing (upper image)

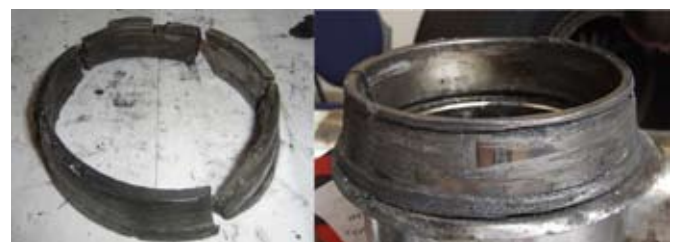
Figure 8

The outer bearing cone had fractured into six large pieces (left image in Figure 8) and its race surface exhibited evidence of elevated temperatures. The inner bearing cone was recovered intact from the axle and did not exhibit evidence of elevated temperature (right image in Figure 8). The original ground surface was visible with

The bearing manufacturer's report concluded that the outer bearing was the first to fail, because the first bearing to fail normally generates the most heat, and that the failure probably occurred due to the outboard bearing cage becoming trapped between rollers and the rotating cup. The report stated that:

Damaged outer bearing cone (left) and inner bearing cone (right)

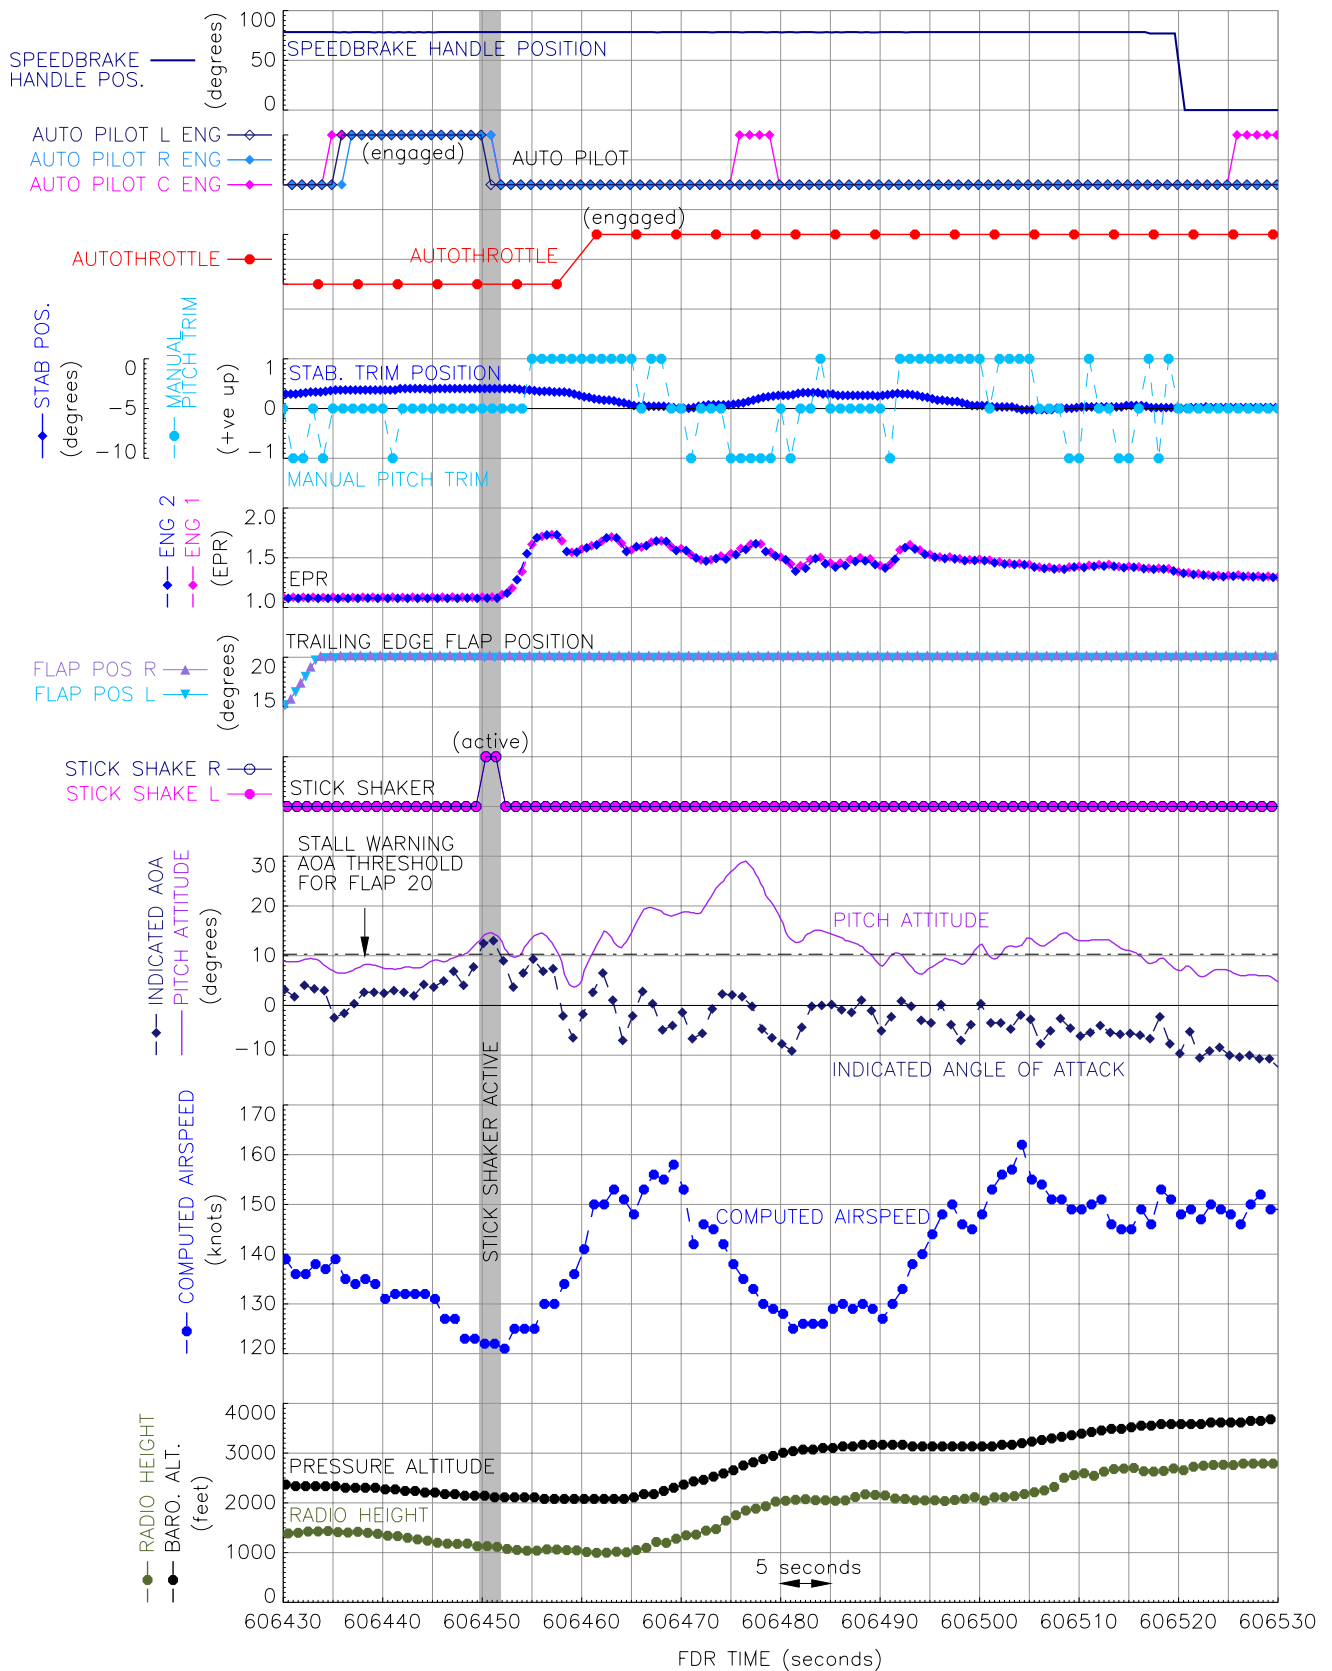
Figure 1

Salient FDR Parameters for the serious incident to G-MONK

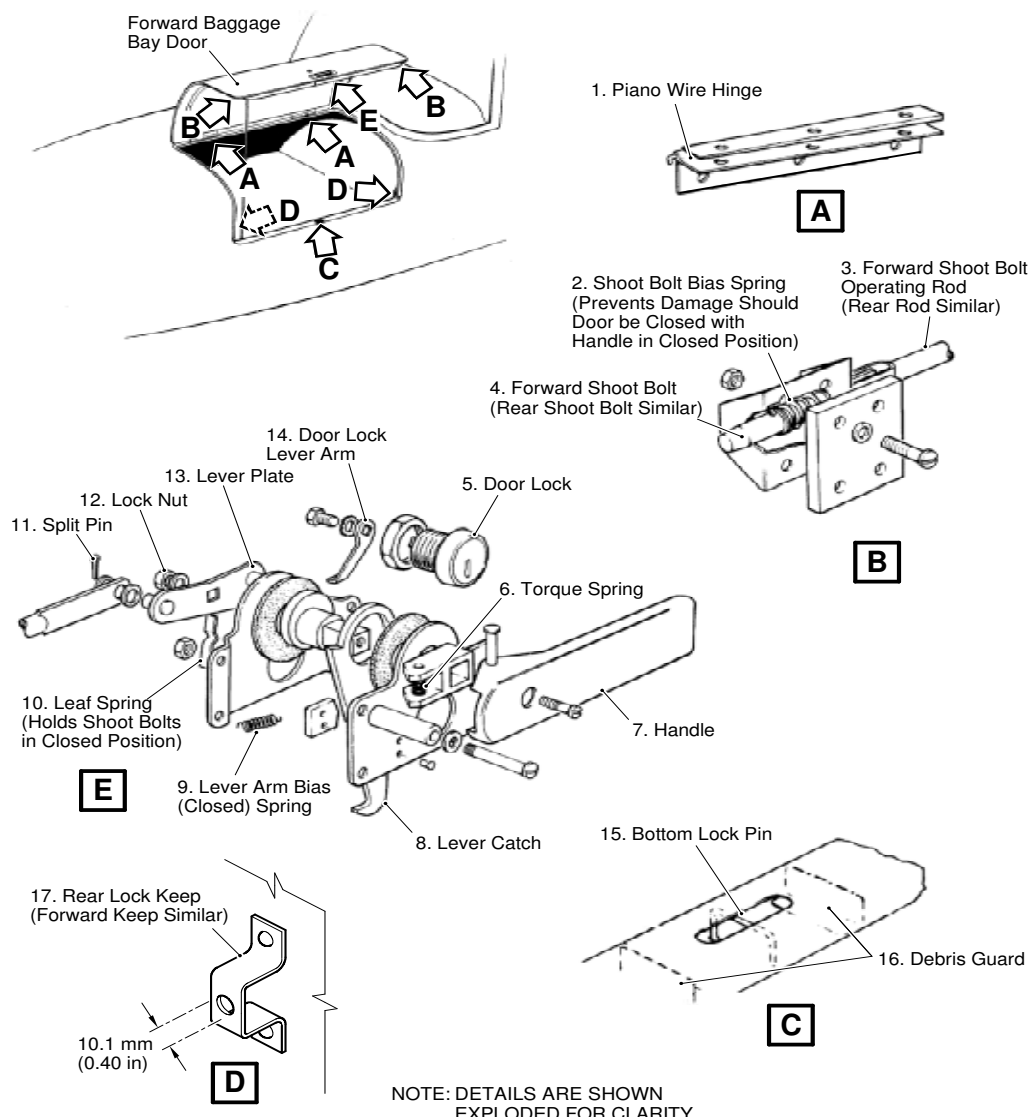
Diagram extracted from SB BN2A Mk111-319

Initial enquiries made by the operator regarding the dispatch of the aircraft, concluded that the door was unlikely to have been incorrectly latched prior to departure. Without any physical evidence from the door and its latch, which had fallen into the sea, the operator carried out an inspection of its remaining six aircraft. This inspection called for a detailed visual examination and revealed evidence of movement between the lever assembly and the eccentric lock. The square drive on the lever showed evidence of 'rounding off'. Subsequent movement between the square drive and the lever could

result on the lock nut becoming loose and the handle detaching.

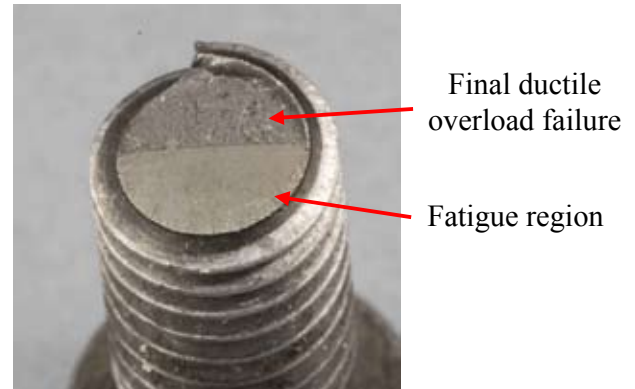
Figure 2

Typical fracture surface on broken Allen head bolt

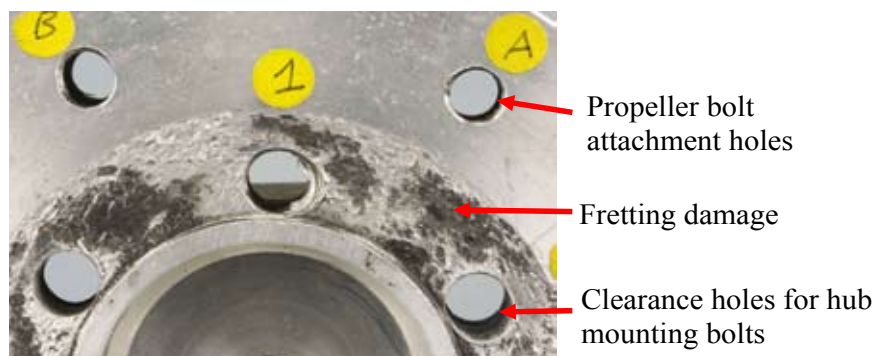
Figure 3

Damage to propeller hub

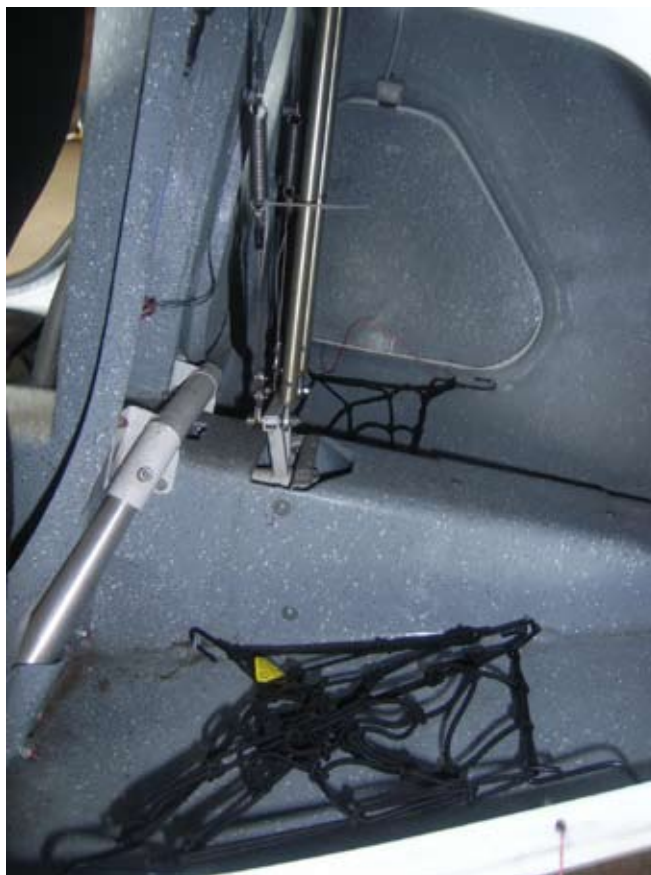
Figure 1
G-CFAZ baggage restraint
