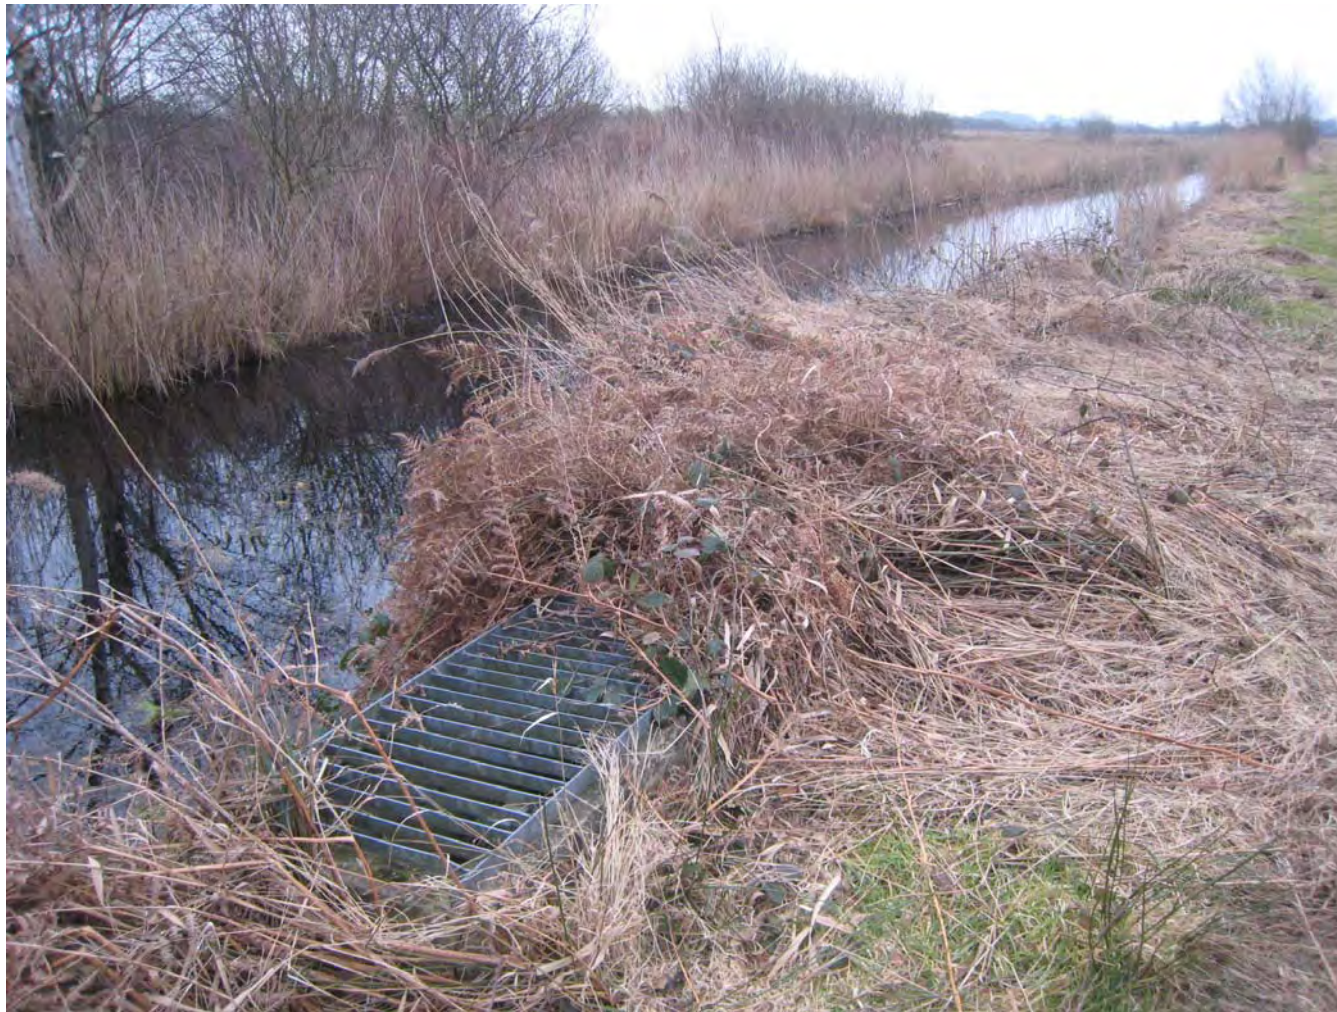
**Figure J1** The northern sluice and adjacent drain within the internal system, looking SSW. The Commissioners' Rond is on the right. (27/2/2012)

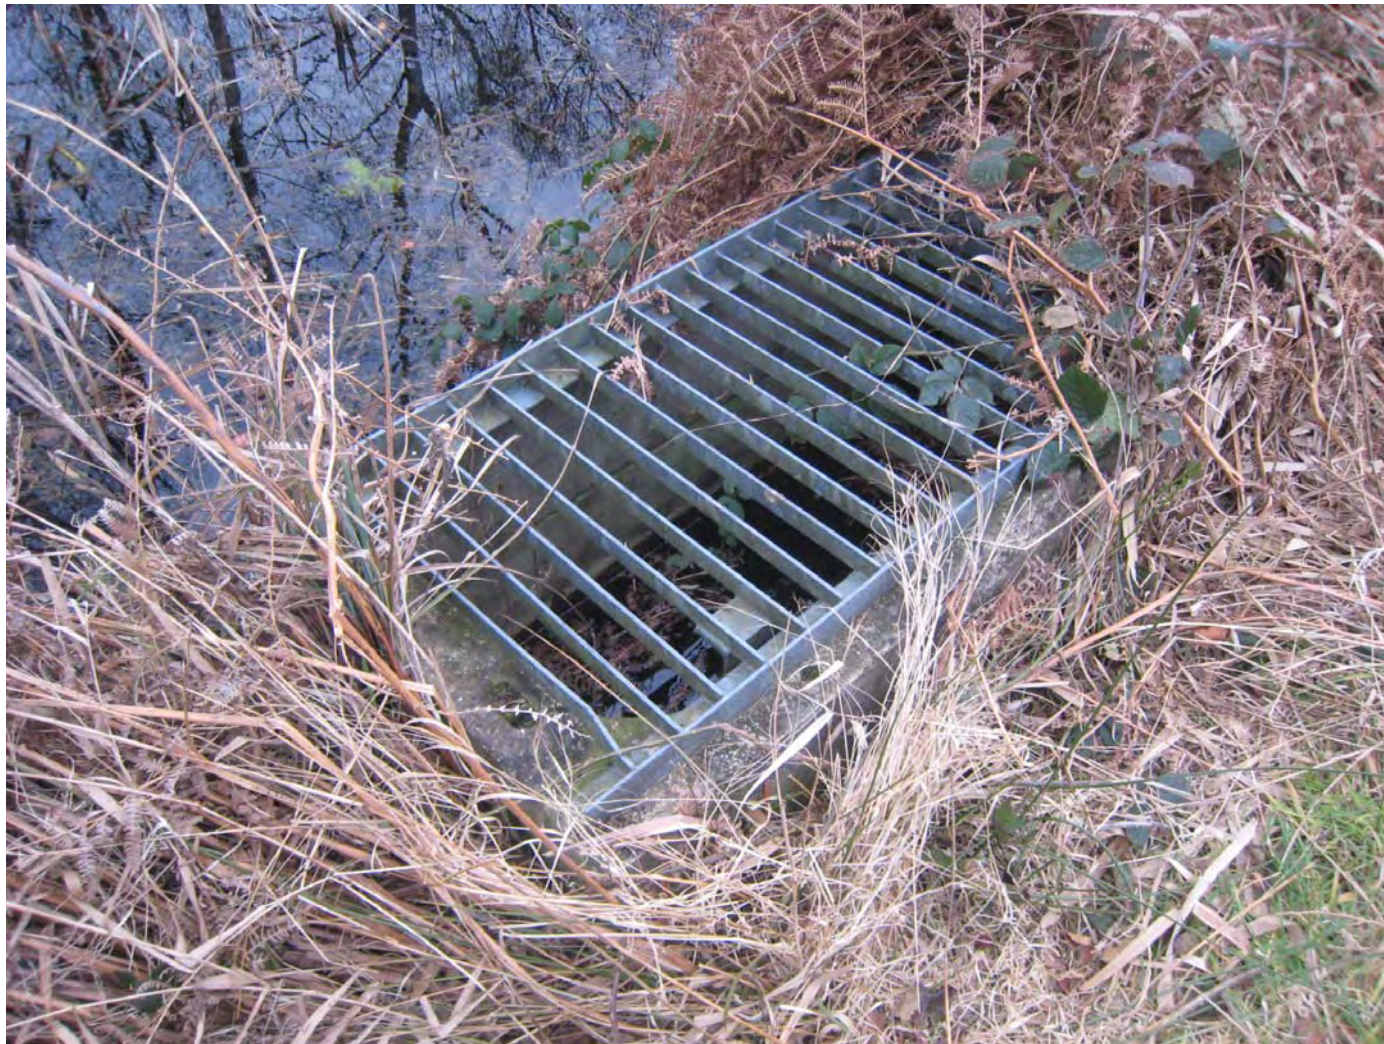
**Figure J2** Close-up of the northern sluice showing the wooden boards (27/2/2012)

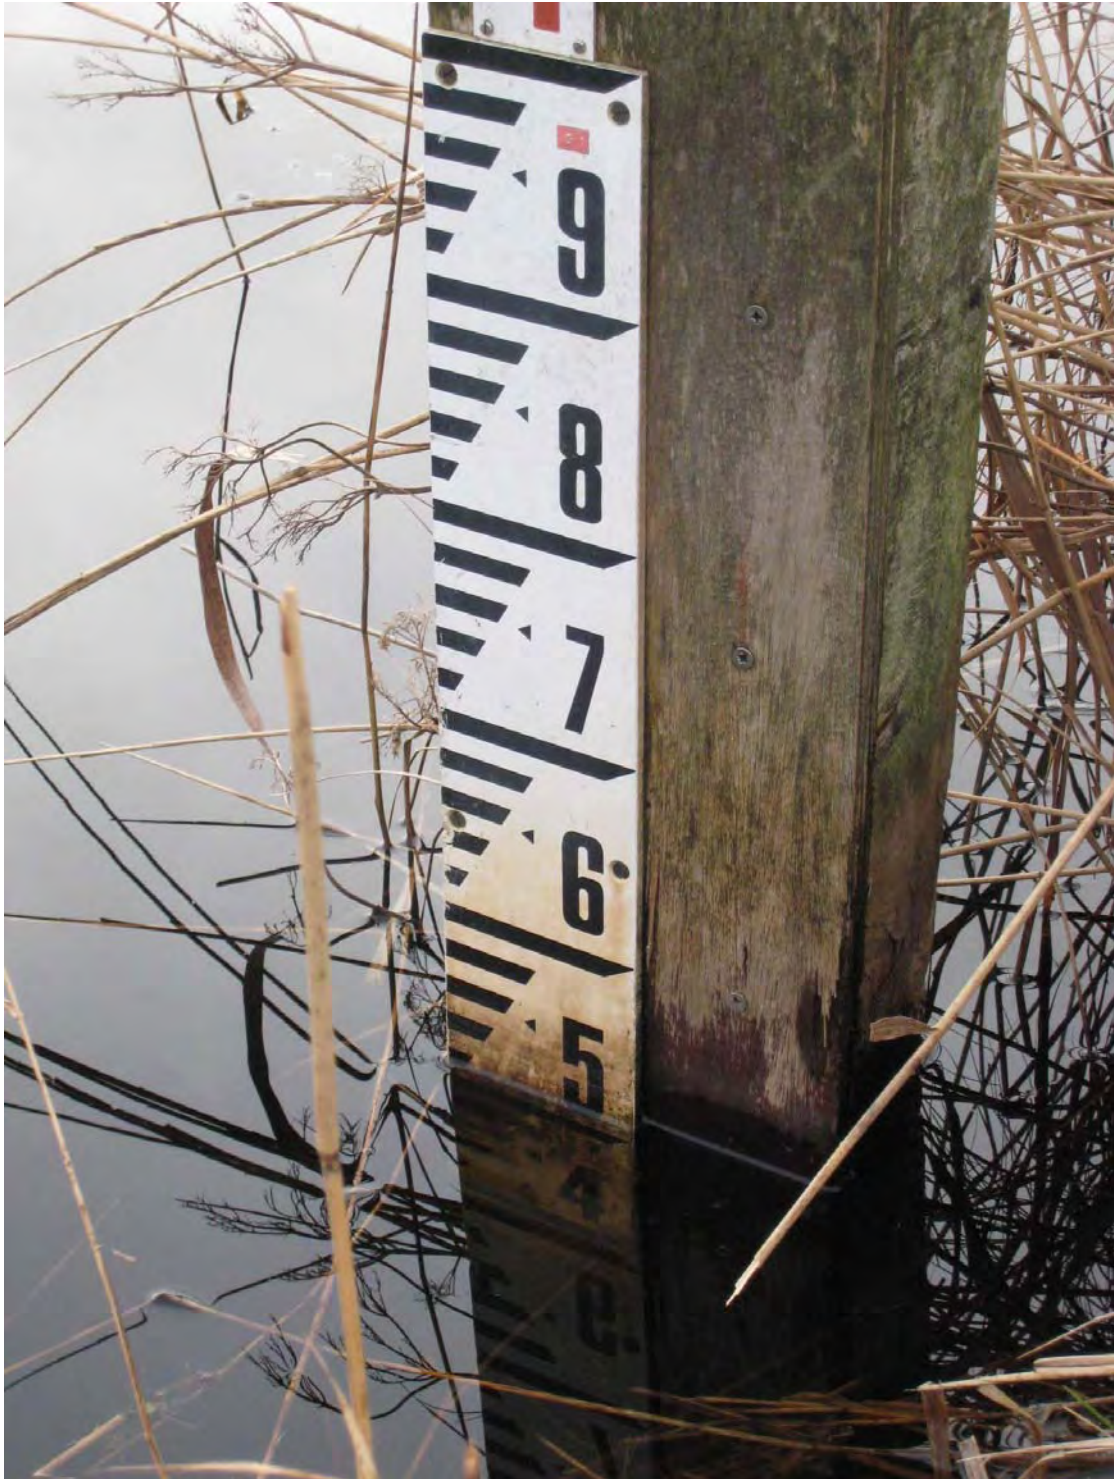
**Figure J3** Gaugeboard NTG3261G1 within the internal system, close to the northern sluice. Note iron staining on the gaugeboard extends up to the 6.5 mark (27/2/2012)

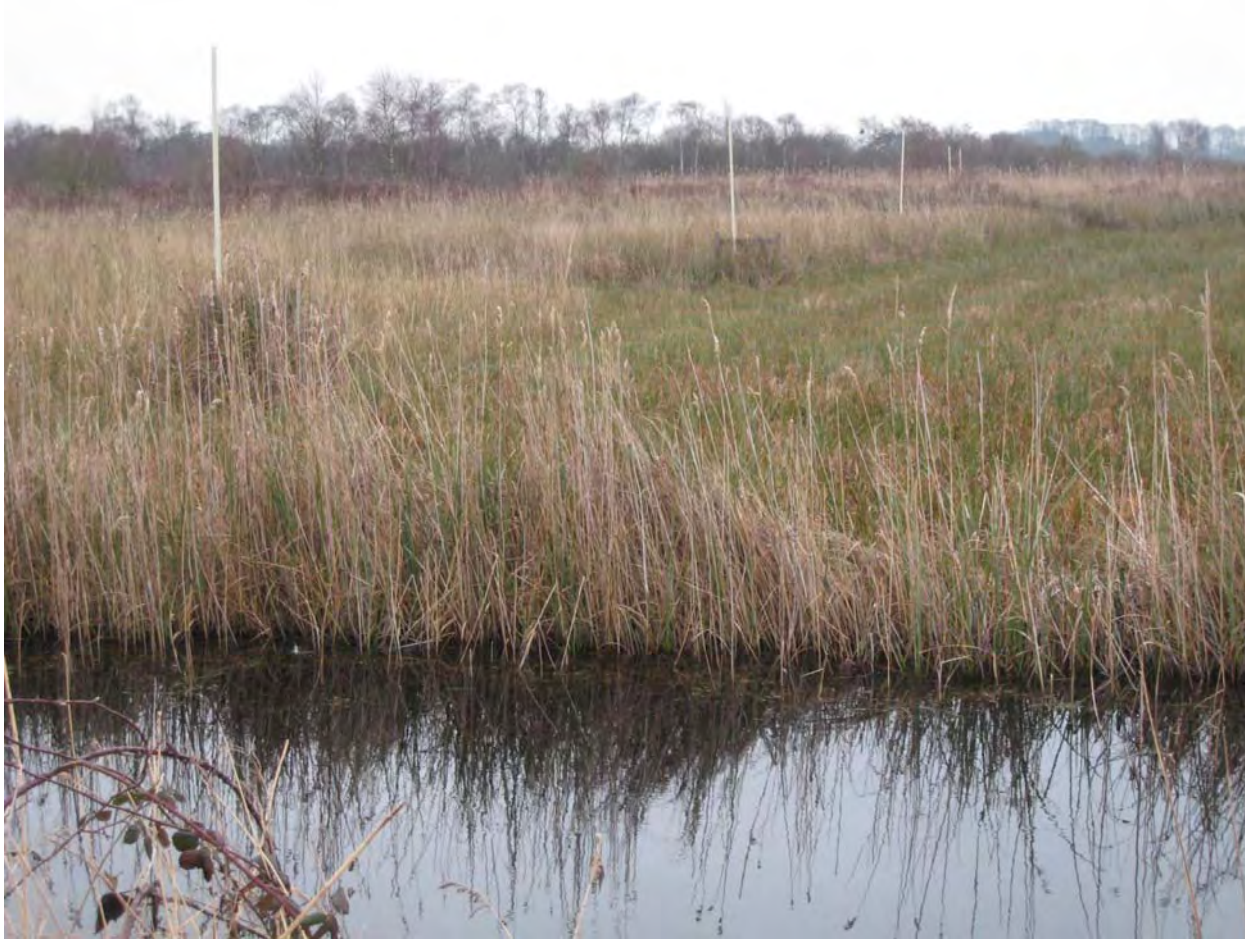
**Figure J4** Line of dipwells within Sedge Marshes marked by white posts. Dipwell TG32/617b is the only one with a datalogger installed, and is central within the line of 5 dipwells. The water level in the internal dyke (foreground) appears to be the same as in the Marshes. Photograph taken from the Commissioners' Rond looking ENE (27/2/2012)

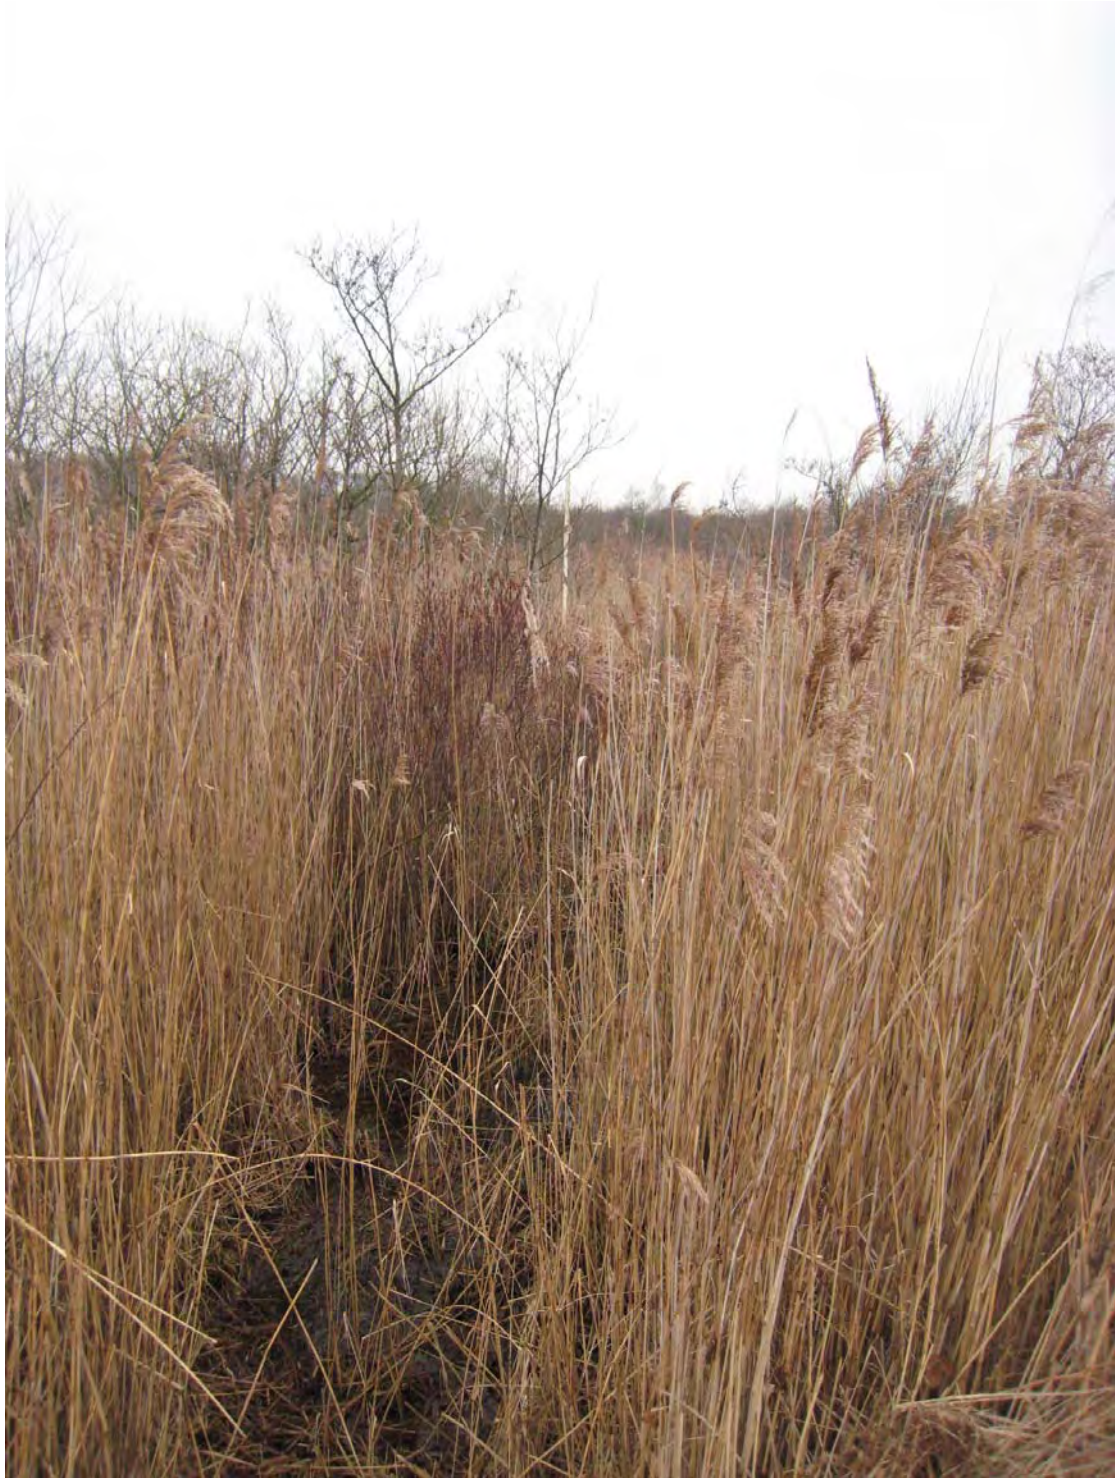
**Figure J5** External dyke separating the Commissioners' Rond from the line of dipwells (marked by white posts) in the southern part of Great Fen. The dyke is very overgrown. Gaugeboard NTG3261G2 is located in the same dyke further north, with the dyke being similarly overgrown. Photograph from Commissioners' Rond looking west (27/2/2012)

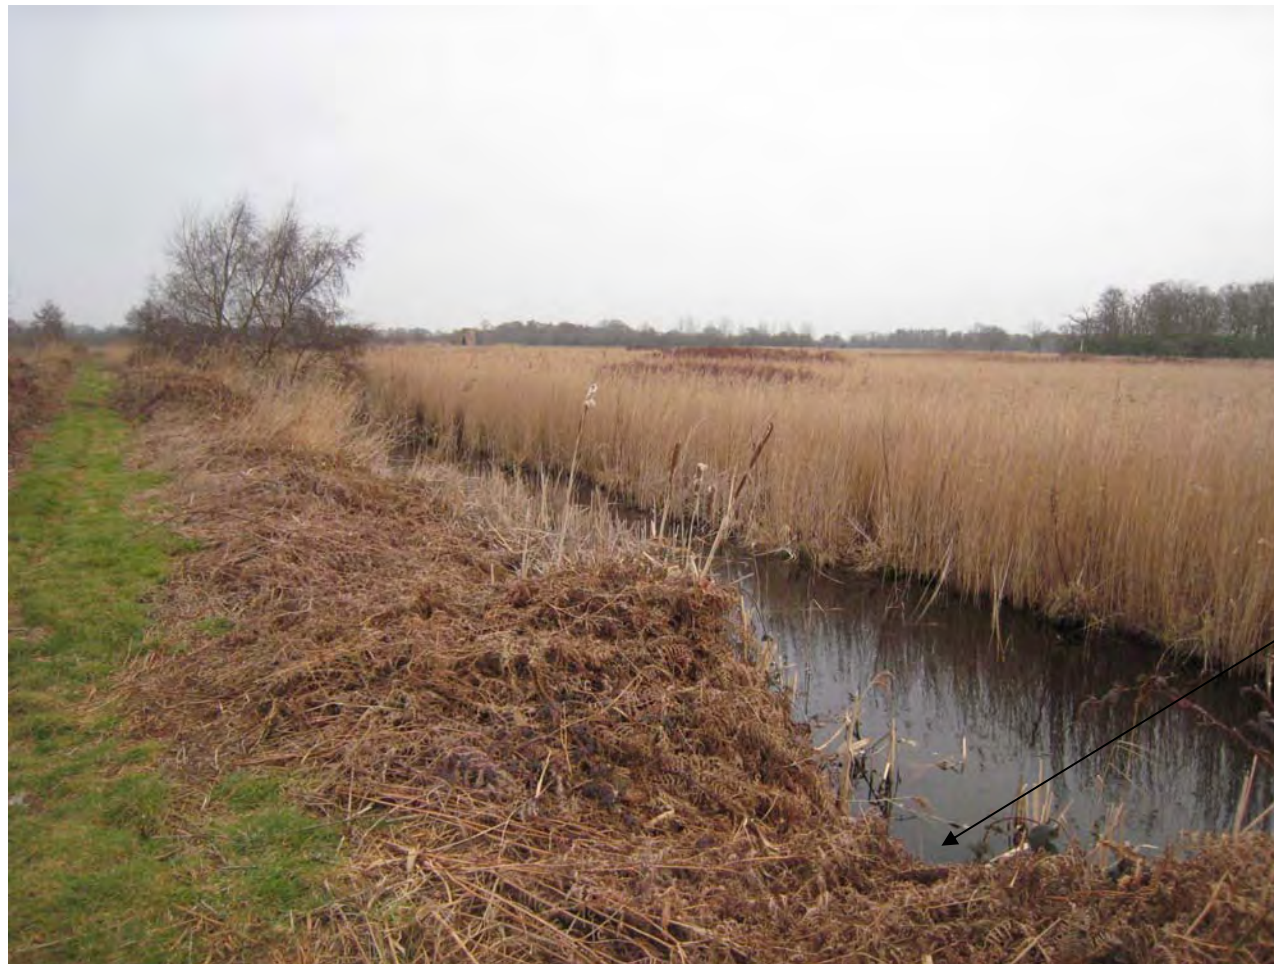
Sluice location

**Figure J6** Commissioners' Rond (left) with internal dyke near the southern sluice, looking north. The sluice is largely hidden by vegetation (27/2/2012)

Boundary dyke in  
internal system

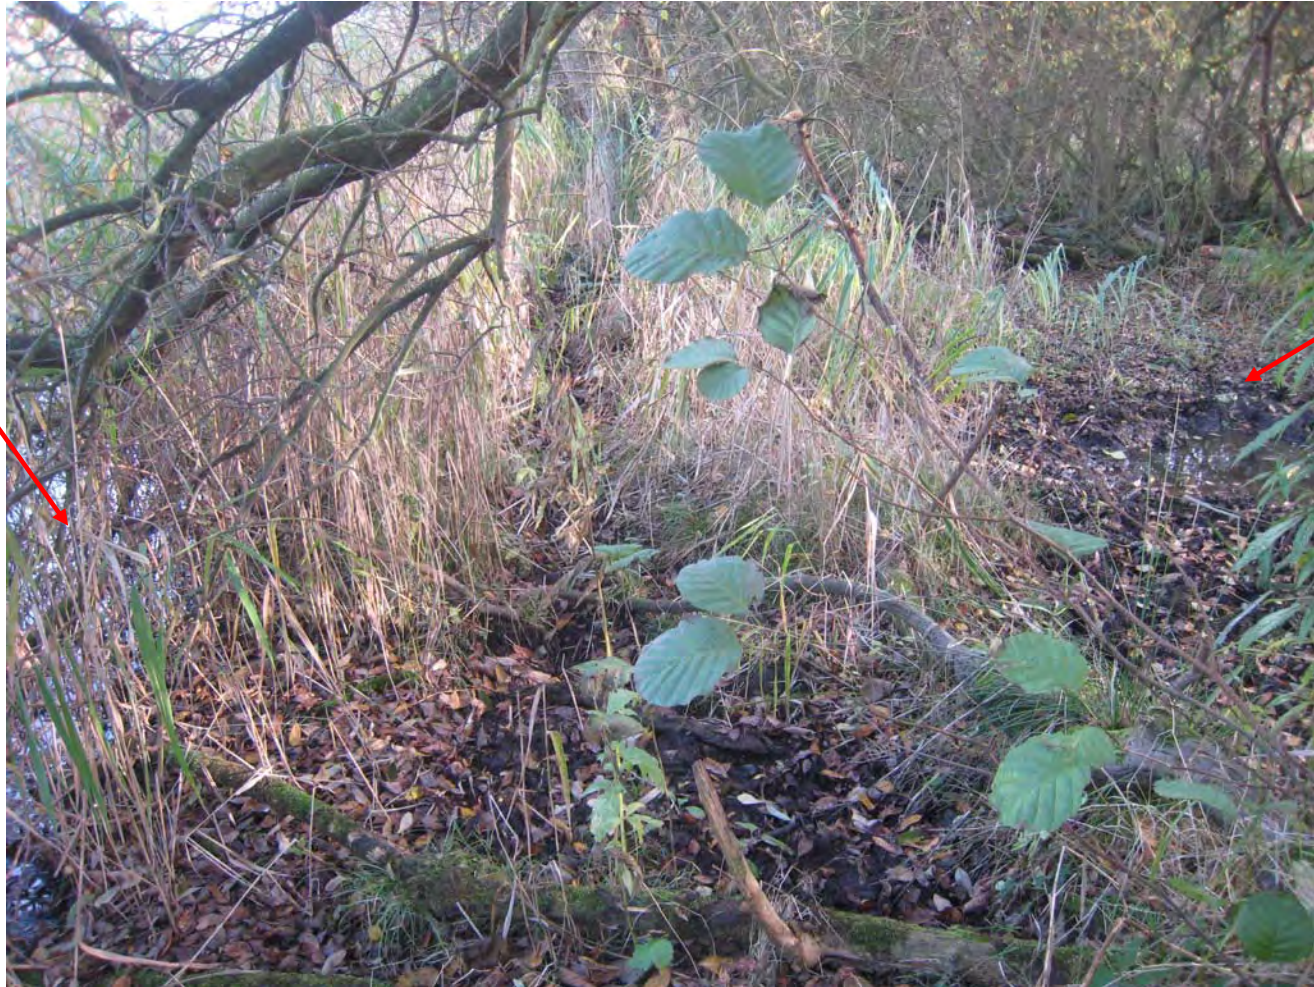
Pool of water

**Figure J7** The Bund at the southern end of Catfield Fen's Internal System, looking east (10/11/2011)

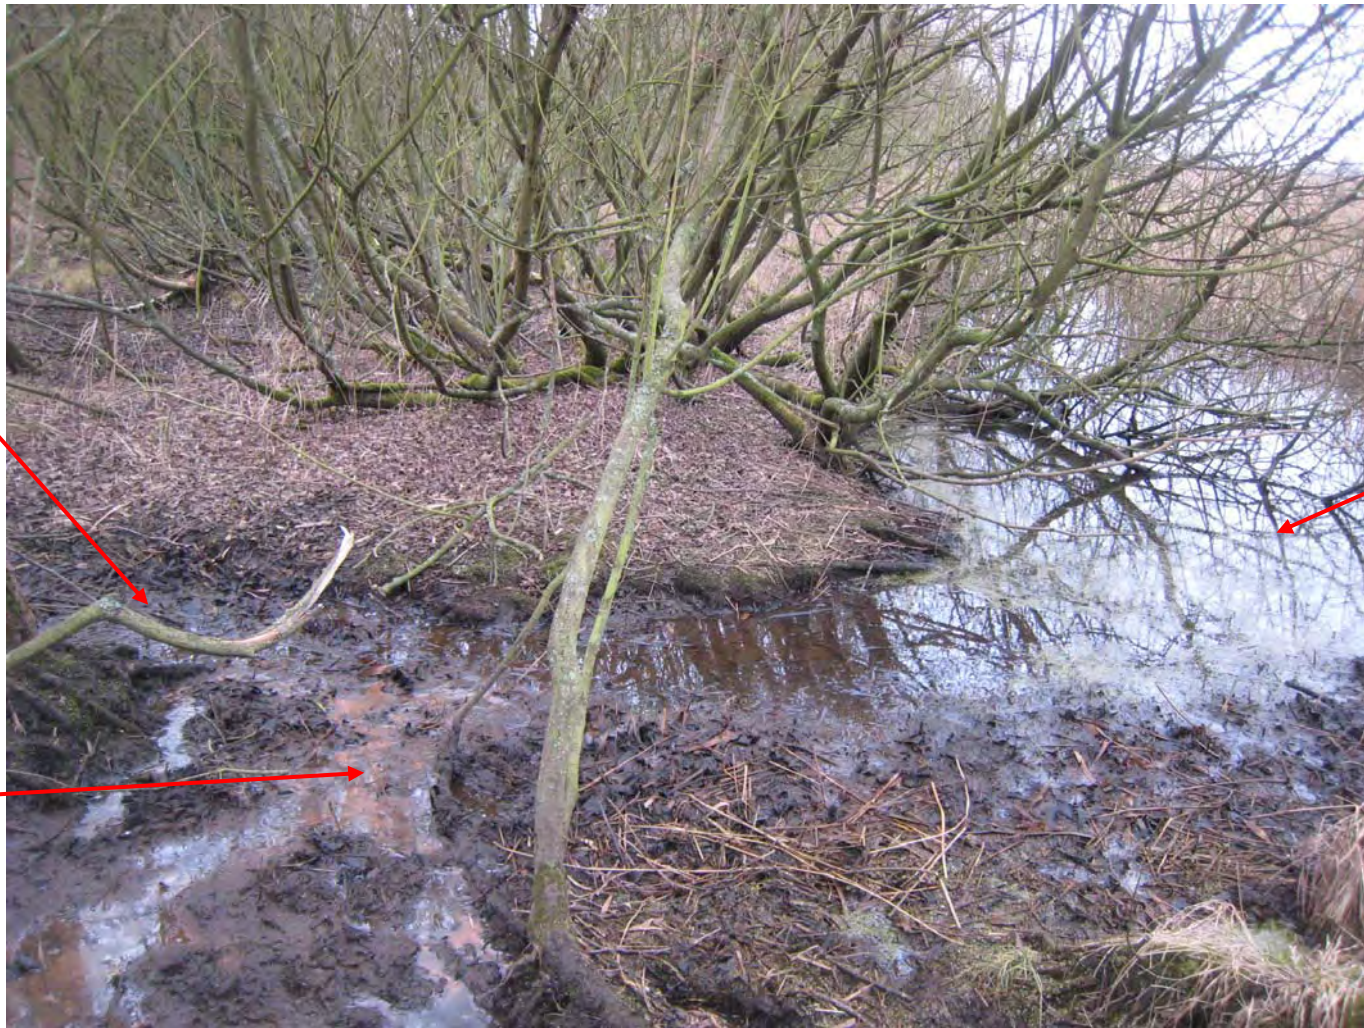
**Figure J9** Southern part of the raised area separating the internal system from the dyke leading southwards to Sharp Street Fens. Photograph taken about 20-30m south of the location shown in Figures J7 and J8, looking south (27/2/2012)

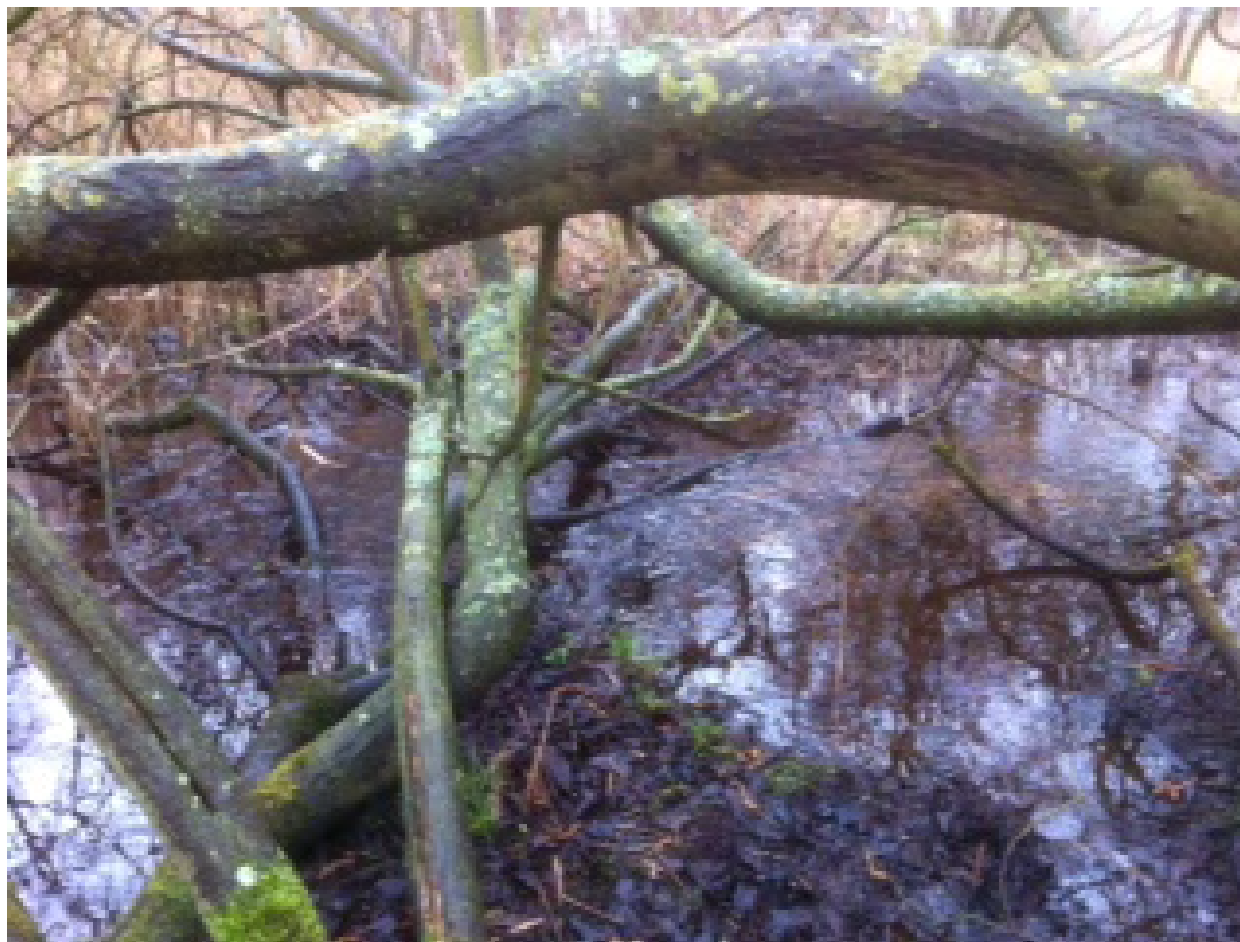
**Figure J10** Water flowing swiftly from right to left (north to south) through a gap in the bund, about 20m further east from where the photograph in Figure J7 was taken. The internal system boundary dyke is just off-photo to the left. (Photograph by Mr A Alston, 7 March 2012, after heavy rain on 4-5 March. An accompanying video clip is available)
