SPECIAL BULLETINS

S2/2010 Airbus A321-231	G-MEDJ	24-Aug-10	1
-------------------------	--------	-----------	---

COMMERCIAL AIR TRANSPORT

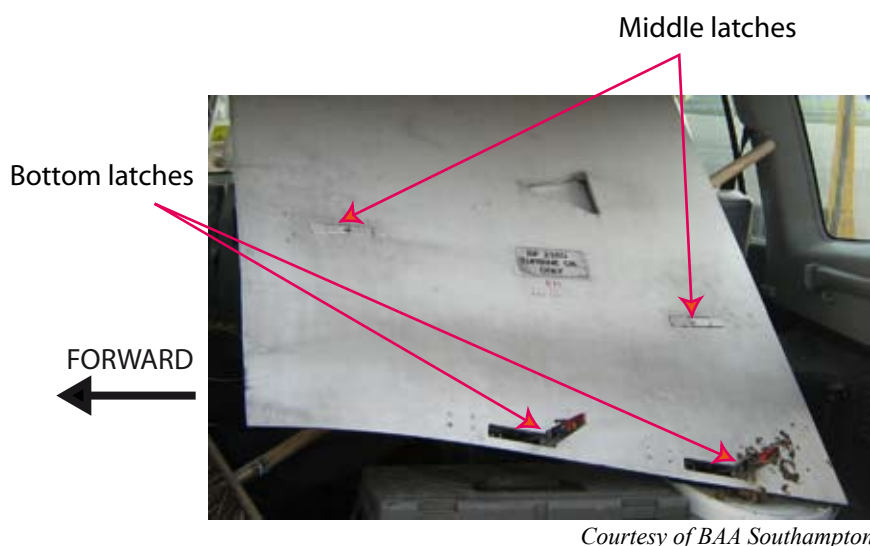
Figure 1

The No 2 engine inboard forward access door was found by airport staff in the grass area approximately halfway along and to the east of the runway. It was found with the two centre latches closed and locked but with the two lower latches fully open (Figure 1).

The lower latches had grass and dirt embedded within the lever mechanism indicating that they were in the open position when the door impacted the ground. Examination of the latch pin receivers in the nacelle structure showed no evidence of the pins having been forced out of their locked positions. All four quick-release positive-lock pin latches were found to be serviceable and showed no evidence of the latch pins having been engaged immediately prior to the engine bay door becoming detached from the aircraft.

No 2 engine inboard forward access door following recovery

Following this event the operator launched a safety campaign to highlight to aircrew, engineering and ground staff the importance of securing and checking of engine access doors on all its aircraft types.

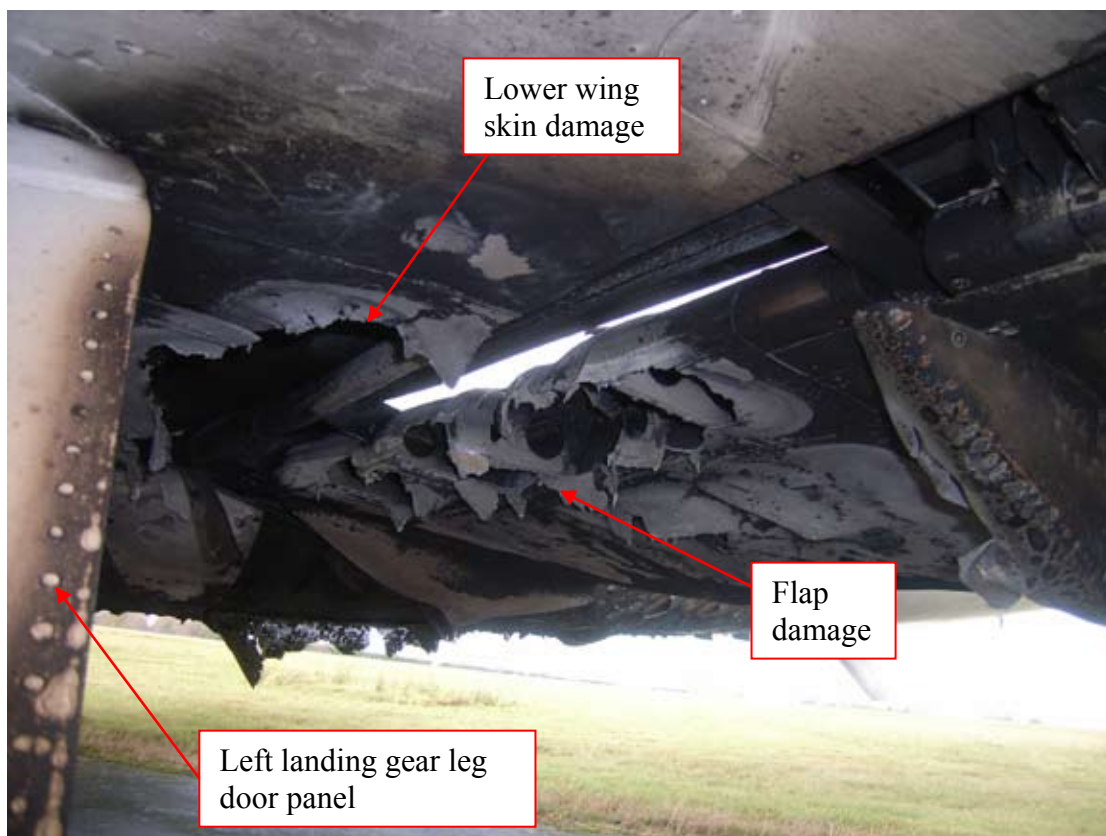
Figure 4

lower skin of the adjacent flap, which had been partially deployed at the time (Figure 4). The landing gear bay within the wing was heavily sooted with extensive heat damage evident to the upper wing skin and the electrical wiring looms running along the rear of the wing. The fuselage panels adjacent to the left MLG bay were severely heat damaged and the whole of the fuselage, rear of the wings, was heavily sooted. The number two hydraulic system reservoir level indicator showed that the system contained no hydraulic fluid; the number one hydraulic system reservoir was indicating just over half full. There was no evidence of fire around the right MLG.

Lower wing skin and flap fire damage

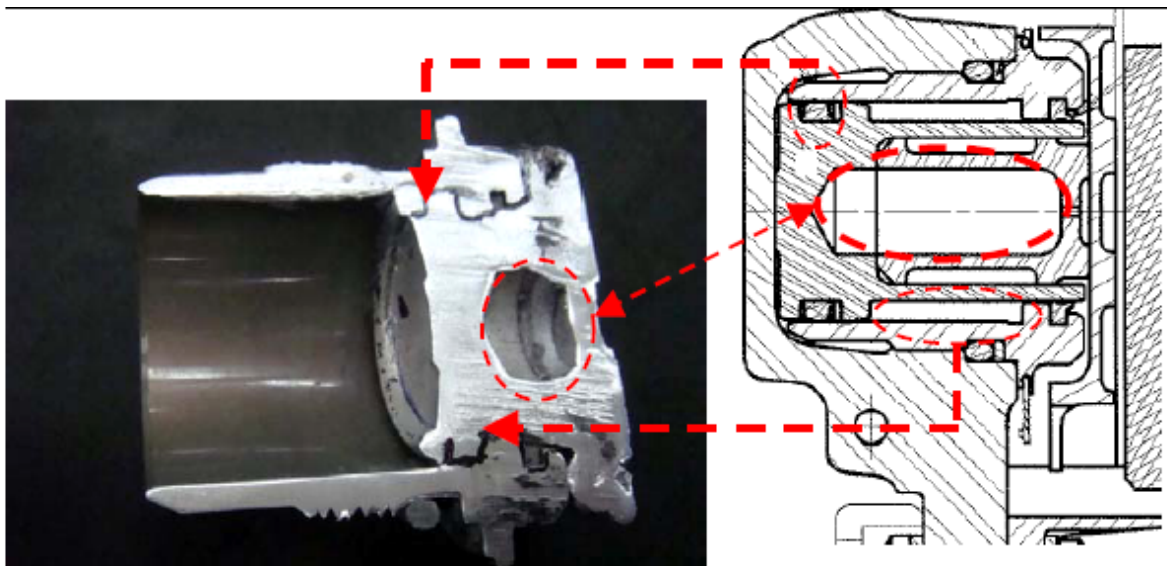
Figure 5

The inspection found that all three units displayed severe heat damage after experiencing 'exceptionally' high brake energies. The elastomeric static and dynamic piston seals were completely destroyed (seal degradation would have started at a temperature of 183°C). The aluminium alloy housings within the brake piston assembly had melted, indicating temperatures in excess of 200°C and the pistons themselves were significantly deformed (Figure 5). The protective coating on the carbon discs had been removed indicating temperatures in excess of 1,200°C.

Brake piston deformation

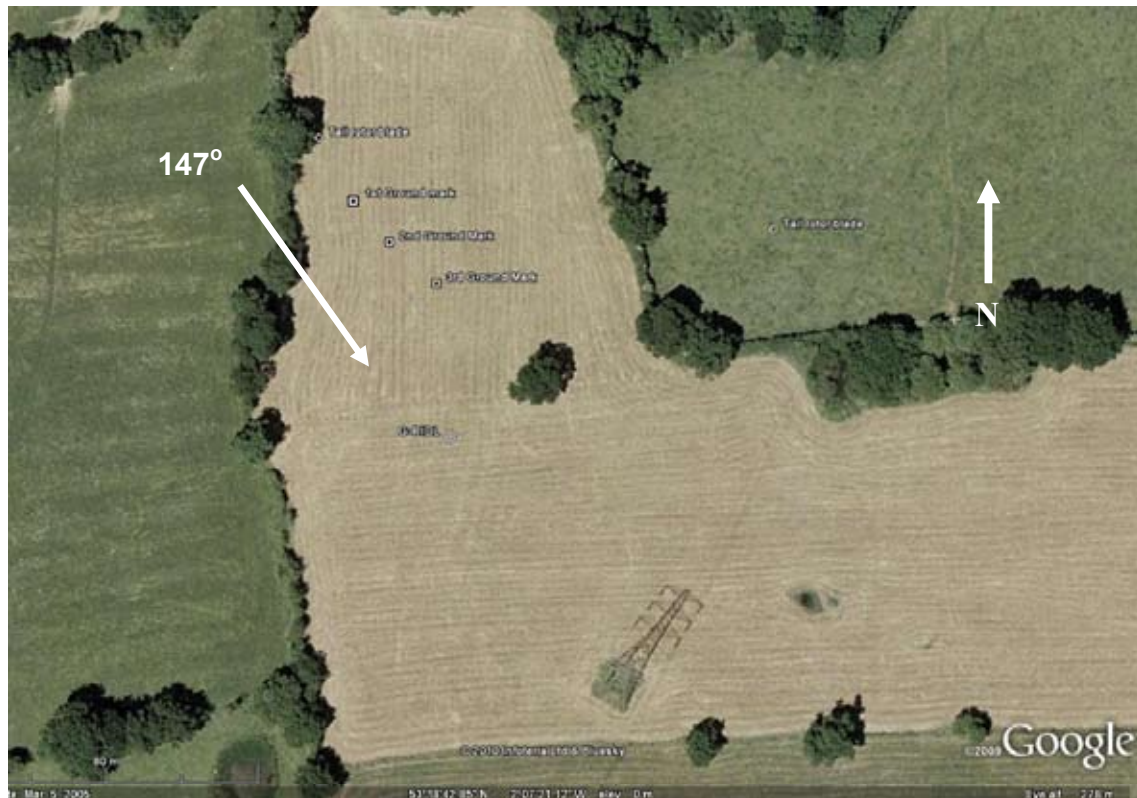
Figure 2

A third ground mark was identified 15 metres beyond the second, which was consistent with the right skid striking the ground. The final ground mark was produced when one of the main rotor blades struck the ground. This had resulted in the fuselage of the helicopter rotating 180° around the rotor head and landing heavily on its right side. The helicopter came to rest in a low-lying, waterlogged area of the field, 53 metres beyond the point of first ground contact. There was no evidence that the helicopter had made contact with any of the trees surrounding the field, or the overhead electricity cables which crossed the field.

Accident site

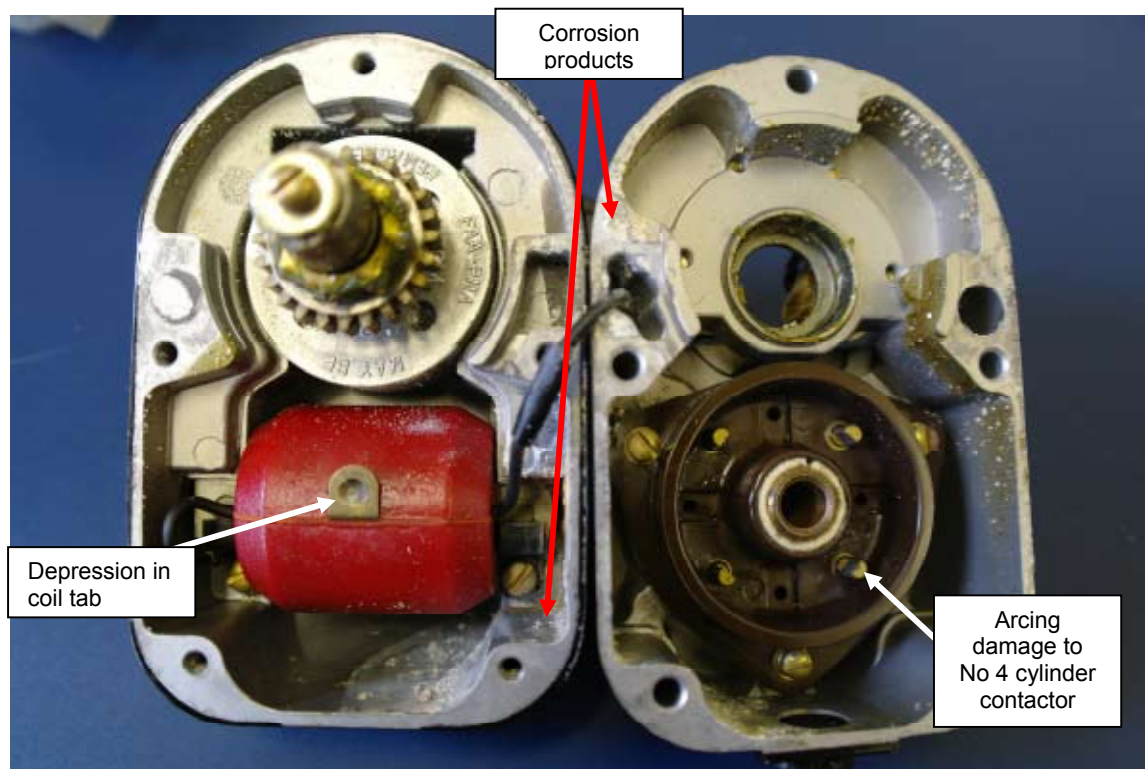
**Figure 3**

A bench test of both magnetos confirmed that sufficient energy was being produced to generate a spark across a representative air gap. On disassembling the magnetos, no defects were observed in the right magneto; however, when the left magneto was opened, clear evidence of water ingress was found. Examination of the mating faces of the magneto case halves failed to identify the location of water ingress. Removal of the distributor gear revealed evidence of arcing damage to the number four cylinder contactor and the presence of a layer of oxide on the contactor. The copper outlet tab on the magneto coil was coated in a layer of oxide and a depression had formed in the middle of the tab (Figure 3).

Measurement confirmed that the depression had been formed as a result of a loss of material from the tab. The carbon brush in the distributor gear was measured and found to be 10.7 mm long (the minimum permitted length is 9.53 mm), but the surface of the brush that touched the magneto coil tab was pockmarked as if material had been plucked from its surface. The formation of oxide on the conducting surfaces would have resulted in an increase in the electrical resistance and also accelerated the rate of wear of the components. The damage to the number four cylinder contactor confirmed that arcing had occurred between the

Left magneto showing corrosion and contactor damage

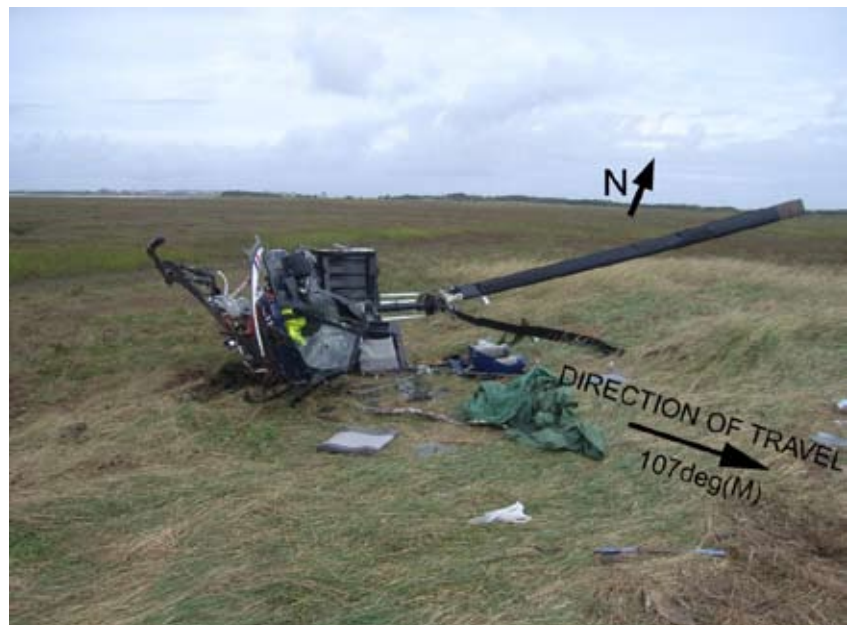
Figure 8

indicated that the helicopter had some sideways travel to the left at the time of impact. The furthest piece of wreckage, a piece of perspex, was located 16 m east of the main wreckage. The left skid had broken, the right skid had splayed outwards and both seat pans had been crushed, indicating that the helicopter had not initially struck the ground on its left side, but that it had rolled onto its left side after impact in a moderate left bank.

The three main rotor blades were intact with no damage to their leading edges, trailing edges or tips, indicating that they had little rotational energy at impact. One rotor blade was bent upwards, one was bent downwards, and the third had multiple bends and wrinkles from impact with the ground. Chordwise mud splatter on the tips of the blades indicated that some rotation was present at impact. The tail rotor gearbox had remained attached to the tail boom and both tail rotor blades were attached to the gearbox. One tail rotor blade was undamaged, and the other, which was buried, had a damaged tip. The

Accident site - parts of the cabin structure have been removed and the green tarpaulin was placed on the ground after the accident
