PART 1.4 – FINDINGS

ESCAPE SYSTEM AND SURVIVAL ASPECTS

TECHNICAL EVENTS

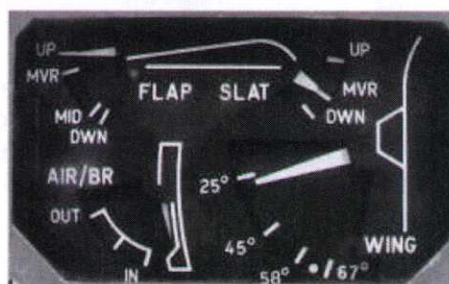
Figure 7

a. From 130 sec to EOD the wing sweep was at 27.9° and not the expected 25° or 45° position. On the subsequent selection of MVR the flaps were in the UP position and the slats were in the MVR position. The flap position was as a result of the wings not being at 25°.

16. Following confirmation of the ac configuration at impact, the Panel considered the possibility of a temporary restriction within the wing sweep mechanism or both an unserviceable and/or misread Cockpit Position Indicator (CPI) as factors. Investigation into the CPI found that the graduation movement of the wing sweep indicator from 25° to 27.9° was small. A slight gauge discrepancy could easily be interpreted as the wings being fully forward (25°). With the wings fully forward (25°) the selection of MVR would have provided a flap and slat indication on the CPI as shown in Figure 6. With the wings at 27.9°, only the MVR slats would travel (Figure 7). Additionally, slat deployment could easily be confirmed visually on the leading-edge of the wing (though the flap would not have been visible). At MVR selection, the gauge movement for the flaps on the CPI is less than that of slat. The calibration of ZE982's CPI could not be proven post the accident. The final recorded check of the wing sweep was verbal by the Pilot and was carried out after selection, during a relatively benign phase of flight. The selection of MVR was carried out on entry to the series of valleys at TARBET, coincident with an increase in workload. The Panel could not rule out a combination of gauge error, gauge interpretation and/or temporary restriction as factors effecting the ac configuration at the time of the accident. Nonetheless, considering the weight of evidence, the Panel concluded that the final configuration was more likely to be as a result of mis-selection and subsequent gauge interpretation, rather than a technical event.

Likely Configuration at Accident

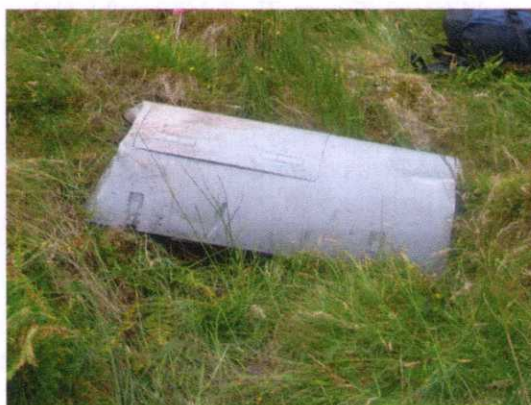
Figure 4

19. **R-ADR Identification.** The R-ADR was not found at the crash scene until day 4. The R-ADR was found within its associated spine panel (Figure 4) and, as there were no associated external marking, the spine panel was frequently overlooked.

R-ADR spine panel

The Panel observed that the R-ADR spine panel of ZE982 was not marked, thereby directly contributing to the delay in recovery of the R-ADR. Additionally, the internal colour of the R-ADR bay was no different to the rest of the ac's internal finish. Also, the organisations in attendance at the crash site were not fully aware of the DEF STAN symbol for a flight data recorder.
