# Kit!

## ENGINEER'S CORNER THE PRINCIPAL ENGINEER FOR LAND EQUIPMENT

### KiT 81 | 2012

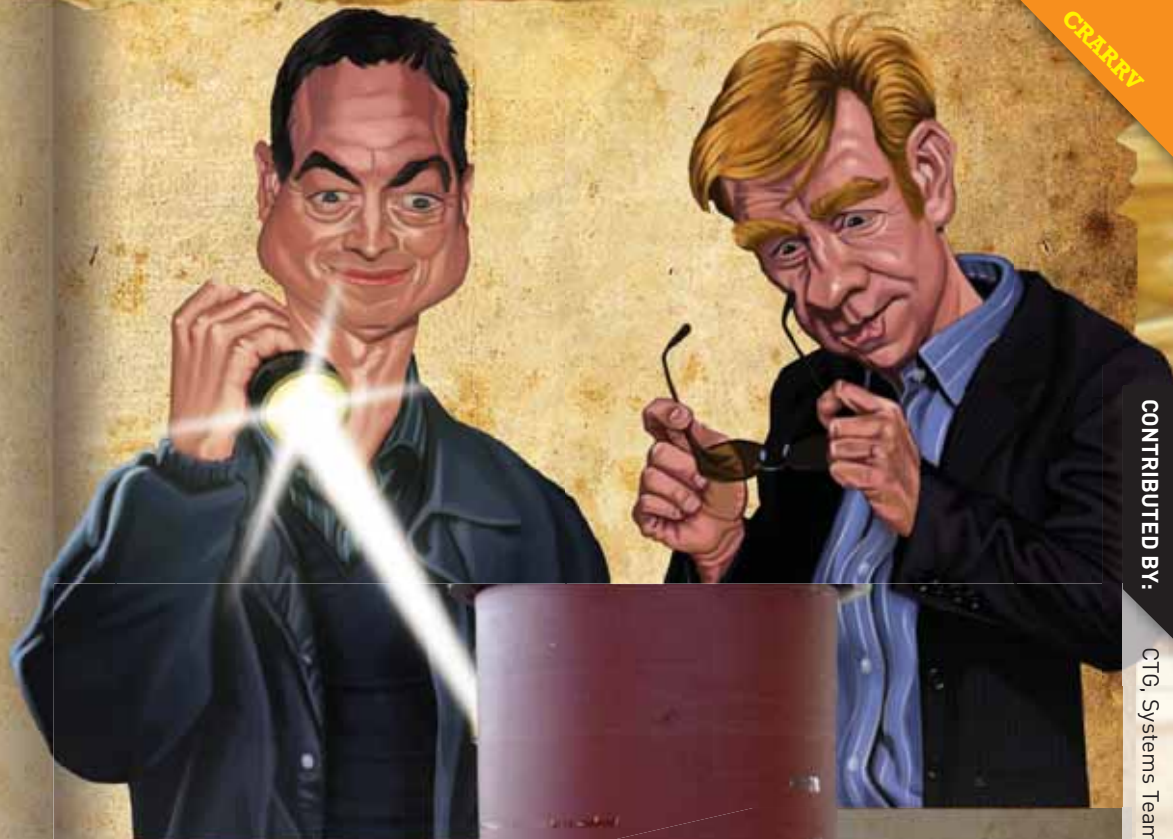
## Main Winch failure

This winch was fitted to a CRARRV at 10 Trg Bn (Bordon). The storage drum drive gearing had suffered from a catastrophic failure - it would not have been visible with the winch fitted.

The capstans and storage drum operate in unison by hydraulic linkage, the winch capstans cannot apply a load sufficient to cause this damage; when winching out the storage drum motor acts as a brake until the PRV opens at 70 bar to maintain a tail tension on the rope.

It is possible that the vehicle was being reversed away from a casualty while in freespool and a gear was inadvertently selected before the vehicle had been brought to a halt. The interlocks should have prevented a gear selection but there may have been secondary faults on the winch...

**This is an unusual failure that will be very expensive to repair - we need to understand the circumstances that caused it - does anyone know what happened?**

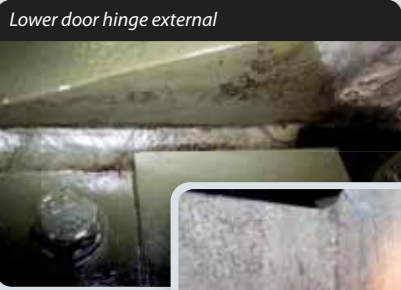
Lower door hinge external

There is a safety concern on all variants of Warrior with the one-piece rear door concerning fracture to the rear door lower hinge - see picture below. The crack has extended completely through the fabric of the door and is visible on the inside.

The damage was likely to have been caused by the additional stresses placed on the door hinges during manoeuvring of the vehicle with the rear door open. It is also possible that continued operation of the rear door actuator when the door is obstructed or if the micro-switches are not correctly adjusted will contribute to the failure.

The door hinges must also be lubricated IAW the relevant 601 to ensure that the door opens and closes smoothly.

This is not an isolated incident, other Warrior vehicles were examined and found to have similar problems. A level 2 repair scheme will be issued to units detailing weld repair procedures.

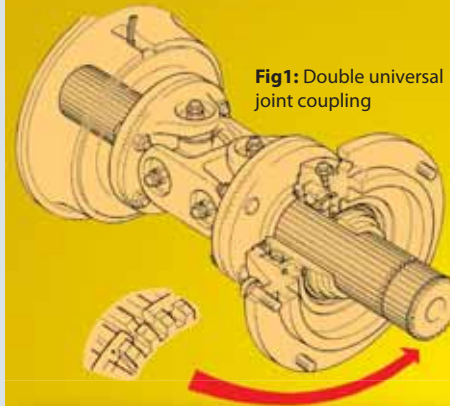
There is an obvious misalignment between the transmission output flange and the final drive input flange on this vehicle. SEFIT must be informed if difficulty is experienced in fitting the LHDS - **do not be tempted to fit the shaft as overheating and possible catastrophic failure may occur.** The misalignment between final drive and transmission cannot be corrected at unit level as both the pack and final drive are bolted rigidly to the hull. **In cases of misalignment Units are to initially ensure that:**

- The pack is correctly located and secured in the hull and that the RH trunnion alignment ring is fitted correctly
- The final drive input bearing is serviceable
- The bulkhead bearing through which the transmission output shaft runs is serviceable
- The transmission output shaft snap ring is correctly located in the groove - **see detail in Fig 1** and that the output shaft is pushed fully into the transmission so that the snap ring prevents the shaft from inadvertent disengagement.

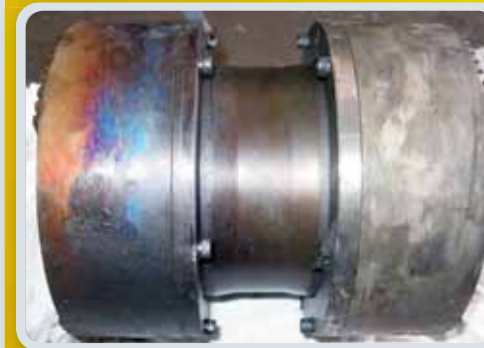
This LHDS has overheated – the characteristic blue colour indicates that the temperature has risen to around 300° C. This overheating has been caused by a misalignment of the final drive input flange with the transmission output flange causing the LHDS to run eccentrically. The LHDS is designed to tolerate a maximum of 1.5° misalignment. The overheating will not occur if the vehicle travels short distances as the heat gradually builds up due to the sliding friction between the LHDS internal gear teeth. **Any LHDS that exhibit this colour change must be reported to SEFIT immediately and the vehicle quarantined.**

Difficulty in withdrawing or replacing the drive shaft assembly, either prior to towing the vehicle or before a pack lift - **indicates that the alignment is incorrect and should be investigated.**

The modified LHDS is fitted with Viton O rings, Viton is a fluoroelastomer - at high temperatures or in a fire, fluoroelastomers decompose, and may release hydrogen fluoride. Upon contact with moisture, including tissue (skin), hydrogen fluoride immediately converts to hydrofluoric acid, which is highly corrosive and toxic, and requires immediate medical attention upon exposure. **Any residue from burnt or charred O rings must be handled using protective equipment.**

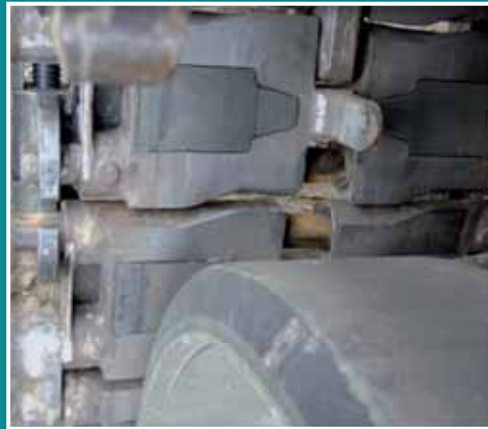
Misaligned track

The track pins and top hat will be damaged if the end connector is fitted without correcting the misalignment and an attempt made to align the links by forcing the top hat into the end connector.

The use of the guide bar to align the links is being added to the CR2, CRARRV and T2 AESPs.

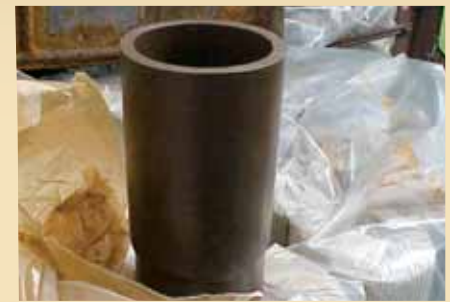
Can anyone identify this component - it is roughly 30 cm in height, has a mass of 27kg and is made from steel.

DSDC Longtown has a large quantity that needs to be disposed of but the component has no identifying marks and there is no paperwork.

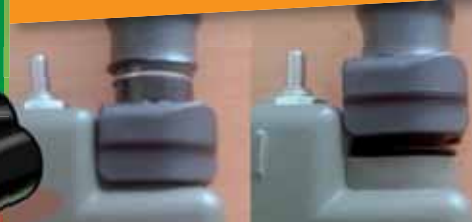
## Gooseneck Antenna Installation

Recent EFRs regarding both antenna and socket failures have highlighted users incorrectly attaching/removing the gooseneck Mk3 to the EZPRR.

This prevents undue stress being transferred to the antenna connection. The gooseneck is to be used at all times in conjunction with the antenna. The Mk3 Gooseneck NSN 5985-99-676-6698 is available for users to demand. AESPs held on TDOL are being updated to reflect this change.

Users need to **push the collar of the Mk3 firmly down** against the body of the EZPRR after screwing the gooseneck on.
