Published 9 March 2017

DA 40 Diamond Star	G-CBFA	16-Jul-16	3
--------------------	--------	-----------	---

<b>Aircraft Type and Registration:</b>	DA 40 Diamond Star, G-CBFA	
<b>No &amp; Type of Engines:</b>	1 Lycoming IO-360-M1A piston engine	
<b>Year of Manufacture:</b>	2001 (Serial no: 40.063)	
<b>Date &amp; Time (UTC):</b>	16 July 2016 at 1546 hrs	
<b>Location:</b>	Old Warden Aerodrome, Bedfordshire	
<b>Type of Flight:</b>	Private	
<b>Persons on Board:</b>	Crew - 1	Passengers - 2
<b>Injuries:</b>	Crew - None	Passengers - None
<b>Nature of Damage:</b>	Nose landing gear leg, nose wheel, propeller and possible damage to engine	
<b>Commander's Licence:</b>	Private Pilot's Licence	
<b>Commander's Age:</b>	42 years	
<b>Commander's Flying Experience:</b>	269 hours (of which 38 were on type) Last 90 days - 26 hours Last 28 days - 21 hours	
<b>Information Source:</b>	Aircraft Accident Report Form submitted by the pilot

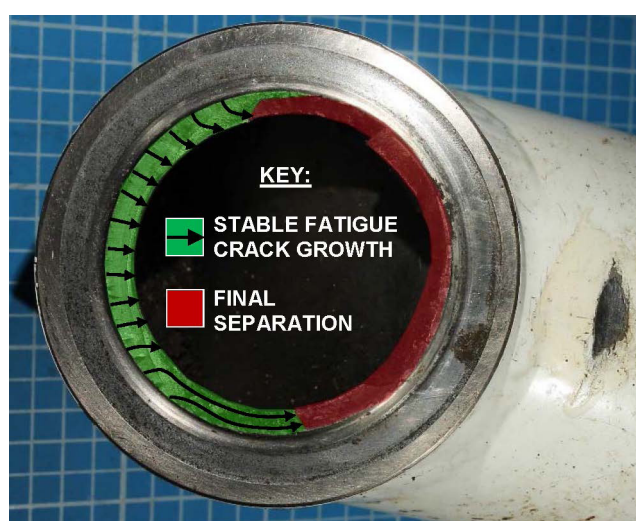
**Figure 1**

The fracture surfaces were examined by a metallurgical consultant, who concluded that the failure was due to a fatigue fracture which had progressed approximately half way across the part, Figure 1. At this point the nose leg had failed in overload, resulting in separation of the nosewheel assembly.

Failed part of nose gear leg, view looking up with forward to the left showing fatigued area (green) and crack growth

*'It is difficult to tell something about the number of landings, the distance the aircraft has to taxi on ground that a fatigue fracture can propagate as shown in the pictures. It is also possible that the propagation of fatigue or forced fracture was favored by one or more hard landings.'*
