Near miss between a train and line-side workers on Dutton Viaduct, Cheshire, 18 September 2017

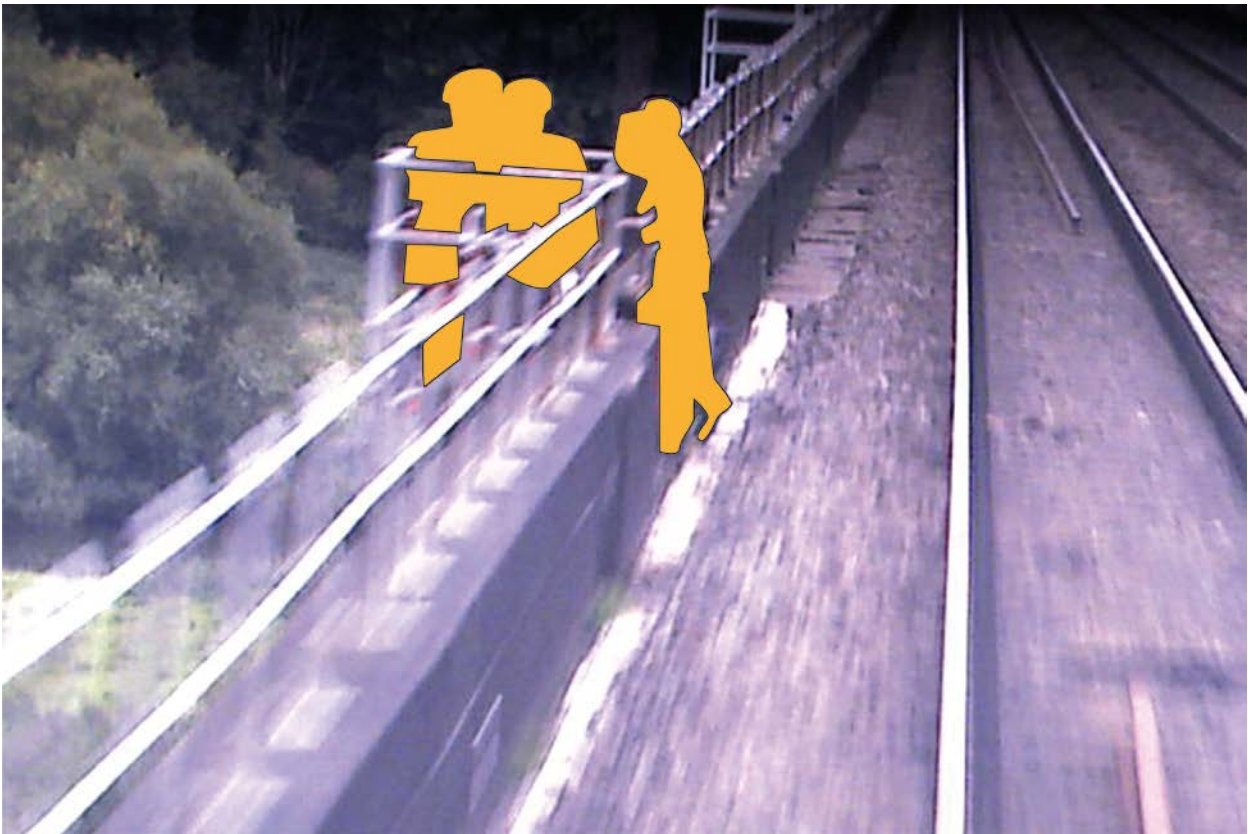
Image from forward-facing camera on train 9M84 showing the group of line-side workers moving clear (image courtesy of Virgin Trains)

Despite the prohibition of access to the railway lines (including the refuges) on the viaduct while trains are running, the group of workers chose to cross from a refuge on the down side of the railway to a refuge on the up side of the railway. Train 9M84 was approaching them on the up line as they were completing the crossing. The last worker managed to get into the refuge approximately half a second before the train passed the location.

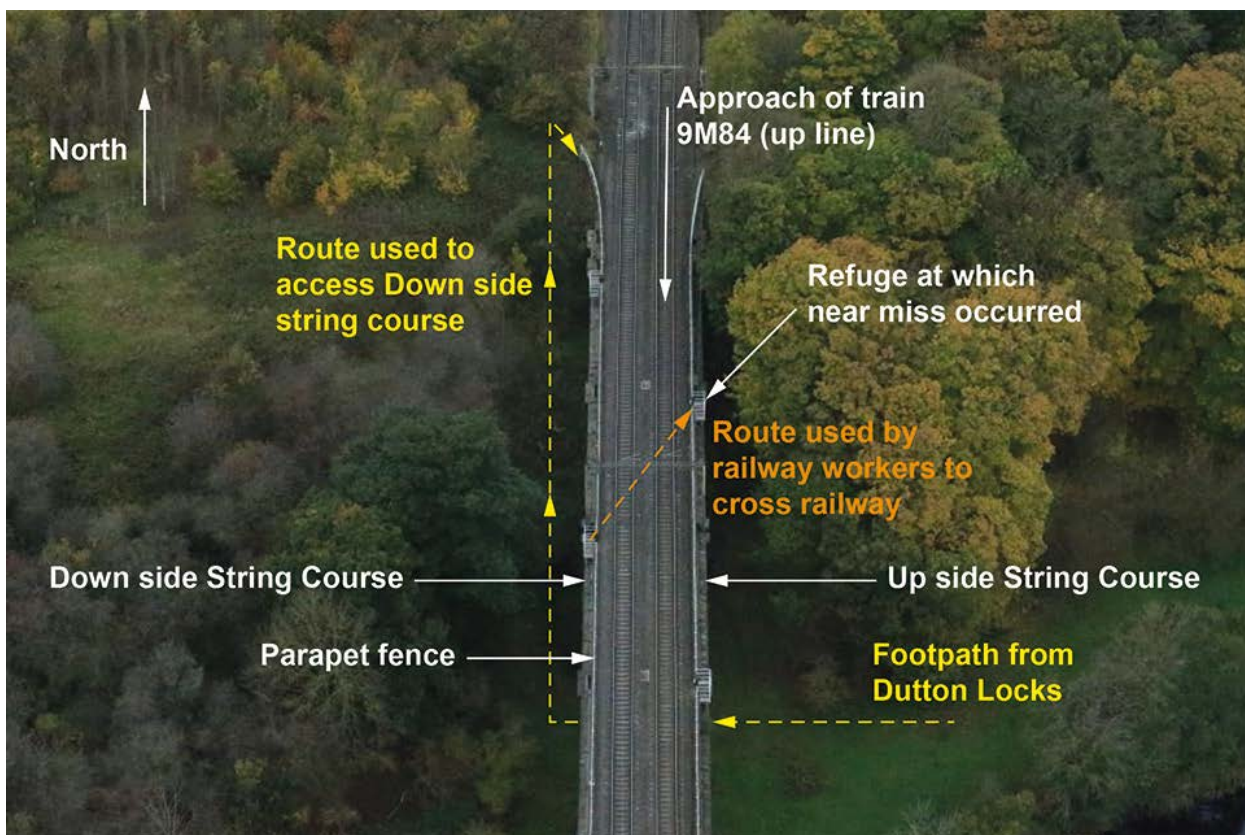
The viaduct has horizontal string courses along its length on both the up and down sides. Access to the string courses is available from the adjacent embankment without the need to first gain access to the railway tracks. The string courses form ledges that are approximately one metre wide, located at a level lower than the railway tracks and separated from the railway by the parapet fence. Access to the string courses is permitted when trains are running and each string course can be used as a working platform for the inspections of the viaduct. However, ropes must be used to ensure safe working on the string courses. To allow the use of ropes, anchor points must first be installed.

The north end of Dutton Viaduct, showing the parapet fence, string courses, path of the group and the refuge where the near miss occurred (image courtesy of Network Rail)

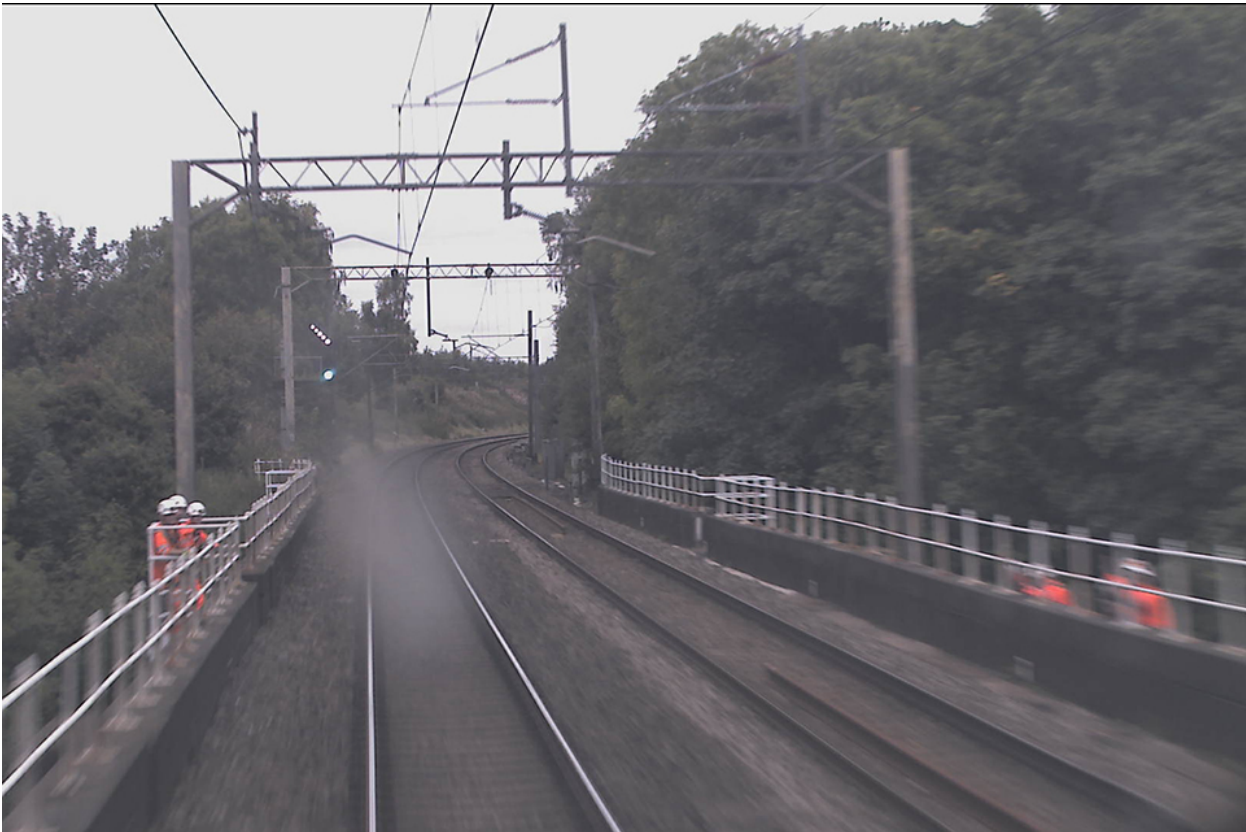
During the day, the team inspected the first five arches of the viaduct. When it was time to finish and return to Dutton Locks, the sub-team which had been working on the down side were concerned about the problems they had encountered with access that morning. They decided to cross the railway to gain access to the up side string course, and leave the viaduct by that route. The group climbed from the string course into a line-side refuge on the down side of the railway. Forward facing CCTV cameras on a northbound train captured images of the sub-team in the refuge, waiting to cross, at 16:54 hrs.

Image from a northbound train (on the down line) at 16:54 hrs. The down side sub-team can be seen in a refuge. The up side sub-team can be seen on the right, stood on the string course. (Image courtesy of Virgin Trains)

The group then crossed the railway lines from the down side to the up side. The refuge on up side was not directly opposite and so the group sub-team had to cross the lines diagonally which extended their crossing time. While they were crossing the up railway line, train 9M84 approached the viaduct round a left-hand curve, and the near miss occurred.
