# Track workers struck by ballast thrown from the track bed by a passing train near Chathill, Northumberland, 16 February 2017

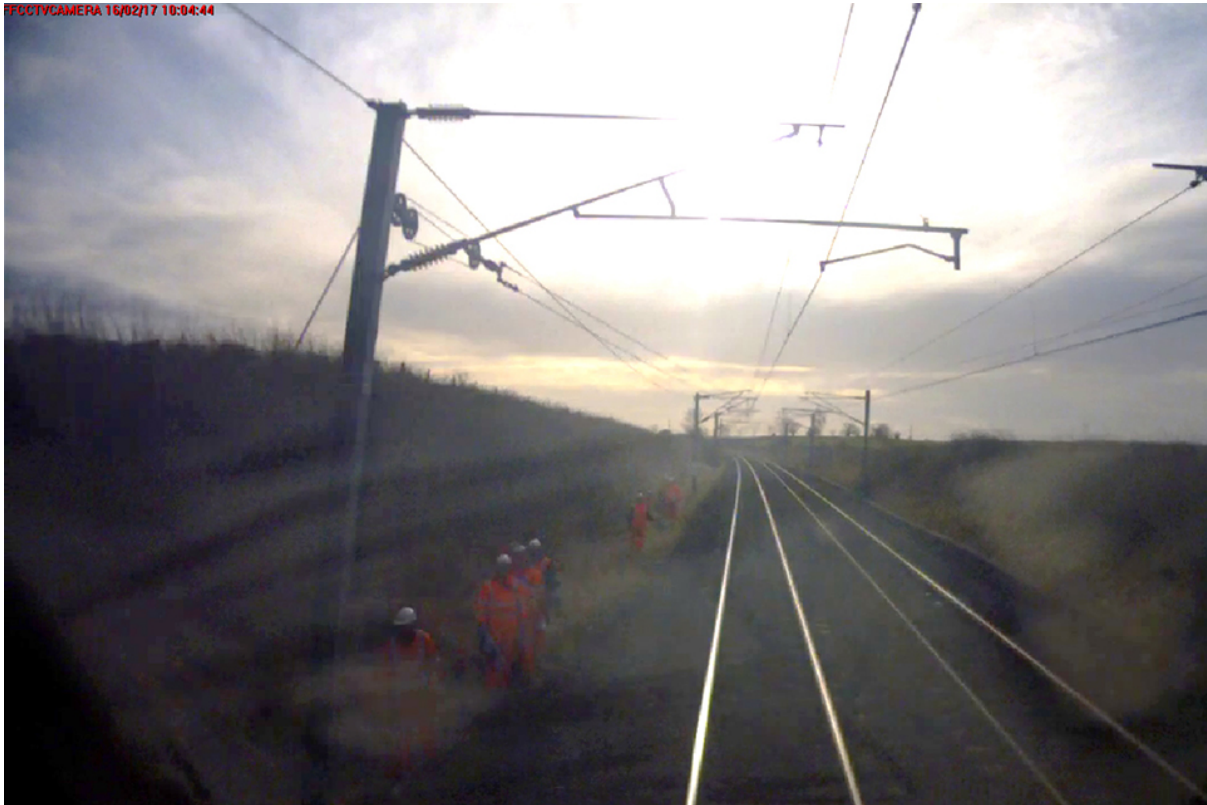
At around 10:10 hrs on 16 February 2017, two track workers were struck by flying ballast thrown up by a passing train travelling at 98 mph (157 km/h). One end of a flexible hose had become detached from the train and was dragging along the track. Neither track worker suffered significant injury.

The track workers were part of a group of seven Network Rail staff who were inspecting the overhead wires above the tracks. They were all standing in a position of safety on the left-hand side of the line with respect to the direction of travel of the train.

View of the group of track workers from the forward facing CCTV on the train (photo courtesy of CrossCountry Trains)

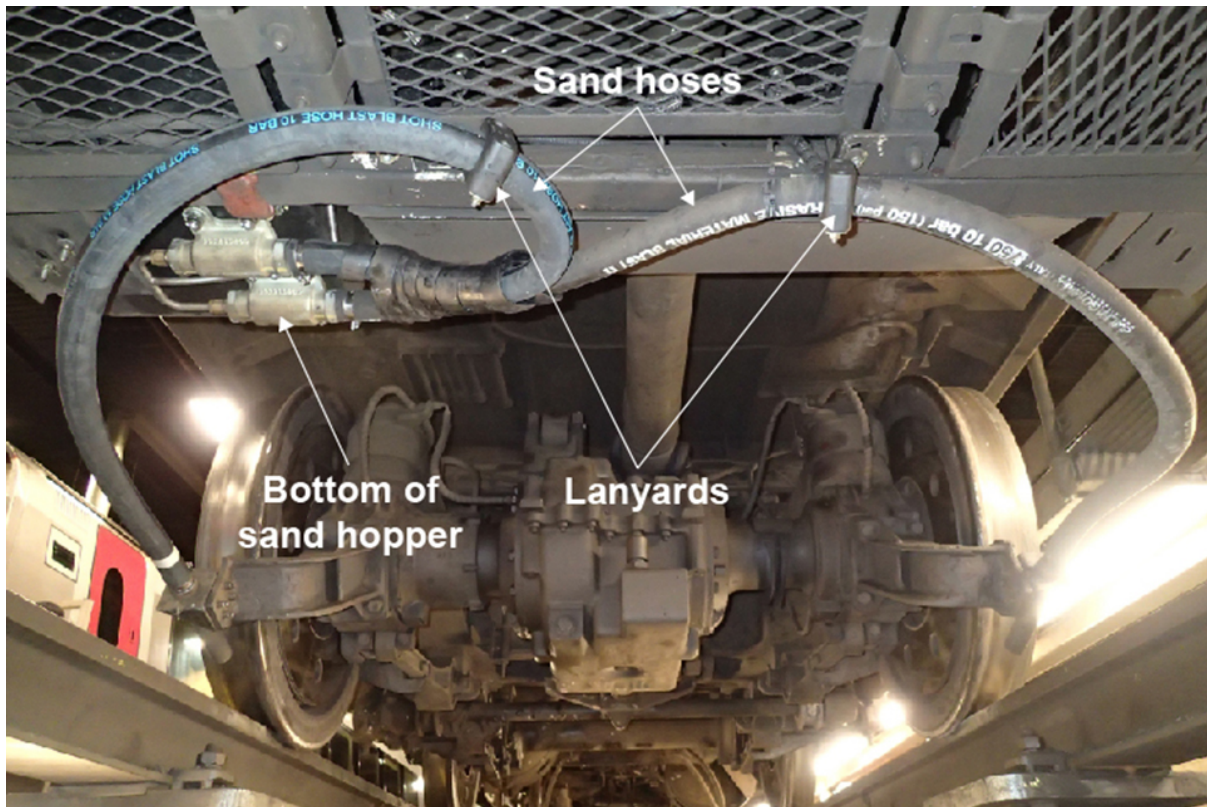
The hose which partially detached from the train was part of a new sanding system that had been fitted on 6 February 2017 (below), in response to recommendation 1 of the RAIB report into a buffer stop collision at Chester station on 20 November 2013 ([RAIB report 26/2014](#)). Sand hoppers had been mounted on the underframe of the two end vehicles of CrossCountry Trains class 220 and 221 units, with flexible hoses running from each hopper to brackets attached to the inner bogie to deliver sand to both rails in front of the third axle (from the driving end). Each hose was supported by a lanyard fitted under the vehicle body.

**Underside of class 220 vehicle showing the location of the sanding equipment**

The cause of the detachment was not determined with certainty. However, the RAIB considered evidence from this and other similar failures (see later). Those identified by drivers all appeared to have occurred on high speed sections of lines. The RAIB concludes it was most likely that the section of hose between the lanyard and the bogie mount deflected downwards and snagged on track infrastructure features; such as check rails or anti trespass guards at level crossings. The deflection is considered likely to be the result of aerodynamic loads, possibly in combination with other dynamic loads; the hose is orientated across the width of the train's underframe (above) where there is considerable longitudinal air flow when the train is travelling at speed.

Although the FMEA identified that both failure of the mounting arrangement and the hose itself would cause the hose to become detached or misaligned, the only effect identified was its impact on the sanding system (ie sand might not reach the rail). It did not identify the possible effects on other systems or personnel if the hose was dragged along the track. The design load cases for the system did not consider any effects of aerodynamic loads on the hose when the train was travelling at high speed.

Since the introduction of the new sanding system at least 16 sand hoses have detached from CrossCountry Trains class 220 (14) and 221 (2) units. Half of these were identified by drivers in service and half by maintenance staff at Bombardier's maintenance depot. Bombardier instigated fleet checks on all class 220 and 221 units fitted with the modification and has implemented a temporary solution to all these trains ahead of a permanent solution becoming available. Bombardier reported that the temporary solution has been effective in preventing further incidents.
