CONTENTS

COMMERCIAL AIR TRANSPORT

Summary of:	Aircraft Accident Report No: 5/2007	102
	Report on the incident to Airbus A321-231, G-MEDG during an approach to Khartoum Airport, Sudan on 11 March 2005	
List of recent aircraft accident reports issued by the AAIB		107
	(ALL TIMES IN THIS BULLETIN ARE UTC)

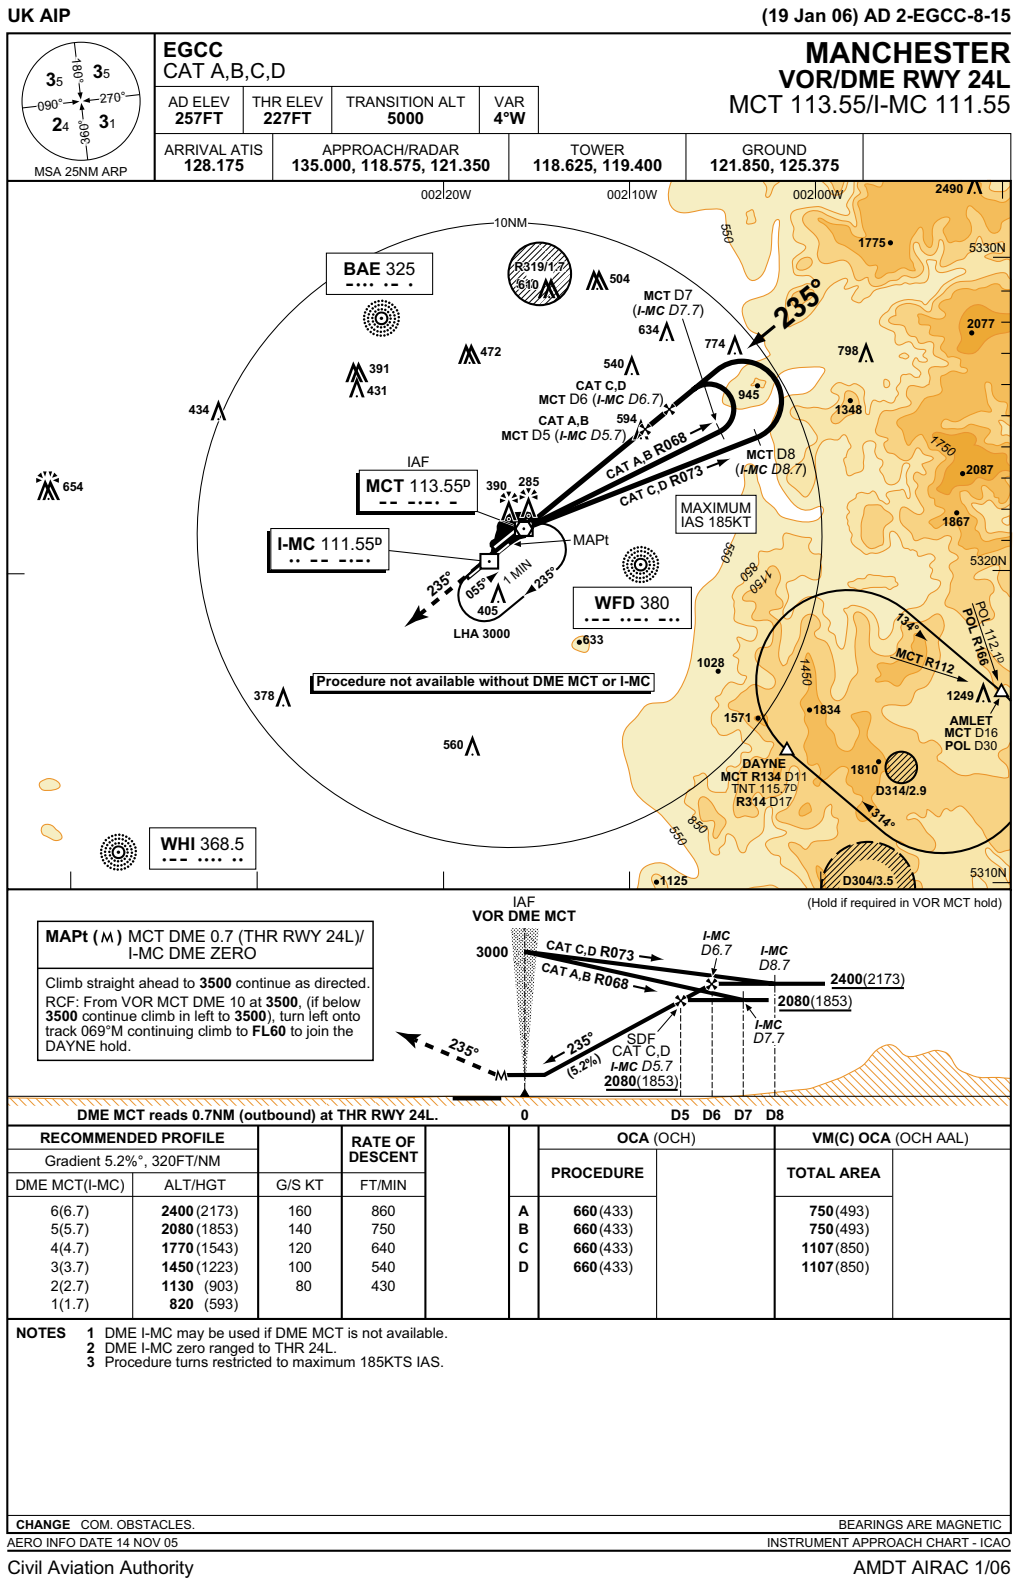
Figure 1

This information indicates that the aircraft descended below the minimum procedure altitude of 2,400 ft before passing the FAF and below 2,080 ft before passing the associated SDF at 5 nm. As the aircraft passed within 5 nm of the threshold its track began to converge with the published approach track.

Manchester VOR/DME RWY 24L procedure

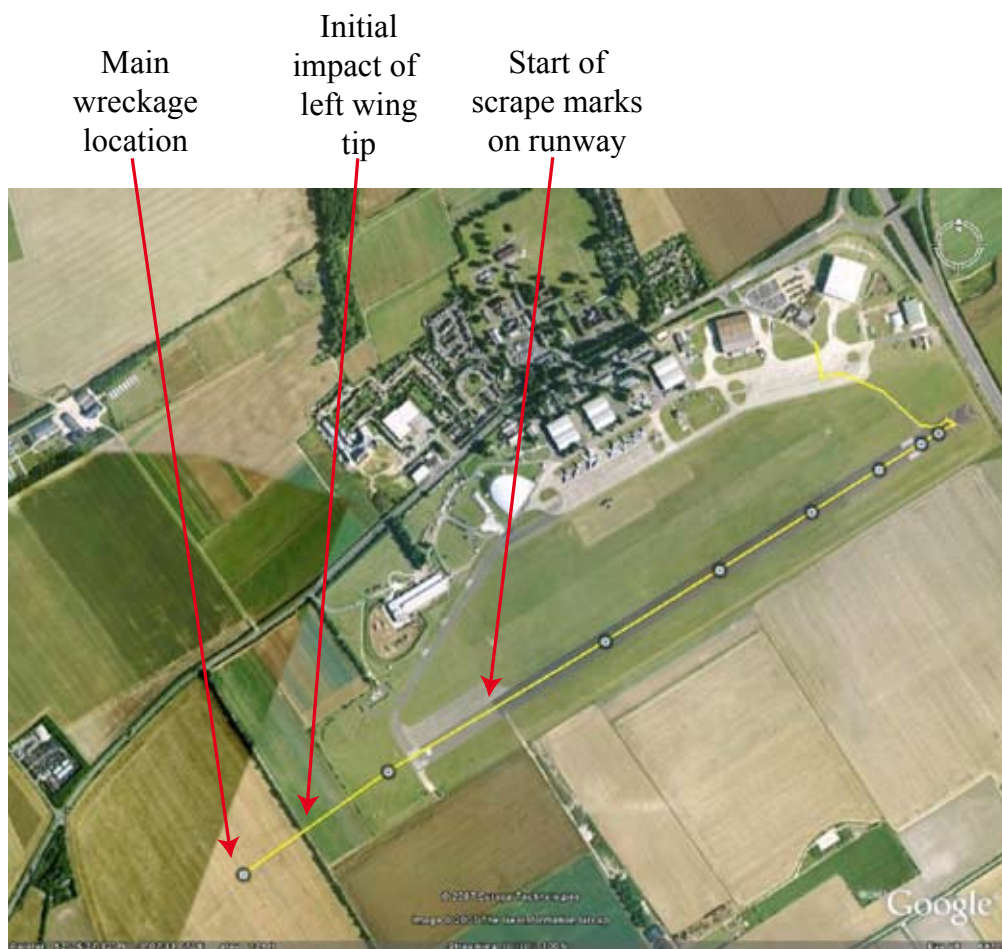
Figure 2

From examination of the wreckage it was found that the landing gear was down at impact and the position of the electrically driven linear actuator indicated that the flaps were at 32° which was the takeoff setting. This flap position was also confirmed, from the photographic evidence, as being set during the takeoff roll.

The accident sequence and wreckage location is shown at Figure 2:

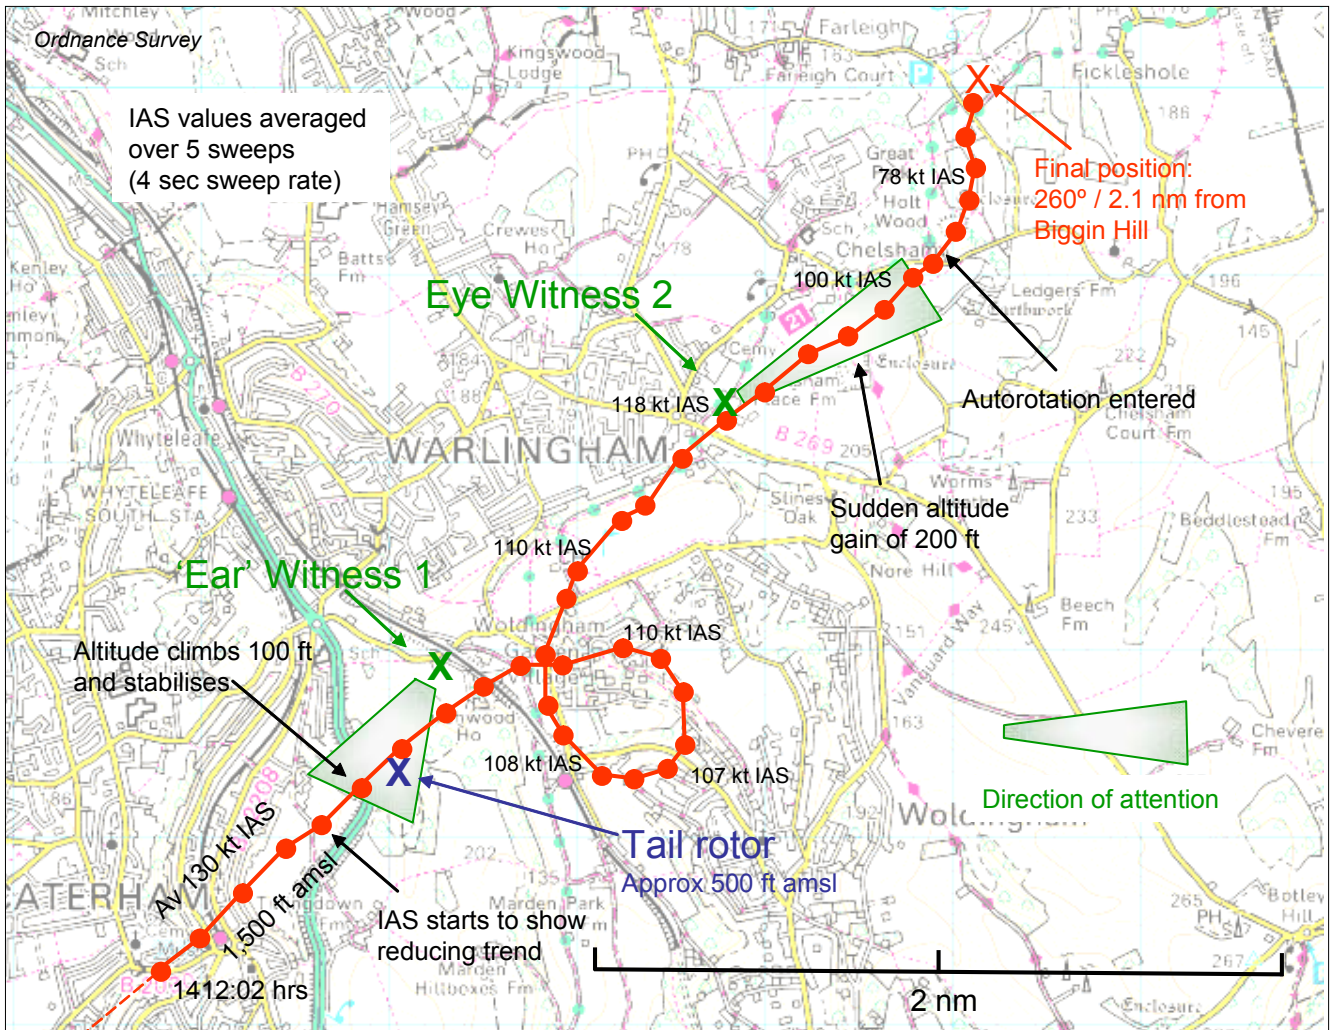
Figure 1

Diagram illustrating G-DNHI’s track for the last part of the flight, and the location of witnesses

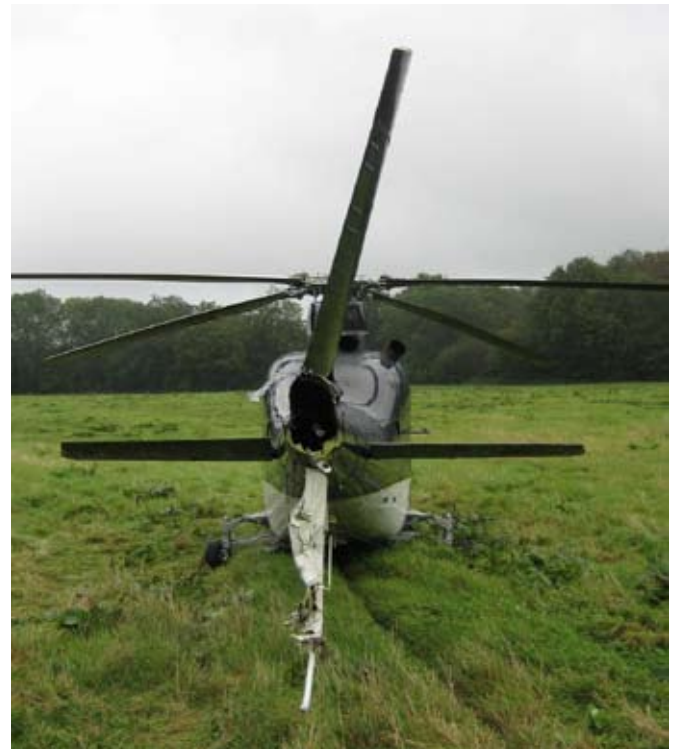
Figure 2

Initial examination of the helicopter revealed that the tail rotor assembly, including the gearbox, and left engine outboard exhaust duct were missing, Figure 2. One of the main rotor blades had a deep indentation on its under surface at, approximately, the half-span point. The upper vertical stabiliser was inclined about 25° to the right and its fixture to the tailboom was severely disrupted. The lower vertical stabiliser had suffered severe damage to its trailing edge consistent with being struck by the tail rotor blades.

The tail rotor and its gearbox were found some time after the accident, in the vicinity of the first uncommanded yaw event; the exhaust duct has not been found to date.

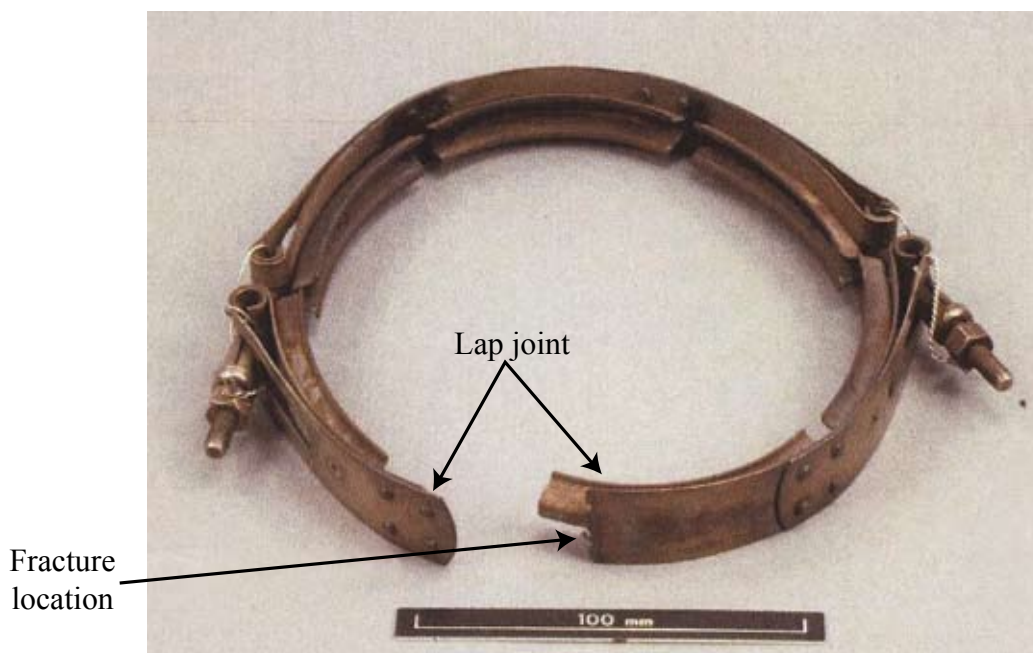
Figure 3

Mormon¹ clamp (part number 4606AC), that had been used to attach the outboard exhaust duct to the left engine, was found loose in the engine bay. This had failed at a position approximately one third of the way around the circumference of one of the two halves of the clamp, Figure 3.

Failed exhaust-duct-to-engine Mormon clamp

It was evident that a failure of the strap had occurred on one half of the subject clamp, beneath where it was overlapped by one of its folded back ends. Detailed examination revealed that a crack had formed and that this had initiated in the strap's central region. The crack had then propagated towards the strap's outer edges, running through two rivet holes, before the remaining material failed in overload, Figure 5. Metallurgical examination of the fracture faces indicated that the nature of the crack was consistent with chloride-driven stress corrosion cracking.

As a result of the accident to G-DNHI, Agusta has issued two SBs, 109-123 and 206-242, whose status they regard as mandatory, titled '*Inspection to grooved clamps P/n 4656AA or P/n 4606AC that attach the engine exhaust ducts*'. These SBs apply to Agusta A109A, A109A11 and A109C helicopters (issued 16 November 2006) and Agusta-Bell AB206A/B helicopters (Issued 18 December 2006). They require that a detailed visual inspection for cracks and corrosion of the clamps after removal, using a 10x magnifying glass, within 50 operating hours of the SB's issue date. After this initial inspection, repetitive inspections are required every 200 hours/annually for the A109 fleet and 100 hours/annually for the AB109 fleet. EASA have issued an Airworthiness Directive which mandates these SBs. This inspection regime is regarded as reducing the probability of an in-flight catastrophic clamp failure to an acceptable level.

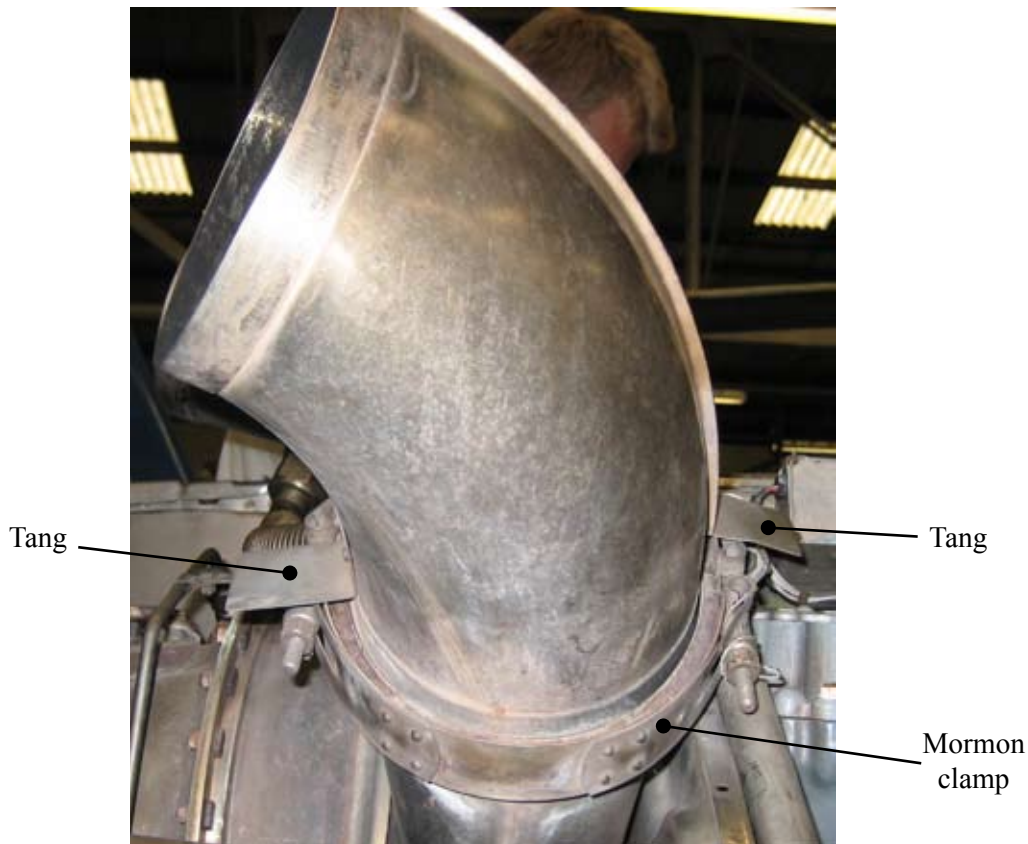
The exhaust duct is a stainless steel ovalated tube curved through 45°, 26 cm in length, and with a lip formed at the engine casing interface end, Figure 4. This lip corresponds to a lip on the engine casing which facilitates the use of a Mormon clamp to join the two. A total of four clamps are used to attach two exhaust ducts to each of the engines.

duct from exiting through the aperture in the engine cowl in the event of a clamp failure, Figure 4. This modification has been applied to all production models of the Agusta 109 helicopter.

Figure 4
Exhaust Duct arrangement

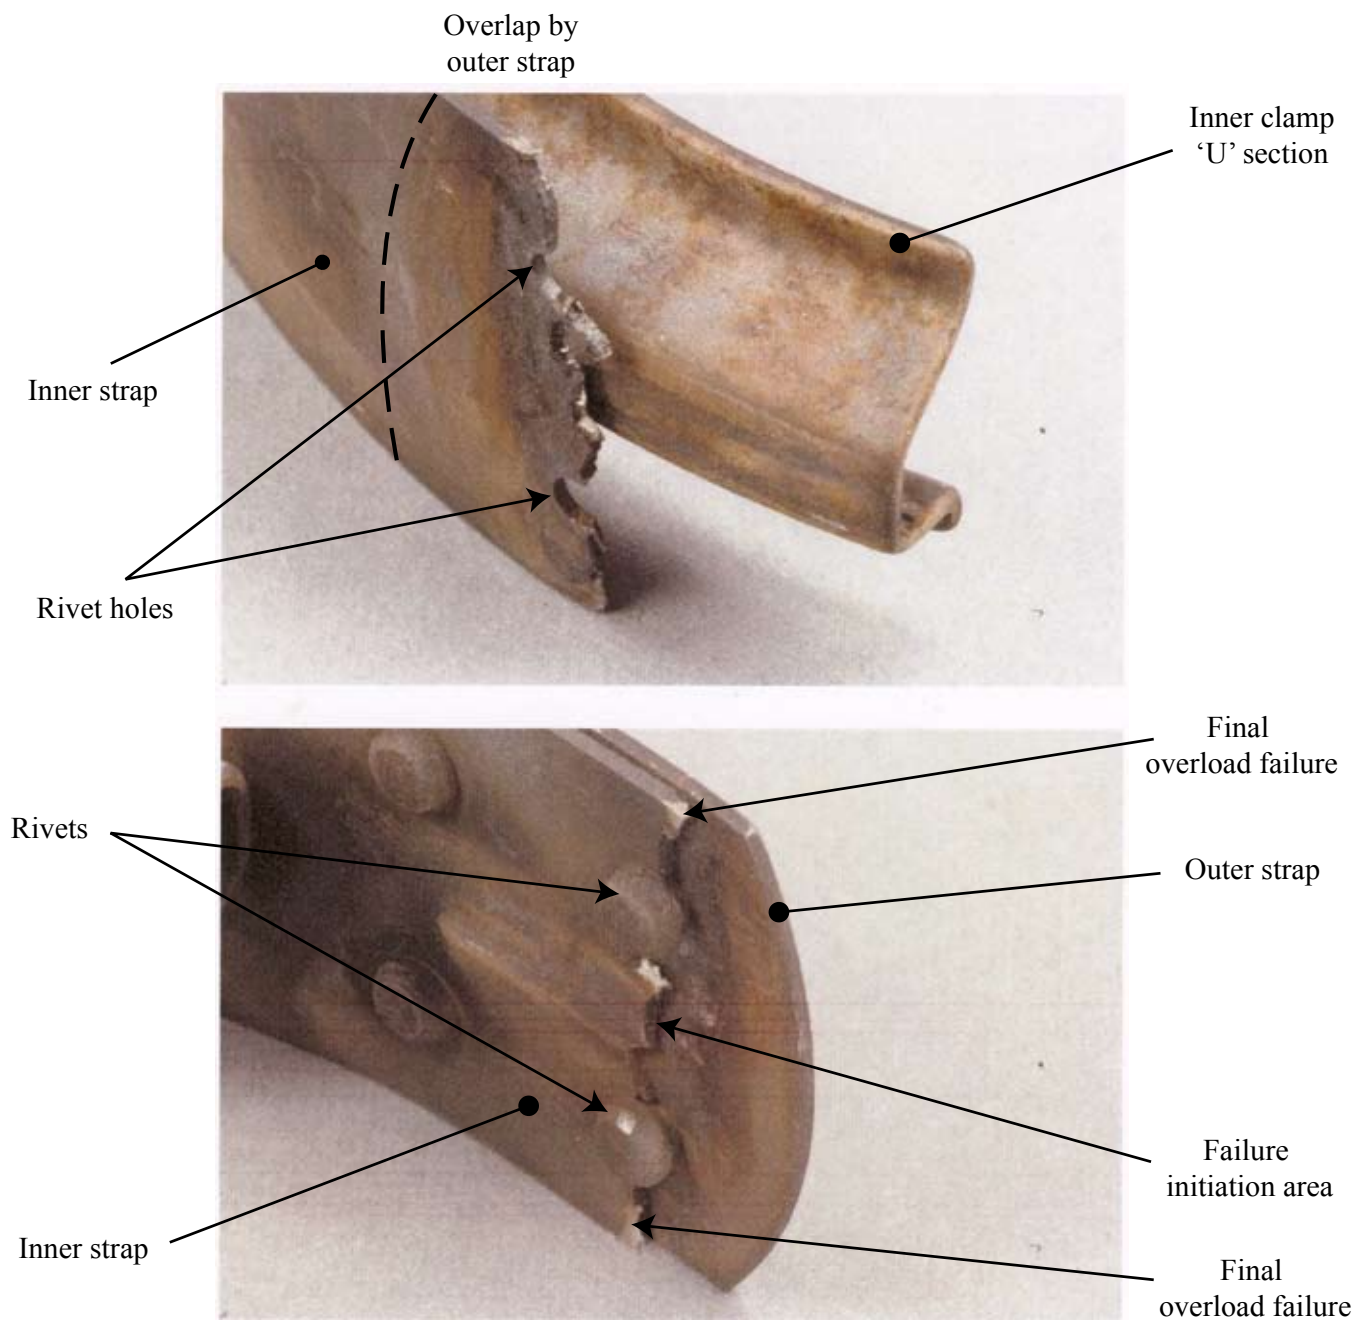
The location of the crack on the strap was effectively hidden by the overlap of its end section. This would not have allowed early detection by visual examination or non-destructive testing by, for example, fluorescent dye-penetrant, unless the clamp had been removed. Another area on the failed clamp associated with the strap overlap was found to have surface-breaking cracks which, on further examination, also exhibited characteristics of stress corrosion cracking.

Figure 5
The two halves of the fracture of the failed clamp

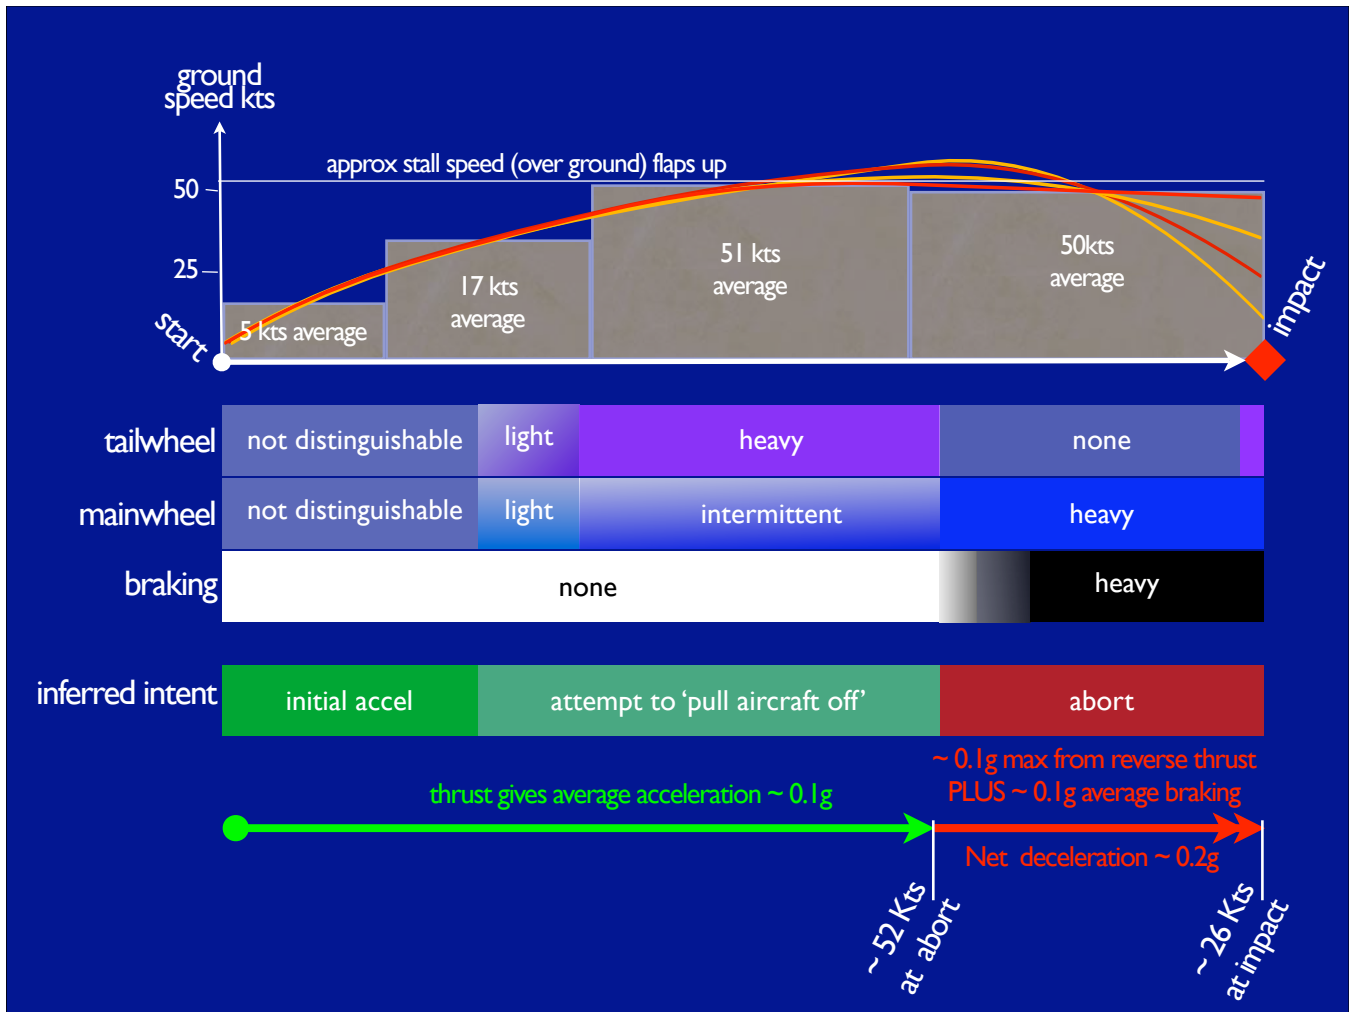
Figure 2 shows a range of speed profiles broadly compatible with the average acceleration segment speeds from the GPS data, giving a range of terminal speeds (at impact with the F100 aircraft). Those profiles having terminated at a high impact speed with the F100 also fit well with the average segment speeds for both acceleration and abort phases. Those profiles giving an impact speed below about 35 kt do not make for a very convincing fit with the final average speed block, suggesting that the maximum speed obtained was more likely to have been 52 - 53 kt than the 60 kt which lower impact speed profile would imply. An abort speed of 52 - 53 kt is also consistent with the tyre track evidence, which suggest that the aircraft was marginally wing-borne at that stage. (No lift off speed is given by the manufacturer for a takeoff without flap, but the flaps-up stall speed of 52 kt would equate to a ground speed, in this case, of the order of 51 kt.) It is also the case that the principal decelerative forces acting on the aircraft comprising the combination of main wheel braking and, if used, reverse thrust, would not have been capable of slowing the aircraft significantly, and certainly not below 25 kt at impact.

Possible speed profiles

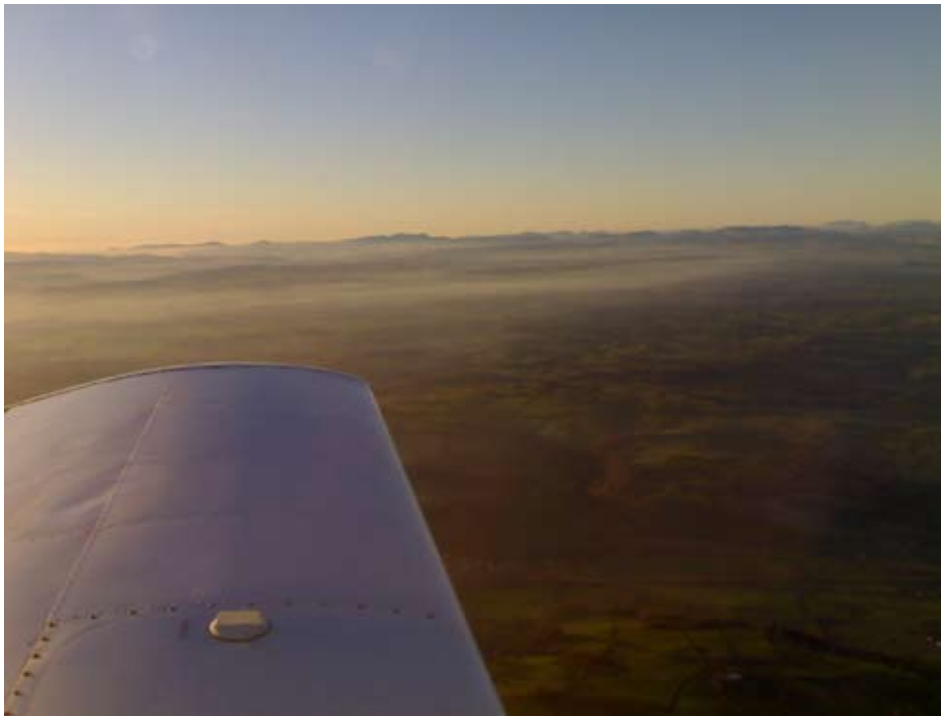
Figure 1

A photograph recovered from the pilot's mobile telephone after the accident, showed the view from the aircraft in flight, at 1620 hrs, Figure 1. This revealed the conditions to be VMC, and it was assessed to have been taken in the area of Welshpool Airfield.

Photograph taken from G-BBBK in the Welshpool area at 1620 hrs on 3 February 2007, some 52 minutes before the accident

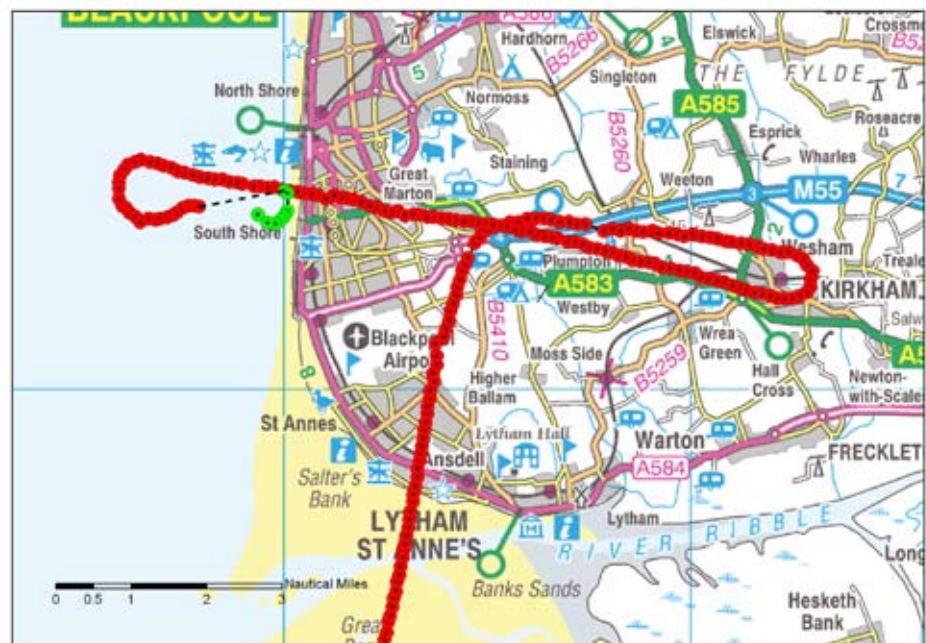
Figure 2

Radar track of G-BBBK positioning to land at Blackpool Airport

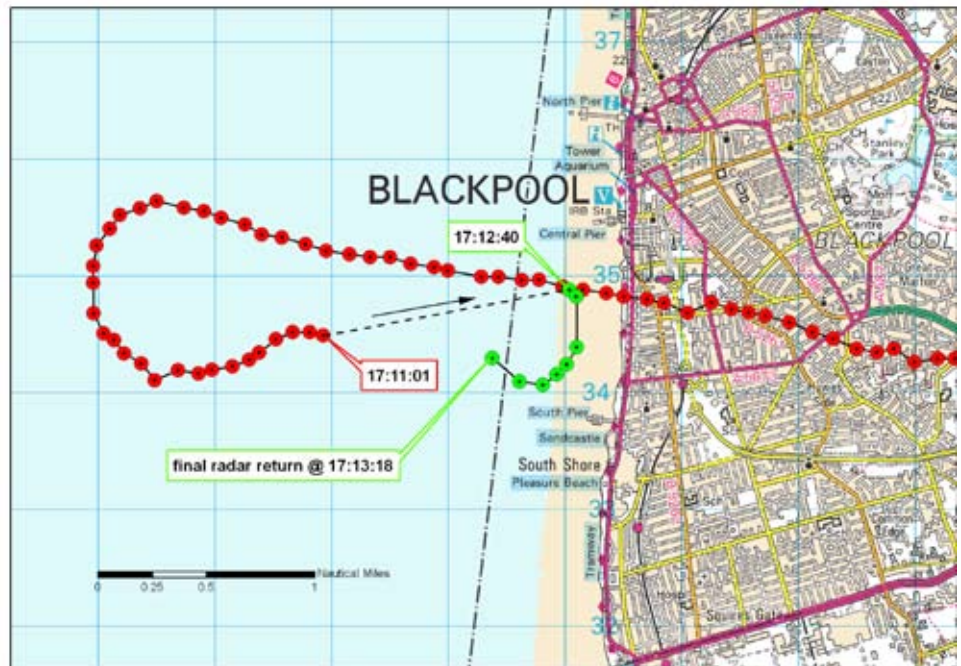
Figure 3

Detail of last section of Radar track of G-BBBK.
Lack of data between 1711:01 hrs and 1712:40 hrs suggests that the aircraft was below 100 ft amsl between these times
