SS Richard Montgomery Survey Report 2009

Maritime & Coastguard Agency
2010

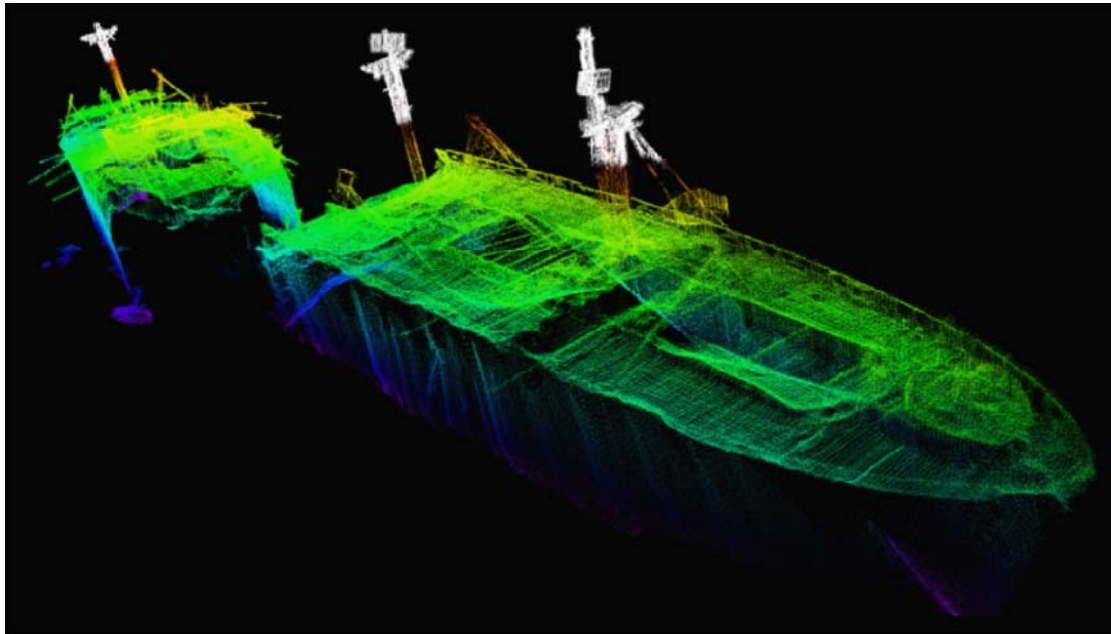
Figure 1 Point Cloud visualised in Fledermaus showing bathymetry and laser data

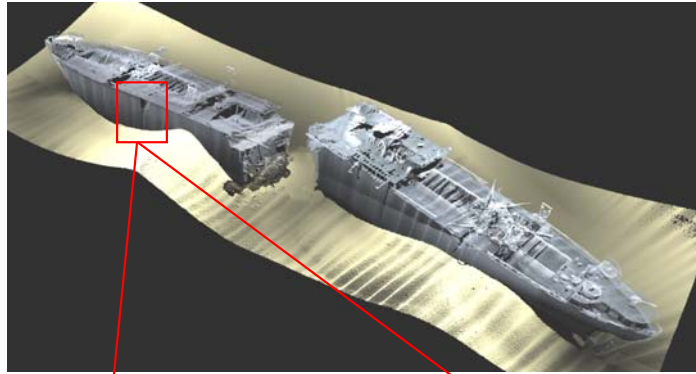
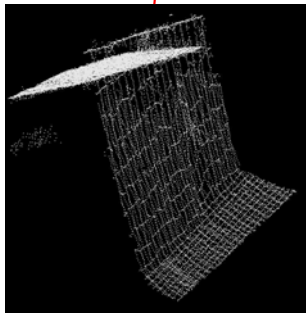
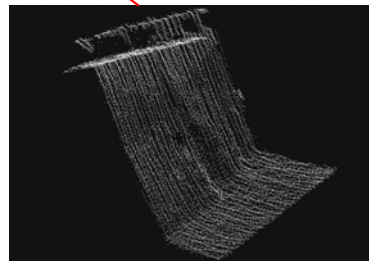
4.3 Previous sonar surveys have noted that both sections of hull are hogged, and survey data from 2009 suggests a slight increase in the level of hogging. This is difficult to measure, but is evidenced through a visual inspection of survey data from the area around Hold 2, which appears to show slightly more pronounced bulging, and a further drop in the portside deck plating at Hatch 2.

4.4 This hogging was noted when the vessel first went aground in 1944 and the distortion, particularly around the area of Hold 2, has been apparent since the first multibeam sonar survey of the wreck. The apparent gradual increase in bulging is probably the result of the weight of the cargo in an area where the structure is likely to be weakened due to the split in the hull plating and may also be linked to the build up of sediment around the wreck. Previous surveys have suggested that this is likely to become more pronounced as the steel corrodes.

Figure 2 More pronounced buckling of hull plating in 2008 data

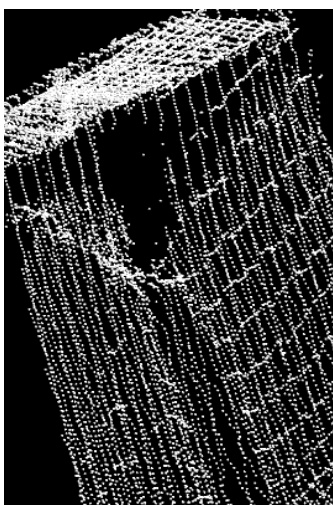
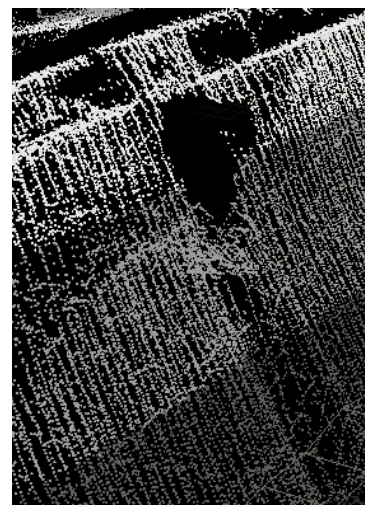
Figure 3 Crack at Hold 2

4.5 The aperture and crack on the port side at Hold 2 has been noted in surveys since at least the early 1970s. The 2009 survey data suggests that the aperture may have increased in width at its upper part by approximately 50cm since 2008.

4.6 Data from the 2009 survey put the current measurements of this aperture on the port side of Hold 2 at 1.95m wide and extending 3m down the sheer plate from deck level. The protruding section at the base of this aperture, which is attached to a section of hull plating that has fallen in, appears to remain unchanged from 2008.

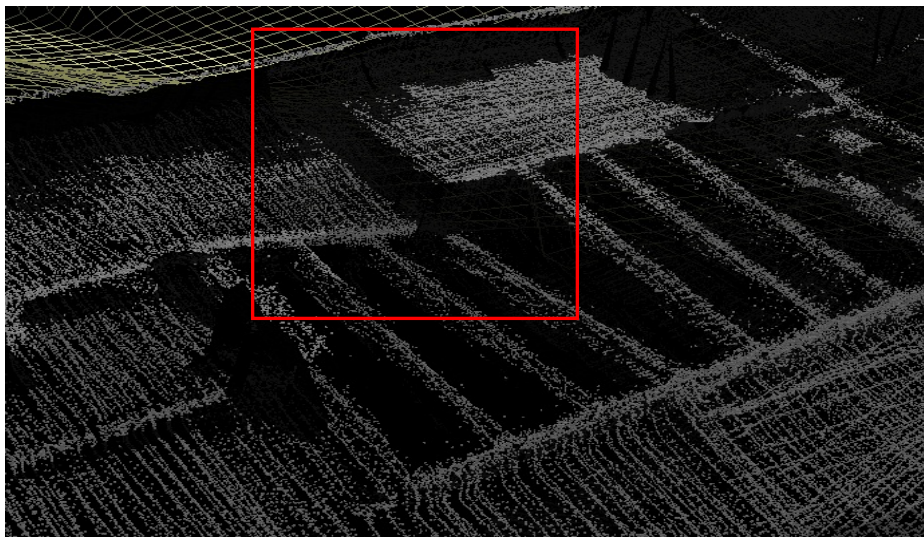
4.7 Associated to this aperture on the port side of Hold 2 is a section of collapsed deck plating directly above it. This deck plating dropped from 35cm in 2006 to 50cm in 2008 and had dropped a further 60cm to 1.10m in 2009. The starboard side of Hold 2 has also demonstrated some level of deterioration.

Figure 4 2009 survey data showing deck plating, port side Hold 2

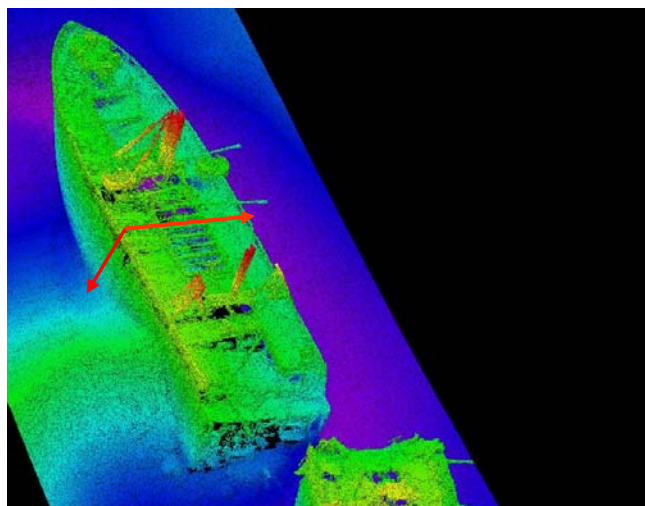
4.8 Assessment of the 2009 survey data has included measurements fore and aft of the crack on the port side in order to determine whether the hull forward of the crack is at the same orientation to the hull aft of the crack. These measurements show that there is a 1.6° difference in hull orientation fore and aft of the crack.

Figure 5 Area of structural weakness at Hold 2

4.9 Historical research undertaken by Wessex Archaeology Ltd shows that Liberty ships were plagued by structural failures and, in 1946, the US Maritime Commission reported that one in five had suffered structural failure of some sort. Such structural failures included the splitting of hull plates, cracking in bulwarks that developed into cracks down the side of the hull, and a particular weakness forward of the bridge at Hold 3. The SS Richard Montgomery is showing evidence of all of these, with the weakness forward of the bridge being where the ship broke in two.

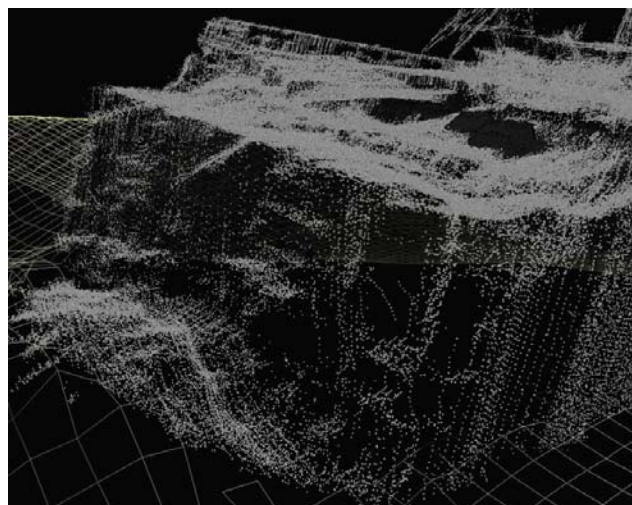
4.11 There are two apertures in the bulkhead, neither of which show any signs of change or deterioration since the 2008 survey. The 2009 survey did not note any other changes or deterioration in this bulkhead or in the debris field on the seabed below it and between the two sections of the wreck.

Figure 6 2009 survey data of bulkhead aft of Hold 3

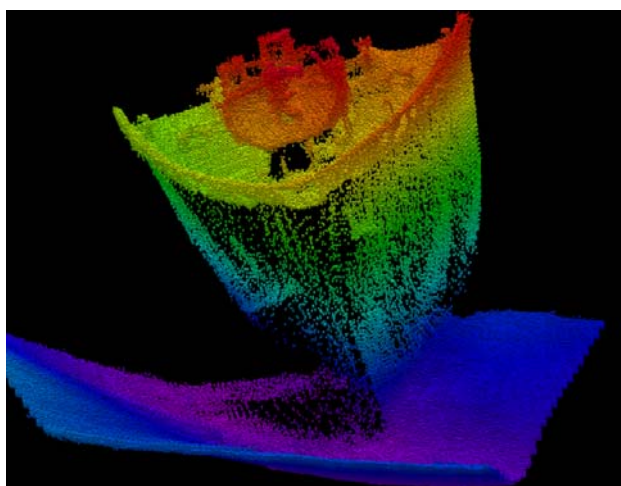
5.4 As in 2006 and 2008, the survey data from 2009 suggests that the hull is fully supported by seabed sediment at both bow and stern. In fact, it is thought that scouring around the wreck has gradually allowed the structure to settle on a London Clay bedrock and there is probably no significant amount of sediment under the wreck.

Figure 7 Sediment at bow, 2009

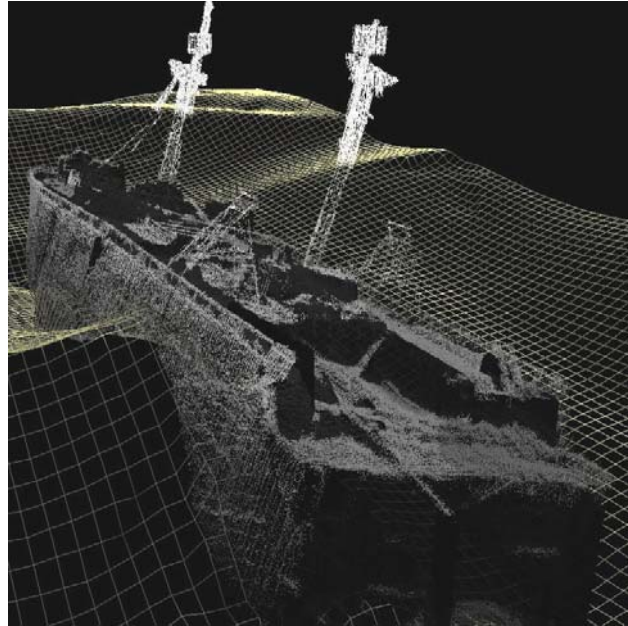
Figure 8 Bow section masts showing multibeam & laser data (2009)

7.2 The multibeam sonar and laser scanning data were merged to produce measurable details of the wreck in its entirety, both above and below water. Both datasets can be directly compared with survey results from 2008. These comparisons did not identify any measurable changes since 2008 and show that all three masts are still approximately vertical in relation to the main hull section.

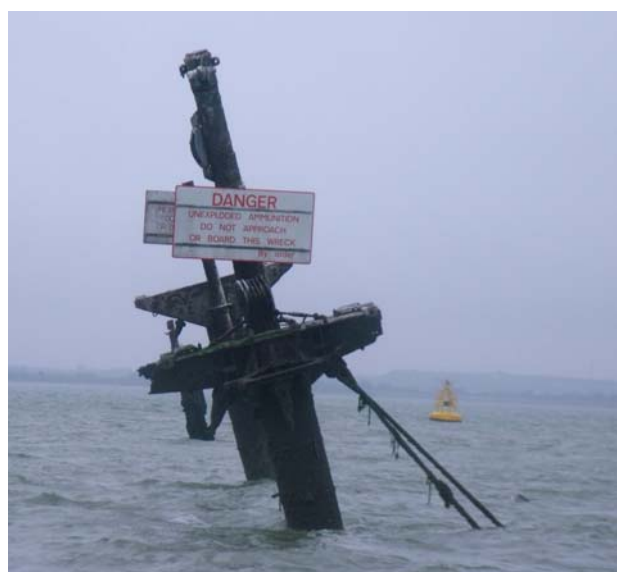
7.4 Photographic data gathered in 2009 did not identify any noticeable changes since 2008. However, all three masts are extensively covered in marine growth making it difficult to ascertain the condition of the underlying metal structure.

Figure 9 Photograph taken during 2009 survey

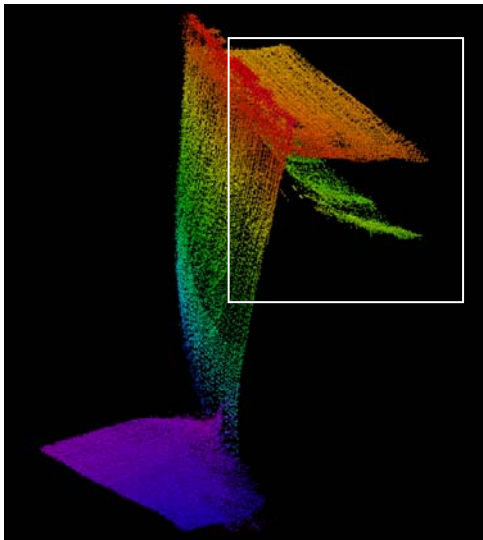
10.2 Given that the bow section of the wreck remains largely intact and continues to provide containment for the cargo, previous diver and sonar surveys have been able to provide only a small amount of measurable data for the remaining cargo. This includes some evidence of the contents of Holds 1, 2 and 3. The 2009 survey did not note any changes to these.

Figure 10 Hold 1 'tween deck cargo visible Figure 11 Debris mound below Hold 3

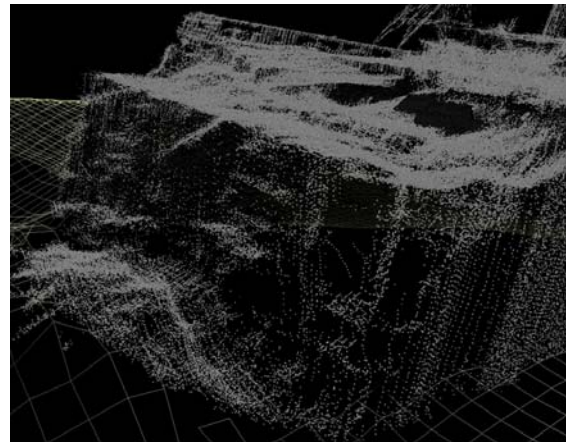
10.3 The debris mound between the two sections of the wreck was also surveyed. A comparison between the multibeam surveys undertaken in previous years and the 2009 survey results indicate that no changes have taken place in the size and shape of this debris and there is no evidence of any cargo material having spilt from apertures in the bulkhead or elsewhere on the wreck.
