CONTENTS

COMMERCIAL AIR TRANSPORT

(ALL TIMES IN THIS BULLETIN ARE UTC)

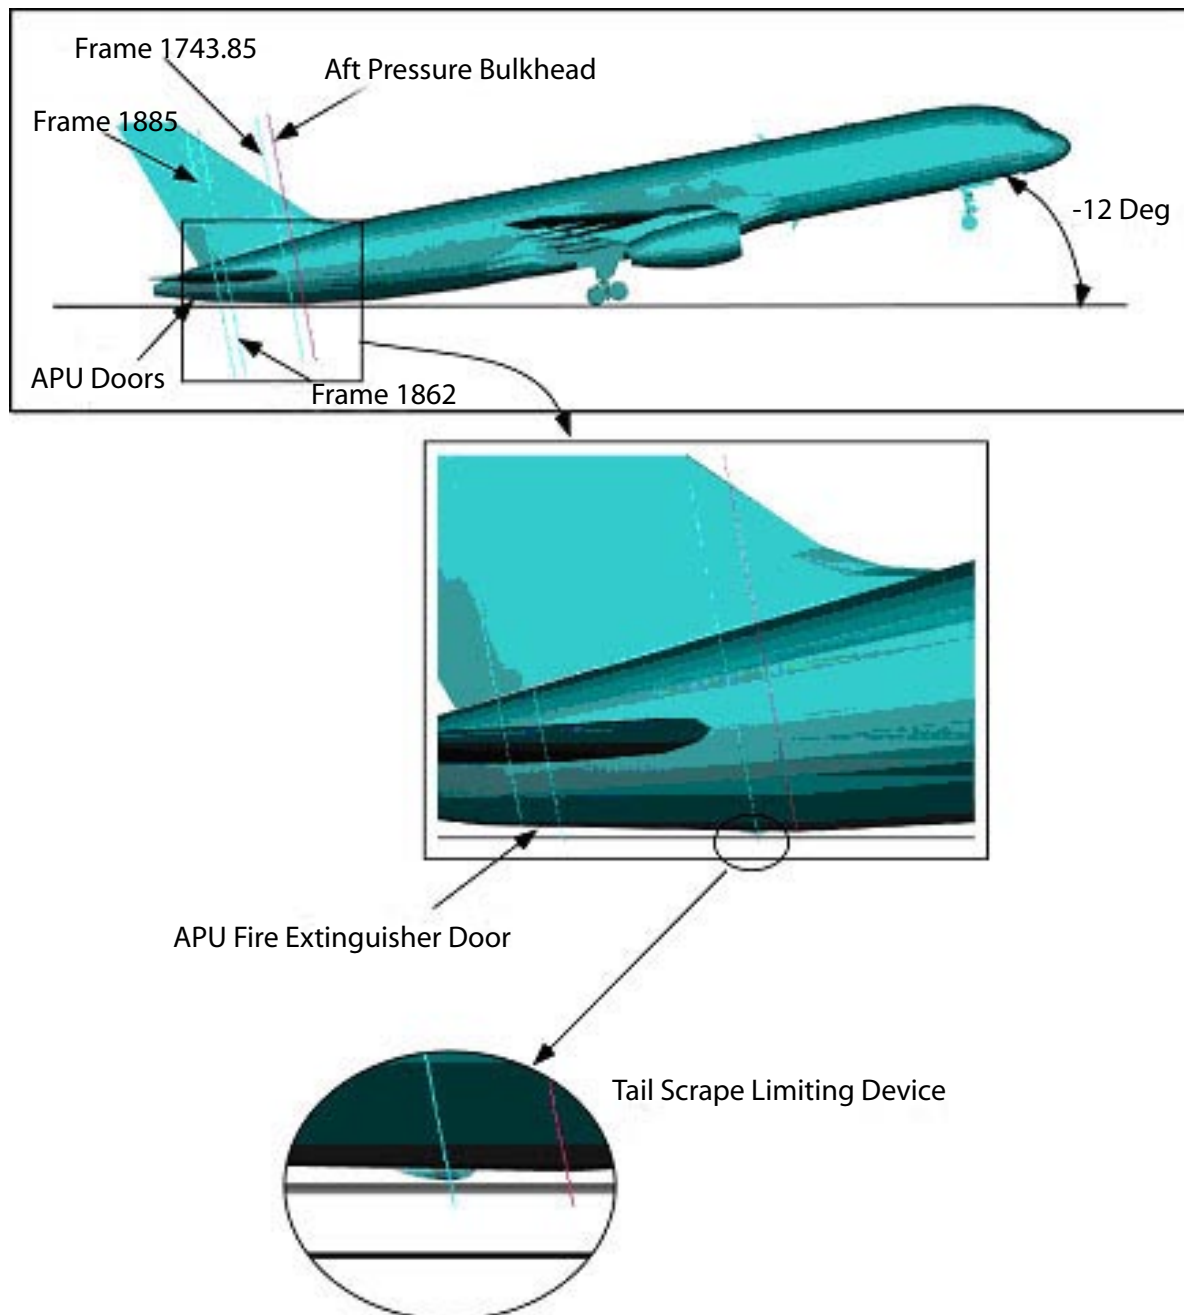
Figure 1

The TSLD had extensive contact damage, with the inverted section worn down so that it was flush with its fairing. Around the device, the airframe skin had buckled and rivets, attached to the frame, had pulled away from the external skin. Internally, frame 1743.85 had been

Moving aft from the TSLD, the next contact point was at the APU fire extinguisher access door located between frames 1862 and 1885. Light scrapes were evident 150 mm aft of frame 1862, with these worsening toward the rear of the aircraft. 420 mm aft of the frame, the paint on the access door was worn away in line with the centreline of the aircraft and over an area measuring 160 mm wide and 90 mm in length. The APU access doors were mounted just aft of frame 1885, with a deflector strip mounted on the frame. The centre of the deflector strip was totally worn away, with scuffing of the airframe skin underneath over a width of about 100 mm either side of the aircraft centre line. The scrape damage continued onto the two APU access doors up to a point 470 mm aft of frame 1885. The APU doors contained several proud roundhead rivets and those along either side of the centre line had been completely worn down; coupled with additional wear of the door down to its metal skin. This damage was worse on the right hand door, with the damage at its widest point some 65 mm to the right of the centre line. The left door also suffered similar damage but this only extended 20 mm to the left of the centreline.

The airframe damage was limited to the un-pressurised area of the aircraft. The aft pressure bulkhead remained undamaged, which was mainly as a result of the TSLD. The aircraft was later flown to its home base for repair. The frame and the skin damage repairs at frame 1885 were carried out in accordance with prescribed manufacturer structural repair manual instructions and a bespoke doubler repair was carried out to the skin surrounding the TSLD. The APU fire extinguisher doors, the two APU access doors and the deflector strip were all replaced with new parts. (See Figure 1)

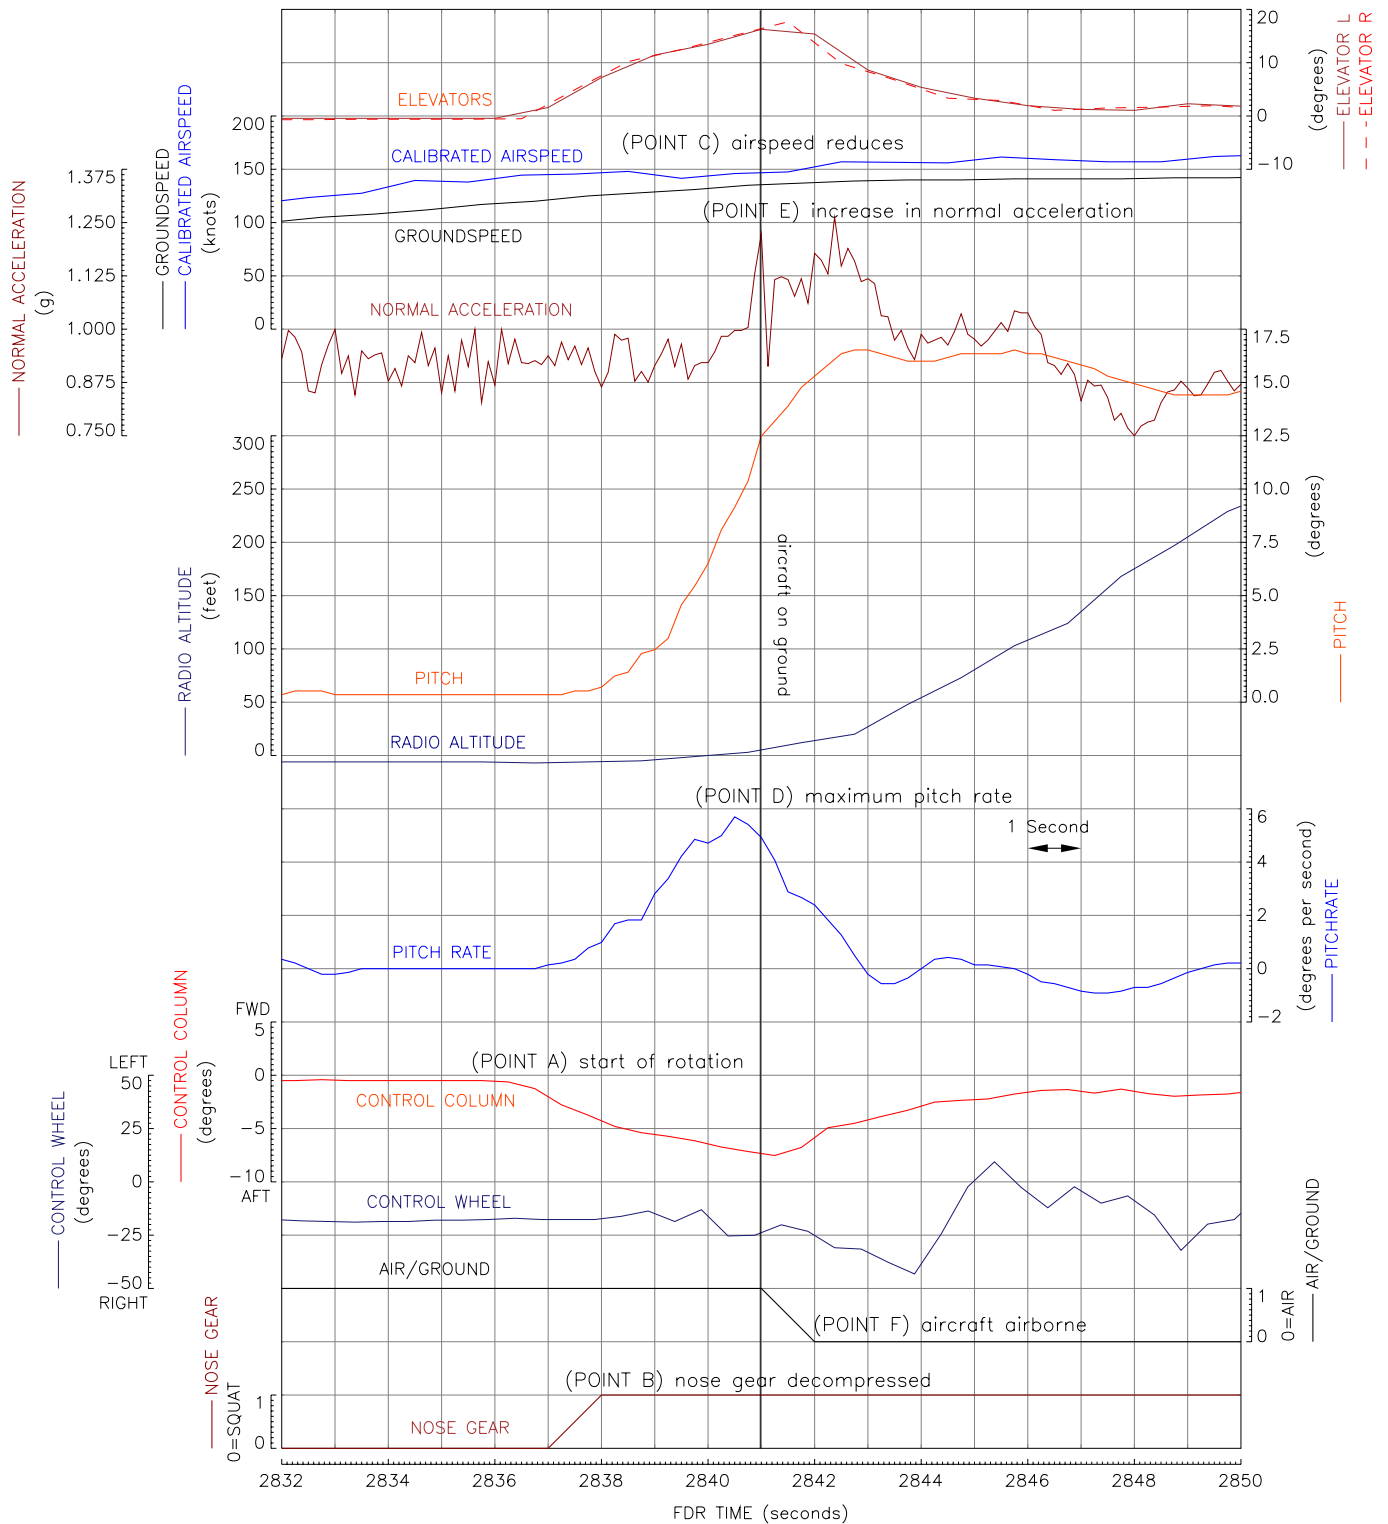
Figure 2
Salient FDR Parameters

Figure 2 details the salient parameters during the takeoff phase. At 1647:18 hrs, at an airspeed of about 144 kt and a groundspeed of about 120 kt, the control column started to move aft (Figure 2, Point A) and about two seconds later the nose squat switch indicated that the nose gear was no longer compressed (Figure 2, Point B).

About one second later the airspeed reduced to about 142 kt (Figure 2, Point C), however the groundspeed continued to increase.

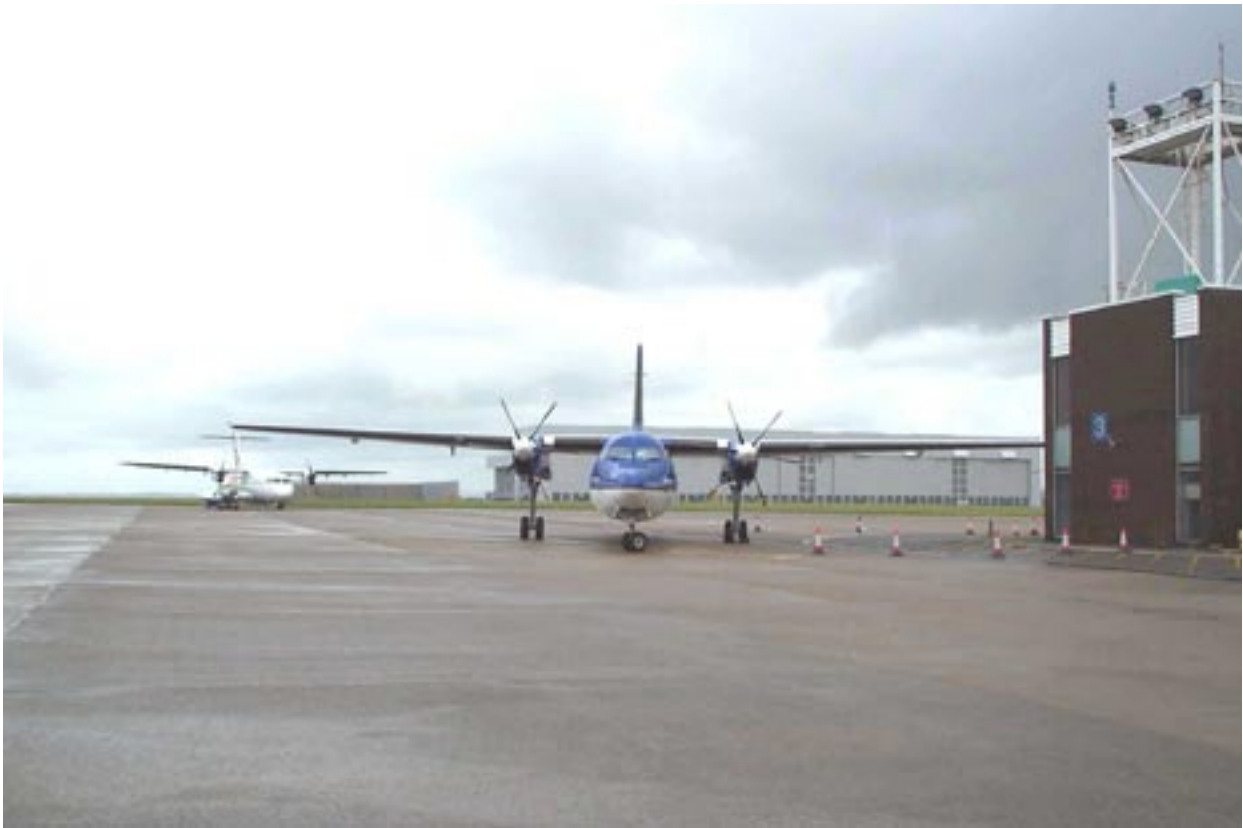
Figure 1

As the marshaller brought the aircraft towards the West Pier, in an easterly direction, he signalled to the aircraft to turn to the right in order to manoeuvre the aircraft onto the stand's yellow line. The aircraft then continued forward before starting the right turn and its right wing tip then hit the end of the West Pier (see Figure 1).

Aircraft position immediately after impact

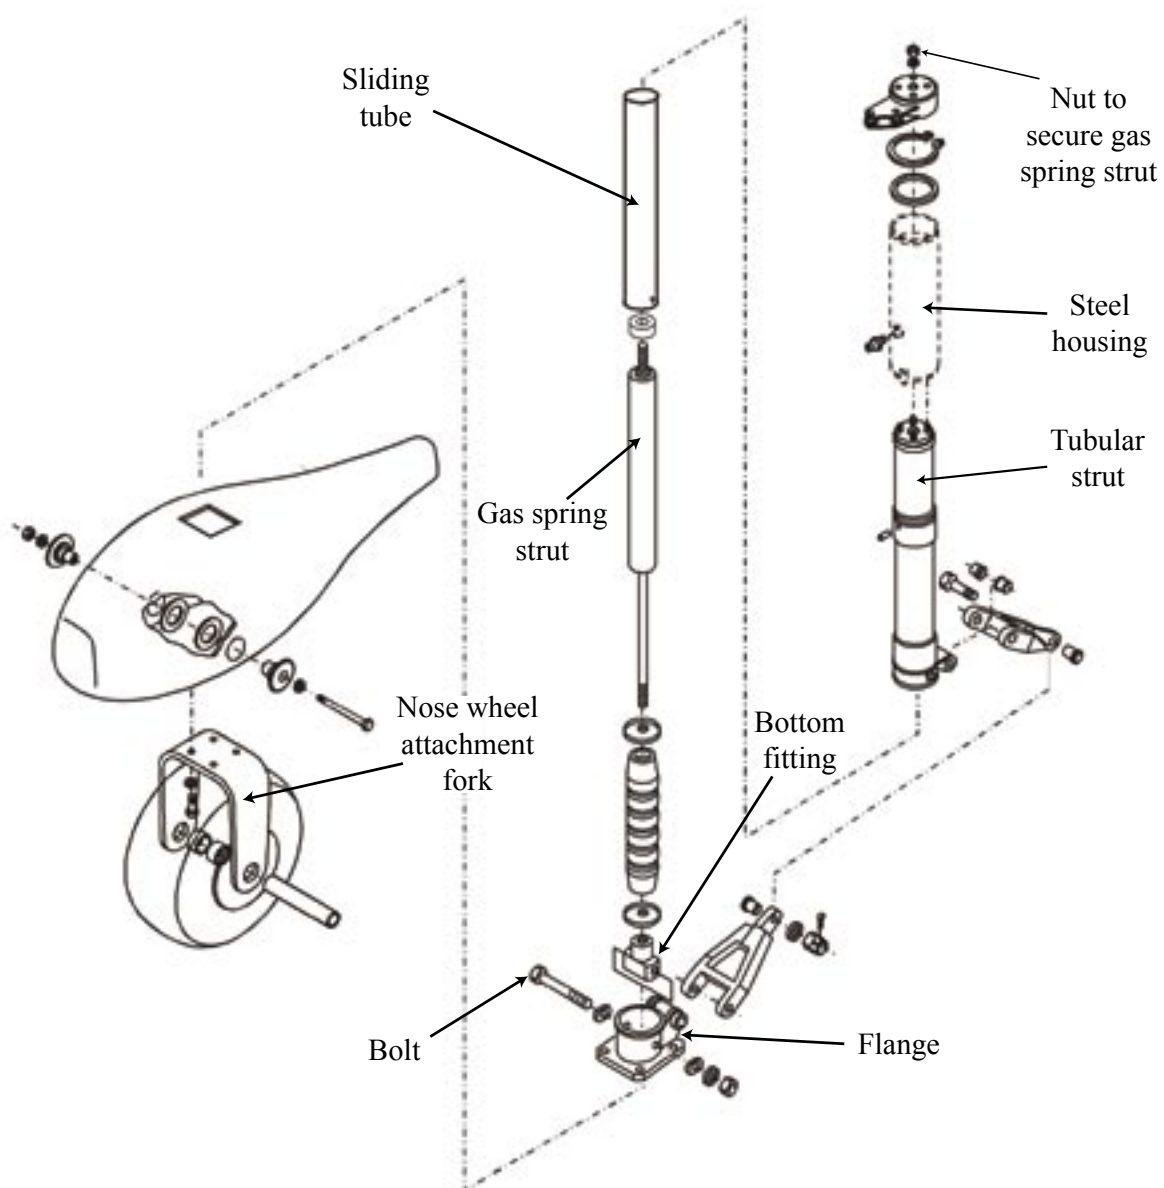
Figure 1

nose landing gear sliding tube and gas spring strut bottom fitting to the flange had been incorrectly fitted such that the bolt only secured the bottom fitting to the flange. Consequently, when the aircraft landed, the weight on the nose wheel was sufficient to cause the failure of the bottom of the gas spring strut which resulted in the collapse of the nose wheel. See Figure 2.

Nose landing leg assembly

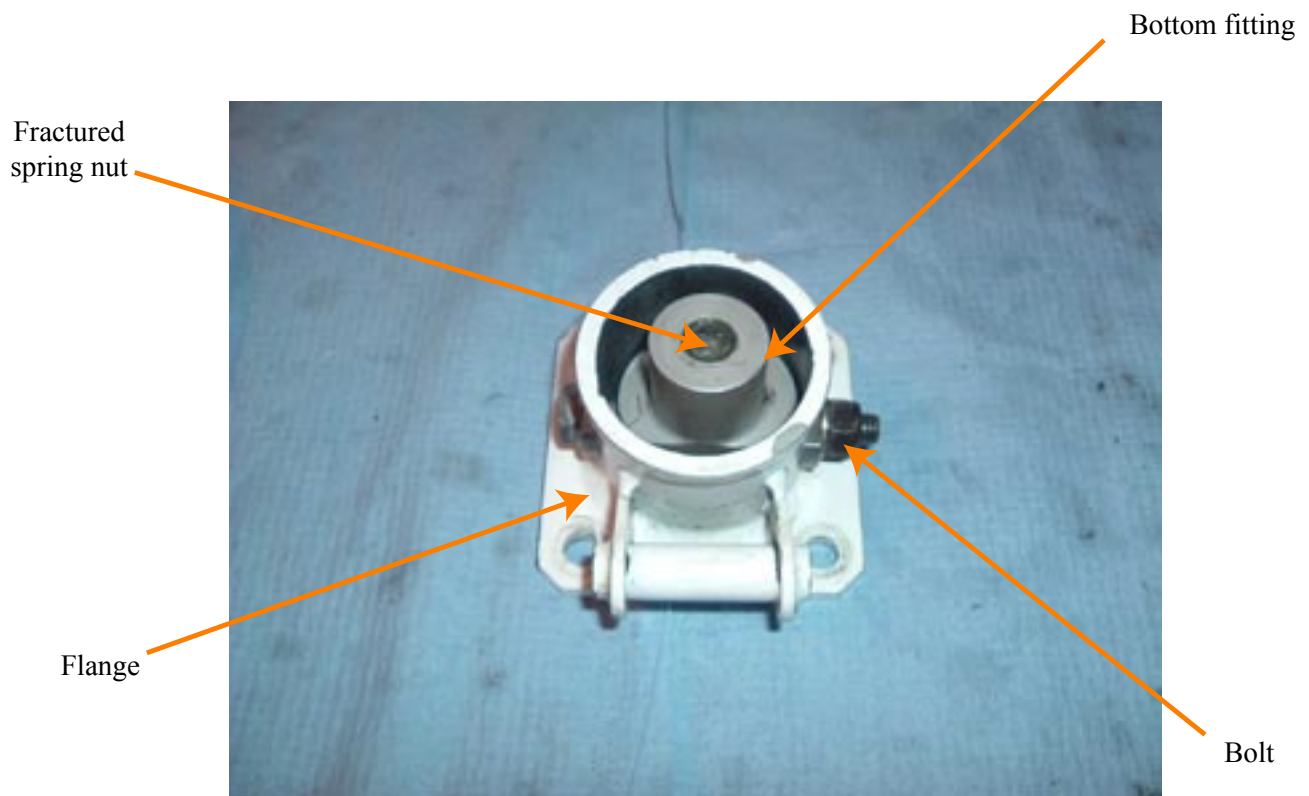
Figure 2

Failure of gas spring strut

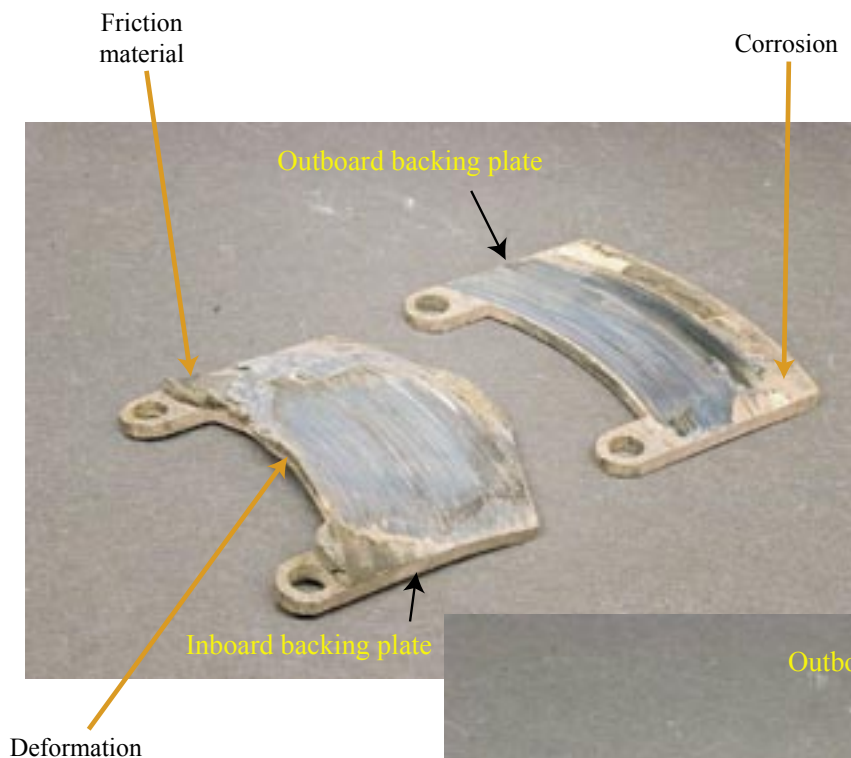
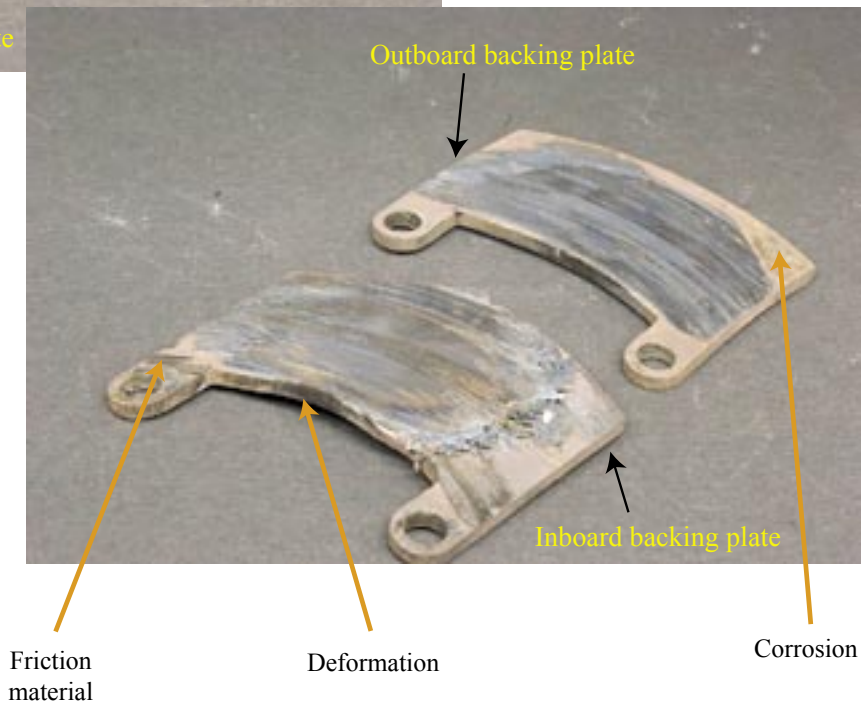
'a thin surface layer approximately 40 μm thick was present, which energy dispersive x-ray (EDX) analysis showed to consist of iron and oxygen. It was also observed that the surface layer showed evidence of spalling.'

Figure 2
Brake pads (left)

Figure 3
Brake pads (right)

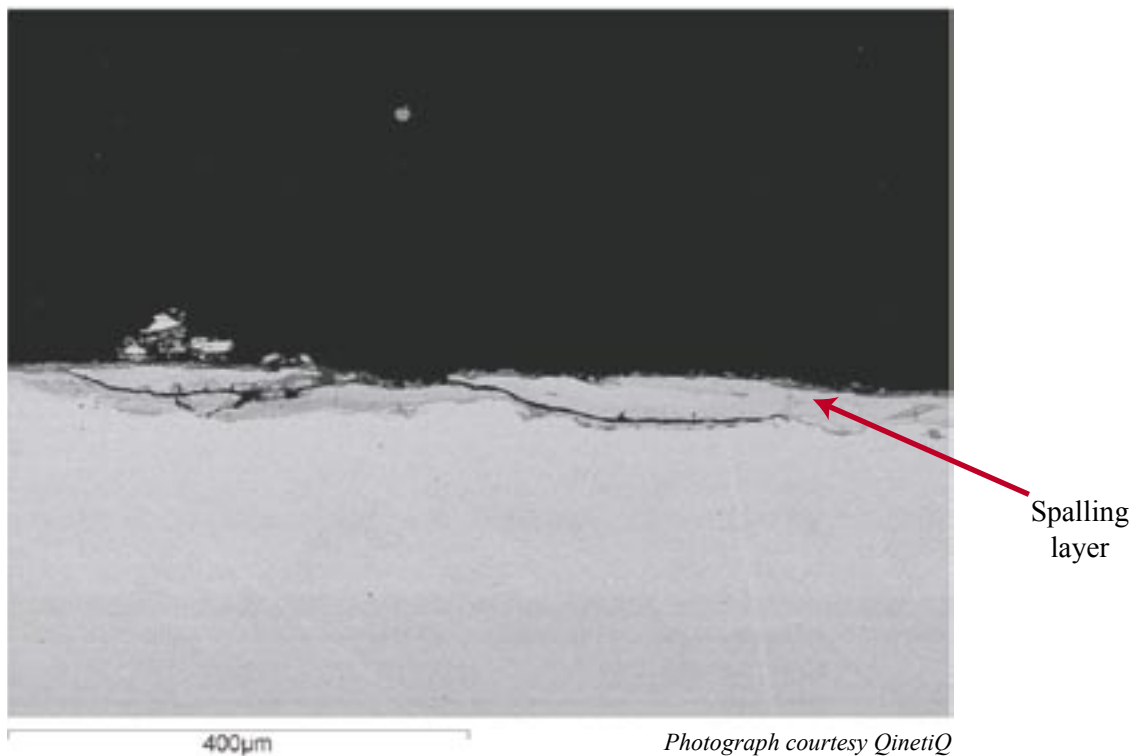
**Figure 4**

Spalling describes the flaking of a surface where cracks run parallel to the surface, in this case due to the oxide layer (see Figure 4). They found

‘showed evidence of cracking within the friction material and surface oxidation on the surface of the backing plate.’

Cross Section through a smooth area of the right inner backing plate

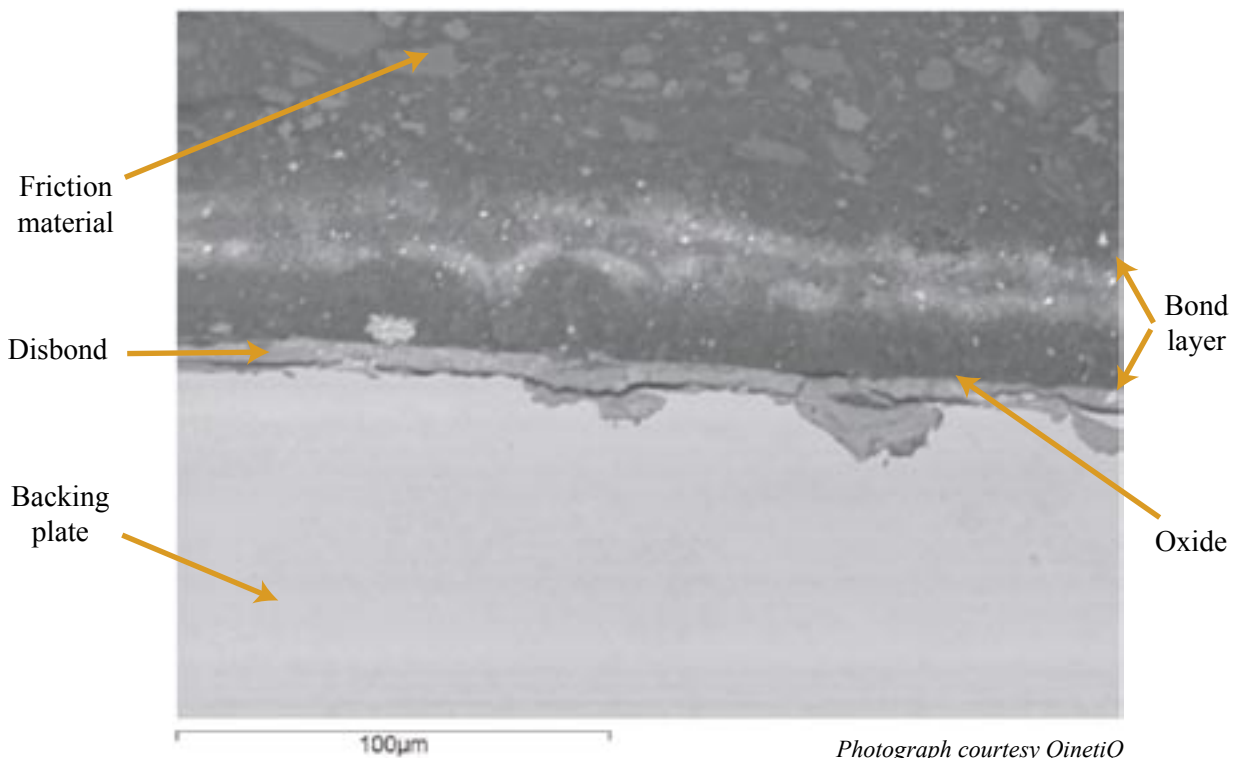
Figure 5

in colour, which suggests thermal oxidation, as opposed to atmospheric corrosion. The oxidation is likely to have resulted from overheating of the pads during braking as the backing material was contacting the discs, overheating could also account for the distortion that was observed in two of the pads. Where small sections of friction material remained, examination showed that it was bonded to an oxide layer that was present on the surface of the backing plate. In some areas the oxide layer had separated from the backing plate, resulting in the friction material no longer being bonded.

The cause of the brake pad failure can not be positively identified due to the lack of evidence remaining. The small sections of friction pad that did remain showed evidence of the friction
