MAFF Buffer Depot, Rhydymwyn, Mold

Underground Caverns at Rhydymwyn, Mold

Stability Inspection and Remedial Works

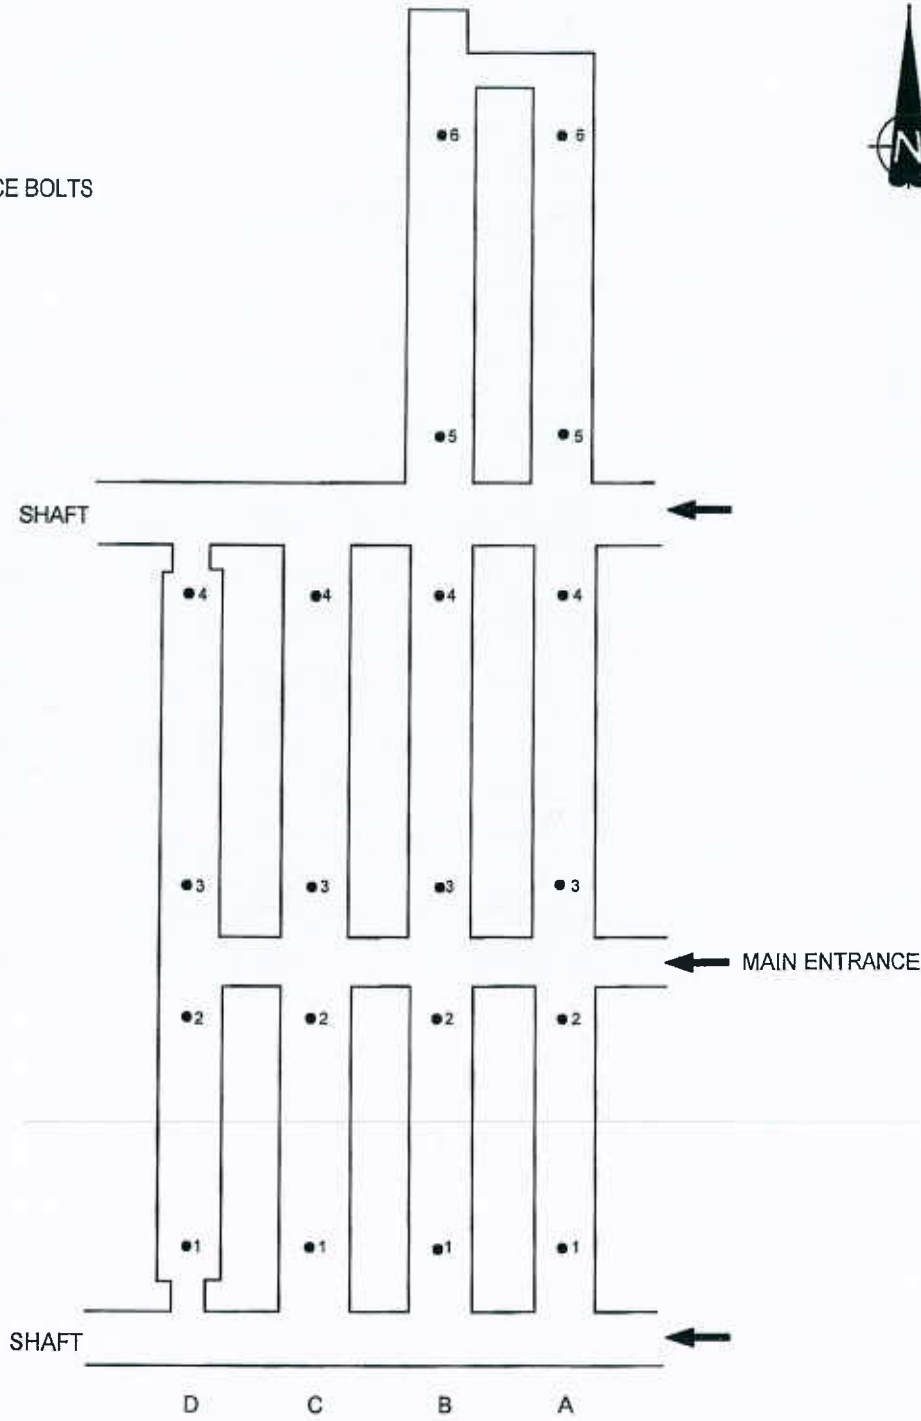
CLIENT CITEX	DRG No NL00910/01	SCALE Not to scale	DATE April 2002
PROJECT UNDERGROUND CAVERNS AT RHYDYMWYN, MOLD	DRAWN BY JD	CHECKED BY RNB	APPROVED BY PG
DRAWING TITLE PLAN OF CAVERNS FOR REFERENCE

- 2.1 In April 2001 eight tell tale monitoring stations were installed on the concrete buttressing at D1 (TT1 to TT3 and TT5 to TT9), one was installed above the entrance to the southern shaft tunnel in Cavern D opposite the concrete buttress (TT4) and one installed at position D2 (TT10). TT6 was found to have been damaged in 2007 and refitted. It was set to the reading taken in 2006. Additional tell tales have been installed in 2007 across a crack on the Cavern wall above the entrance to the southern shaft (TT11) and across a fine crack identified on the concrete floor parallel to the south western trench of Cavern C (TT12). The locations of D1 and D2 are shown on Drawing No NL00910/01.
