PART 1.4 – ANALYSIS OF FACTORS & FINDINGS

1.4.1 The XZ936 Service Inquiry (SI) was convened on 10 Jun 14 to investigate the circumstances surrounding the incident involving a QinetiQ owned Gazelle HT3 at MoD Boscombe Down and to make recommendations in order to enhance Defence air safety. Whilst the main focus for the Panel centred on the Human Factors (HF) aspects of the incident, the Panel's Terms of Reference (ToRs) directed a broader investigation to include organisational influences.

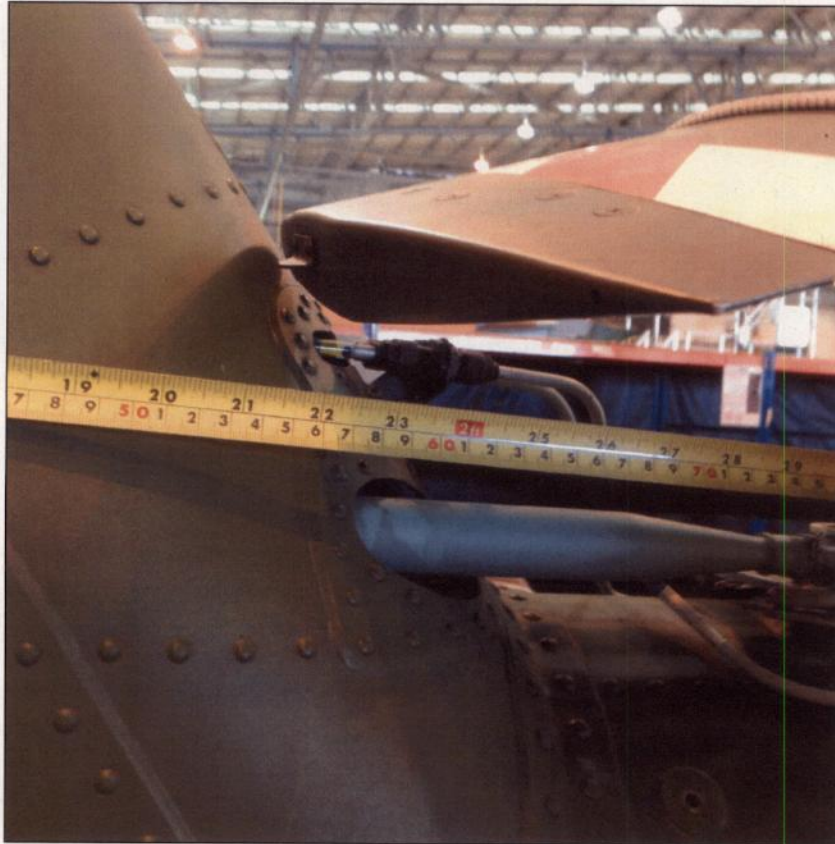
Fig 3 – MRB ability to strike tail

1.4.17 **Main Rotor Head (MRH) design.** The Gazelle has an articulated rotor head with three blades that are marked individually Red, Yellow and Blue for identification during maintenance activities. The blades are relatively flexible in the flapping plane and it is a consequence of the Gazelle's design that it is possible for blades to interact with the tail section of the aircraft in certain dynamic conditions (Fig 3). Examples include:

The Panel found a further 7 recorded instances of the tail section being struck by MRBs during Gazelle EOLs since 1978. The Panel consider the design of the Gazelle, which allows possible interaction between the MRBs and tail, to be a **Contributory Factor**.

1.4.25 **Recommendation: Joint Helicopter Command and Air Warfare Centre DDH Gazelle should re-emphasise to all Gazelle crews the potential for Main Rotor Blade interaction with the tail and the importance of the related advice on the conduct of EOLs found in the Gazelle Aircrew Manual.**

1.4.26 **Recommendation: OC Handling Squadron should incorporate an explicit warning in the Gazelle Aircrew Manual that combinations of low Nr, low collective pitch and aft cyclic must be avoided as they present a high risk of a Main Rotor Blade strike on the tail.**

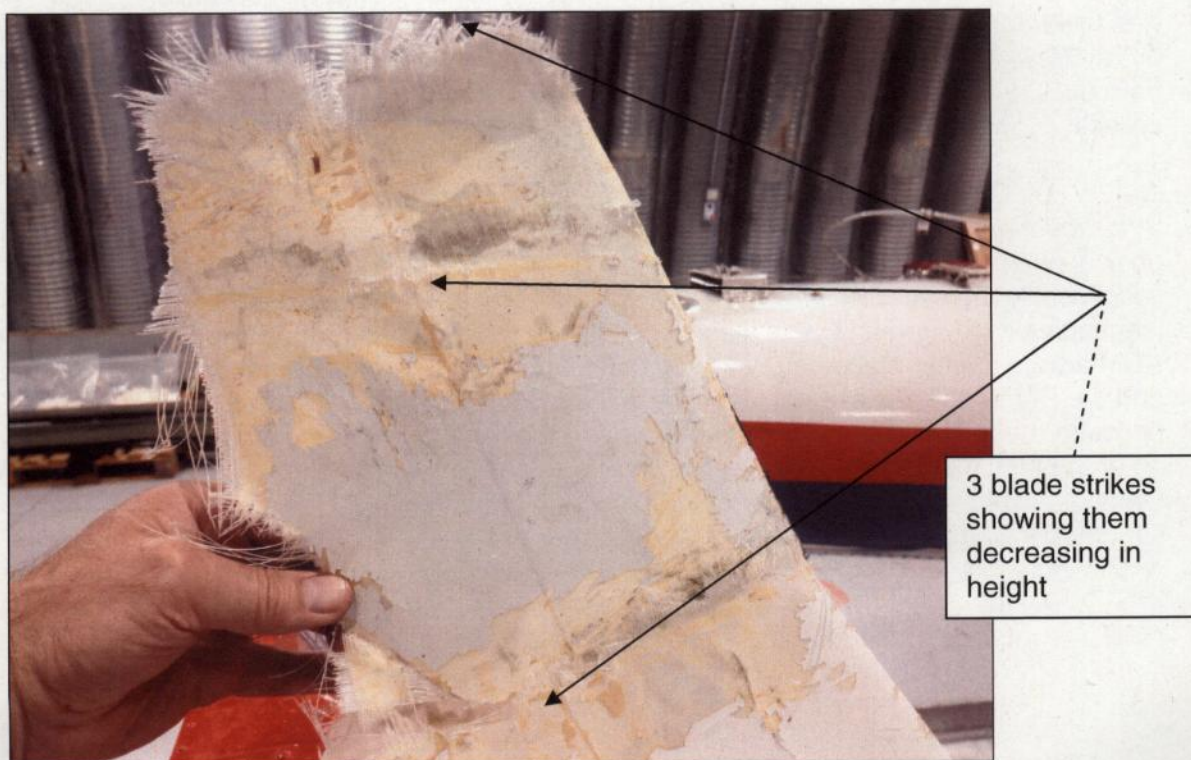
Fig 4 - Blade interaction with Lateral Stabilizer

stabilizer was found in several pieces that, when reconstructed, showed multiple marks suggesting progressively lower blade strikes (Fig 4). The lateral stabilizers sit higher than the main section of the tail boom and could therefore be struck in isolation by blades that do not fly low enough to strike the main tail section. These are a comparatively soft part of the aircraft structure that, whilst likely to make a sound when struck, are unlikely to significantly damage a blade. As the blades progressed lower, they were more likely to come into contact with rigid parts of the aircraft's structure such as the Tail Rotor Drive Shaft. On inspection of the MRBs, it was found that two of the blades had suffered only superficial damage with some paint scuffing and impact marks on the blade tips whilst the Red MRB had sustained far more significant damage. The two rigid hydraulic lines that run the length of the top surface of the Gazelle tail, one pressure and one return, were completely severed by the blade strikes during the incident sequence. The tail rotor control cables were also severed meaning no physical control linkage remained between the fenestron and the pedals.

1.4.20 **Blade impact conclusion.** The Panel concluded that the Red MRB was the first to strike the tail followed by the other two blades. The Red MRB then struck the tail again sustaining damage which caused a change from its demanded flight path. This led to the blade striking the tail for the third and final time, lower, severing it from the fuselage.

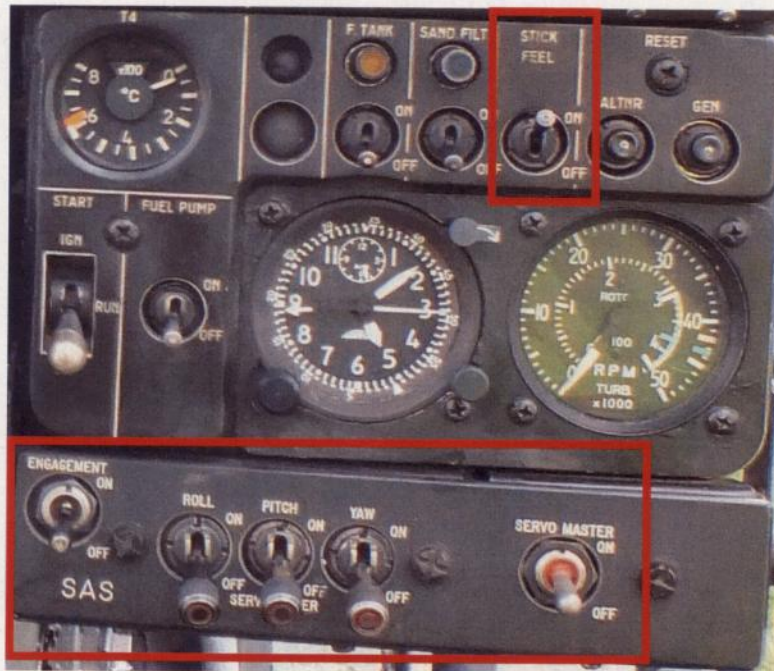
Fig 5 - Position of SAS and Stick Feel switches post-landing (XZ936)

1.4.28 **Trim system.** The Gazelle HT3 has a 'stick feel' that provides a spring force about a neutral datum that can itself be moved by operating the 'trim release' button on the cyclic. 'Stick Feel' was found selected to the 'on' position after the incident (Fig 5). Unlike the 'beeper trim' systems found on other aircraft, the system cannot be motored to a new trim position. As a result it does not have the ability to 'run away' so the Panel discounted trim runaway as a factor. When the cyclic is trimmed to a position, deviations from this position create a force towards the trimmed position but this force is easily overcome by a pilot. The Panel considered whether the crew had operated the trim system during the landing sequence, inadvertently trimming the cyclic to the fully aft position contributing to disorientation with respect to the cyclic position. Whilst the possibility of this contribution could not be completely discounted, the crew had stated that the aircraft was trimmed for the final time at 65 kts in the descent and the Panel could find no evidence to suggest otherwise.

1.4.29 **Stability Augmentation System (SAS).** The HT3 is fitted with a SAS that when selected 'on' works via the control runs to smooth oscillations in pitch, roll and yaw that are not induced by the pilot. During an actual EOL the SAS would drop out as it is fed by the Alternating Current (AC) electrical system that is engine driven. As such the ACM mandates that practice EOLs should be flown with the SAS 'off'. The SAS was found selected to the 'off' position after the incident (Fig 5). Additionally, the SAS actuator positions were recorded by the FTI and the trace shows no active rate damping thus confirming the SAS as 'off'. As a consequence the Panel discounted SAS interaction as a factor in the incident.

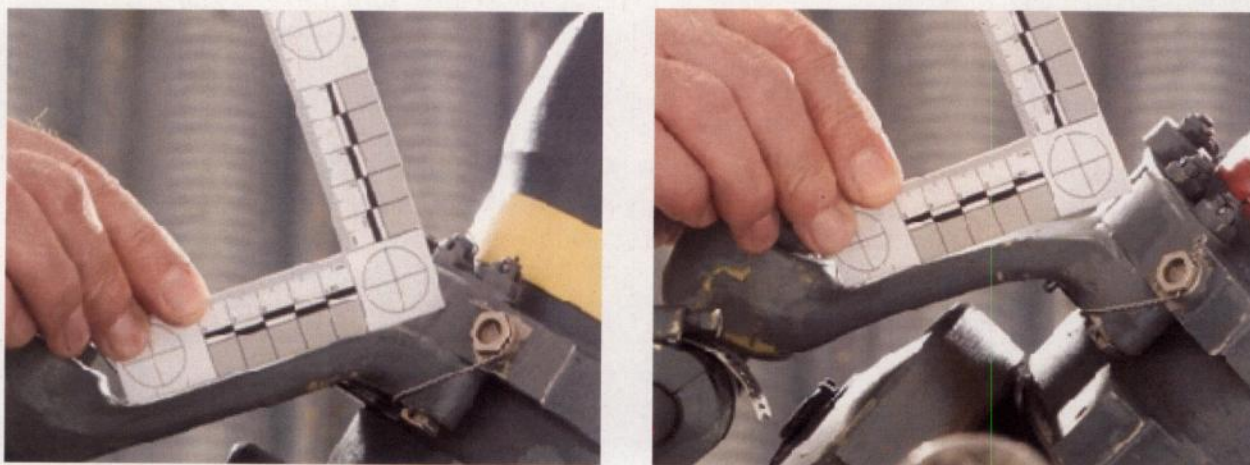
Fig 6 – An undistorted PCH and the distorted Red PCH

- a. The Pitch Change Horn (PCH) that connects to the Red PCR at its top end was significantly deformed upwards which would have required a large force (Fig 6). For the PCR to have failed in isolation and subsequently bent the PCH, it would require the broken upper portion of the PCR to make contact with a section of the rotor head and transfer force to the PCH. Had this occurred there would be witness marks on the PCR at the base of the broken upper portion. No such witness marks were present nor is there any obvious mechanism whereby the PCR could interact with the head in this way.

- b. A force applied through the intact PCR and PCH together would create damage consistent with the pattern seen on both components.
- c. Had the PCR failed in isolation prior to the blade strikes there would be significant evidence of it on the FTI trace through degradation of in-flight stability and an increase in vibration from out of balance forces. These characteristics were not present on the FTI trace until the blades struck the tail.

The Panel concluded that the PCR failure occurred as a result of the blade strike(s) against the tail and therefore was not a factor in the aft cyclic position prior to the strikes.

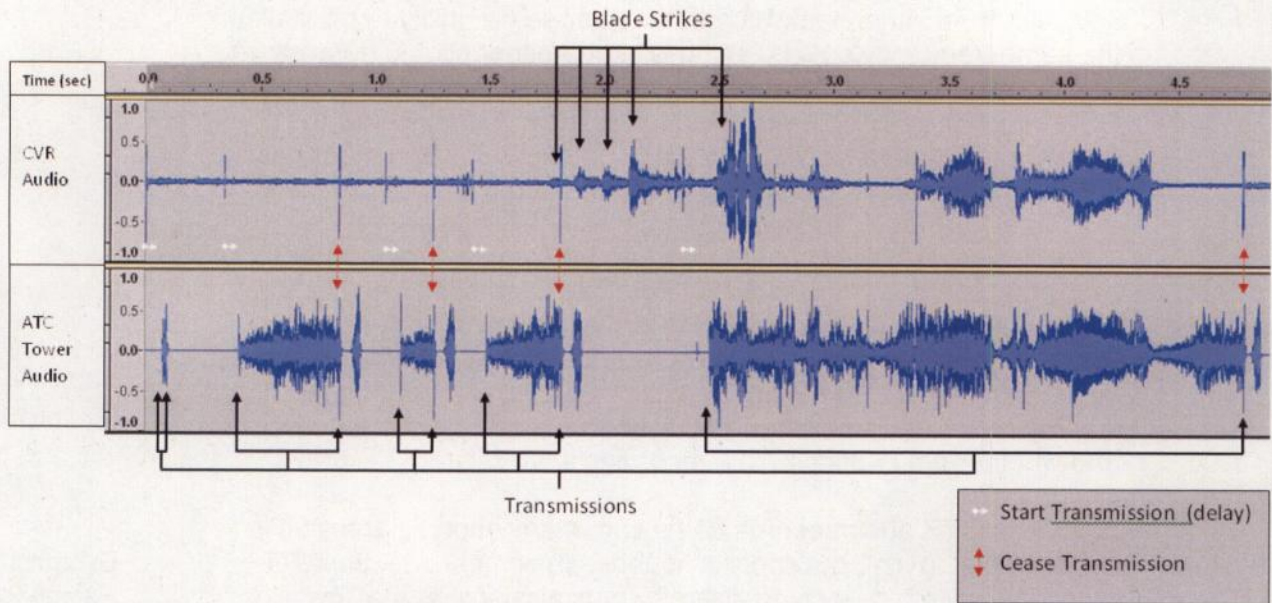
Fig 7 – CVR and ATC Audio

c. As there are multiple stations on the Tower frequency, the Panel sought to determine the source of the transmissions. Had the fragments of audio overlain on the carrier wave been from another source, they would be audible on the CVR in addition to the internal sounds and would sound external. Instead, only the clicks themselves are audible on the CVR and thus the Panel concluded that the source of the transmissions was XZ936. The Panel assessed that it is extremely unlikely that both seat occupants were independently interacting with their respective PTTs over such a short period of time. Furthermore, as the longest transmission in a five second sequence of transmissions could be sourced to the RHS, in all probability all of these unintended transmissions were RHS generated.
