Rail Accident Investigation Branch

Rail Accident Report

Two signal passed at danger incidents, at Reading Westbury Line Junction, 28 March 2015, and Ruscombe Junction, 3 November 2015

Report 18/2016
September 2016

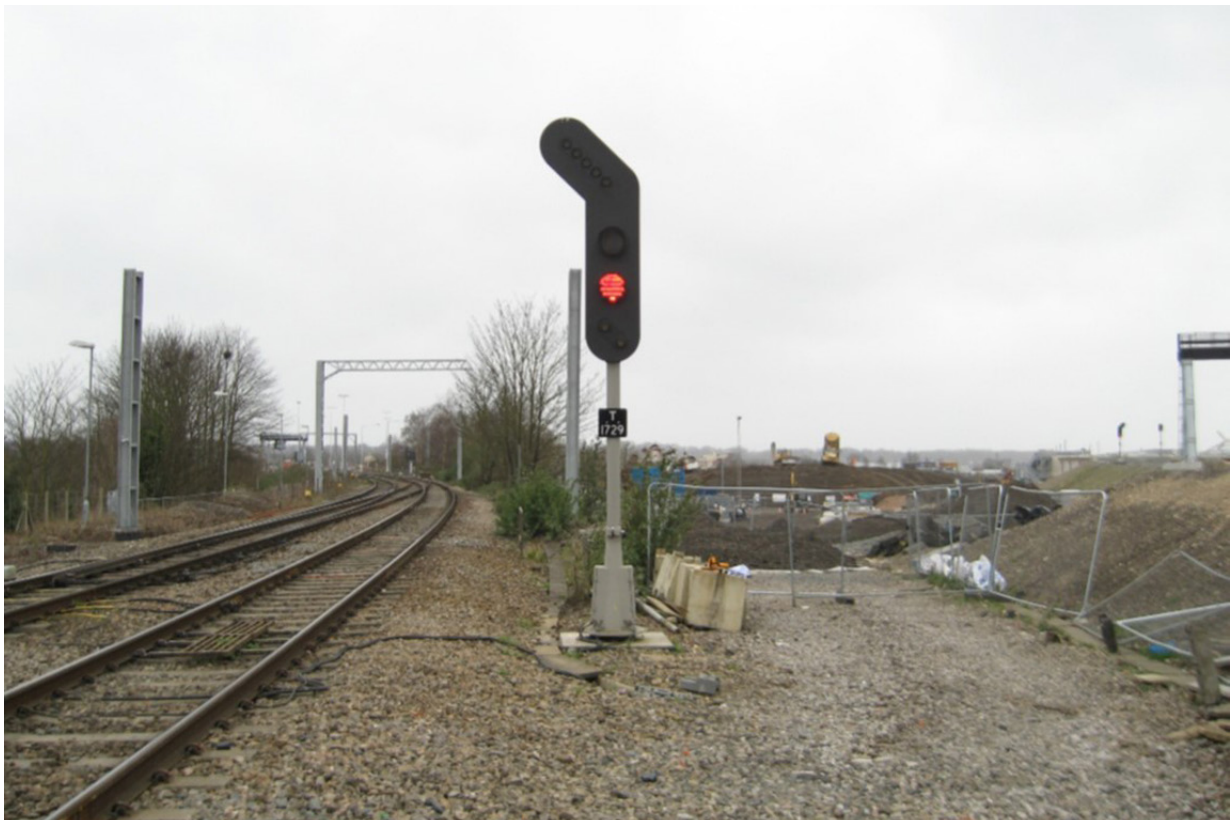
- 7 T1729 is a four-aspect LED signal located on the right-hand side of the *bidirectional* Up Westbury line at 36 miles 29 *chains*, approaching Reading Westbury Line Junction to the west of Reading station (figure 2). For the path that train 7C29 took on 28 March 2015, this signal is preceded by two similar four-aspect signals. Permissible speed at this location is 40 mph (64 km/h).
- 8 On the morning of 28 March 2015, signal T1729 was being held at danger because the parallel signal (T1727) was showing a proceed aspect to allow for the passage of passenger train 2K32 (figure 3).

Figure 2: Signal T1729 at Reading Westbury Line Junction (image courtesy of DB Cargo (UK) Ltd)

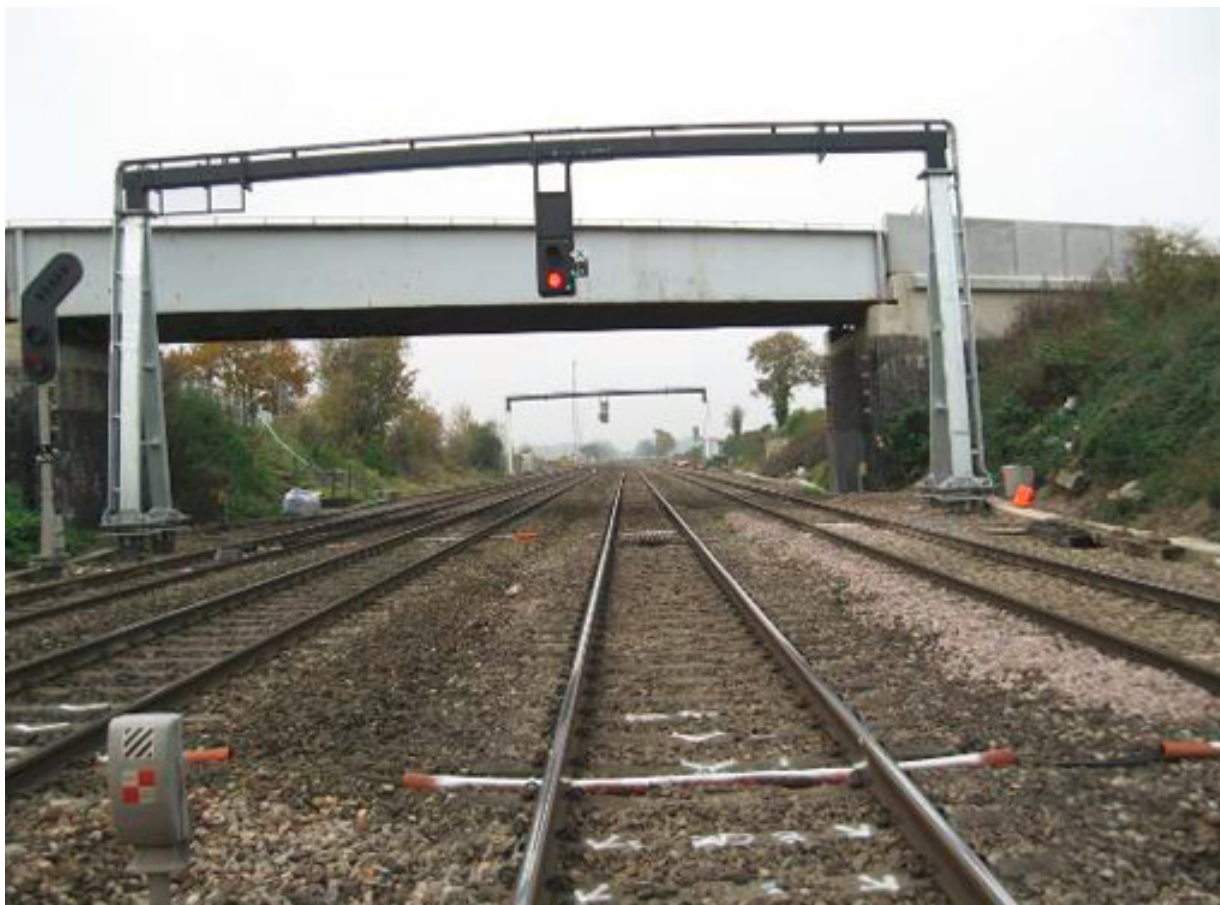
- 9 T1627 is a gantry-mounted four-aspect LED signal protecting Ruscombe Junction on the Down Relief line at 29 miles 16 chains, to the east of Twyford station (figure 4). Its preceding signals are T1623 (four-aspect) and T1611 (three-aspect), meaning that when T1627 is at danger the two signals on the approach to it show green and single yellow respectively. Permissible speed at this location is 60 mph (97 km/h) for freight trains and 90 mph (145 km/h) for passenger trains, although the maximum permitted speed for the train concerned was 45 mph (72 km/h) (see paragraph 15).

Figure 4: Signal T1627 at Ruscombe Junction (image courtesy of DB Cargo (UK) Ltd)

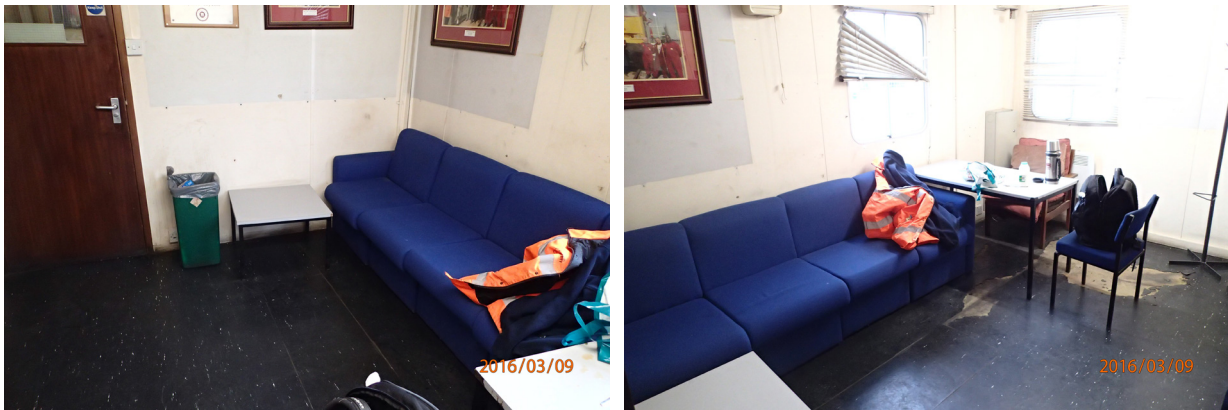
- 72 Evidence gathered during the current investigation found widespread dissatisfaction with the standard of the drivers' facilities at Acton train crew depot relative to equivalent facilities at other depots. The RAIB's inspection confirmed that the designated rest facility at Acton was not conducive to napping because of the amount of noise, its location (being on a through route between other rooms), and the unsuitability of the furniture for napping (see figure 6).

Figure 6: The rest facility at Acton train crew depot

123 Although DB's current position largely meets the requirements of these recommendations, RAIB notes that the facilities provided for napping at Acton depot were not fit for purpose (paragraph 68).
