AAIB Bulletin

2/2015

Aircraft Type and Registration:	Gulfstream 550, HZ-A6	
No & Type of Engines:	2 Rolls-Royce BR710C4-11 turbofan engines	
Year of Manufacture:	2004	
Date & Time (UTC):	10 December 2013 at 0325 hrs	
Location:	Stansted Airport, Essex	
Type of Flight:	Commercial Air Transport	
Persons on Board:	Crew - 4	Passengers - 3
Injuries:	Crew - None	Passengers - None
Nature of Damage:	Underside of left wing and left landing gear door	
Commander's Licence:	Airline Transport Pilot's Licence	
Commander's Age:	53	
Commander's Flying Experience:	8,685 hours (of which 1,311 were on type) Last 90 days - 70 hours Last 28 days - 0 hours	
Information Source:	AAIB Field Investigation

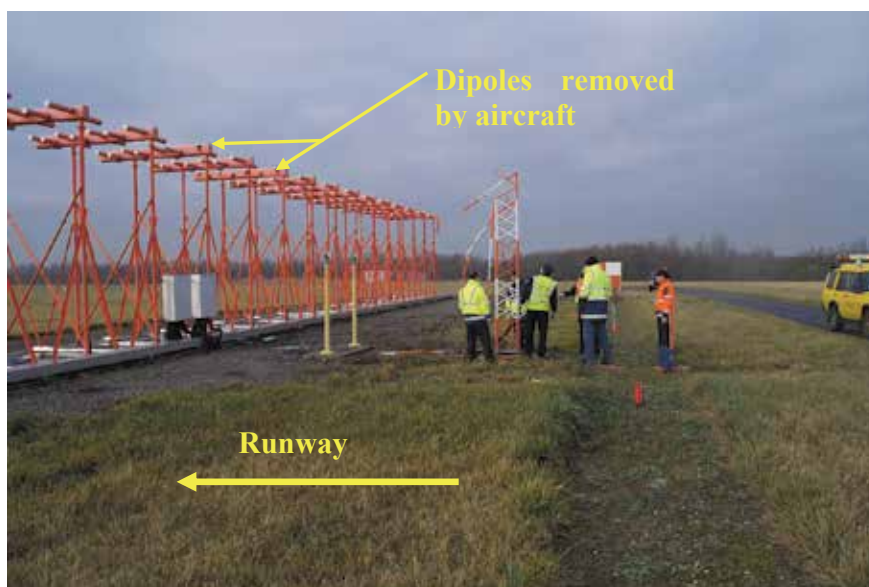
Figure 2

Examination of the airfield on the approach side of Runway 22 threshold revealed that the aircraft had successively struck the Runway 22 ILS localiser monitor aerial and the Runway 04 localiser aerial array. These structures were located only 5 to 6 m apart and the damage can be seen in Figure 2.

View of damaged monitor aerial and ILS localiser array

It was apparent that the aircraft had broken off the top of the monitor tower before striking the dipoles on stanchions 13 and 15, which placed the aircraft slightly right of the runway centreline. The latter impact had dislodged eight of the dipoles, which were scattered over the grass towards the runway.

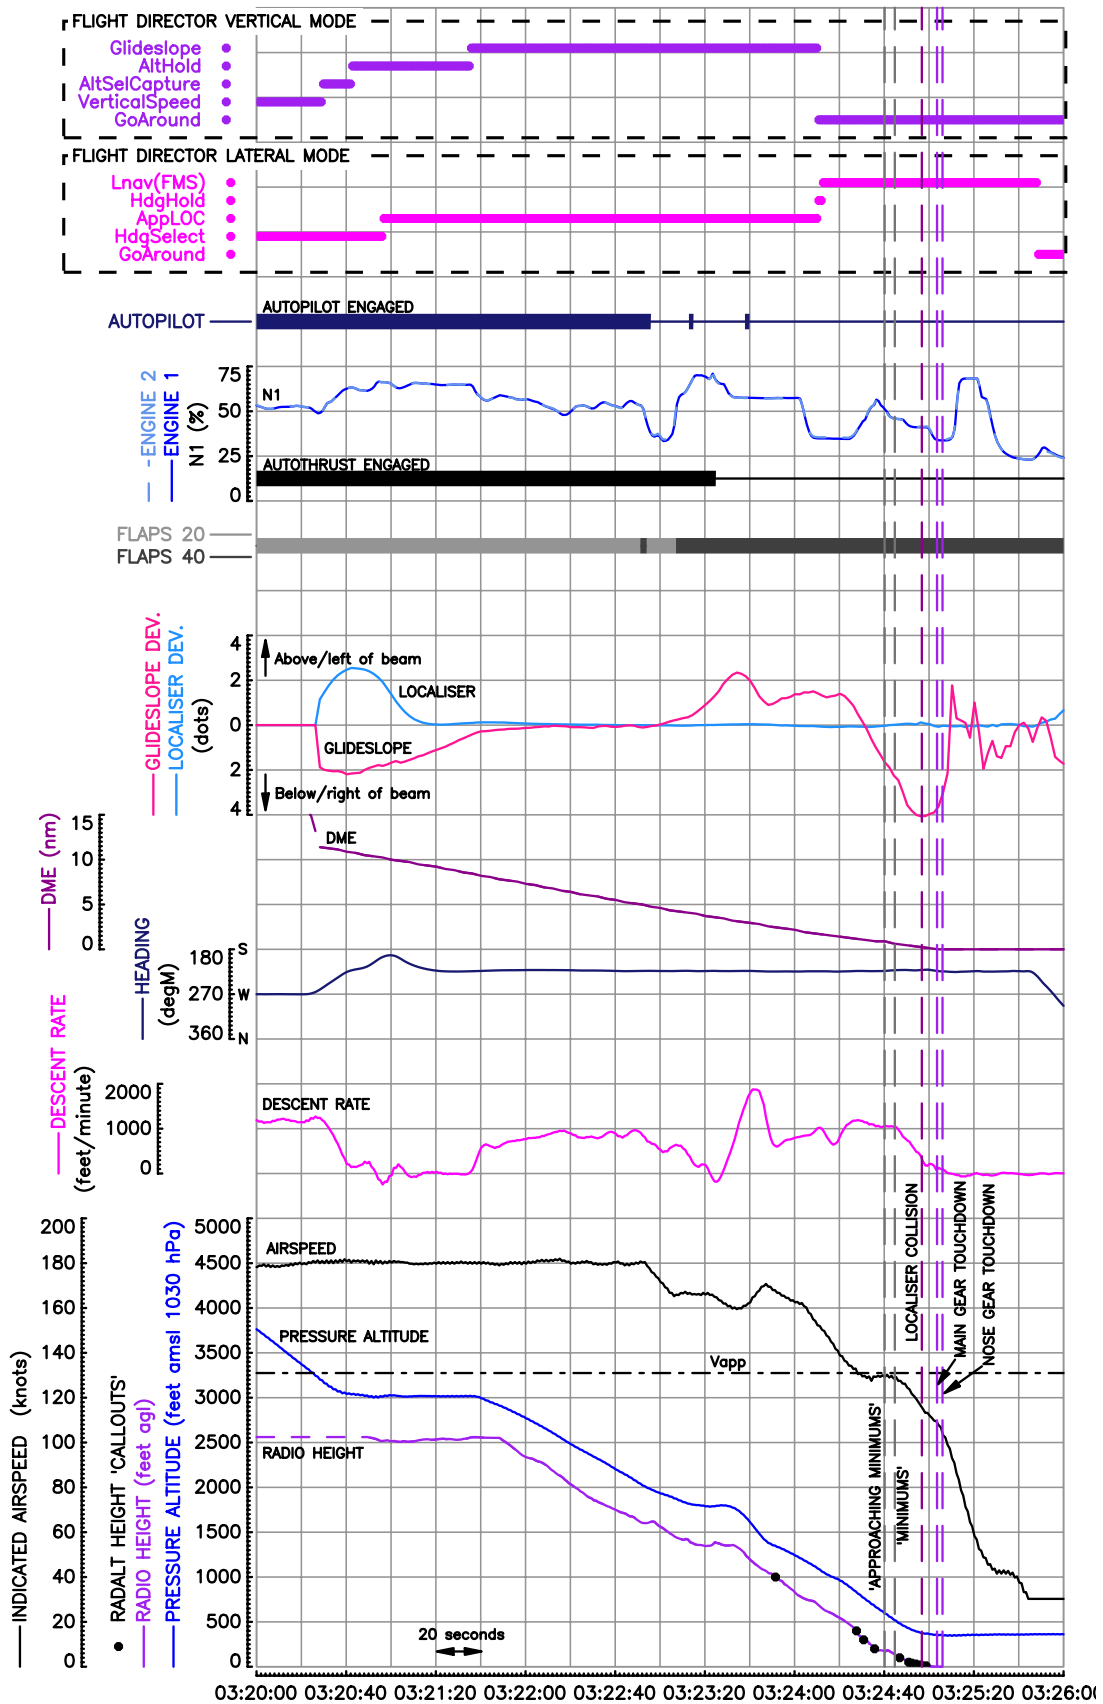
Figure 3

Distance to Runway 22 (nm)	Radio Height (feet agl)	IAS (kt)	UTC	Event
4.99	1612	178	03:22:56	AP disengaged
4.10	1387	167	03:23:14	AP briefly engaged
3.58	1388	165	03:23:25	AT disengaged
3.07	1234	161	03:23:39	AP briefly engaged
2.43	1000	167	03:23:52	'1000'
1.79	690	152	03:24:11	FD-vert: <i>Glideslope to GoAround</i> FD-lat: <i>AppLOC to HdgHold</i>
1.66	647	150	03:24:13	FD-lat: <i>HdgHold to Lnav(FMS)</i>
1.02	300	129	03:24:31	'300'
0.90	179	130	03:24:40	'APPROACHING MINIMUMS'
0.64	141	128	03:24:45	'MINIMUMS'
0.26	20	116	03:24:56	'20'
0.25	19	115	03:24:57	Collision with localiser
0.13	10	112	03:24:59	'10'
0	3	108	03:25:04	Mainwheel touchdown
0	0	103	03:25:06	Nosewheel touchdown

Salient recorded flight data for approach and landing at Stansted

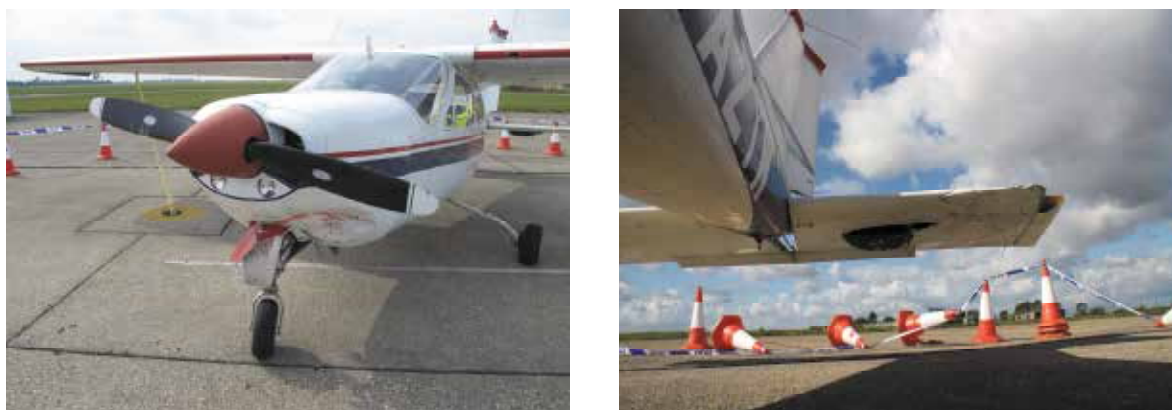
Figure 2

G-AZTW landed successfully at Bedford Aerodrome. There was a 12 cm wide scuff mark on one blade of the propeller, and a 50 cm long dent with red witness marks in the left lower part of the cowling, see Figure 2. Several small pieces of aircraft structure from G-TOMZ were removed from the nose gear door of G-AZTW. There were some scuff marks along the fuselage underside. The landing gear was down, with no evidence of any witness marks that might have occurred had the gear been down during the collision. There was extensive damage to approximately 75% of the underside of the left horizontal tailplane, and a piece of the horizontal tailplane tip fairing was found approximately 500 m from the main wreckage of G-TOMZ.

Images of G-AZTW at Bedford Aerodrome

By comparing the damage and the witness marks on both aircraft it appears that the initial impact was between the rotating propeller of G-AZTW and the right wing tip of G-TOMZ. The damage to the lower left of the engine cowling on G-AZTW suggests that the propeller was around the five o'clock position when this occurred. Thus G-AZTW was slightly higher than G-TOMZ at the time of the collision resulting in the damage to the lower fuselage and horizontal tailplane of G-AZTW.

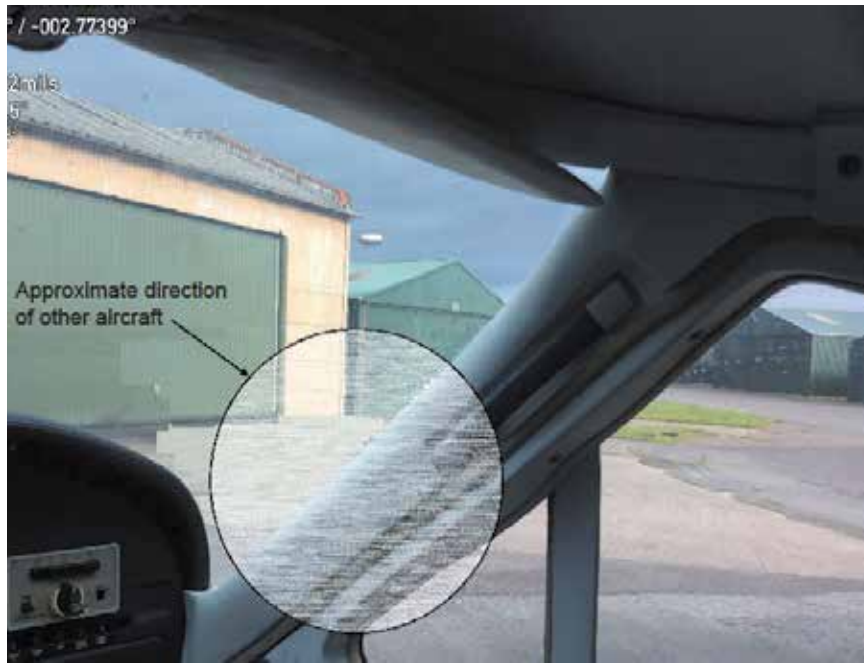
Figure 6

An assessment was made of the likely views that each pilot would have had when looking in the direction of the other aircraft. See Figures 6 and 7. It was determined that G-AZTW had a large door frame to the right side of the cockpit; G-TOMZ had a wingstrut outside the left window.

Pilot's eye view from a F177RG in the direction of G-TOMZ

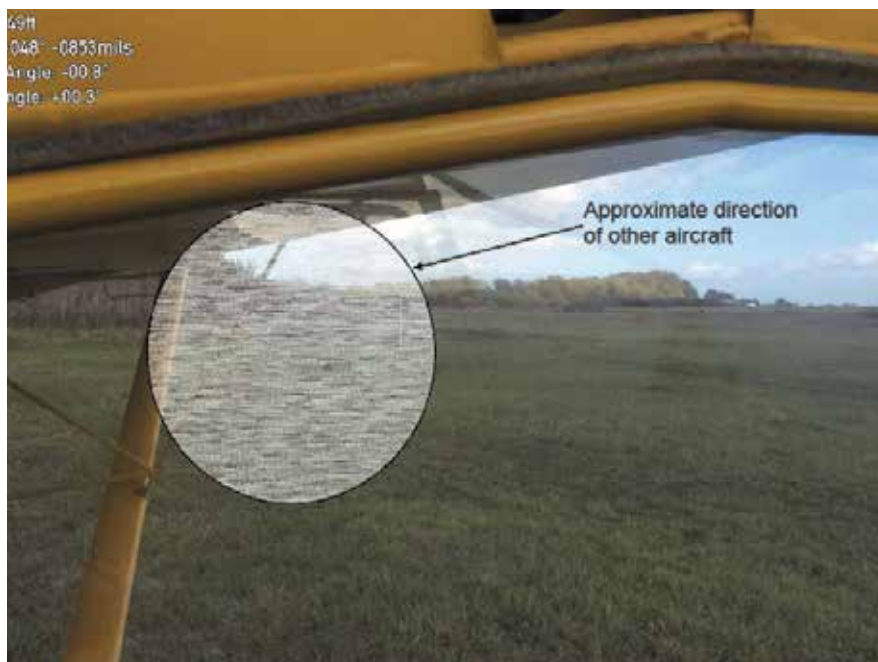
Figure 7

Pilot's eye view from a Denney Kitfox in the direction of G-AZTW
