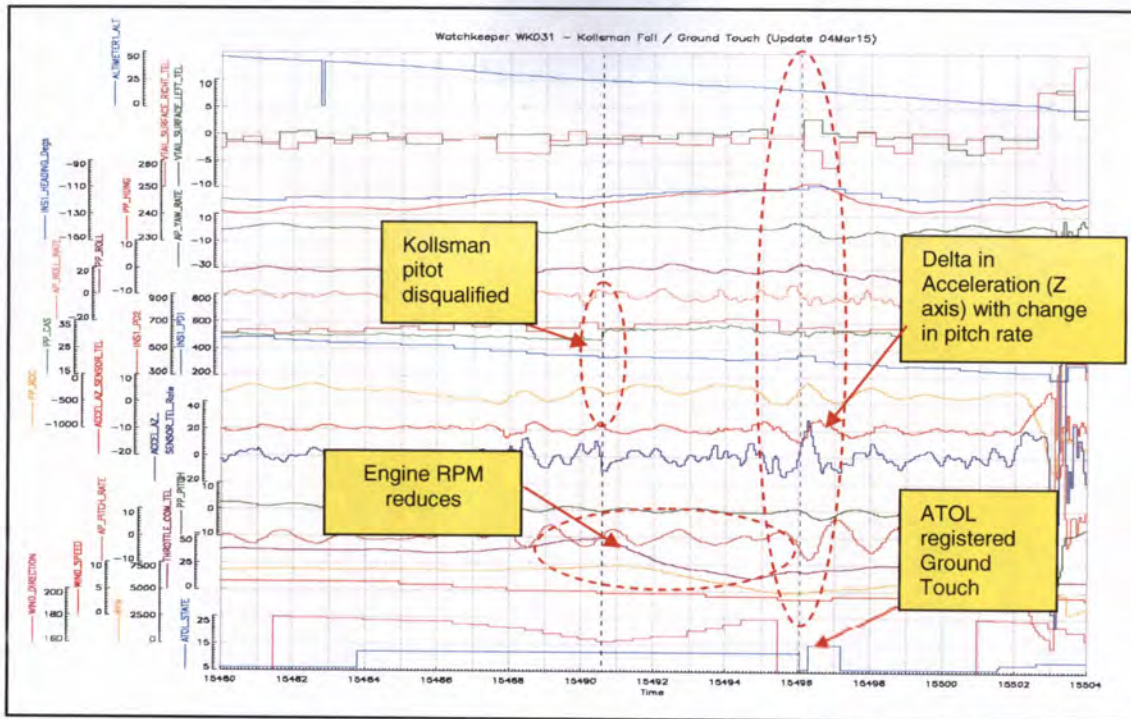
Figure 18 – VMSC Data Kollsman Pitot disqualification

1.4.160. **Initial analysis.** During the initial analysis of the VMSC data, the Panel found that the Kollsman pitot had produced erroneous readings during the approach and had been disqualified by the VMSC prior to 'Ground Touch' sensing (Fig 18). The Panel needed to understand the possible cause of the disqualification and its effect on the UAV's performance and whether it was a factor in the accident.

1.4.161. **Pitot System disqualification.** The VMSC data in Fig 18 shows the effect the failure the Kollsman Pitot had on Calibrated Air Speed (CAS) and engine RPM. One of the main parameters used by the VMSC FCS is Present Position (PP) CAS, which is an averaged reading of the Space Age Pitot data (INS1_PD2) and data from the Kollsman Pitot (INS1_PD1). The data in Fig 18 shows that PP CAS followed an averaged reading between the two diverging pitot inputs. As the graph illustrates, the INS1_PD1 reading started to drop off, which indicated that the Kollsman Pitot System was potentially partially blocked. After a period of approximately 10 secs the VMSC, which was monitoring the two pitot inputs from both INS/GPS units, disqualified the input from the Kollsman Pitot and reverted to solely using the Space Age pitot.

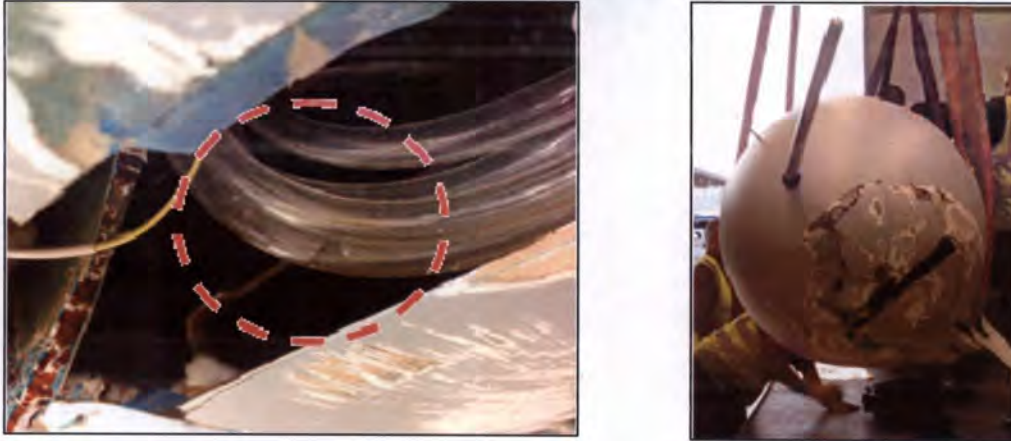
Figure 19 - WK031 Nose and Kollsman Pitot Probe Damage and Fluid found in Pipes

1.4.162. **Possible cause of Kollsman Pitot blockage.** The reliability of the Kollsman Pitot System as originally installed had been problematic in adverse weather conditions and was identified as an area for improvement. A lack of a dedicated water drainage system on the Kollsman pitot system had contributed to suspected partial system blockages and the associated effects on UAV performance. This particularly occurred when water was ingested beyond the probe heater and settled at the lowest point within the pipes. Due to this issue Kollsman pitot pipe lines were increased to ¼” diameter and a secondary Space Age pitot was fitted which also had ¼” pipes and a drainage system.

1.4.163. **Water ingress.** Water was found in the Kollsman probe the day after the accident. However, Fig 19 illustrates the damage caused to the nose cone of the UAV after the accident. The Kollsman probe was bent in an upwards direction (in relation to how the aircraft was lying on the airfield post impact) and was left uncovered at the scene overnight during inclement weather. Therefore, the Panel believe that it is possible that water was ingested post-accident. However, analysis of the data from the GFCC logs, the GCS VR and the WCAs displayed to the crew all point to a partial pitot pipe blockage before the accident which was becoming progressively more blocked over time. Therefore, the Panel concluded that the most likely cause for the disqualification of the Kollsman pitot air speed readings by the VMSC was water ingress in the pitot pipe and

the associated partial blockage.

1.4.164. **Recommendation.** The Panel recommends that the Hd UAST should review the performance of the Kollsman Pitot System, and if appropriate incorporate a drain point.

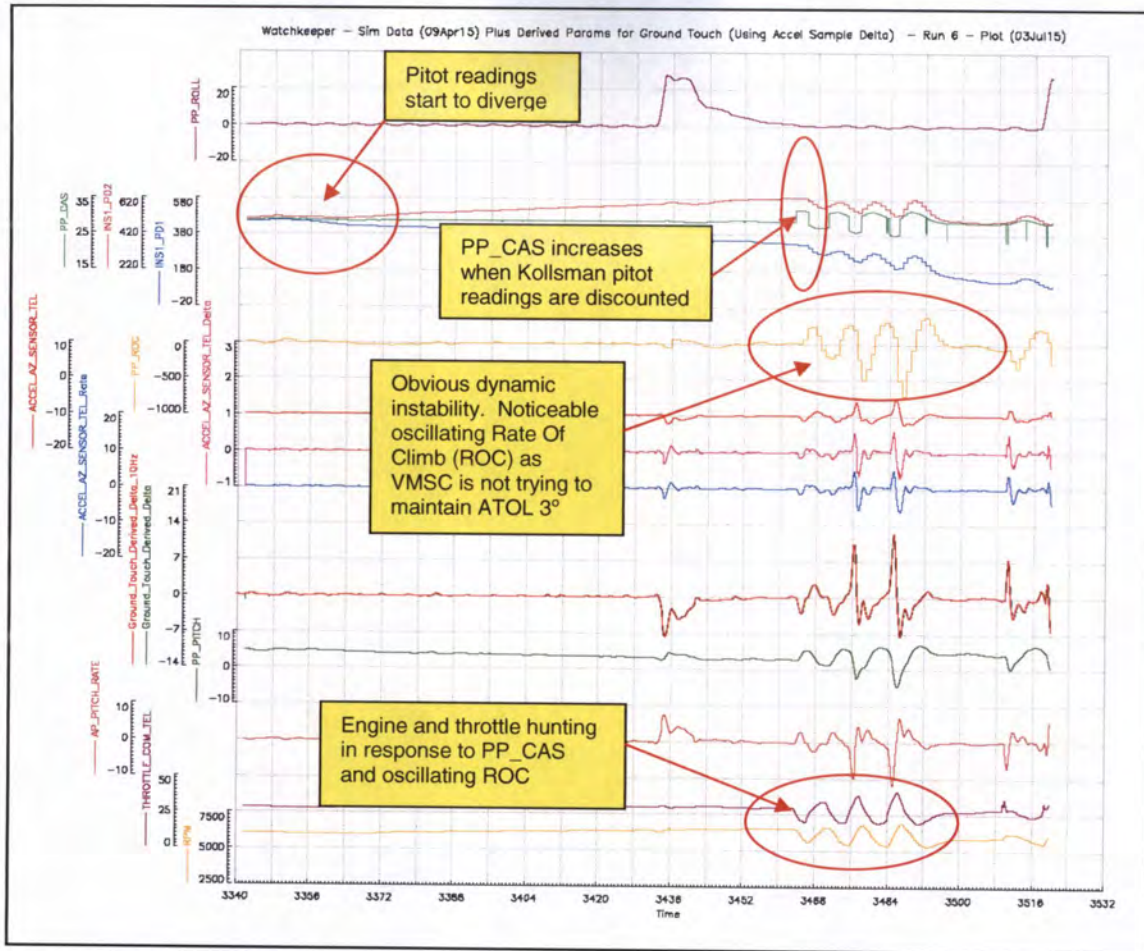
Figure 20 - Simulator Flight 6 - Straight and Level

1.4.167. **During cruise.** The straight and level conditions of route flight for Simulator Flight 6 (Fig 20) were deliberately selected to discount the influence of the ATOL landing process and the 3° glide slope. Analysis of the data showed that when the Kollsman pitot was disqualified, similar to WK031, the engine RPM reduced but this is where the similarity ended. Very quickly an obvious dynamic instability was established, which supported the theory being tested that the threshold for 'Ground Touch' could, if the dynamic instability was large enough, be reached.

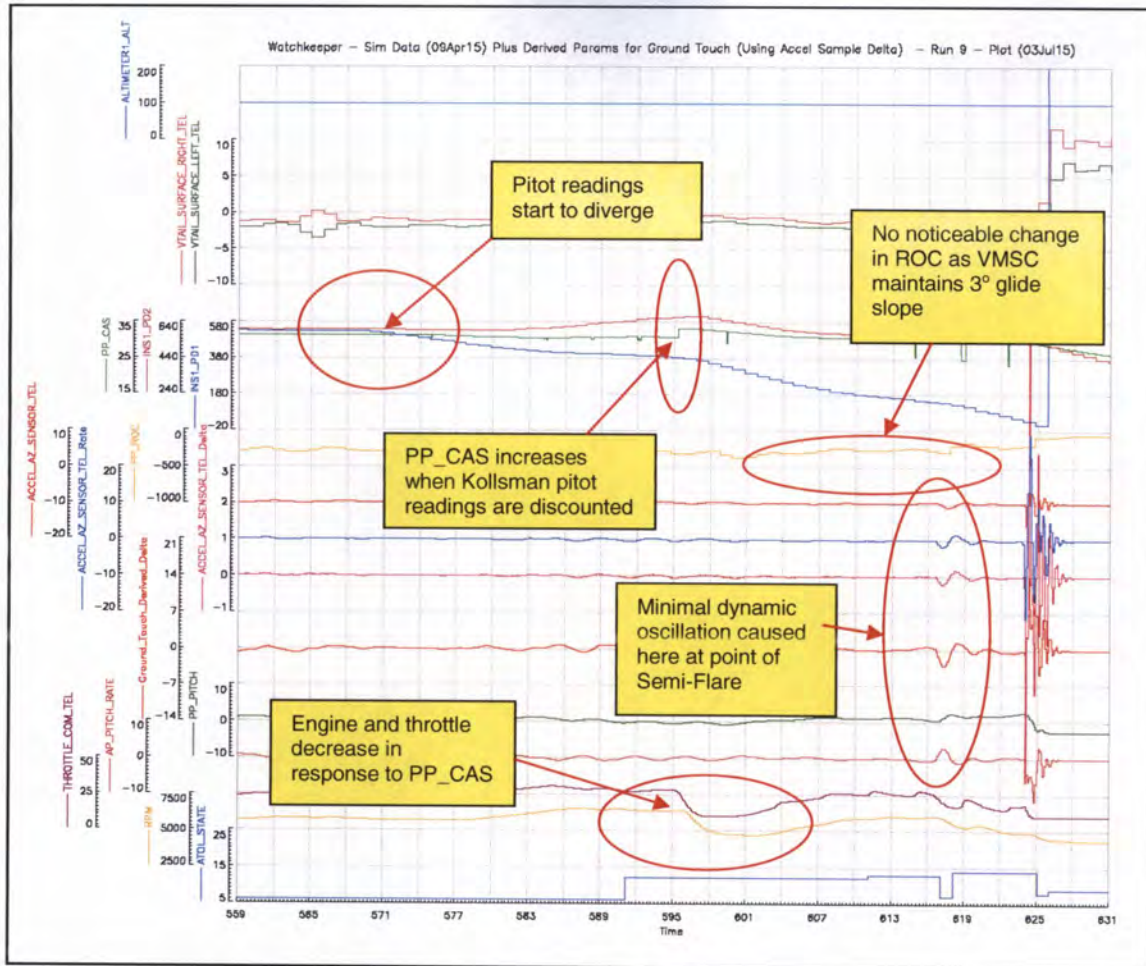
Figure 21- Simulator Flight 9 - Replicate of WK031 Accident Sortie

1.4.168. **During approach.** The conditions for Simulator Flight 9 (Fig 21) were matched as closely as possible to replicate the WK031 accident flight. Analysis of the data showed that when the Kollsman pitot was disqualified, the engine RPM initially started to reduce. However, unlike Flight 6, the RPM change had minimal effect on pitch and the Panel concluded that this was due to the overriding priority of the VMSC to maintain the 3° glide slope, and not air speed, as in the cruise. The lack of instability displayed during the landing phase, as a result of the UAV prioritising the 3° glide slope over its air speed, allowed the Panel to discount the relationship between engine RPM and the change in vertical acceleration experienced when the Kollsman pitot was disqualified. The Kollsman pitot therefore was **Not a Factor** in the accident.
