Rail Accident Investigation Branch

Rail Accident Report

**Serious injury sustained by a signal technician
at Kennington Junction
23 May 2008**

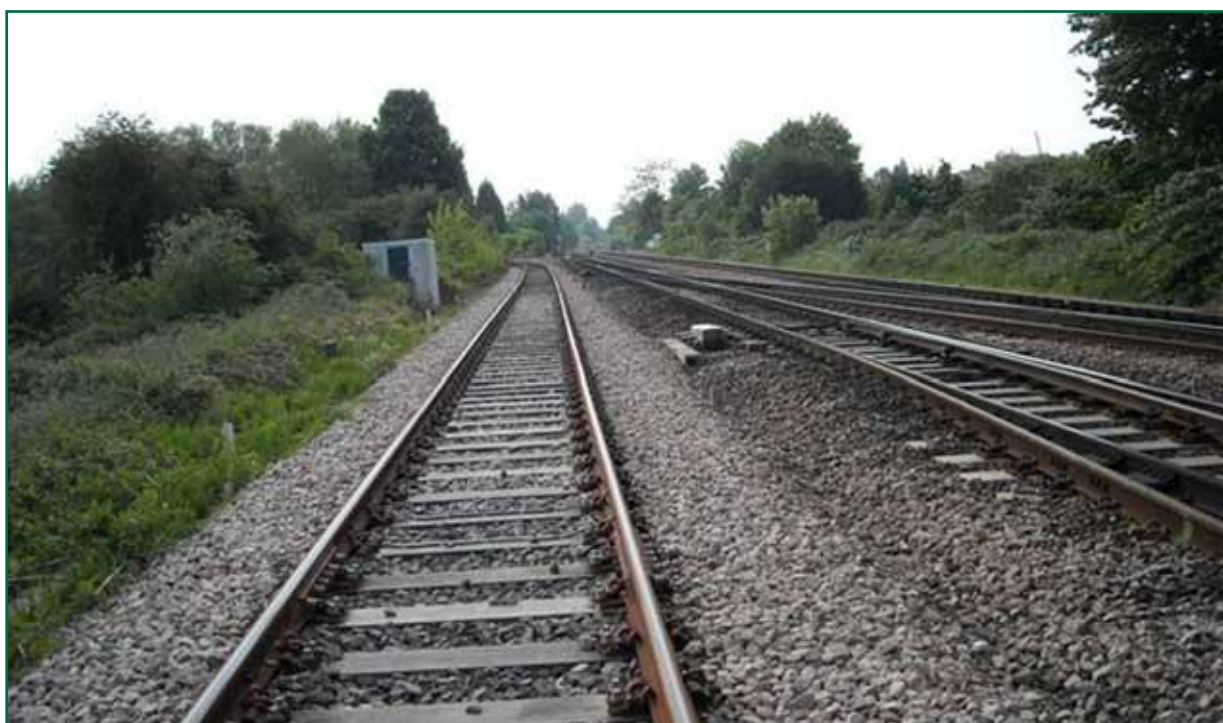
Figure 5: View from the lookouts position of the line towards Didcot (Photo courtesy of Network Rail)

36. The team arrived at Kennington Junction at about 21:00 hrs when it was still daylight, and left their van close to the junction points. They planned to begin work by undertaking the facing point lock tests on the crossover between the up and down lines (207A and 207B points).
37. Whilst the team leader and his assistant were unloading tools from the van the lookout went to the other side of the line and took up his duties in the customary place for work on 207 points. He was not instructed by the team leader (COSS) where to stand or given any other instruction. He stood at various times in the cress or 4 foot of the up goods loop from where the best possible sighting of approaching trains on the down line could be obtained. However, a passing up train would cut off the lookout's line of sight for the down line.

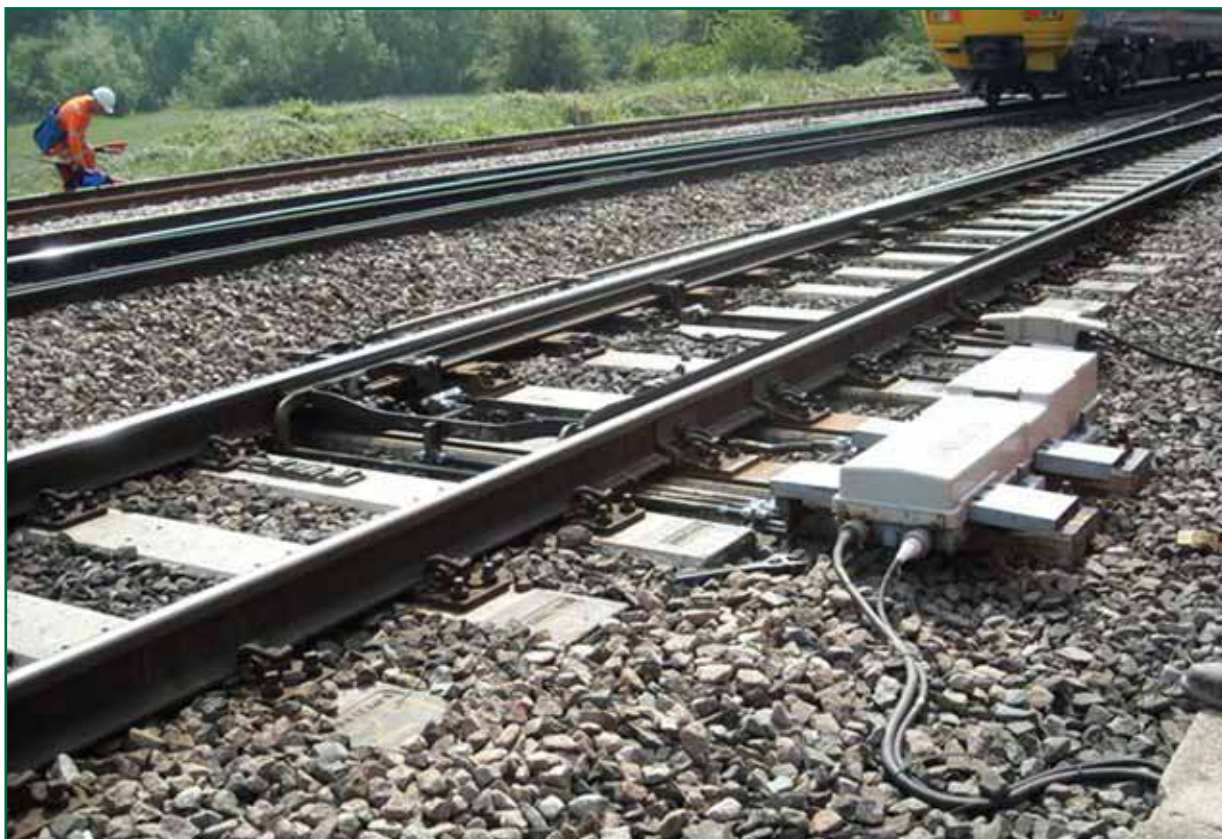
Figure 6:207A point machine. The down line is closest to the camera (Photo courtesy of Network Rail)

40. At 21:21 hrs, with only part of the test completed, the signaller requested that points be handed back so that a train could pass. The assistant wound the points back to their original position and the team leader then confirmed to the signaller that they had handed control back to the signaller. Both technicians then moved to a position of safety in the cess. The covers on the point machine were not replaced.

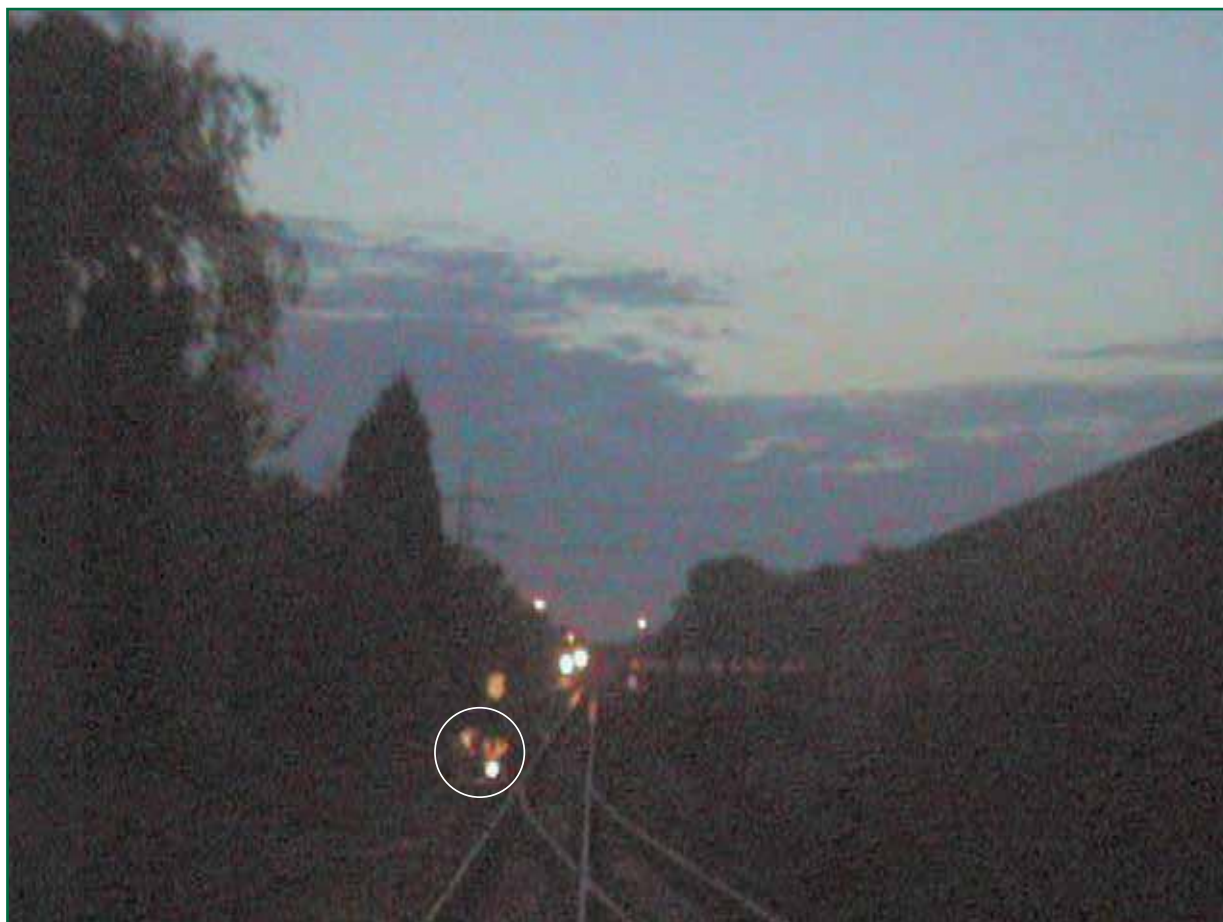
Figure 9: Still frame of the forward facing camera - Distant view. The picture is taken facing Oxford with the down line visible (from centre bottom). The orange Hi-Vis jackets of the technicians can be discerned just to the left of the points and the outline of the freight train on the up line can be seen (lower right quadrant). (image courtesy of First Great Western)

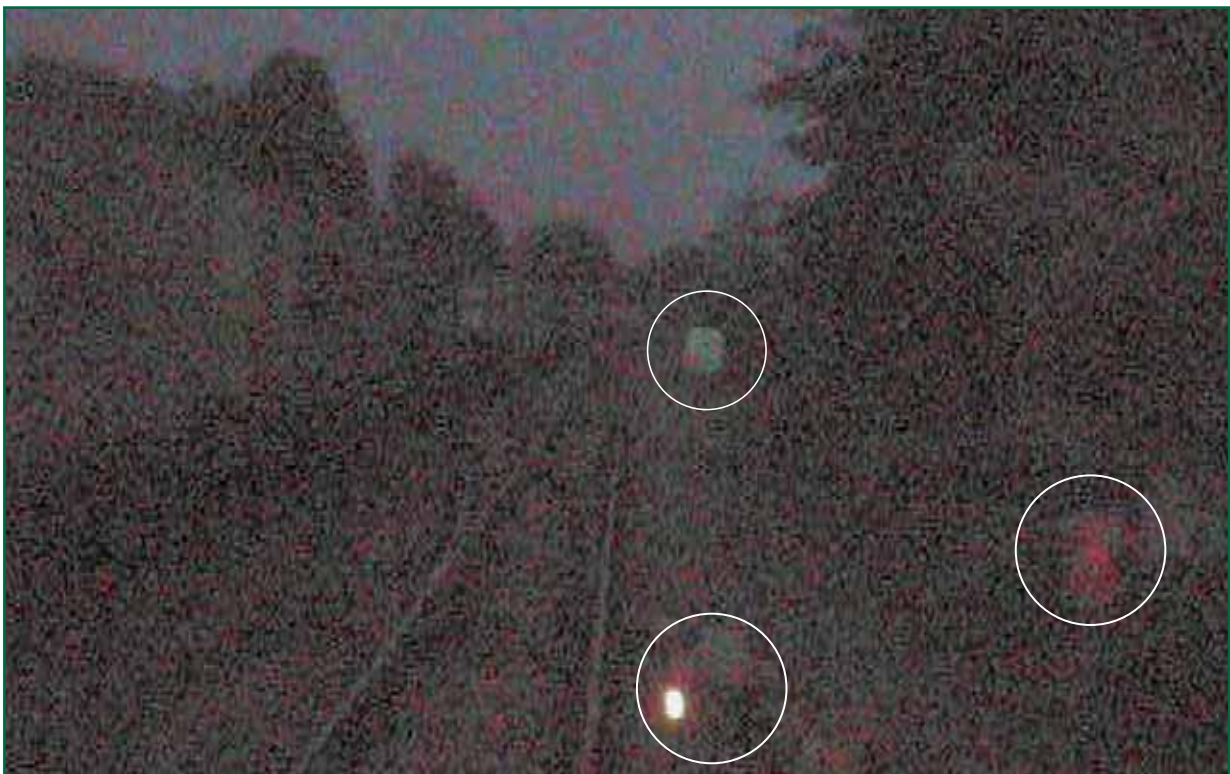
Figure 11: Still frame of the rearward facing camera - Immediately after train had passed 207A points. The down line from London can be seen in the centre of the picture; the freight train is still present on the up line to the left of the picture. The Hi-Vis vest of the assistant (lower right), the illuminated torch (centre bottom) and the outline of the technicians' van (centre) can be seen. (image courtesy of First Great Western)
