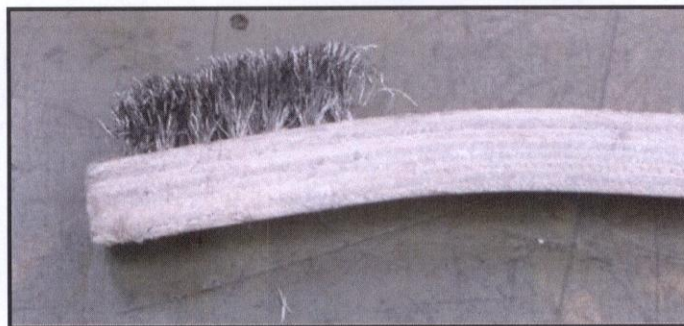
Fig 41 – Wire Brush

1.4.209 **Wire Brush Bristle Contamination.** In signal 2 of Fig 37 – XZ210 EFD Signal Traffic, it was noted that a small fragment of stainless steel wire was evident on MDP 5. The debris was "*not considered critical*" at the time; however, the post crash engineering investigation noted the presence of more small fragments of stainless steel wire within the ECU A63169 oil system. These fragments of wire were identified as broken bristles from small wire 'toothbrushes' (Fig 41) used for removing carbon deposits in engines during engine overhaul at ERS. In addition, the RR and 1710 NAS MIG investigation also discovered that this brush material was detected in other engines shortly after overhaul on the test bed and in service.

1.4.211 Further research led to the conclusion that although the presence of brush wire was highly undesirable within the ECU oil system, its presence was coincidental and not related to the engine failure. Additionally, the PT addressed the usage of the wire brushes at ERS and RR. This resulted in the withdrawal of the recommendation to apply a 5-hourly MDP inspection regime if brush wire particles had been found, reverting back to normal sampling routines using the EFD safeguards already in place.

1.4.212 The presence of the wire bristle fragments was not considered a factor in the failure of the Module 7 in this case; however, the presence of any debris in the oil lubrication system of the ECU was undesirable and so the Panel found that the use of the wire brushes in the maintenance facilities was an **other factor**.

1.4.210 Whilst the investigation of ECU A63169 continued, there were concerns that serious damage resulting from interaction with foreign bodies such as wire fragments could not be discounted. Therefore an urgent safety recommendation was made to reduce the sampling to 5-hourly on any engine that was found to have such debris within the Gem ECU oil system and the Gem EA were to investigate where and how these wire brushes were used during Gem ECU overhaul and reassess their suitability for continued use.
