# RESTRICTED – SERVICE INQUIRY

## PART 1.3 – NARRATIVE OF EVENTS

1.3.1. **Overview.** On 20 Aug 11, following an uneventful display at the Bournemouth Air Festival and 2 local area flypasts, the Royal Air Force Aerobatic Team (RAFAT) recovered to Bournemouth International Airport (BIA). The team commenced a visual recovery at approximately 1345, positioning on the extended centre-line of runway 08 in ‘Big Vixen’ formation as shown at Figure 1. Visibility was in excess of 10km with a clearly defined horizon and a light wind from the Southeast. During the break to land (break), and after apexing at the targeted downwind height of 500ft, XX179 progressively overbanked with an accompanying downward steepening of the aircraft’s flight path. Noting that XX179 was descending, the pilot of XX266, who was now immediately behind XX179, transmitted 2 radio warnings of “4 check height”, which were heard by other members of the formation. Shortly after this, XX179 was observed to impact open fields south of the airport perimeter and broke up before coming to rest in the vicinity of the River Stour; there was no post-crash fire. No ejection was observed and the pilot of XX179 was located in th

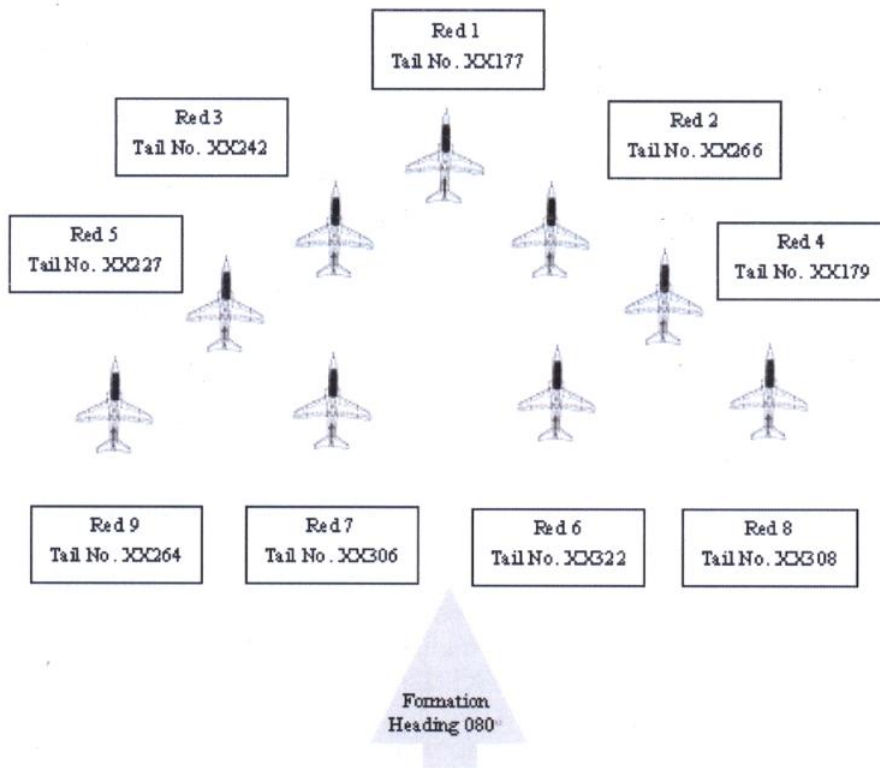
**Figure 1 – Big Vixen Formation**

1.3.6. **Recovery.** At approx 1345, after receiving clearance from Air Traffic Control (ATC), the team commenced a visual recovery and positioned on the extended centre-line of runway 08 in 'Big Vixen' formation. Red 1 indicated that the break to land would be either a looping break or a flat Left/Right break with the former being defined by a loop over the airfield prior to initiating the break and the latter being initiated from a straight and level run-in. To maintain sufficient energy for a looping manoeuvre, Red 1 aimed to recover at a speed of 360Knots Indicated Air Speed (KIAS). Approximately 2 minutes prior to recovery, BIA ATC instructed the RAFAT that the Battle of Britain Memorial Flight (BBMF) had taxied and had a latest take off time to avoid overheating on the ground. Approximately one minute prior to recovery, Red 1 elected to fly a flat Left/Right break as this would save time and allow the BBMF to get airborne sooner.

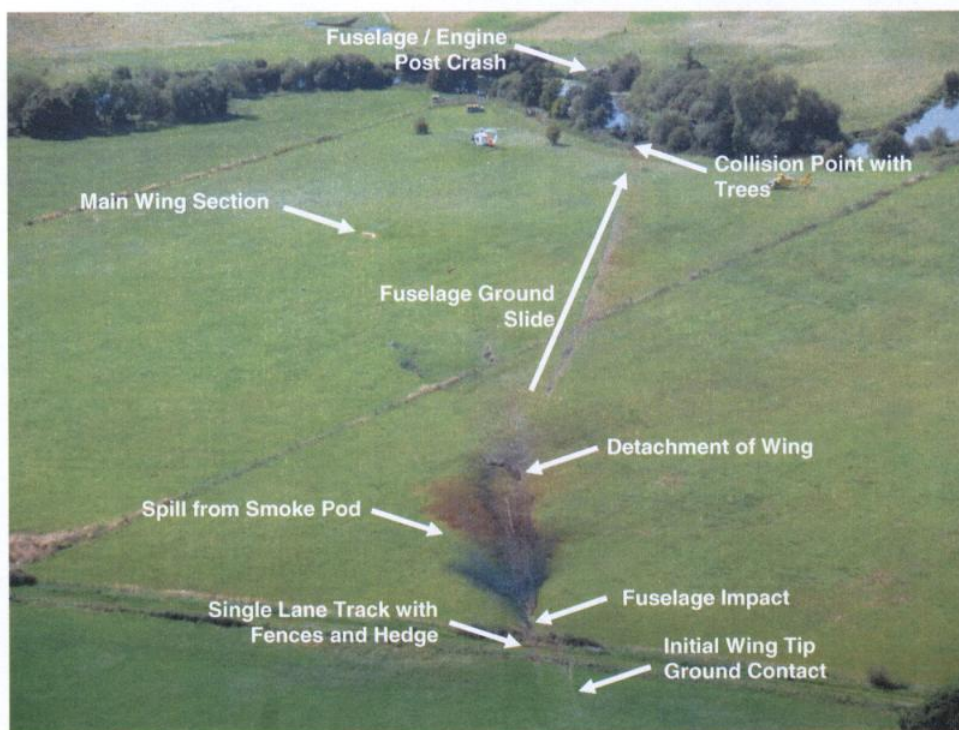
**Figure 2 - Aerial Photograph of XX179 Crash Site Viewed from Northeast**

1.3.9. **Crash Site Ground Orientation and Accident Data.** The accident occurred to the north of Bournemouth, on private land, in the vicinity of Throop as shown at Figure 2. Ground marks and aircraft debris ran in a westerly direction for approximately 500m to the western bank of the River Stour. At the widest point, aircraft debris was scattered to a width of 120m. The overall debris footprint covered an area of approximately 46 000 m<sup>2</sup>.

- a. **Wing Tip Ground Contact.** The initial wing tip ground contact can be seen at Figure 2. XX179 struck 2 barbed wire fences on either side of the track and debris from the right wing was found in the immediate vicinity of the track. The aircraft struck a wooden fence post which punctured a hole in the right lower forward section of the air intake, leaving a broken portion of the post protruding from the airframe. XX179's roll angle, as it crossed the track, was calculated<sup>1</sup> to be 18° right wing low with the aircraft continuing to roll out of bank. Witness marks on the airbrake confirmed that the airbrake was extended as the aircraft struck the first barbed wire fence.

- c. **Detachment of the Wing.** The first substantial ground scar occurred when the remaining leading edge of the right wing dug into the ground following the fuselage impact. This resulted in the detachment of the wing section from the fuselage. Once detached the wing section tumbled a further 200m where it came to rest, upside down, to the south of the main fuselage track. The detachment forces altered the fuselage's direction of travel, as shown on Figure 2.
