## PART 1.3. - NARRATIVE OF EVENTS

1. **Introduction.** ZE982, as callsign BLACKSMITH 1, was the lead of a pair of Tornado F3 ac flying a routine trg sortie from RAF LEUCHARS. The sortie aim was to conduct medium and low-level intercepts for part of an E3D AWACS sqn acceptance check for a weapons controller. The sortie conduct included Quick Reaction Alert (QRA) intercept profiles followed by a low-level navigation exercise. Prior to the sortie brief the crew were informed that the AWACS would be late on task. The original airborne time was achieved with the low-level navigation exercise re-planned prior to the AWACS on-task. Both F3 ac, in Configuration 3, took off at 1128 hrs from RAF LEUCHARS, flowed west at 3000ft and entered low-level to the west of PERTH. At 1142 hrs, during the navigation through a series of valleys to the west of TARBET, BLACKSMITH 2 (in trail) rounded a ridge in a left-hand turn and witnessed a fireball in the expected vicinity of ZE982. BLACKSMITH 2 took immediate recovery action in a westerly direction to avoid the rising fireball. ZE982 had struck the north slope of GLEN KINGLAS at 1198ft Above Mean Sea Level. The ac impacted civilian owned open hillsi

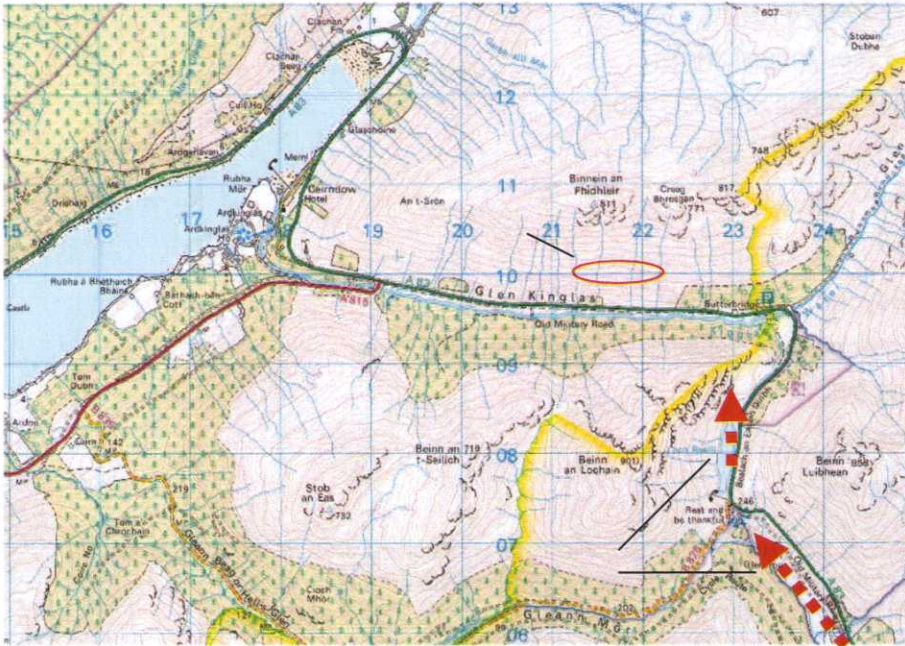
Figure 1  
Accident Location

a. The initial impact point was N 56 14 58 W 004 52 15 (D M S) 222228.378 N710035.602 (National Grid), 1198ft AMSL on the north slope of GLEN KINGLAS, SCOTLAND. The Glen is approximately 37 miles north-north west of Glasgow and runs east-west. The A83 road and RIVER KINGLAS run along its floor and the Glen has steep sides with numerous burns running down the hillside in ravines. Figure 1 shows the direction of approach from the south-east with the crash site circled.

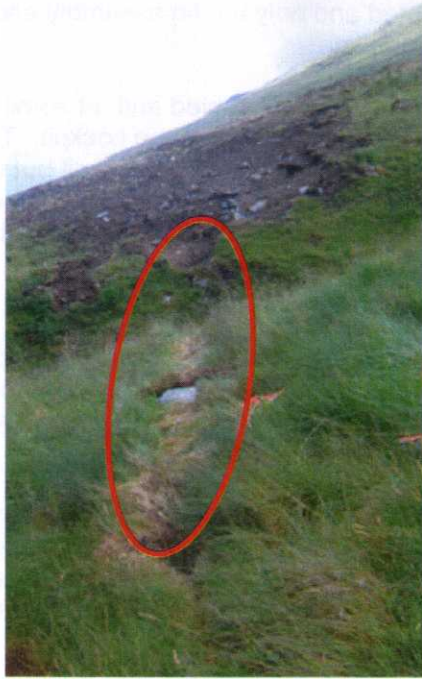
Figure 2  
Initial Impact Point

b. The ac initially impacted a slight rise in the hill side with what was likely to be a fin of the left 2250L fuel tank (Figure 2). On the west side of a subsequent hollow was the main impact (Figure 3).

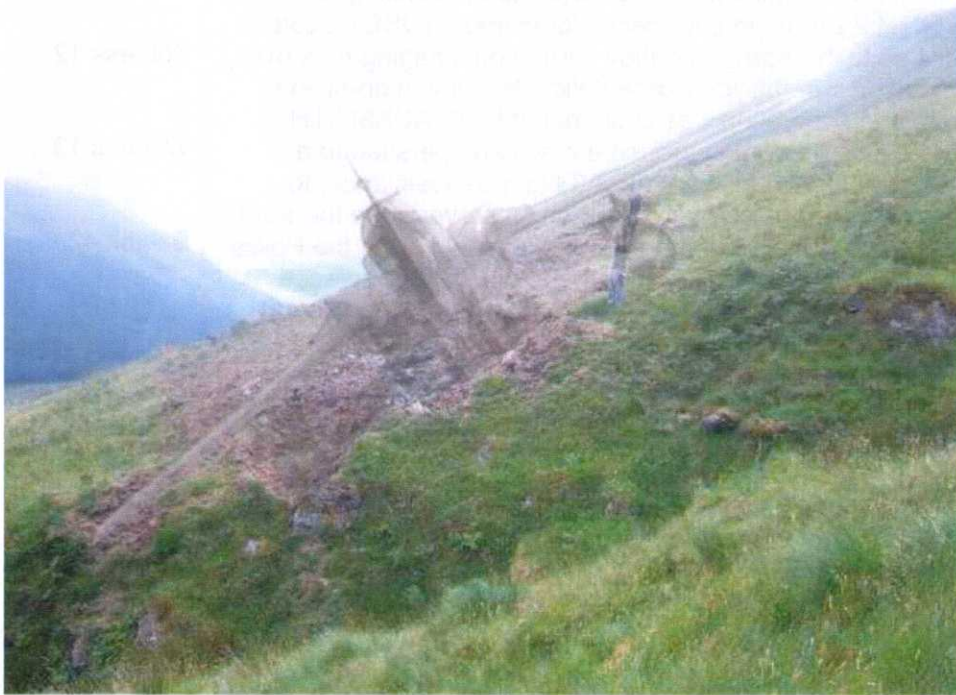
Figure 3  
Main Impact Point (with ac overlay)

c. There was a large fireball on impact and the engines, wing-box and cockpit had sufficient momentum to continue in the direction of travel. The

other parts of the airframe fragmented and only the fin assembly and right taileron were found substantially complete.
