PART 1.4 – FINDINGS

1.4.8. **Cause.** The cause of the accident was **engine failure**. Oil starvation resulted in overheating which led to engine failure. (TOR D)

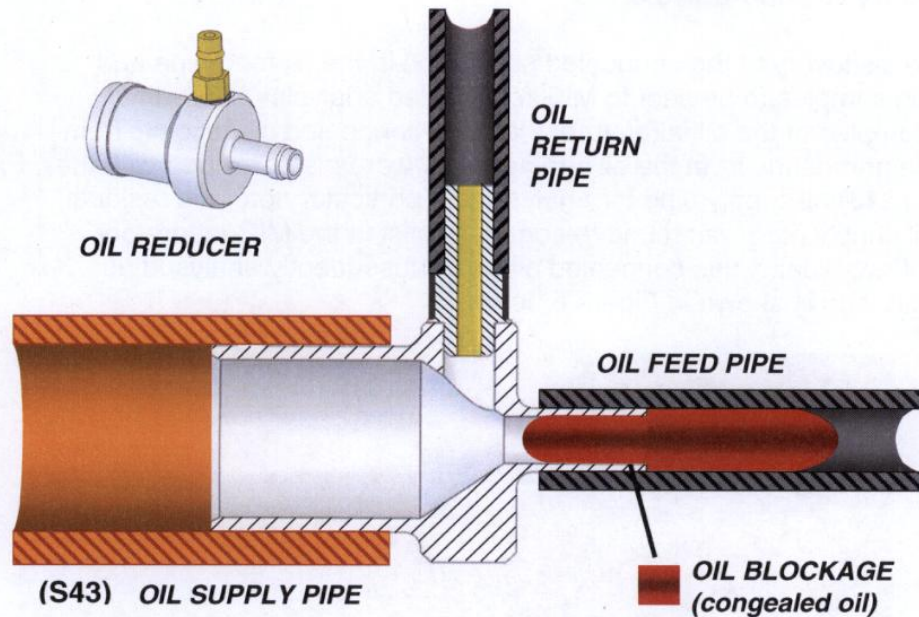
Figure 6 - Oil reducer Diagram

1.4.24. During the engine removal, the aircraft technician Sergeant who was assisting the MilAAIB investigator, noticed a thick brown congealed substance, which appeared to block the oil feed pipe. The early detection of this phenomenon enabled a fleet-wide check to ensure the serviceability of the other aircraft in theatre. This was particularly relevant as these oil pipes had been subject to a recent engine modification. No further anomalies were found in this area on the other UAs. The area where the blockage was discovered is shown in figure 6 and 7.

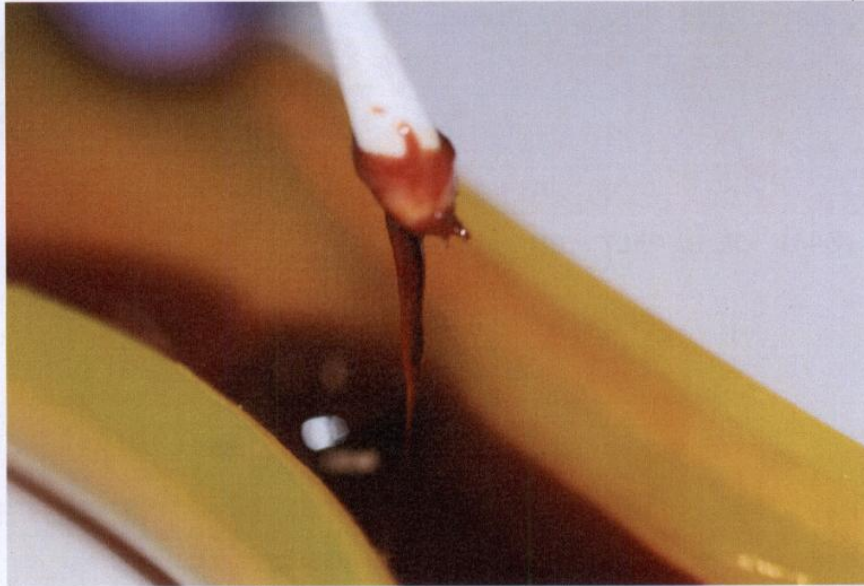
Figure 8 - Congealed oil discovered in (S43) Supply pipe in the laboratory

1.4.27. The discovery of the congealed substance in the oil feed pipe and reducer enabled samples to be sent to MIG for detailed analysis. MIG were supplied with samples of the oil taken from the tank, congealed oil deposits from the oil feed pipe and debris from the oil strainer. MIG were also provided with the large diameter (**S43**) oil supply pipe for analysis. Of particular note, the residual oil within the oil supply pipe was found to congeal whilst in the MIG laboratory over a period of two weeks; this congealed oil was subsequently analysed as part of the inquiry and is shown in Figure 8 below.

1.4.29. MIG's initial GC⁹ analysis into the congealed oil samples from the oil pipe indicated that the phenomenon was highly likely to be linked to the additive packages present in the oil: i.e. the lubricant had become separated from the viscosity improving additives, resulting in a soft and tacky deposit. The 'normal' oil samples taken from ZK515's oil tank were tested for viscosity and constitution and both were found to be consistent with typical fresh Mobil Pegasus 1.

1.4.30. MIG then contacted ExxonMobil, the manufacturer of the Pegasus 1 oil, in order to improve understanding of the nature of the additive packages present in the oil. Consequently, ExxonMobil tasked the Lubricants Technical Support (LTS) Laboratory in Canada to examine the samples of congealed oil taken from ZK515's oil feed pipe at the crash site and the (S43) pipe residue discovered in MIG's laboratory. LTS were specifically asked to identify the nature of the congealed oil found in the oil pipes and to ascertain whether this anomaly was due to oxidation by-product, additive drop-out or something else. The congealed deposits were analysed using Fourier Transform Infrared Spectroscopy, which highlighted the presence of an additional ester within the oil, which is not found in Mobil Pegasus 1. A database search for this ester indicated that it is consistent with a polyester polymer. Small pieces of the inside of the (S43) oil supply pipe were then sectioned and analysed by the same method. The overlay of the composition of the congealed samples and pipe sample indicates that both spectra show the presence of the same ester, suggesting the ester material in the oil is highly likely to have originated from the pipe. MIG have concluded that the congealed oil deposits were formed by chemical interaction of the engine oil with the plasticised PVC pipe.

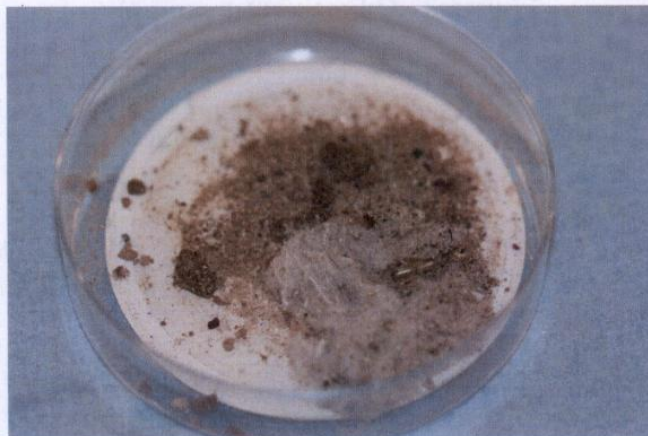
Figure 9 - Debris removed from the Oil strainer

1.4.28. Analysis of the material found within the oil tank's 250 micron strainer, showed the contents to be predominantly fluff together with general environmental dirt (sand or grit). The examination of the strainer did not highlight anything unusual which could be attributed to the event. Figure 9 shows the debris found in the filter.
