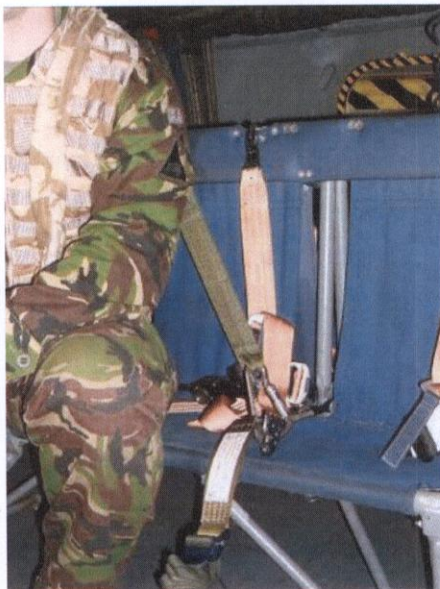
1.4.108 **Strop Snagging Hazard.** As part of the Panel’s investigation into the strop arrangement it became aware of ASIMS reports relating to a potential snagging hazard. With the MK60(M) ACLP secured to an anchor point in the cabin floor the CM may have been required to move around the cabin. The Panel identified that there was potential for the karabiner connecting the two strops to snag on an open seat harness which had the potential to hinder egress in an emergency (see Fig 26 and Fig 27 below). The strop design (joining karabiner) was an **organisational influence** that in other circumstances might influence the outcome of another accident and was thus deemed to have been an **other factor**.

Fig 26 – Karabiner ‘Snagged’

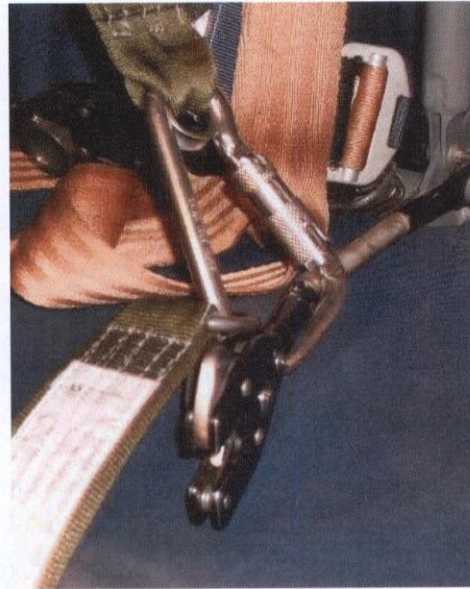
Fig 27 - Karabiner ‘Snagged’ Close-Up

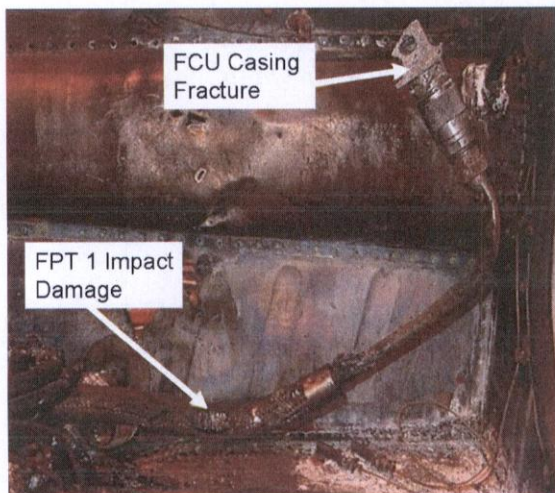
1.4.120 In the XZ256 (HMS Richmond) accident the release of the 1st stage FPT disc of the No1 ECU dislodged the LP fuel pipe from its location clip on the side of the engine case and fractured the LP fuel pipe at the FCU quick connect coupling, resulting in a fuel leak and large fire in the engine bay.

Fig 28 – XZ256 Fuel Pipe Damage

The subsequent heat from this fire led to failure of the No2 engine and the ac ditched. The final accident report from XZ256 recommended that the original U-clip used to hold the LP fuel pipe in place was changed to a fully enclosed P-clip.

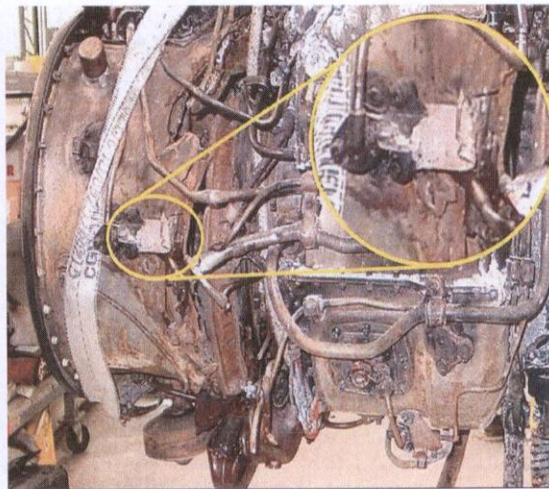
Fig 29 – XZ256 P-clip

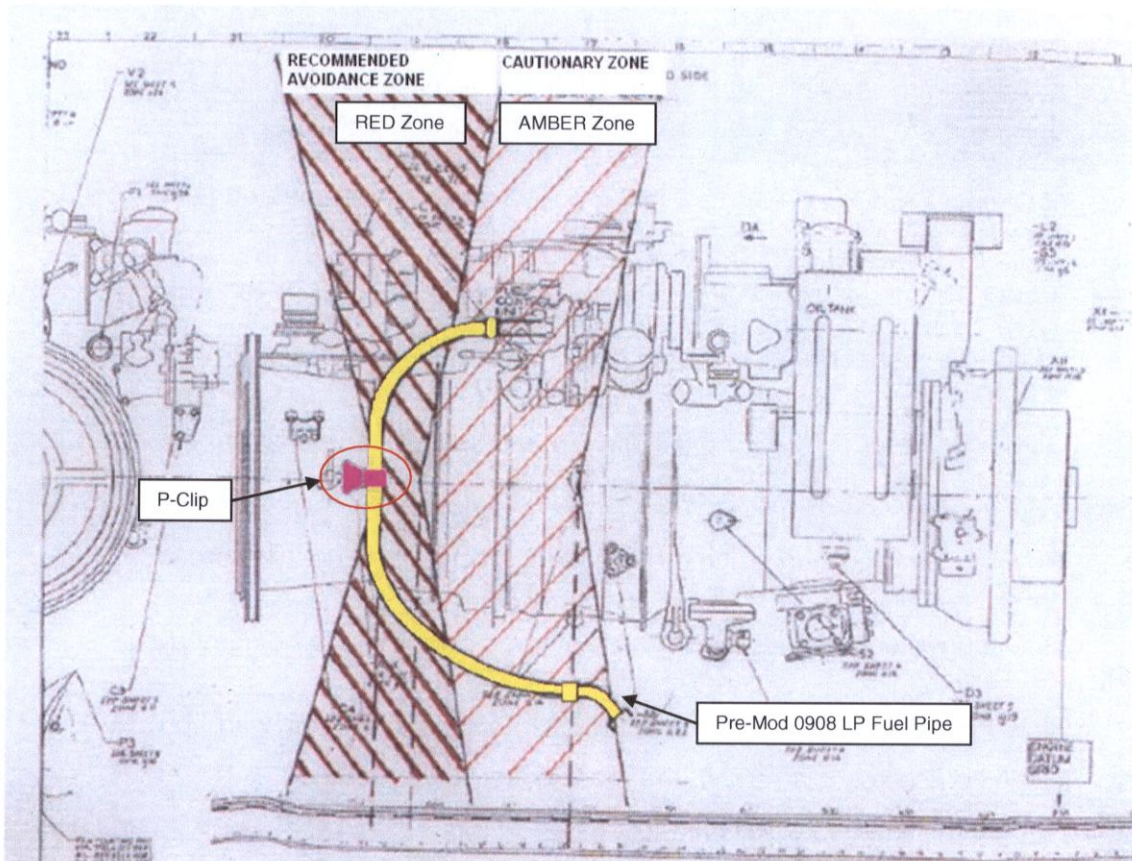
1.4.122 During the modification development process, on-going Lynx survivability studies identified the possibility that an FPT failure might result in the FPT blades 'bursting' through the engine. RR were then tasked with mapping the potential 'burst' area danger zones.

Fig 30 - FPT Burst Zones

1.4.123 Following the RR study, a subsequent Westland Helicopters Limited (WHL) report produced in Mar 05 identified that the LP fuel pipe was in the 'RED' zone. As a result, the Lynx IPT initiated the development of Lynx Mod 0908 and the Helicopter Engines IPT initiated GEM Mod 498 (the modification was specific to the RR Gem Engine and therefore not relevant for Lynx Mk9A), with an initial request to WHL and RR to produce a proposal issued in Jul 05.

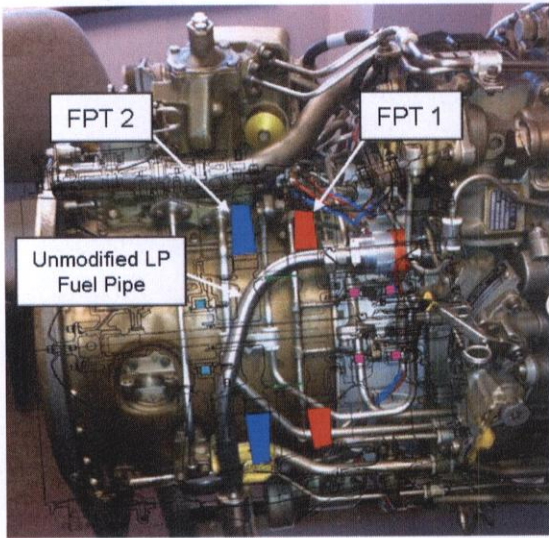
Fig 31 - RR Gem Engine Pre-Mod 0908

- a. **Mod 0908.** Re-routed the port and starboard LP fuel pipes to reduce the risk of fire. To achieve this, new port and starboard fuel-feed hoses were introduced.
- b. **Mod 498.** The re-routing required a new bracket to support the Mod 0908 hoses.

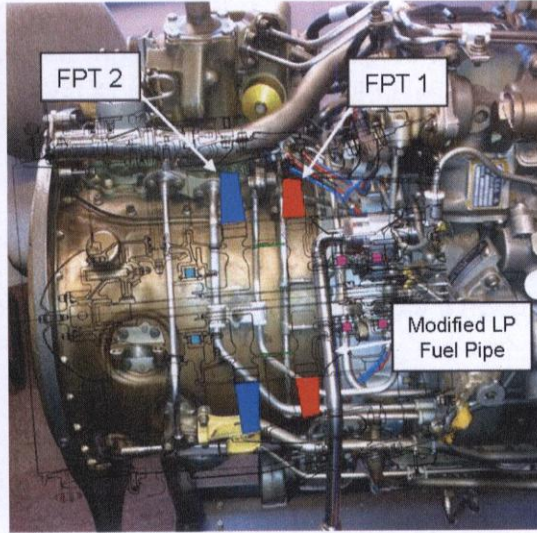
Fig 32 - RR Gem Engine Post-Mod 0908

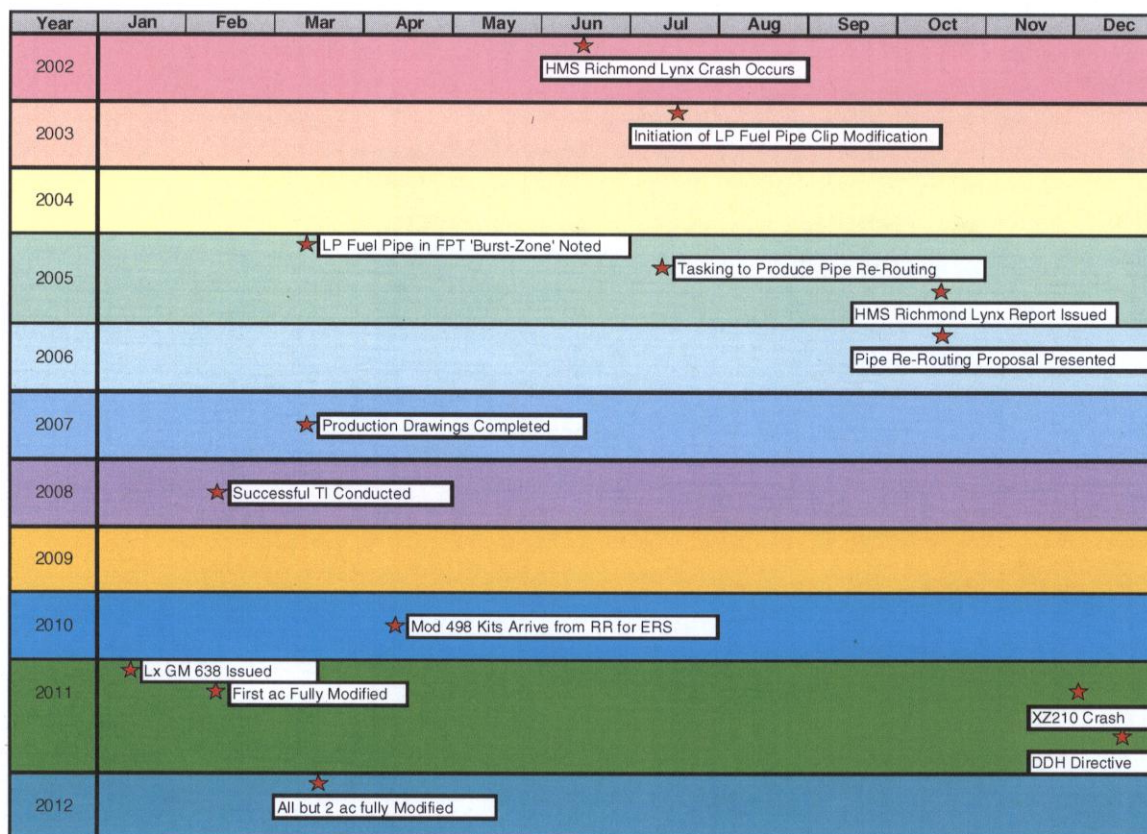
1.4.132 The first ac to have the full modification (Mod 0908 and 498) on both ECUs embodied at a Forward unit was XZ652 in Feb 11 (at 9 Regt AAC at Dishforth). By 1 Dec 11, of the 46 Lynx AH Mk 7s in the Fleet, 6 ac had the full modification embodied on both engines and a further 7 ac had been partially modified (one engine with both Mods).

Fig 33 - Graphical Representation of Mod 0908 / 498 Timeline
