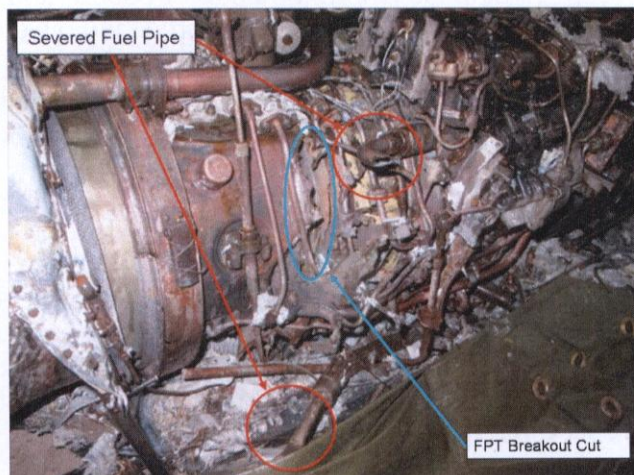
Fig 7 - Severed LP Fuel Pipe

1.4.34 **LP Fuel Pipe Damage.** Evidence in the No2 engine bay showed that when the 2nd stage FPT aerofoil sections exited the engine casing they impacted components in the vicinity with significant force. The No2 engine LP fuel supply pipe was severed midway along its rigid section directly in line with the FPT breakout cut, which led to fuel being pumped directly into the No2 engine bay.

| 1.4.35 | <p>The resultant effect of this fuel leak transformed the emergency in 2 ways:</p> <ol style="list-style-type: none"> a. Smoke. It was likely that the uncontained fuel from the severed pipe sprayed around the hot components and atomised. Engineering analysis concluded that the fuel would have mixed with the hot gases escaping from the Module 7 rupture (FPT inlet temperature was estimated to have been in the region of 400 to 450°C), causing the fuel to partially combust, thus generating large quantities of white/grey smoke. b. Fire. Civilian witness evidence described the ac being on fire prior to landing; therefore, ignition was judged to have taken place at some point shortly after the FPT disintegration. The Panel considered three possible sources of ignition: <ol style="list-style-type: none"> a. Escaping gas stream heating the enclosed space of the engine bay. b. 'Hot plate' ignition as fuel sprayed on to the hot surfaces of the Module 7. c. Electrical spark from a damaged engine bay wiring loom. <p>The most likely of these was deemed to have been hot plate ignition due to the relatively large surface area presented by hot materials exacerbated by a heat soak rise in temperature on various FPT components as internal cooling gas flows suddenly stopped. This became a fuel fire fed by a continuous stream of fuel from the airframe fuel system via the ruptured pipe. The engine bay itself was not airtight but additional air was likely to have been introduced at this stage via holes which would have been made in the engine cowling by the FPT disintegration. The three elements of a fire were therefore present throughout; heat (ignition source), fuel and air.</p> | <p>Annex G</p> <p>Witness 13-19</p> |
| 1.4.36 | <p>The location of the LP Fuel Pipe in relation to the FPT was a function of ac design (organisational influence) which resulted in it being severed by the ejected aerofoil sections. The engineering investigation concluded that this transformed the whole nature of the emergency, which would otherwise have manifested itself as a single engine failure with hot gas leak. In the Panel's view, the crew would have been well placed to deal with an emergency of this nature based on their training and experience; however, the resultant fire and smoke significantly complicated the situation and ultimately led to the complete destruction of the ac. The Panel found that the severing of the No2 LP fuel pipe by the ejected aerofoil sections from the failed FPT which resulted in an engine fire/smoke was an aggravating factor.</p> | <p>Annex G</p> |

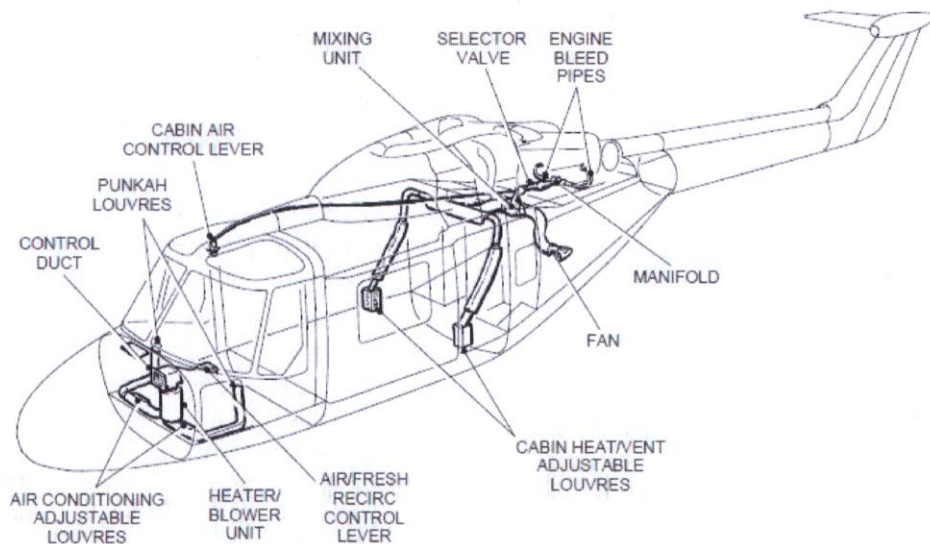
Fig 8 – Lynx Heating and Ventilation Systems

enter this intake it would have had to have been drawn forward and around to the opposite side of the fuselage from the No2 engine at an ac speed of 120kts. This, coupled with the size and position of the intake, approximately 100 x 40mm, made it improbable that this was the route by which the significant quantities of smoke described entered the cabin. It is worthy of note that the Lynx was not commonly renowned for drawing its own engine exhaust fumes into the cabin or cockpit heating system, further supporting the implausibility of this scenario.

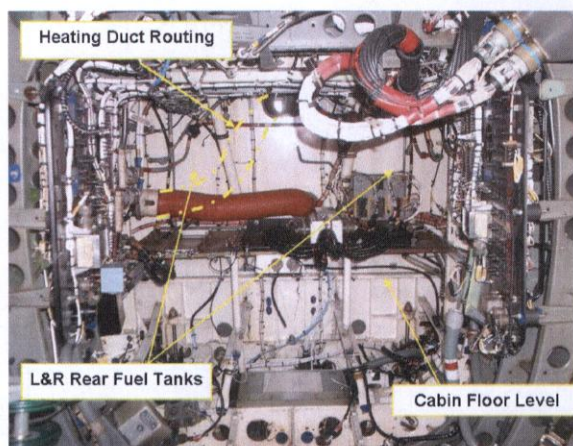
Fig 9 - Lynx Mk7 Rear Equipment Bay
(Avionics removed & heating duct disconnected)

c. **Heating Duct.** The external air component of the heating system travelled along a wire coil re-enforced neoprene duct situated at the forward bulkhead of the equipment bay and was mixed with the engine air in the mixing unit. It was probable that smoke and burning fuel entered the equipment bay via the heatshield holes. Consideration was given to the duct material producing the smoke by smouldering or burning as a result of being in the vicinity of burning fuel or other material in the equipment bay.

d. **Gaps in Cabin Bulkhead.** There were two separate fuel tanks situated against the bulkhead between the cabin and the rear equipment bay. Between the 2 tanks was a void gap of about 300mm wide at the rear of which was the skin separating the cabin and equipment bay. There were several rows of relays mounted on plates or boards attached to the bulkhead. Also at the top was the heating trunk passing through the bulkhead from the mixer unit. These items were covered by an insulation system overlaid on the fuel tank surfaces and covering the void gap from floor to roof in the form of a quilted synthetic blanket attached to the ac structure at the top, bottom and sides by Velcro. This covering would have greatly slowed or even prevented a large inflow of smoke being carried into the cabin. Damage from the engine failure was restricted to a narrow area directly in line with the FPT discs. The rearwards position of the engines, in particular the plane of the FPT being approximately 1.5m aft of the cabin rear bulkhead, meant that it was highly improbable that shrapnel could have penetrated the cabin or cockpit areas thus presenting a potential route for smoke ingress.

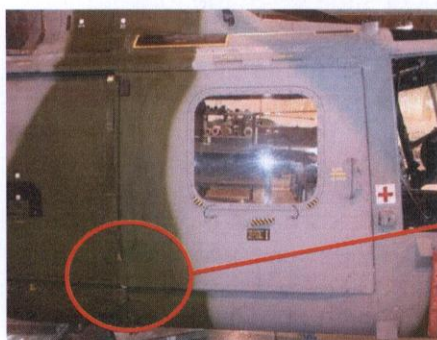
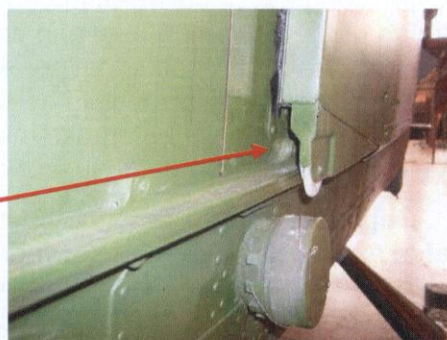
e. **Gap in Cabin Door.** At the time of the accident, the crew estimated that the air speed was approximately 120kts with the ac in a slight descent. Although the cabin doors were shut at the time of the incident, the possibility that smoke entered via gaps between the doors and fuselage was considered. The rotor rotated in an anti-clockwise direction when viewed from the top and there was a possibility that rotor disc downdraught might have drawn smoke forward and down from its source even at this forward velocity. The cabin doors and associated fittings were destroyed by the ground fire; however, examination of a serviceable Lynx Mk7 showed that the aft edge and bottom of the left and right cabin doors have 12mm open gaps when shut, through which smoke could pass (see Fig 12). However, for this to happen the lower aft area of the cabin doors and therefore the ac fuselage would have to be surrounded by smoke and there would also have to be a negative pressure in the cabin.

Fig 11 – Cabin Door

Fig 12 – Cabin Door Lower Edge

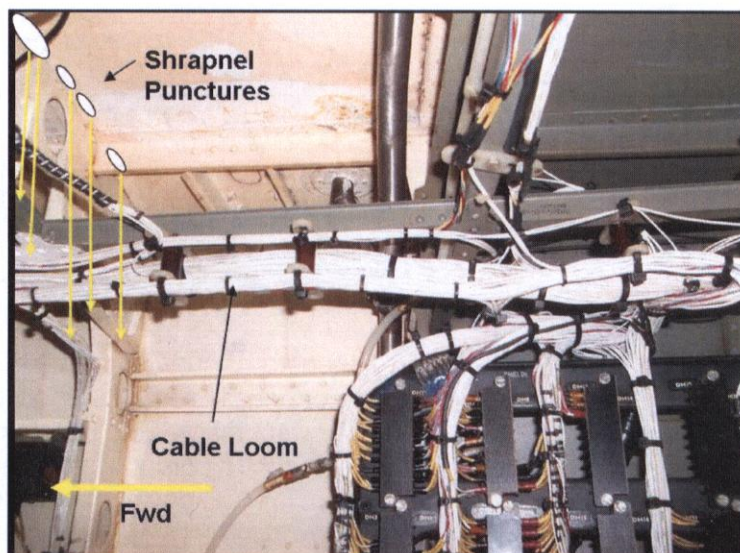
Fig 13 - Avionics Bay – Estimated Shrapnel Trajectories

1.4.50 **Other Systems Damage.** It was clear that the high energy release of the 2nd stage FPT aerofoil sections produced shrapnel⁶ which radiated outwards in all directions precisely in line with the position of the 2nd stage FPT disc. In so doing, they impacted anything in their narrow path, but may also have been deflected from their trajectory by more solid components. Examination of the remains of the wreckage showed that the aerofoil sections did significant but localised damage. Fortunately none of the shrapnel penetrated the engine bay heatshielding where it formed a tunnel between the No1 and No2 engines through which the tail rotor drive shaft passed. It was also important to note that none of the aerofoil sections entered the cabin and cockpit and the location and trajectory of the shrapnel did not present a direct risk to the crew.

1.4.51 In line with the FPT breakout hole on the engine bay floor there were a number of holes and splits in the heat-shield material. Directly beneath these holes, in the equipment bay, was a substantial wiring loom which ran longitudinally between fuselage frames, consisting of 25 wires which were the supply, return and earth cables for a number of engine and airframe sub-systems.

1.4.52 The engineering investigation concluded that the aerofoil sections may have caused disruption to this wiring loom. Although the fire damage was too great to establish which wires were damaged, AW conducted an analysis specifically considering the severing of some or all of the wires in this loom to understand the effect of losing one or more of these cables. In summary the potential losses fell into 2 categories:

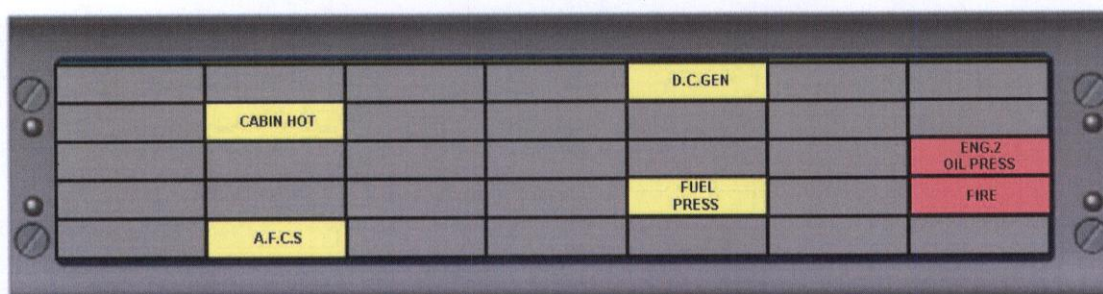
Fig 15 - XZ210 - Possible XZ210 CWP Caption Indications

a. **FIRE.** The red FIRE caption would illuminate when the temperature in either engine bay reached a critical temperature as detected by the firewire loop; this could be caused by a hot gas leak or fire in the engine bay. The FIRE caption would activate the Master Caution audio and illuminate the respective fire button and ECL warning light. In this case, it was likely that the caption was activated immediately after the 2nd stage FPT blade burst which allowed hot gas to escape. There was also the possibility that mechanical damage to the firewire from the FPT blade burst could have resulted in the activation of the caption. In addition, civilian witnesses on the ground reported having seen the ac on fire whilst airborne, which would have activated the caption. Based on the statement by the LHS Pilot, the No1 engine FIRE warning system (ECL fire button indication) also activated at some point during the accident sequence; the Panel judged that this occurred once the heat from the failed engine spread to the No1 engine bay. As the fire in the No2 engine had already illuminated the single FIRE caption, the subsequent activation of the No1 engine fire detection system would not have re-activated the Master Caution audio.

b. **ENG 2 OIL PRESS.** The red ENG 2 OIL PRESS caption would activate when engine oil pressure fell to the level where the pressure gauge pointer moved into the red sector. In this case, the evidence suggested that damage to the oil scavenge system in the form of holes in the scavenge bowls associated with the No 9, No 10 and No 11 bearings resulted from the FPT burst damage; additionally, various oil supply and return pipes were dented and ruptured. It was therefore judged highly likely that oil pressure would have immediately dropped sufficiently to put the gauge into the red “danger zone”, illuminating the CWP caption and activating the audio attention getter.⁸

have illuminated after the failure of No2 engine. In this case, it was possible that damage to the associated wire in the upper starboard loom within the avionics bay (as described in para 1.4.52 above) resulted in the activation of the caption. The No1 engine would have continued to drive the No1 DC starter/generator thereby maintaining the DC supply to the ac.

d. **FUEL PRESS.** The amber FUEL PRESS caption would illuminate when the pressure switches on the LP manifold indicated that the pressure in the system was less than 0.14 bar, which could be due to booster pump failure or fuel leak. In this case, the caption would have activated when the LP fuel pipe was cut by the 2nd stage FPT burst.

e. **CABIN HOT.** The amber CABIN HOT caption would activate when the temperature in the cabin air mixing unit was above 100°C, it may be caused by the fan failing to switch on automatically when HOT was selected in the cockpit. In this case, there was potential for the temperature sensor downstream of the mixing unit to have been activated due to fire within the avionics bay where the unit was located.

f. **AFCS.** An amber AFCS caption could indicate a variety of failures within the AFCS system. In this case, it was possible that the caption illuminated when damage occurred to the associated wire in the upper starboard loom within the avionics bay as described in para 1.4.52 above.

1.4.56 There was no evidence to suggest that any other captions would have illuminated. While the lack of FDR removed the possibility of definitive conclusions regarding sequencing, the Panel judged that the red FIRE and ENG 2 OIL PRESS captions were likely to have activated almost immediately, triggering the Master Caution audio attention getter. The Panel found that the lack of CWP/rad alt audio warning to the CM intercom box was detrimental to the crew member's situational awareness and was an **other factor**.
