PART 1.4 – FINDINGS

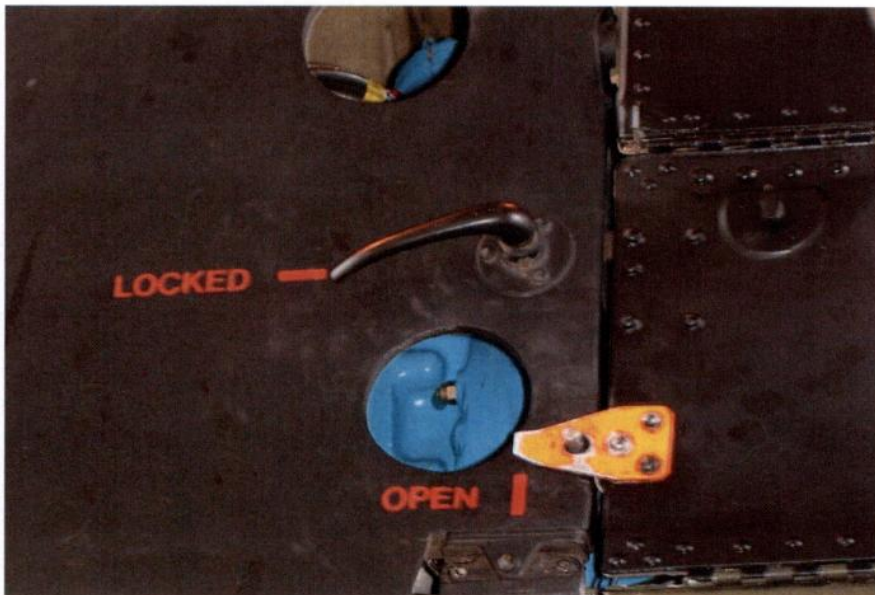
(1) The primary locking handle was found in the locked position at Accident Site 2. There was no evidence to suggest the handle had suffered mechanical failure in flight, and as far as could be reasonably determined, the handle was fully serviceable at the time of the accident. Therefore, the CM either forgot to lock the primary handle prior to flight or the locking mechanism failed in flight. Based upon technical evidence, the Panel considered it most likely that the CM did not secure the primary handle correctly. The Panel therefore found the failure to secure the primary handle was a **breached defence** and **contributory factor**.

Figure 1 – Primary Handle Unlocked

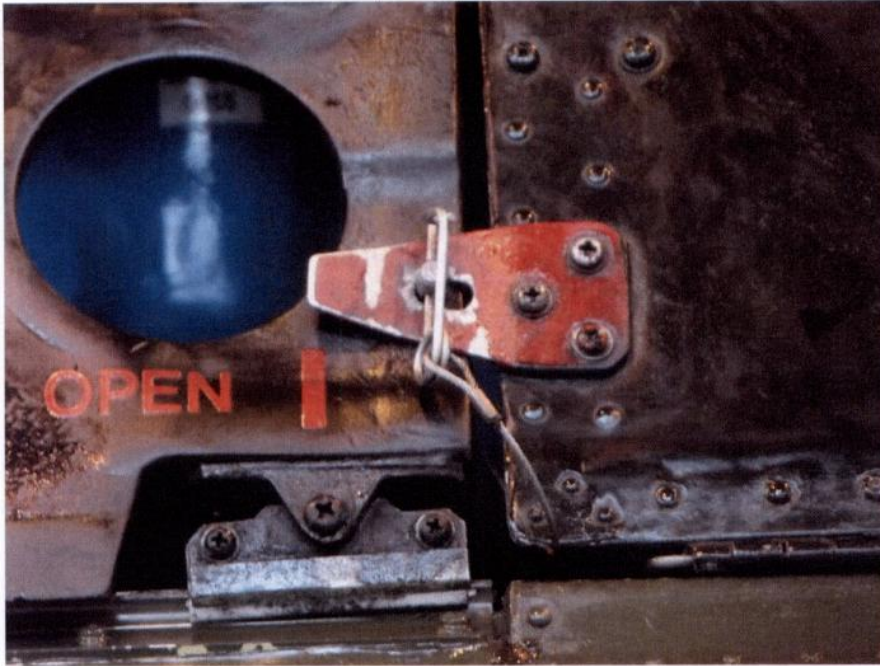
(2) All components of the secondary locking device were found still attached to the ECU cowling, undamaged and fully serviceable. Therefore, the CM either forgot to secure the secondary locking device (bolt and pin) or secured it incorrectly. Since he recalled struggling to secure the bolt and pin, and the NHP watched him carry out this task, the Panel found it most likely the CM secured it incorrectly. The Panel therefore found the failure to secure the secondary locking device was a **breached defence** and **contributory factor**.

c. **Lanyard.** The Panel made the **observation** that the CM did not correctly route the lanyard for the bolt and pin, iaw AP101C-0801-1D3. Instead, the CM routed the wire lanyard under the cowling rather than through the cowling’s access hole. As the incorrect routing was not considered to affect the safety or security of the MRGB cowling, the Panel found the incorrect routing of the lanyard was **not a factor** in the accident.

Figure 2 – Un-gated Locking Indicator Pin (Lanyard Routed Incorrectly)
