PART 1.3 NARRATIVE OF EVENTS

1. On Thur 27 Jan 11, CACTUS 2 was part of a pairs Operational Conversion Unit (OCU) Long Course Simulated Attack Profile (SAP) sortie. The staff pilot and aircraft (ac) captain occupied the front seat and the student Weapon Systems Officer (WSO) occupied the rear seat. After departing RAF Lossiemouth at 1348, the aircraft (ac) proceeded to Tain Air Weapons Range (AWR) where it dropped a single 14Kg practice bomb, after which it continued at medium level to simulate a Paveway IV TIALD attack. On completion of this attack, the ac descended to low level for the remainder of the sortie. At 1435:46 the crew reported hearing a loud machine-gun-like noise emanating from the right-hand side of the ac. The pilot of ZG792 diagnosed this as an engine surge. He immediately brought both throttles back to idle whilst maintaining less than 10 units alpha. The NH appeared to be decreasing, in response to the throttles being brought back to idle, but the right NH continued to decrease below a level usually expected when selecting idle. At this time the pilot noticed that he had REHEAT and R OIL P captions and informed his WSO that he was shutting down the right engine

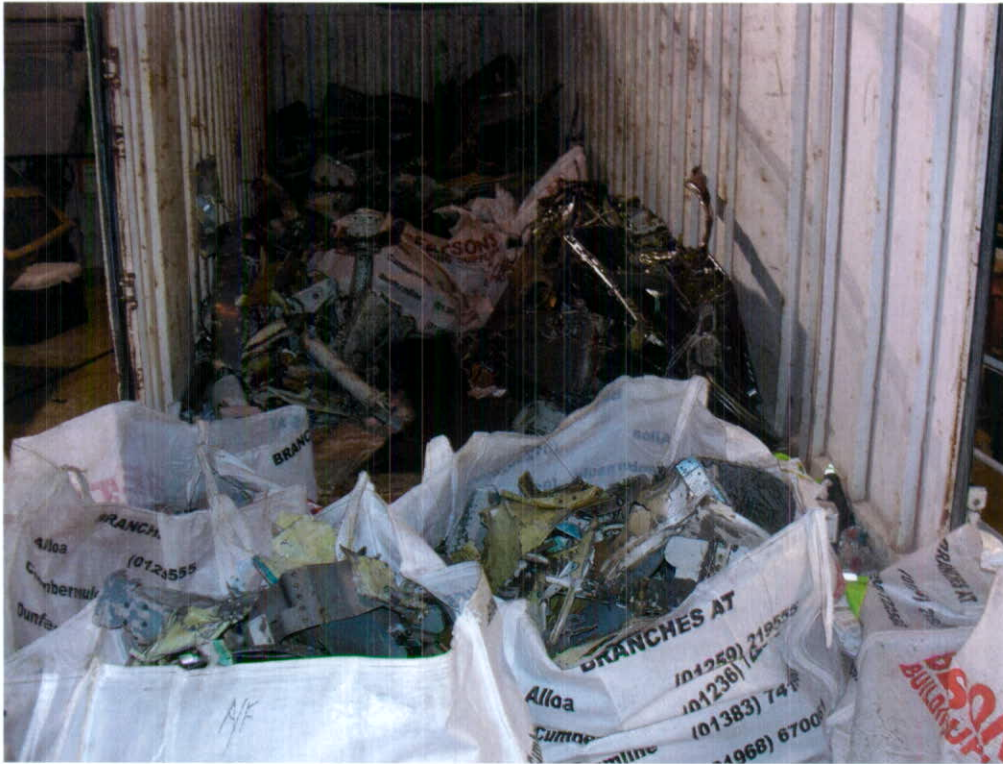
Figure 1 - One of two ISO containers housing the recovered parts of ZG792.
