PART 1.3 – NARRATIVE OF EVENTS

1.3.1 At 1405 on 1 Dec 11, Lynx AH Mk7 XZ210 of 1 Regiment Army Air Corps (1 Regt AAC) departed Gütersloh with a crew of 3 on a routine training flight. The sortie was being flown as part of a 6 monthly Qualified Helicopter Instructor (QHI) check for the left hand seat (LHS) Pilot with an intended profile of a standard tasking scenario including some low level navigation. Simulated aircraft (ac) emergencies were introduced by the ac commander (ac cdr) at various stages of the sortie.

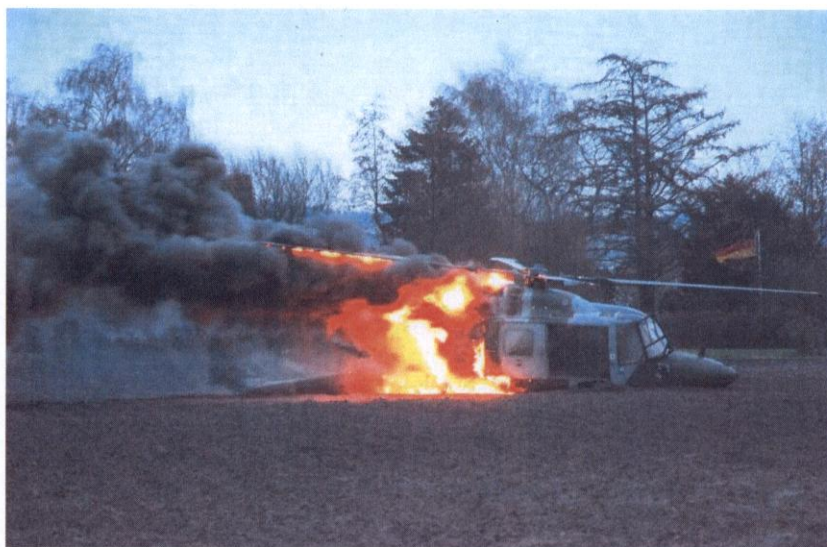
1.3.2 After approximately 1hr 35 mins of flight while in the cruise, having completed various general handling manoeuvres without incident, a major mechanical event within the No2 (starboard) engine took place which initiated an airborne fire within and around the engine bay area. The crew heard a loud bang coupled with the illumination of several red and amber captions on the Central Warning Panel (CWP) and associated audio warning; additionally, the handling pilot reported loss of ac stability.

Fig 1 - XZ210 on fire at the crash site

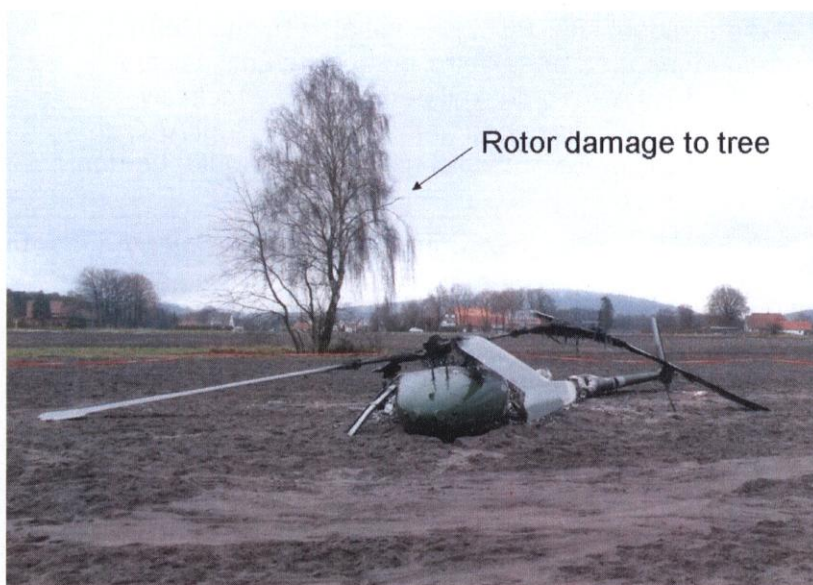
Fig 3 - Remains of XZ210 at the crash site

1.3.33 The ac had landed on fire but intact on its skids, with its nose pointing approximately into wind in a southerly direction. The fire consumed and collapsed the main cabin and cockpit, causing the engines, gearbox and rotor head to settle adjacent to the starboard side of the ac. The tail boom also burnt through aft of the avionics bay and fell to the ground, subsequently rolling over to port.

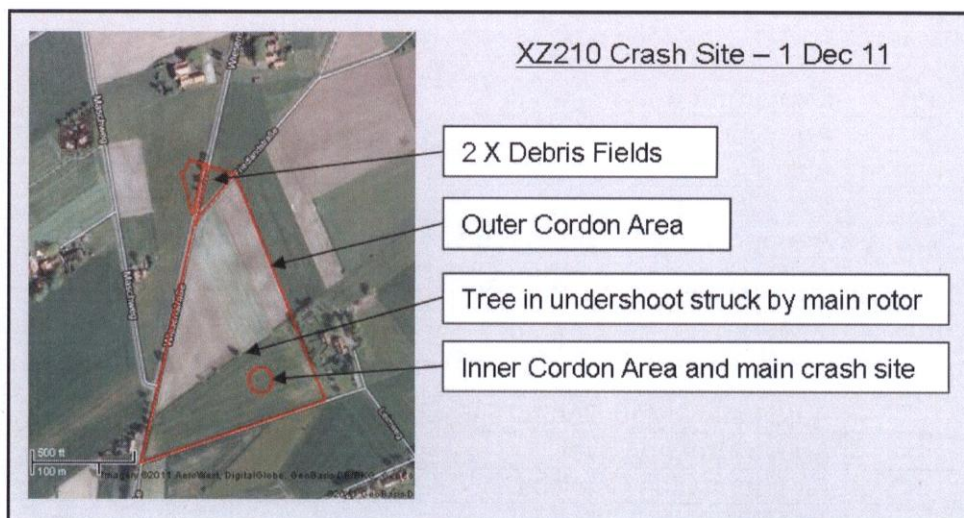
Fig 4 - XZ210 crash site search areas

1.3.42 **Search Process.** During the instigation of the Outer Cordon area, some small items of debris were discovered to the northern edge of the Outer Cordon. A brief line search was conducted by Military Air Accident Investigation Branch (MilAAIB) investigators who identified further fragments; as a result, a more detailed search was instigated using personnel from JARTS and the PCM team. The search was primarily looking for bits of cowling and Free Power Turbine (FPT) blades. The search covered the area of the Outer Cordon and parts of the two fields adjacent to the outer cordon as indicated at Fig 4. The search yielded small fragments of melted aluminium, which appeared to have been ac skin.
