ROYAL AIR FORCE BOARD OF INQUIRY

INTO THE LOSS OF:

**HERCULES XV179
(IRAQ - 30 JAN 05)**

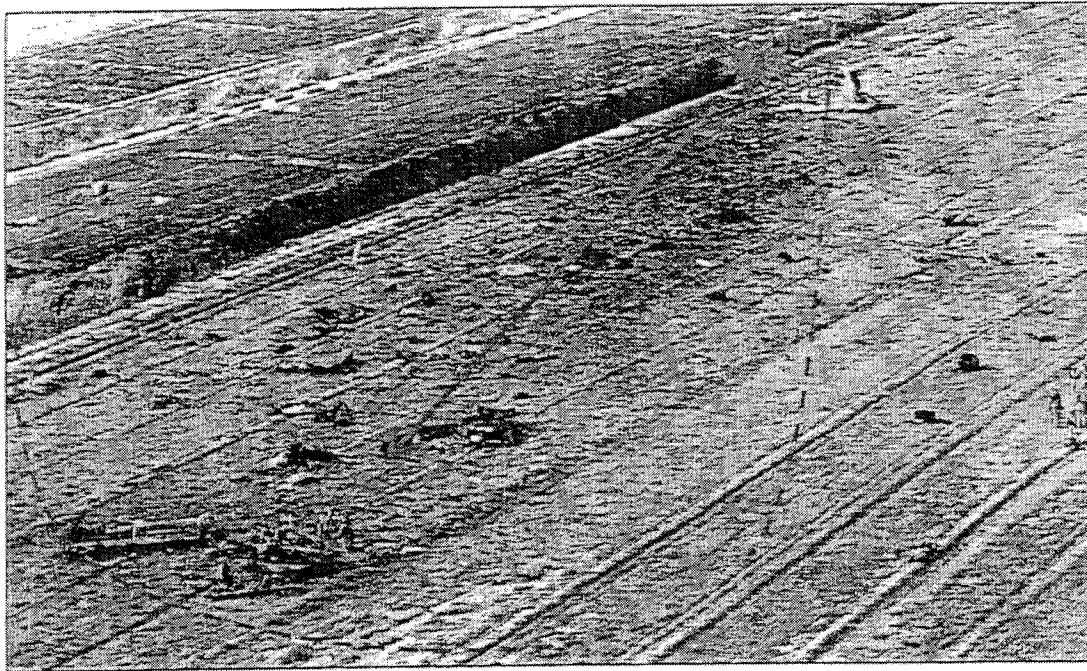
Fig 2.6

stated that the wreckage was consistent with an impact of this nature.

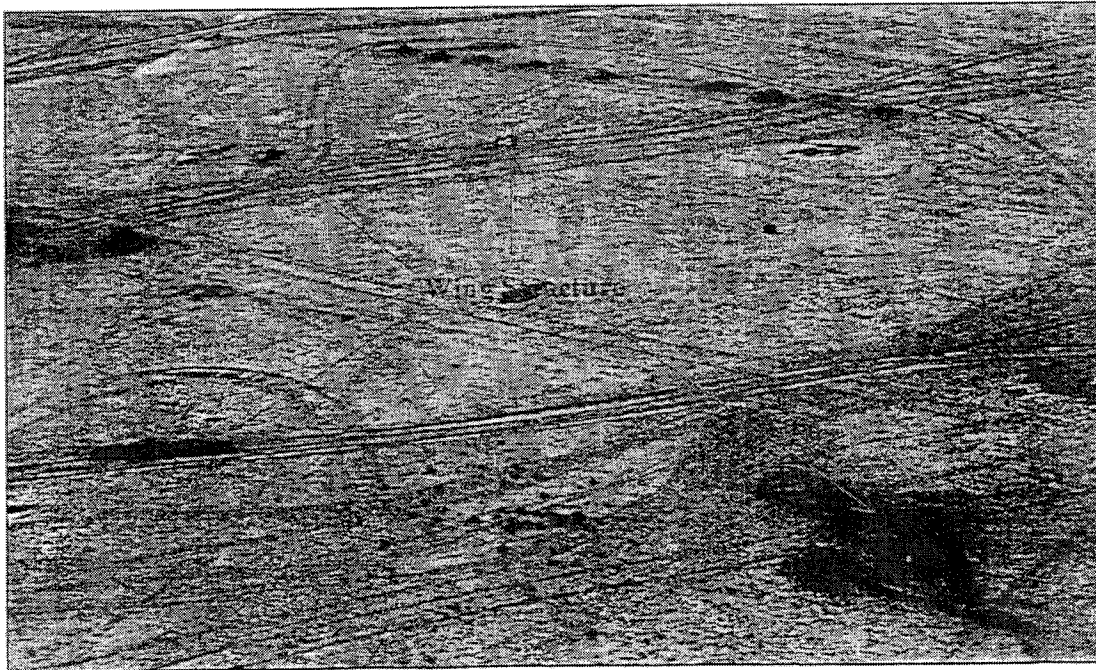
Fig 2.7

b. Remote Site. The wreckage at the remote site was contained within a 100 m radius, as shown at Fig 2.7. The distance between individual wreckage items and the lack of ground witness marks proves that the separated wing section had broken apart before impacting the ground. Suspect were found in the structure and there was evidence of both in-flight and ground fires. From the photographs, MA and the AAIB were able to identify the vast majority of the separated section of right-hand wing.

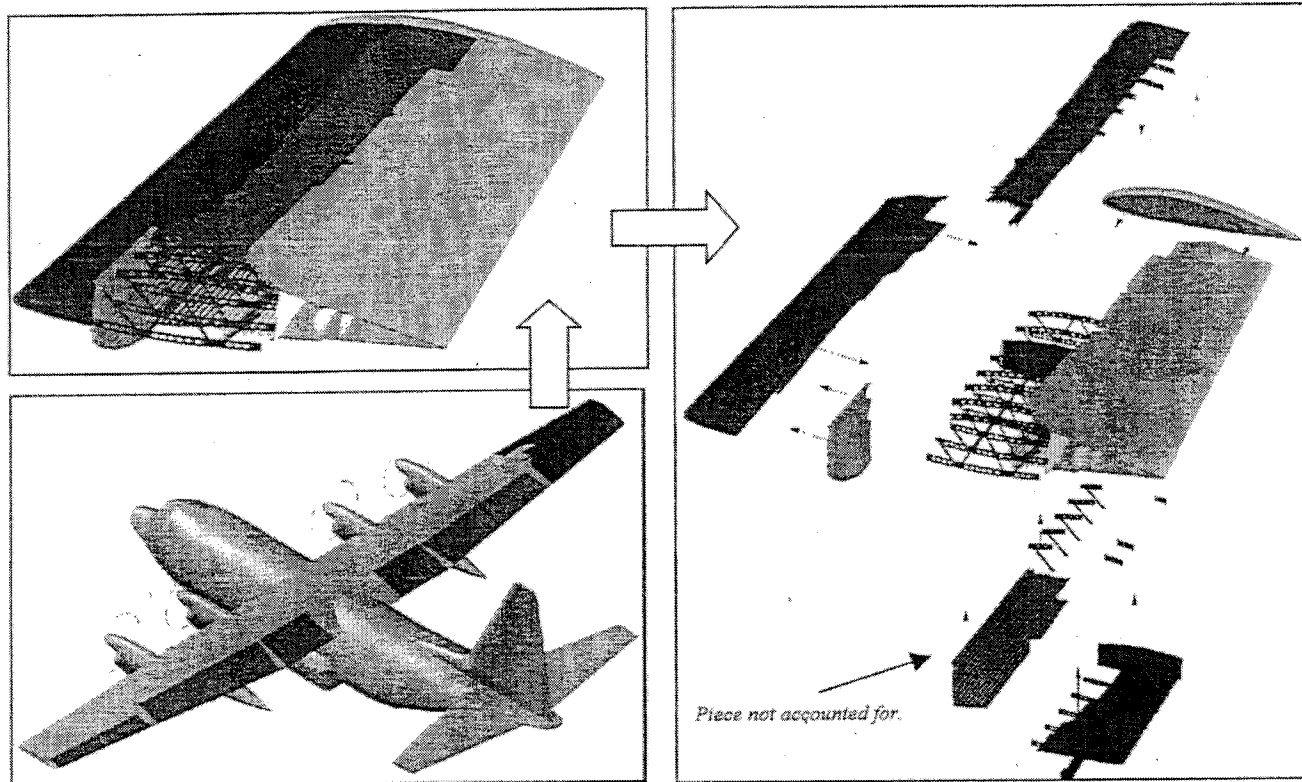
41. The Nature of Wing Separation. The large, relatively intact, but separate sections of outboard wing prove that the wing blew apart due to an internal overpressure. This conclusion is supported by the lack of bending or yielding in the metal structure and the fact that the separated wing section had not detached in one piece, as might be expected from a fatigue failure. Break surfaces were consistent with brittle fractures and fracture lines were random and did not track. The extent of the wing damage is shown in Fig 2.10, which also depicts a computer representation of the individual pieces found at the remote crash site. The over-pressure that

Extent of separated wing section.

Representation of wreckage found at the remote site.

separated the wing must have occurred in the number 4 fuel tank, which extends from the wing tip to the right-hand outboard engine. The cause of this explosive event has been considered in detail by the AAIB Senior Investigator, who concludes that it is most likely to have been caused by an ignition of the fuel/air mix in the space above the fuel, known as the ullage. Aviation fuel as a liquid will not explode; however, the ullage contains a fuel/air mixture that can explode if ignited under the correct conditions. A number of factors, such as fuel/air ratio, temperature, pressure and agitation of the fuel, can affect the volatility of the fuel/air mix. In the case of XV179, the fuel would have been relatively warm, due to the ambient air temperature, and ac manoeuvring could have agitated the tank contents, which would have resulted in more fuel evaporation and increased the fuel vapour content in the ullage. Additionally, the agitation would result in 'misting' which increases volatility. Equally, a fuel leak caused by the

observed damage could have reduced the tank quantity thereby increasing the ullage volume, or a fire, caused by the damage, could have increased the ullage temperature. There is some evidence of airborne fire damage to the separated wing sections and the remaining section of right-hand wing at the main crash site. However, the AAIB conclude that there was no evidence consistent with a sustained airborne fire in the separated wing section and that the fire damage visible in this part of the wreckage occurred after separation, either as the sections fell or as a result of subsequent ground fire. There is evidence of sustained airborne fire on the remaining section of wing at the separation point, which is also likely to have occurred after separation, although evidence for this is less conclusive. This fire caused significant damage to the trailing edge of the wing, in the vicinity of OWS 300, and the observed damage is indicative of significant and sustained sideslip. After detailed inspection of the separation at OWS 317, the AAIB Senior Investigator concluded that there was some evidence of a large penetration consistent with impact. Two localised areas contrasted strongly with the more regular pattern of failure observed elsewhere on the separated wing section. The location of this suspect damage is shown in Fig 2.11. If such a penetration existed, it would allow rapid draining of the fuel tank, provide a possible source for sustained fire and locally reduce the wing's structural strength, which would account for this area becoming the separation point. The source of ignition for the explosive over pressure is discussed later in this report; however, the Board has concluded that the explosive separation of XV179's wing was caused by the ignition of the fuel/air mix in the number 4 fuel tank ullage. Furthermore, the Board concluded that the lack of a suppression system within the fuel tank, such as foam or inert gas, was a contributory factor. The Board also concluded that the violence associated with the separation and the resulting fire, caused significant damage to the remaining section of wing. Consequently, the aerodynamic effect on the ac would have been more significant than the loss of the outer wing section in isolation.
