# ***AAIB Bulletin***

***2/2018***

Boeing 767-36N	G-POWD	19-Mar-17	3
----------------	--------	-----------	---

<b>Aircraft Type and Registration:</b>	Boeing 767-36N, G-POWD	
<b>No &amp; Type of Engines:</b>	2 General Electric Co CF6-80C2B7F turbofan engines	
<b>Year of Manufacture:</b>	2003 (Serial no: 30847)	
<b>Date &amp; Time (UTC):</b>	19 March 2017 at 0900 hrs	
<b>Location:</b>	En route from London Stansted Airport to Rzeszow-Jasionka Airport, Poland	
<b>Type of Flight:</b>	Commercial Air Transport (Passenger)	
<b>Persons on Board:</b>	Crew - 9	Passengers - 262
<b>Injuries:</b>	Crew - None	Passengers - None
<b>Nature of Damage:</b>	None	
<b>Commander's Licence:</b>	Airline Transport Pilot's Licence	
<b>Commander's Age:</b>	52	
<b>Commander's Flying Experience:</b>	8,965 hours (of which 2,635 were on type) Last 90 days - 24 hours Last 28 days - 24 hours	
<b>Information Source:</b>	AAIB Field Investigation

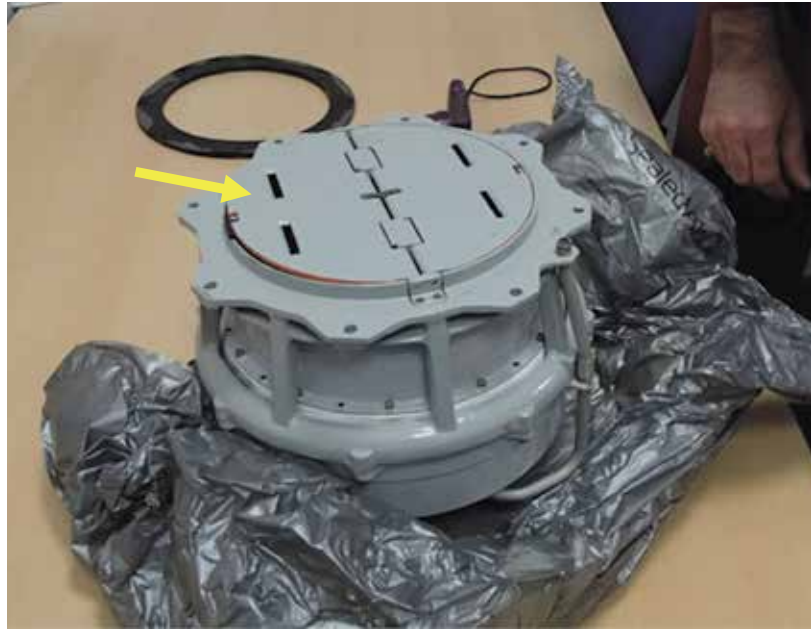
**Figure 1**

Testing and strip examination of the faulty valve proved inconclusive, with no obvious reason for the malfunction being found. The possibility of debris trapped in a metering section of the valve could not be ruled out, although no evidence of this was found.

External inspection of the aircraft revealed that the indicator flag on the upper PPRV upper door flap was visible (Figure 1, arrowed), indicating that the valve had operated in flight, allowing cabin air to leak overboard.

Defective positive pressure relief valve,  
as removed from G-POWD

Whilst the reason for the PPRV's failure was not found, the manufacturer calculated that the valve would have opened at around 3.5 psi differential pressure if a piece of debris as small as 0.0033 inches in diameter had become trapped underneath the ball valve in either the primary or secondary metering section.

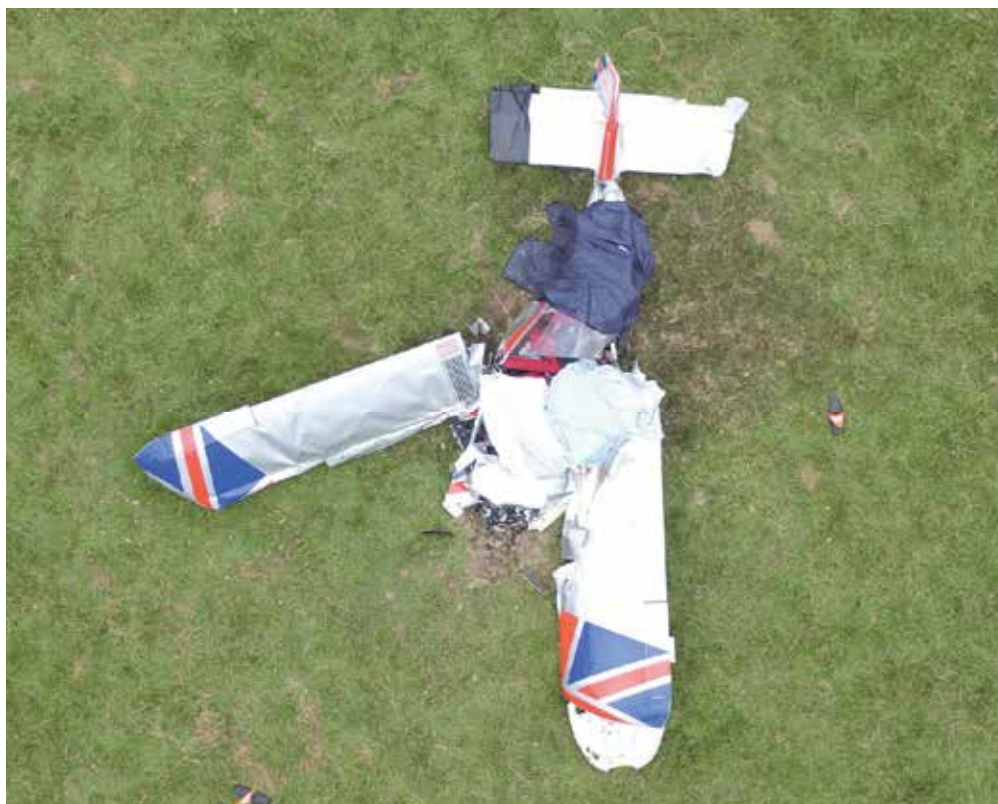
**Figure 2**

The aircraft wreckage was found in a field near Builth Wells, about 360 m and 102° from the last recorded radar return. The wreckage was resting in its initial impact crater, indicating that it had a high vertical speed and low forward speed at impact (Figure 2). The left wing had folded forwards and had sustained significant impact damage to its leading edge near the root but no damage to the outer portions. The right wing had suffered leading edge compression damage along its entire length, and there was an imprint from the right wing in the ground, indicating a steep nose-down impact. Behind the tail, about 50 m away, was a section of the left wing belly fairing (Figure 3). Between this point and the main wreckage site there were no other parts of wreckage.

Overhead view of the aircraft wreckage at the accident site

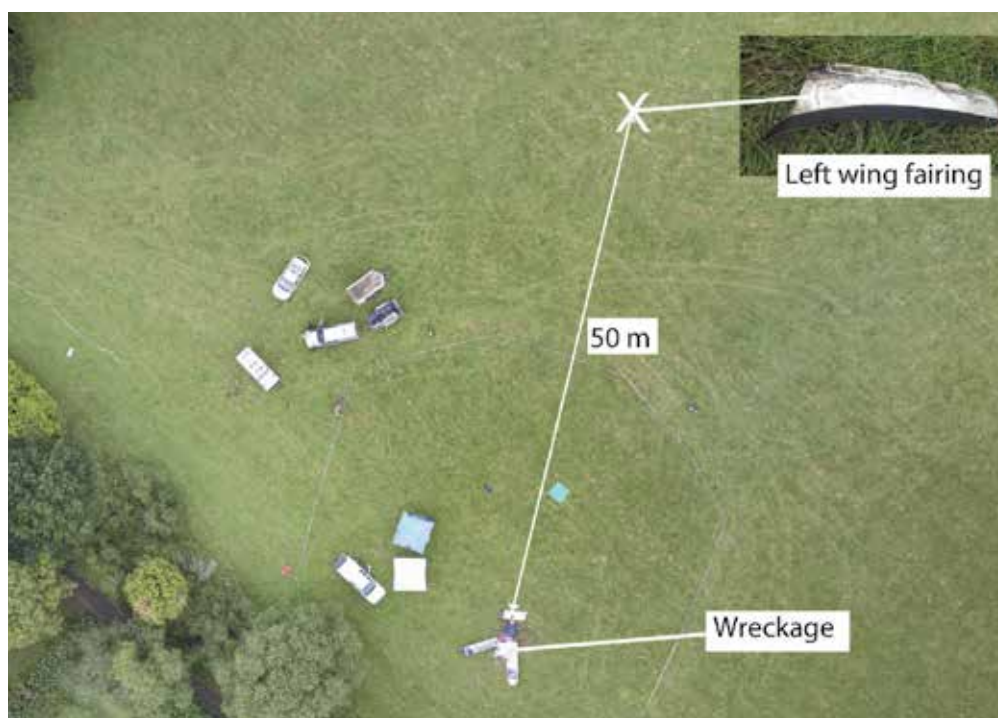
**Figure 3**

Overhead view of the accident site showing distance to the left wing lower fairing

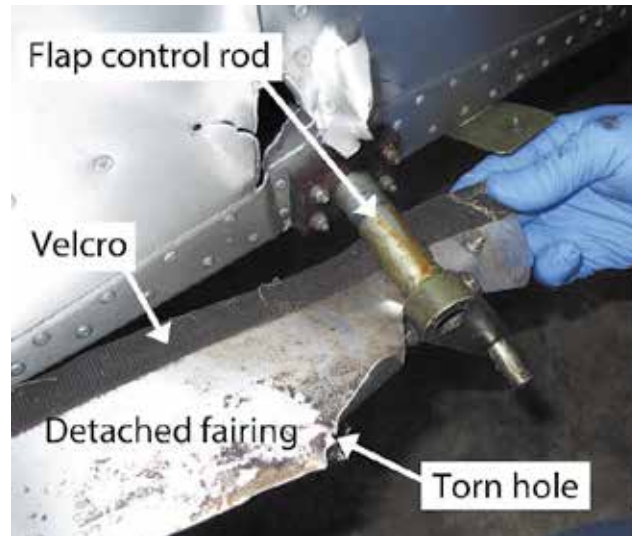
**Figure 7**

The section of left wing belly fairing, which was found 50 m away from the main wreckage, had torn holes where it had been attached by screws to the underside of the left wing. This fairing is not physically attached to the fuselage, but rests against its underside with a strip of Velcro to avoid fretting. There was an indentation in the fairing consistent with it having been pulled against the flap control rod (Figure 7).

Detached left wing belly fairing held alongside the left fuselage of a different EV-97 aircraft

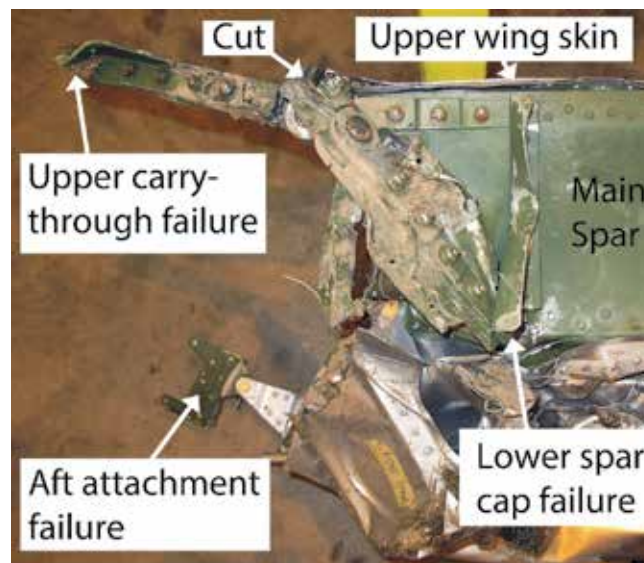
**Figure 8**

The right wing had remained attached and had suffered some internal damage as a result of crushing damage along the length of its leading edge. The left wing had suffered from a structural failure of its lower spar cap and the upper 'carry-through' spar cap in the fuselage had also failed (Figure 8). Both the upper and lower 'main-spar-to-fuselage' attachment fittings were intact; the lower fitting was cut on the fuselage side to enable the wing to be removed. The left wing aft attachment fitting had separated from inside the fuselage. These parts were sectioned and taken to a forensic organisation for detailed metallurgical examination.

View of the forward face of the left wing main spar showing the three failure locations and where the lower forward fuselage attachment was cut in order to remove the wing

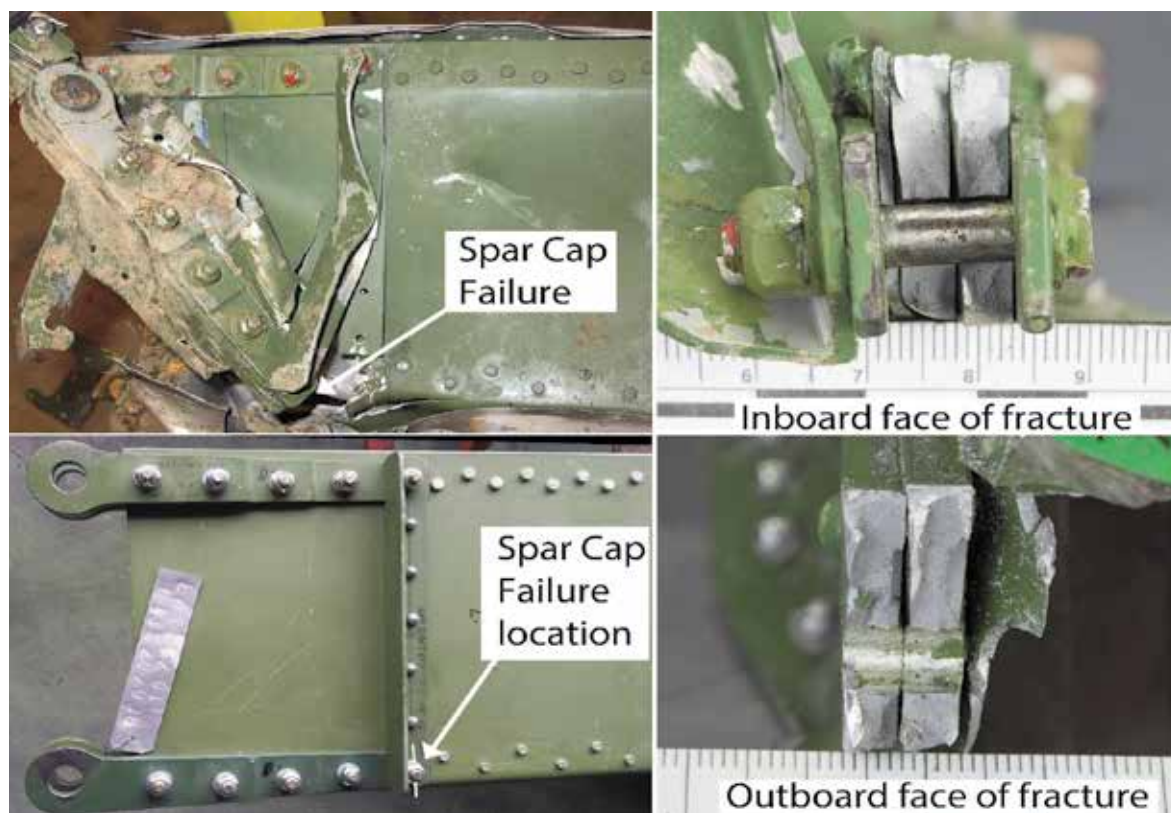
**Figure 9**

The lower wing spar cap consisted of two strips of 2024 T3 aluminium plate fastened together. Each strip had a cross-section of 25 x 5 mm, with the forward facing strip, known as the 'long cap', having a machined radius on one edge. The aft facing strip was known as the 'short cap' due to its shorter length. At the inboard end of the cap, the two strips, along with the web, were sandwiched between two steel attachments which were held together by five 6 mm diameter bolts. The fracture of the spar cap had occurred at the fifth outer bolt (Figure 9).

There was mechanical damage on the forward face of the web in the area of the fracture which suggested that there had been forward movement of the outboard section of the spar cap relative to the inboard section after failure, when the outboard section of spar was inclined upwards by about 25°. Both spar cap fracture surfaces were found deformed in a manner consistent with upwards bending, and there was 'necking' which is characteristic of overload failure. The fracture surfaces were examined in a scanning electron microscope (SEM) which revealed that both had failed in tensile overload with no evidence of fatigue or corrosion.

Top left: view of spar cap failure.  
Bottom left: location of spar cap failure on a new main spar.  
Top right: View of spar cap fracture looking inboard.  
Bottom right: View of spar cap fracture looking outboard

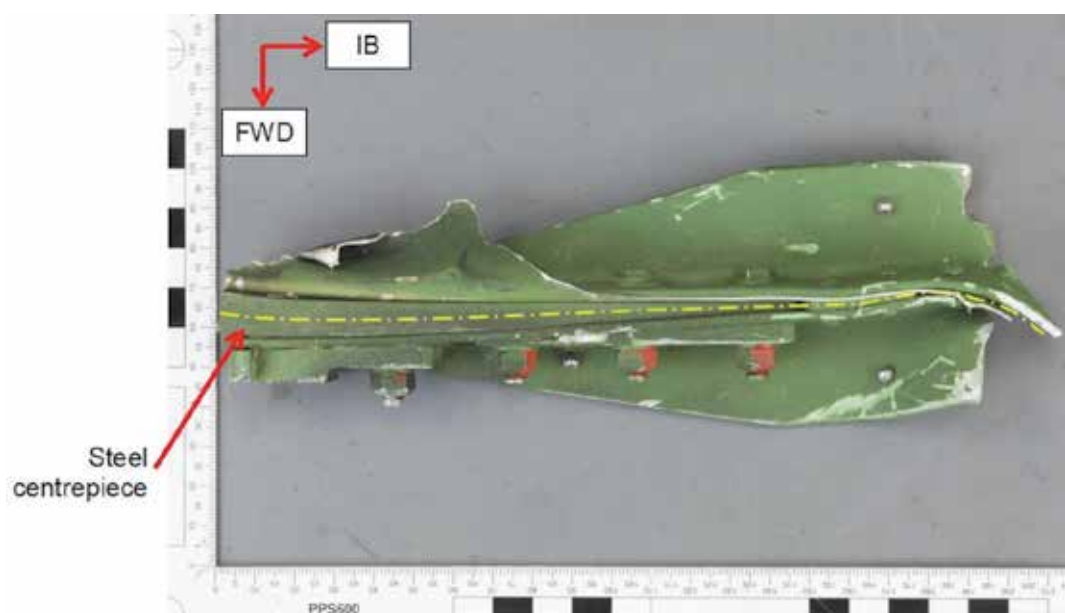
**Figure 10**

The upper carry-through spar had failed inside the fuselage beneath the left pilot's seat and this area had suffered significant crushing damage during the impact after the landing gear collapsed. There was extensive deformation of the lightweight aluminium structure around the fracture, which was consistent with the left wing moving forward. The steel centrepiece (Figure 10) was also found deformed, with an 'S' shape characteristic of buckling. However, SEM examination revealed that the fracture surfaces had ductile 'dimples' characteristic of tensile overload failure with no evidence of shear or compression. It appears that the upper spar was deformed in compression before failing in tension. There was no evidence of fatigue or corrosion.

Lower surface of upper carry-through spar. Cut on left side and fractured on right side. Centre section is made of steel. Fractured parts are aluminium

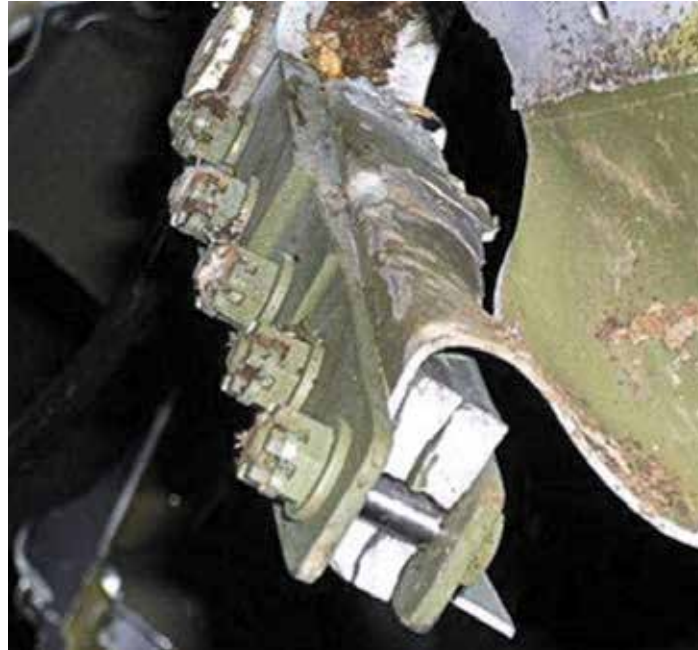
**Figure 11**

a UTS of 515 MPa. The Swiss investigators also tested the strength of the spar cap on another EV-97 which revealed a UTS of 366 to 385 MPa. As a result of these findings the spar caps on all new EV-97 aircraft, including G-GARB, were replaced with 2024 T3 material (minimum UTS 441 MPa) which was cut from plate instead of being extruded. An inspection programme was also carried out to check the strength of all in-service spar caps<sup>9</sup>.

Left wing lower spar cap failure of EV-97 registration 9-249 in Switzerland in 2006

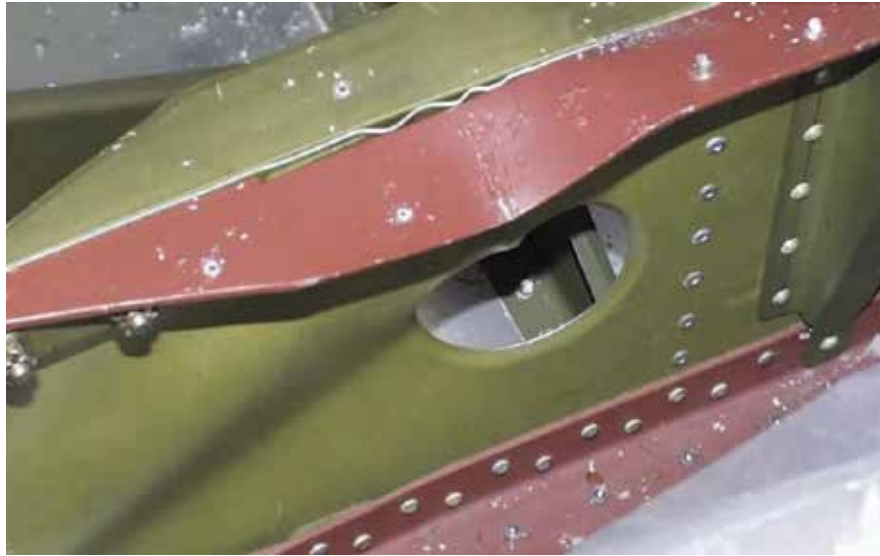
**Figure 12**

Upper carry-through spar buckling which occurred at 1.6 times limit load during the wing strength static test

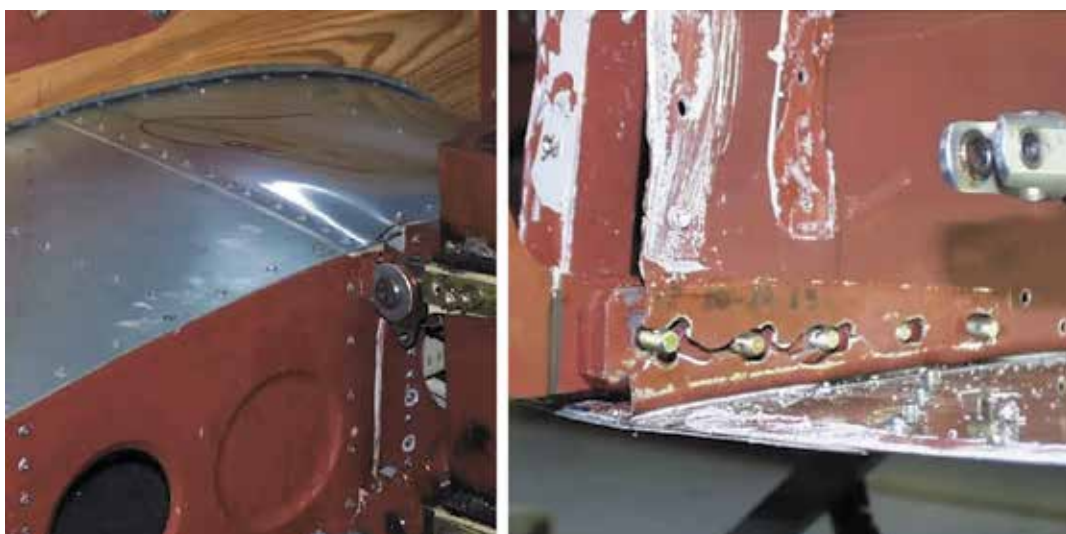
**Figure 13**

Upper wing skin buckling (left) and main spar web failure (right) at 1.68 times limit load during the wing strength static test

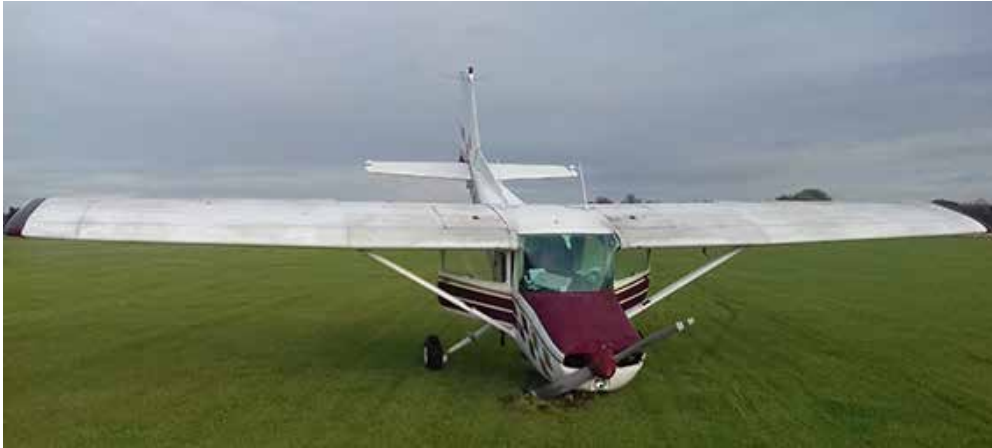
**Figure 1**

was not available. The instructor was therefore unable to prevent the aircraft descending but he held the control column fully back, to prevent the aircraft diving towards the ground and to try to cushion the subsequent touchdown. It landed heavily on both mainwheels but the nose leg had already detached and it pitched forward and both the nose and the right wing tip contacted the ground. The tail rose until the fuselage was inclined almost vertically, for a few seconds, before the aircraft toppled back onto its mainwheels (Figure 1). The occupants then switched off the fuel and electrics before opening their doors and vacating without difficulty.

G-BABC resting on its lower engine cowling

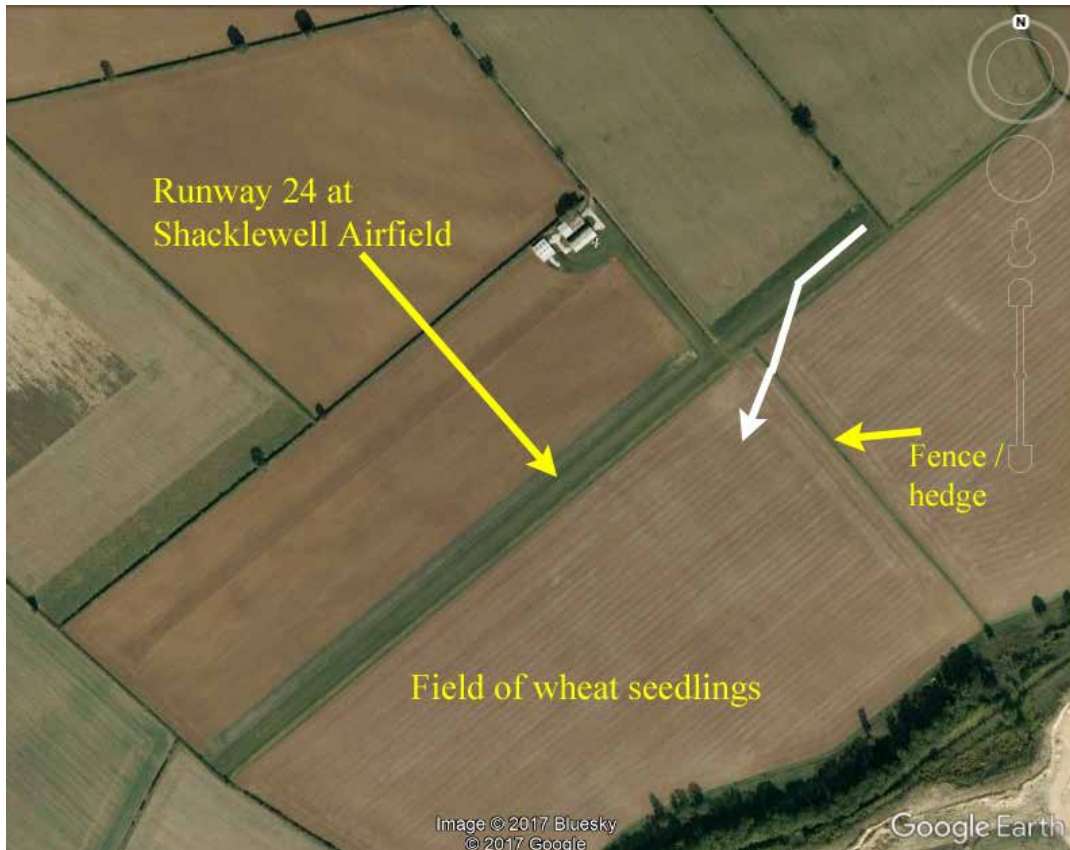
**Figure 1**

Inspection of the aircraft's tyre marks along the grass runway, revealed that those on the left side were deeper than those on the right because the grass there was wetter and softer. The pilot assessed that the drag on the left main gear was increased by the soft ground and he had insufficient rudder authority to overcome this. Earlier that day, when he arrived, he landed further along the runway and the ground there had been firmer. He believed that if he had inspected the threshold area before leaving he might have noticed the soft ground and avoided it, by taking off along the right side of the 15 m wide runway.

White line indicates aircraft's approximate path
