**REPORT OF THE SERVICE INQUIRY INTO  
THE GROUNDING OF HMS ASTUTE ON 22 OCT 2010**

**NARRATIVE OF EVENTS**

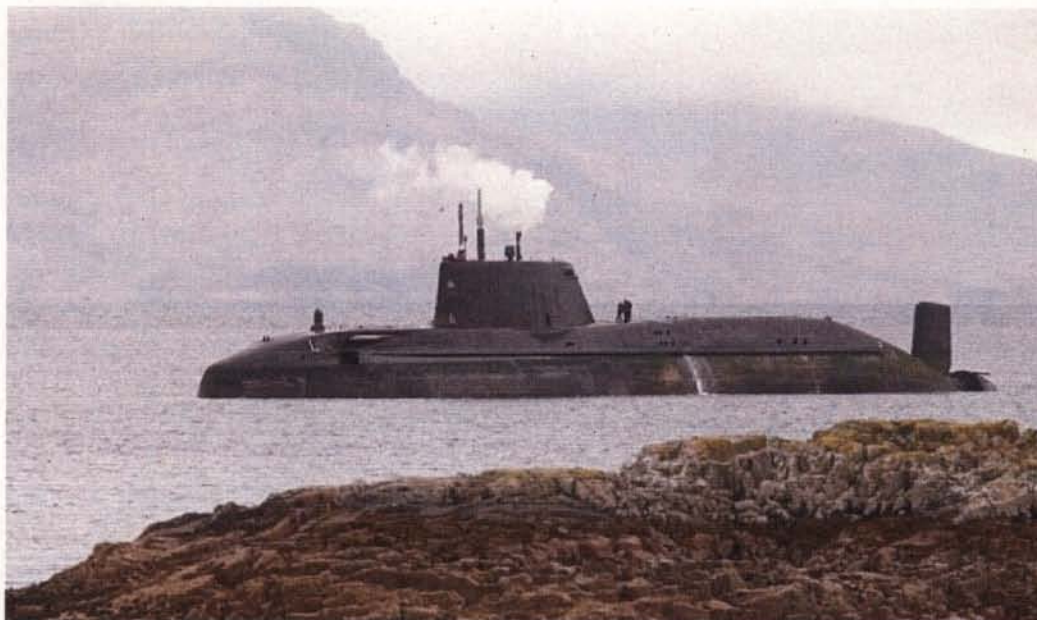
2. The root causes of the grounding were non adherence to correct procedures for the planning and execution of the navigation combined with a significant lack of appreciation by the OOW of the proximity of danger. However, a number of additional causal factors were present, including some deficiencies with equipment. In conducting the Service Inquiry much reliance has been placed on written and spoken statements because of a paucity of recorded electronic data<sup>1</sup>.

**Figure 1 – HMS ASTUTE Aground**

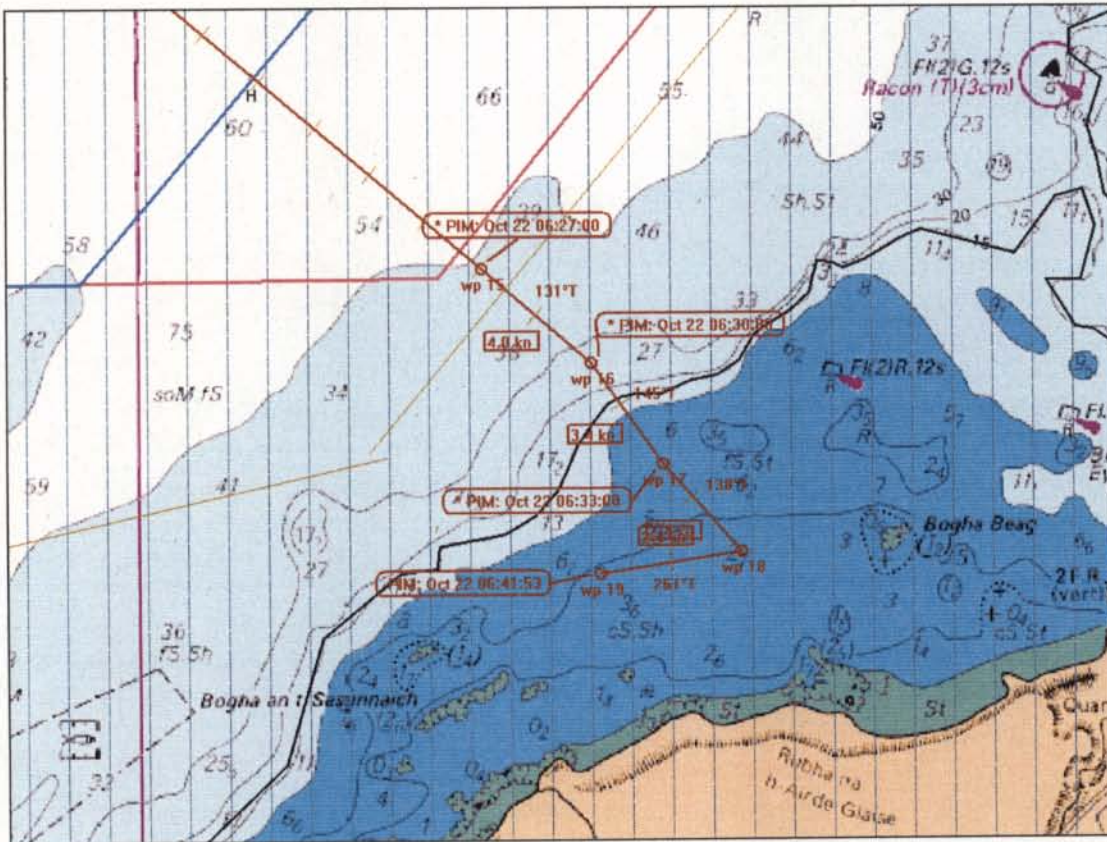
Figure 4 – Grounding Position

23. Realising that the submarine was now very likely aground and without any navigational information in the SNP, the XO (Lt Cdr [REDACTED]) ordered the telegraphs to stop and went below to look at the chart. Arriving in the Control Room at 0637Z he encountered the CO (Cdr [REDACTED]) who had arrived just before him. Both CO (Cdr [REDACTED]) and XO (Lt Cdr [REDACTED]) observed the submarine position on the chart, which was over the LDL and in a charted depth of 5m. ASTUTE's rudder draws 10.64 metres in a normal surfaced trim. The height of tide was calculated to be 4.8 metres at 0635Z<sup>43</sup>.

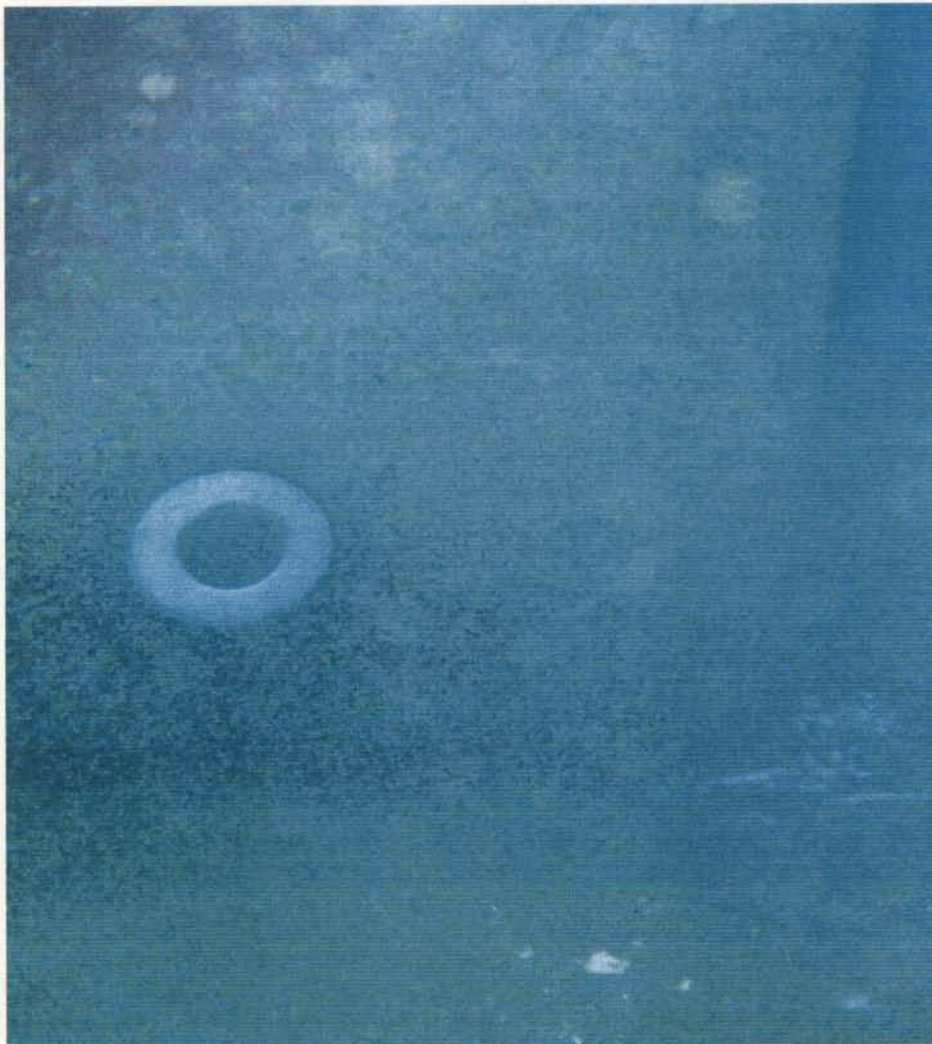
29. At 1230Z divers started an assessment of the condition of the hull and sea bed, reporting at 1330Z that the seabed consisted of soft sand and shale, with no rock. The hull was lying on the seabed with the rudder embedded in the sand and shale by 1-1.2m (Figure 5). At the request of the CO (Cdr ██████████) and CSALMO Representative (Mr ██████████) the divers then used the rib to conduct soundings and determine the best route to deeper water.

**Figure 5 – Rudder Skeg Embedded in the Sand and Shale**

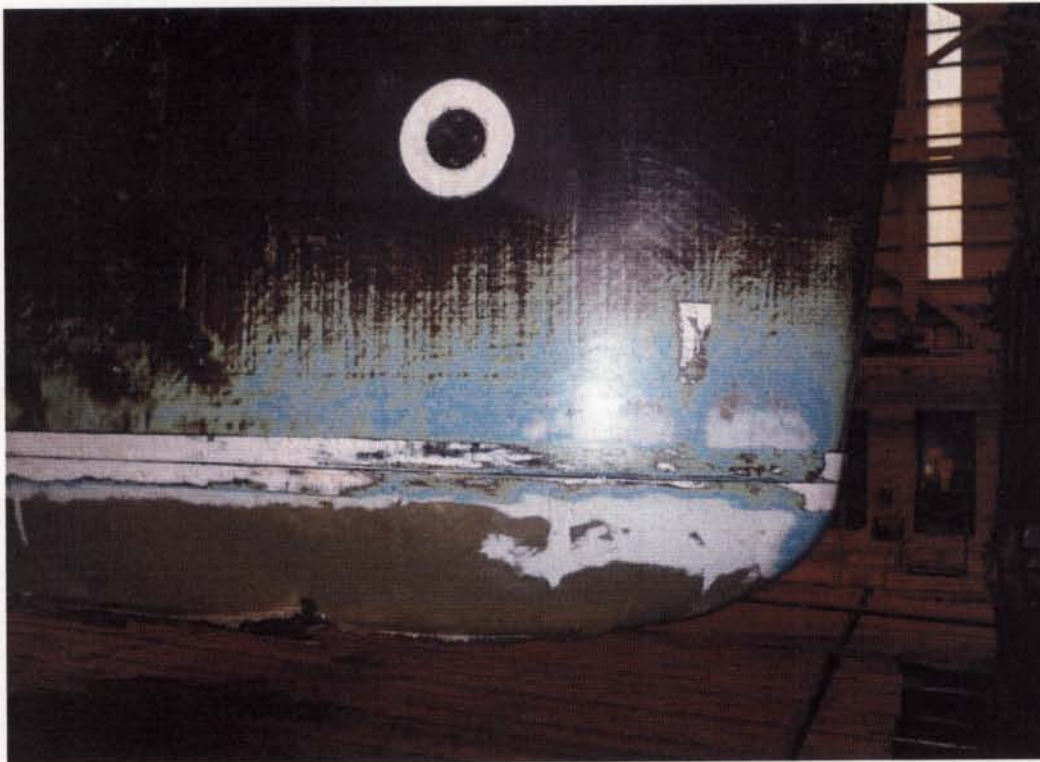
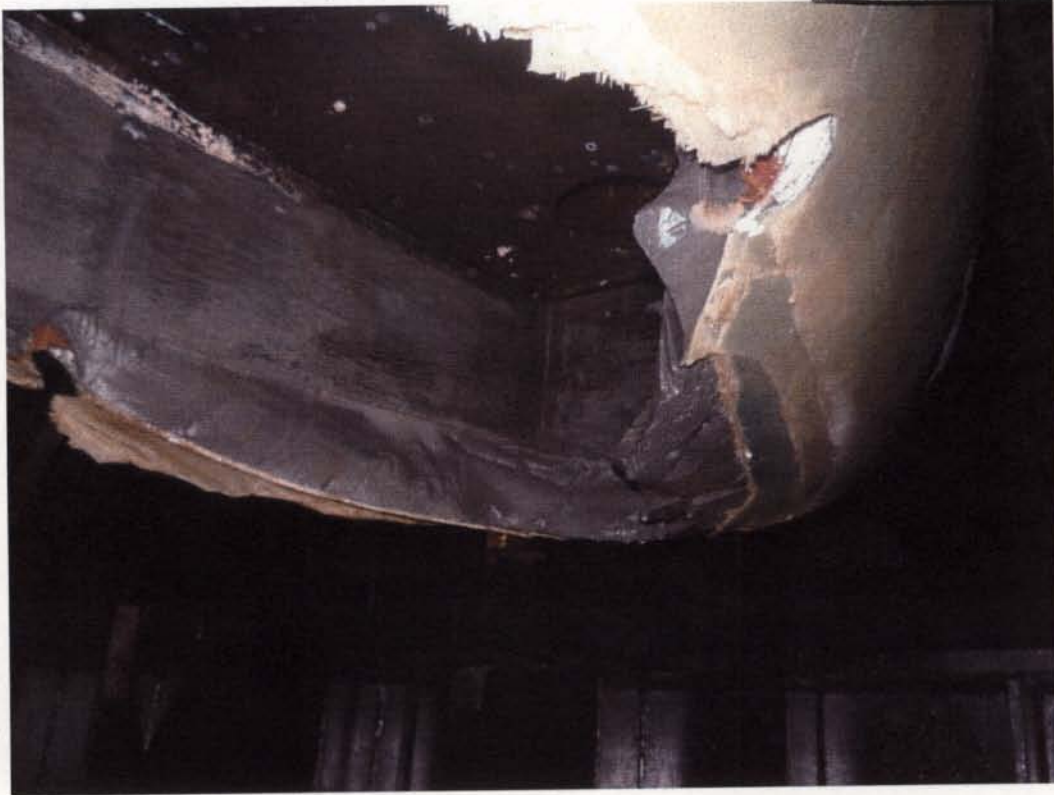
63. An inspection by the Northern Diving Group of the submarine whilst aground indicates the entire hull was resting neatly on the soft seabed. The rudder was seen to be embedded in the silt and slight damage to the leading edge of the rudder skeg was observed. The photographs of the damage caused by the grounding (Figures 7 and 8) show that there is no structural damage to the rudder. Damage is principally limited to the GRP Skeg which has been split and requires replacement and the BUTEC Pinger. Estimates of repair costs have yet to be completed but unit cost of the GRP Skeg and Pinger is estimated at £81K<sup>97</sup>. The rip tow was also deployed and will need replacement.

**Figure 8 – Internal Damage to GRP Rudder Skeg.**
