H.M.S CONQUEROR GREEN PASSPORT

HMS CONQUEROR GREEN PASSPORT

ASBESTOS SURVEY REPORT - TYPE 3

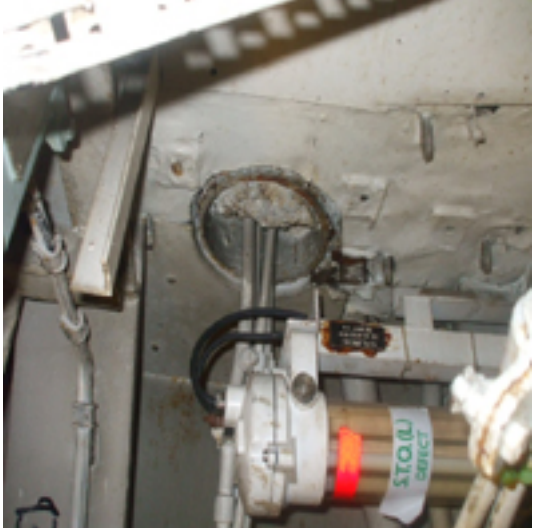
R2	HMS Conqueror	1/006 Sonar Room	covering to duct behind stbd wall partition	Asbestos-containing woven product	21054747-071	remove

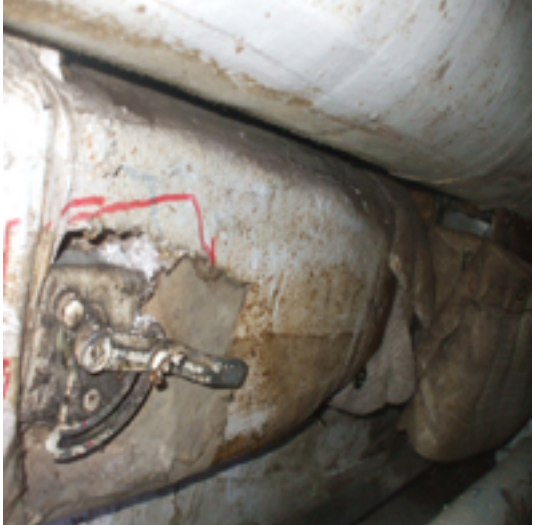
Risk Level Assessment	Vessel	Location	Item / Product Examined	Material Description	Sample No.	Initial Control Recommendation	Photograph
R2	HMS Conqueror	1/008 Control room	pipework in void above computer suite	Asbestos-containing lagging	21054747- 062	remove

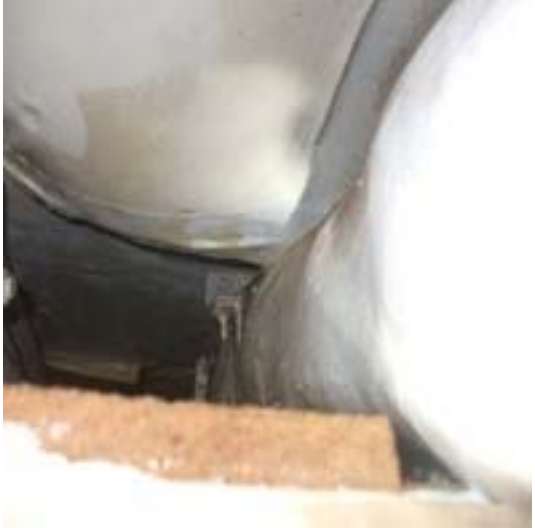
R2	HMS Conqueror	1/008 Control room	pipework above depth gauge	Asbestos-containing gasket	21054747- 065	remove

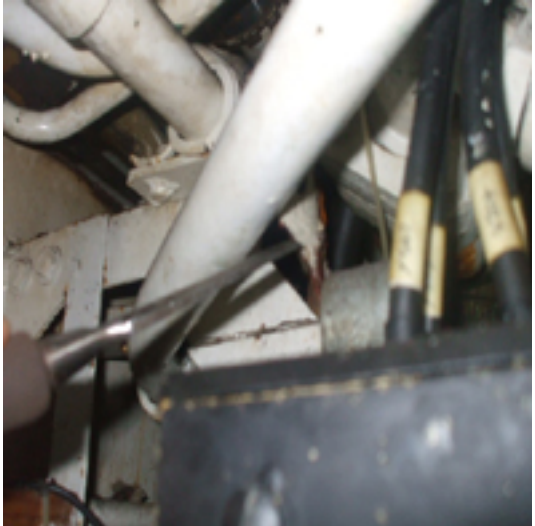
Risk Level Assessment	Vessel	Location	Item / Product Examined	Material Description	Sample No.	Initial Control Recommendation	Photograph
R2	HMS Conqueror	1/008 control room	putty sealant to previous periscope structure	Asbestos-containing mastic	21054747-073	remove

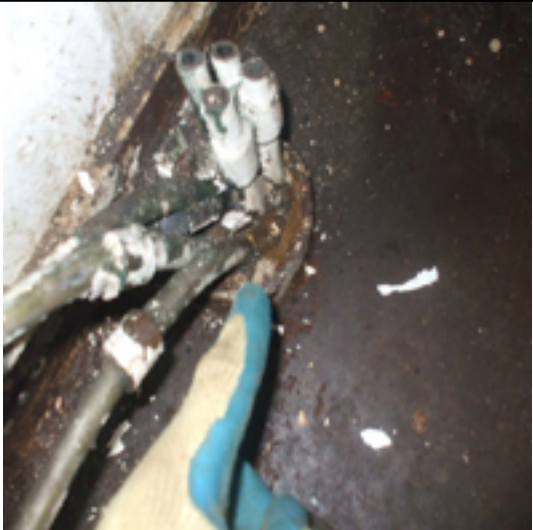
R2	HMS Conqueror	1/015 no.2 spare gear & naval stores	gasket residue to redundant equipment to floor	Asbestos-containing gasket	21054747-090	remove

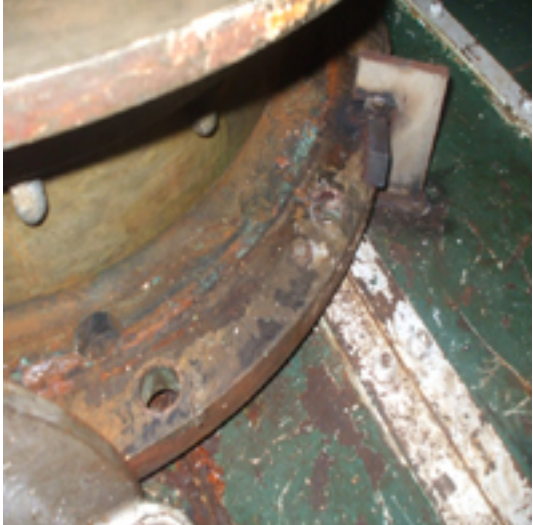
Risk Level Assessment	Vessel	Location	Item / Product Examined	Material Description	Sample No.	Initial Control Recommendation	Photograph
R2	HMS Conqueror	1/016 motor room - lower level	debris to floor (aft port side - frame 112)	Asbestos-containing gasket	21054747-096	remove

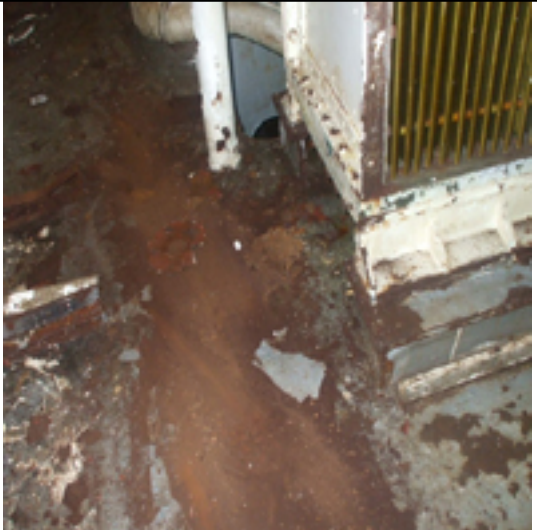
R2	HMS Conqueror	1/016 motor room - lower level	residue to bare flange joints	Asbestos-containing gasket	21054747-097	remove

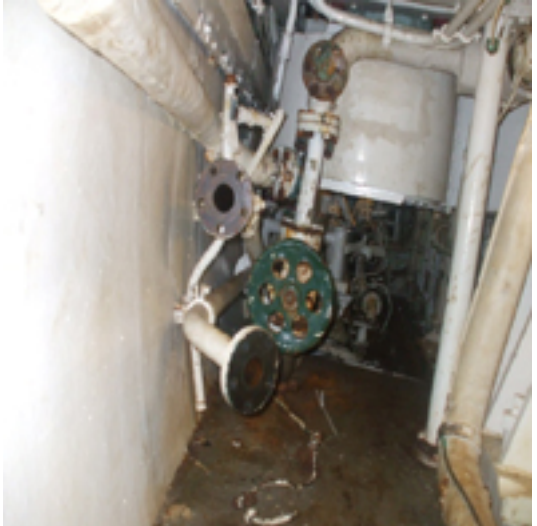
Risk Level Assessment	Vessel	Location	Item / Product Examined	Material Description	Sample No.	Initial Control Recommendation	Photograph
R2	HMS Conqueror	2/001 upper torpedo compartment	debris to floor below stbd lifting band stowage	Asbestos-containing gasket	21054747-004	remove	 
R2	HMS Conqueror	2/005 galley	gasket to oven door	Asbestos-containing woven product	21054747-021	remove

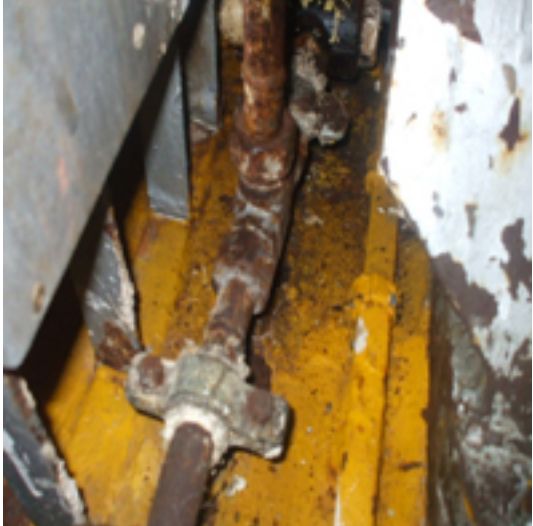
Risk Level Assessment	Vessel	Location	Item / Product Examined	Material Description	Sample No.	Initial Control Recommendation	Photograph
R2	HMS Conqueror	3/001 lower torpedo compartment	debris to void below torpedo chutes	Asbestos-containing gasket	21054747-011	remove

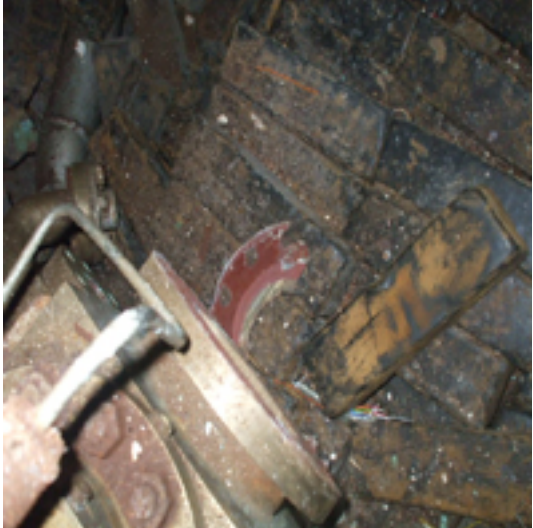
R2	HMS Conqueror	3/018 TG room	gasket debris to floor void	Asbestos-containing gasket	21054747-119	remove

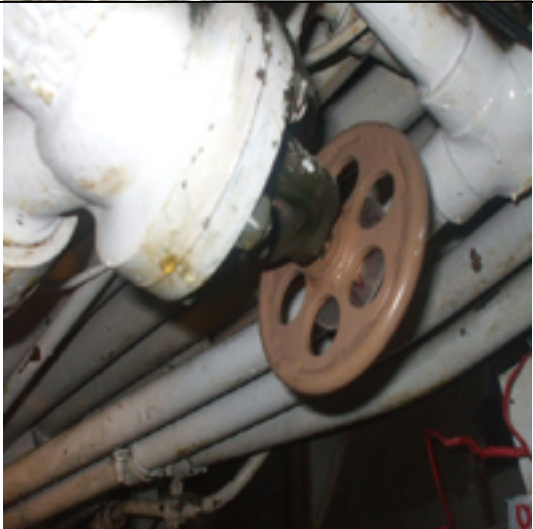
Risk Level Assessment	Vessel	Location	Item / Product Examined	Material Description	Sample No.	Initial Control Recommendation	Photograph
R3	HMS Conqueror	1/008 Control room	pipe work bracket behind redundant computers, starboard side	Asbestos-containing woven product	21054747- 063	remove

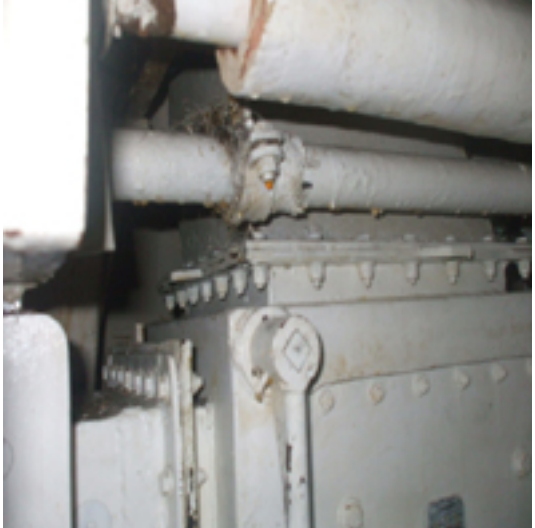
R3	HMS Conqueror	1/008 Control room	pipework	Asbestos-containing gasket	21054747- 064	remove

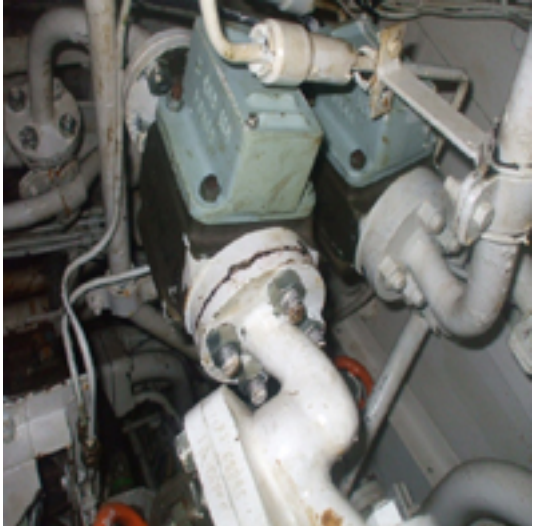
Risk Level Assessment	Vessel	Location	Item / Product Examined	Material Description	Sample No.	Initial Control Recommendation	Photograph
R3	HMS Conqueror	1/008 Control room	large pipe run behind water tank	Asbestos-containing woven product	21054747-066	remove

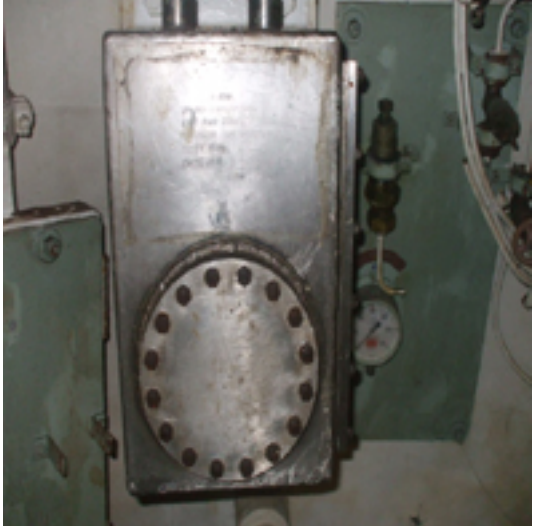
Risk Level Assessment	Vessel	Location	Item / Product Examined	Material Description	Sample No.	Initial Control Recommendation	Photograph
R3	HMS Conqueror	1/016 motor room	pipework	Asbestos-containing gasket	21054747-092	remove

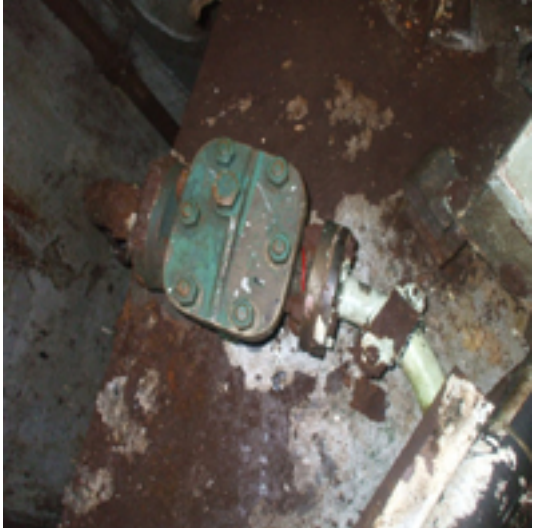
R3	HMS Conqueror	1/016 motor room	gasket to ATU's	Asbestos-containing gasket	21054747-094	remove

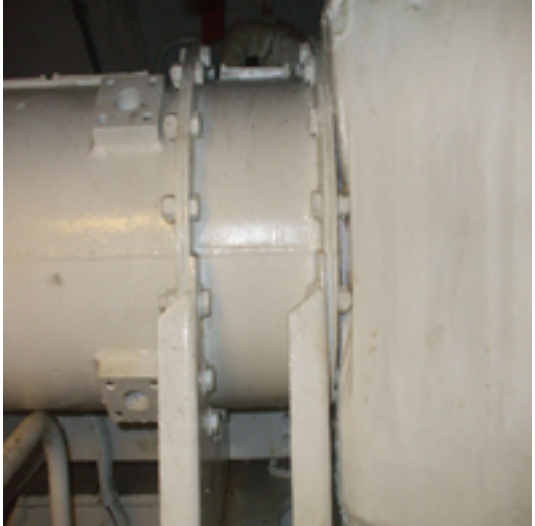
Risk Level Assessment	Vessel	Location	Item / Product Examined	Material Description	Sample No.	Initial Control Recommendation	Photograph
R3	HMS Conqueror	1/016 motor room	gasket to plates seals to tanks	Asbestos-containing gasket	21054747-095	remove

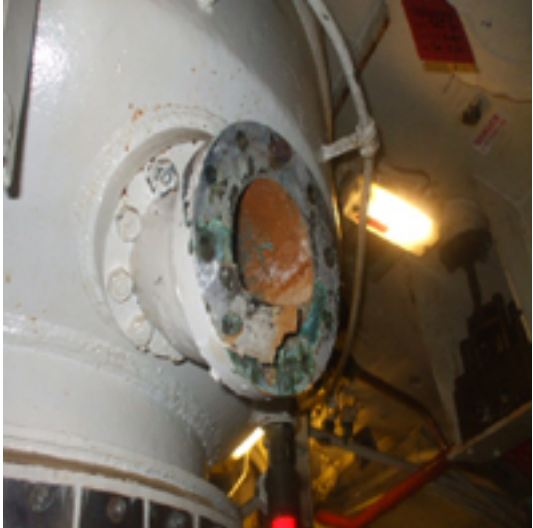
R3	HMS Conqueror	2/002 ships office	gasket putty to flange joints to air handling vents	Asbestos-containing composite	21054747-013	remove

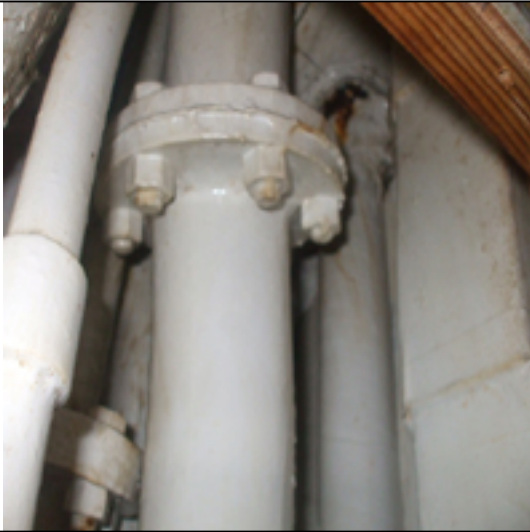
R3	HMS Conqueror	2/011 DG room	gaskets to serck heat transfer plates to AC generator	Asbestos-containing gasket	21054747-100	remove

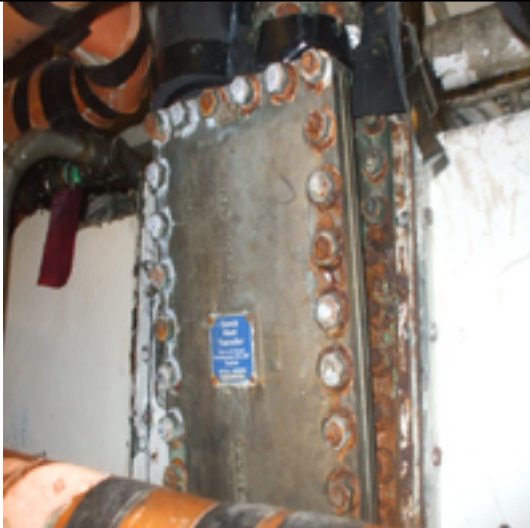
Risk Level Assessment	Vessel	Location	Item / Product Examined	Material Description	Sample No.	Initial Control Recommendation	Photograph
R3	HMS Conqueror	2/011 DG room	gaskets to air heater duct plates & pipework	Asbestos-containing gasket	21054747-101	remove

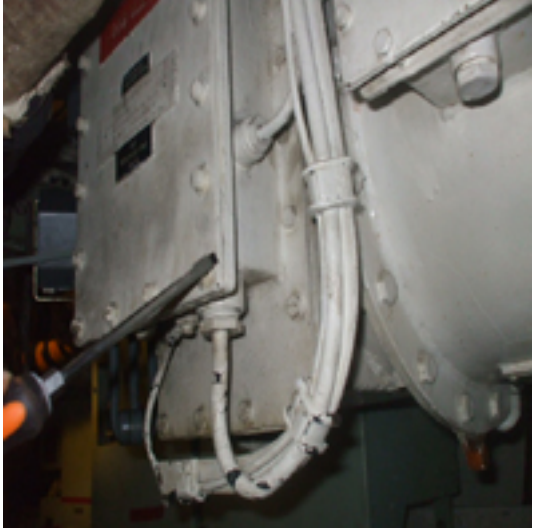
R3	HMS Conqueror	2/011 DG room	pipework	Asbestos-containing gasket	21054747-102	remove

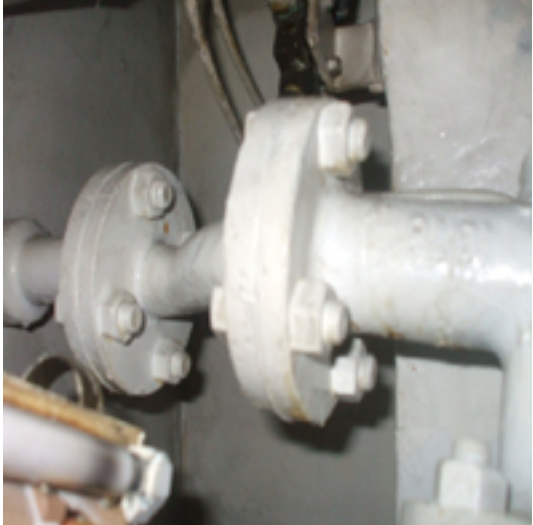
Risk Level Assessment	Vessel	Location	Item / Product Examined	Material Description	Sample No.	Initial Control Recommendation	Photograph
R3	HMS Conqueror	2/011 DG room	gaskets to diesel generator no.2	Asbestos-containing gasket	21054747-103	remove

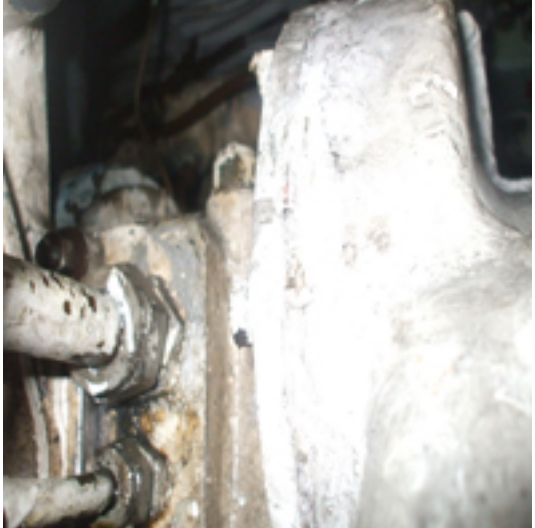
R3	HMS Conqueror	2/011 DG room	wrapping to white coloured 0.5inch pipe run behind diesel generator no.2 (frame 83)	Asbestos-containing woven product	21054747-104	remove

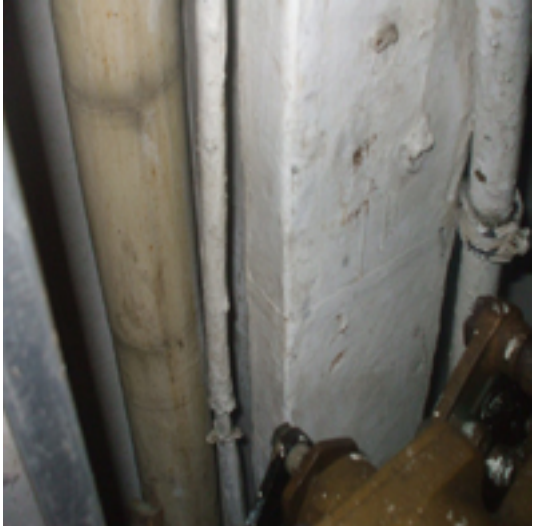
Risk Level Assessment	Vessel	Location	Item / Product Examined	Material Description	Sample No.	Initial Control Recommendation	Photograph
R3	HMS Conqueror	2/011 DG room	wrapping to brown coloured 0.5inch pipe run behind diesel generator no.2 (frame 83)	woven product		remove	 
R3	HMS Conqueror	2/011 DG room	fuseguards to main electrical supply controls	Asbestos-containing composite	21054747-105	remove

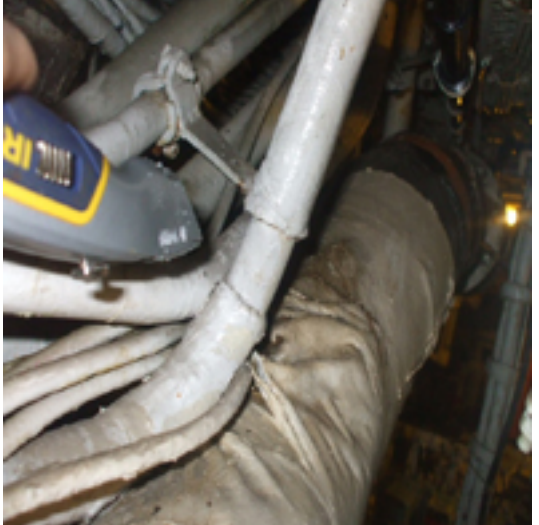
R3	HMS Conqueror	2/012 MMS	gaskets to ATU joints and plating	Asbestos-containing gasket	21054747-123	remove

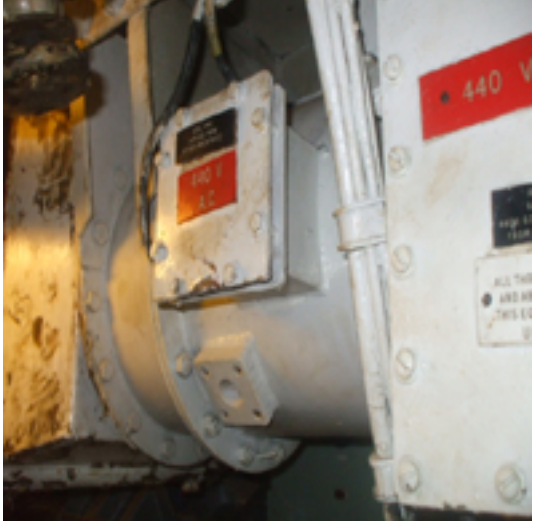
Risk Level Assessment	Vessel	Location	Item / Product Examined	Material Description	Sample No.	Initial Control Recommendation	Photograph
R3	HMS Conqueror	2/012 MMS	pipework gaskets throughout location	Asbestos-containing gasket	21054747-124	remove

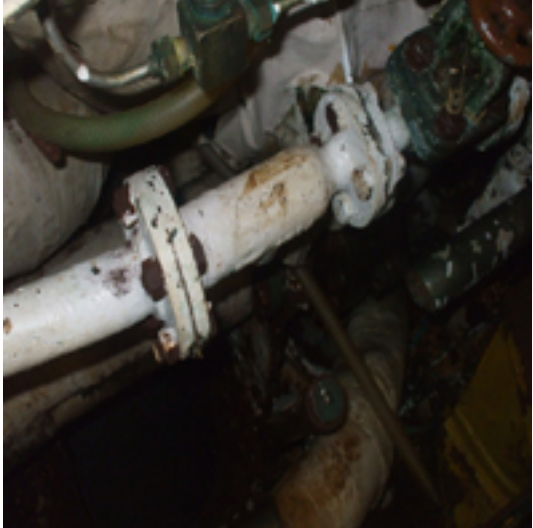
R3	HMS Conqueror	2/012 MMS	gaskets to engine casing throughout	Asbestos-containing gasket	21054747-127	remove

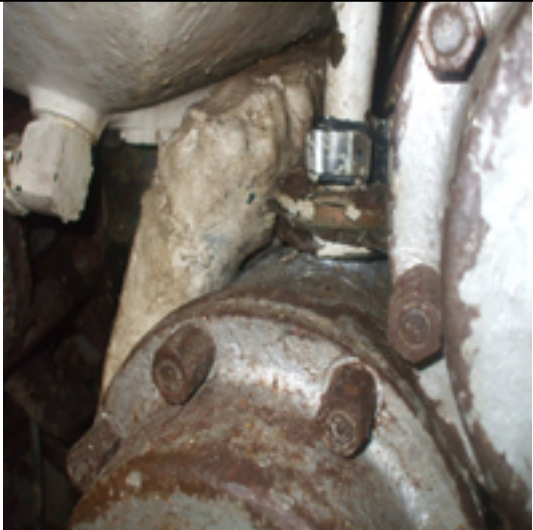
R3	HMS Conqueror	3/018 TG room	lining to pipework brackets throughout	Asbestos-containing woven product	21054747-118	remove

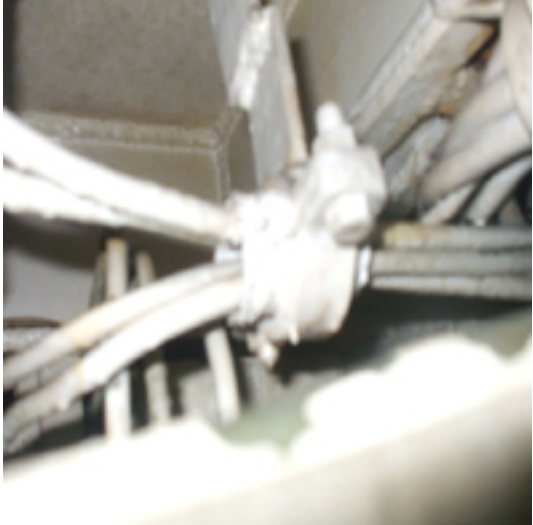
Risk Level Assessment	Vessel	Location	Item / Product Examined	Material Description	Sample No.	Initial Control Recommendation	Photograph
R3	HMS Conqueror	4/001 MMS	pipework	Asbestos-containing gasket	21054747-149	remove

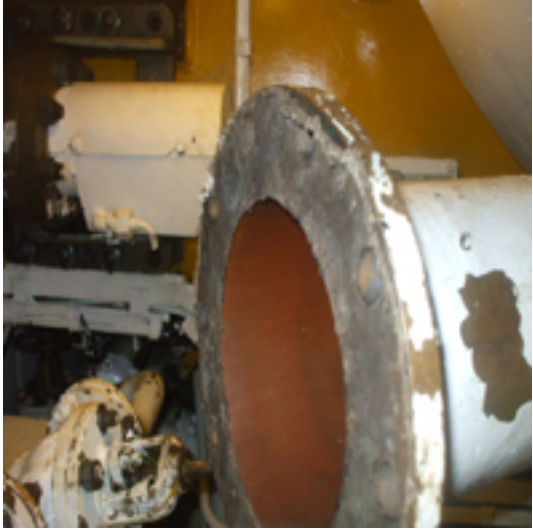
R3	HMS Conqueror	4/002 Slop tank room	pipework gaskets throughout	Asbestos-containing gasket	21054747-150	remove

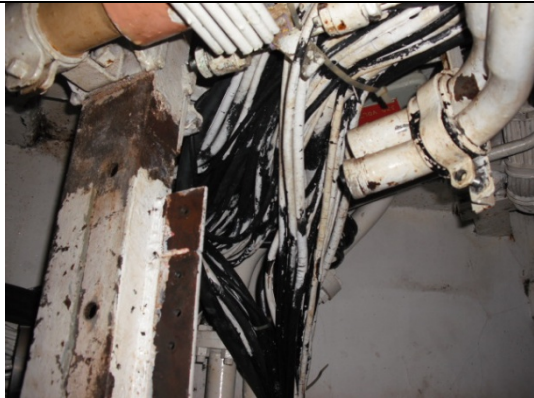
HMS Conqueror	2/011 Diesel Generator Room	AFT Deckhead triple core mains power cable	PCB Containing cable	11	Dispose of accordingly during recycling

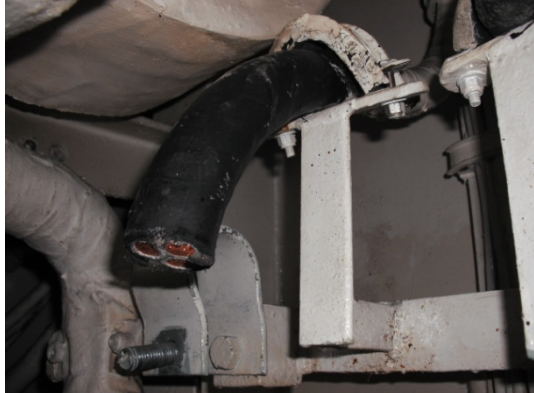
Vessel Name	Location	Item / Product Examined	Material Description	Sample No.	Initial Control Recommendation	Photograph
HMS Conqueror	2/011 Diesel Generator Room	AFT Deckhead triple core mains power cable - painted	PCB Containing cable	12	Dispose of accordingly during recycling

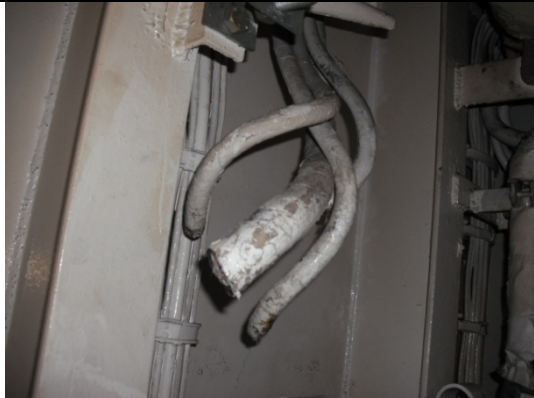
HMS Conqueror	2/011 Diesel Generator Room	AFT Deckhead triple core mains power cable - painted	PCB Containing cable	13	Dispose of accordingly during recycling

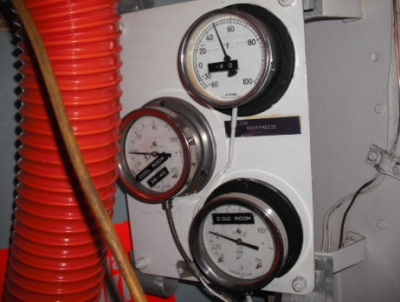
HMS Conqueror	LP Blower Room	Thermometers	Mercury Table B B-4	Visual	Small quantity

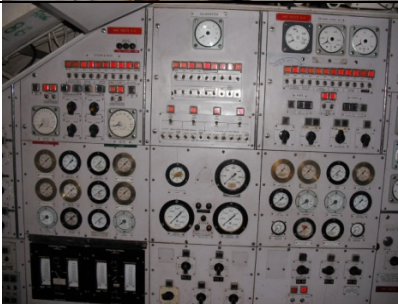
Vessel	Location	Item / Product Examined	Hazard Description and number from Appendix 1 of the Guidelines	Sampling Strategy	Extent	Remarks/Comments	Photograph
HMS Conqueror	1/010 Manoeuvring Room, to tank above DG access ladder	Pressure gauges	Beryllium Copper, Phosphor Bronze	Visual	2 Units

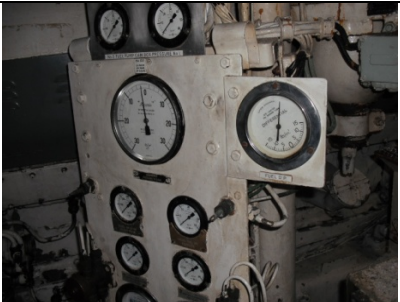
HMS Conqueror	2/011 Diesel Generator Room	Pressure gauges to Hydraulic control units	Beryllium Copper, Phosphor Bronze	Visual	2+ Units

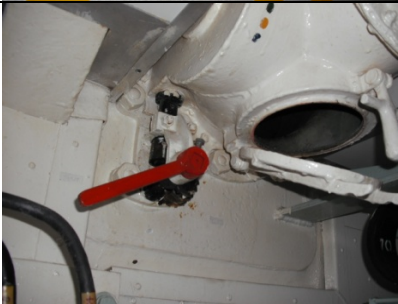
Vessel	Location	Item / Product Examined	Hazard Description and number from Appendix 1 of the Guidelines	Sampling Strategy	Extent	Remarks/Comments	Photograph
HMS Conqueror	2/003 Oxygen Generator Room	Lubrication oil to Oxygen Generators	Lub oil C-3	Visual	Residual	Left over from active service

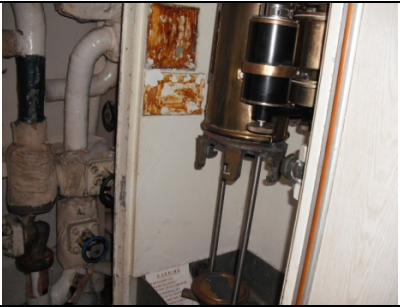
HMS Conqueror	2/005 Galley	Lubrication oil to GASH Ejector	Lub oil C-3	Visual	Residual	Left over from active service

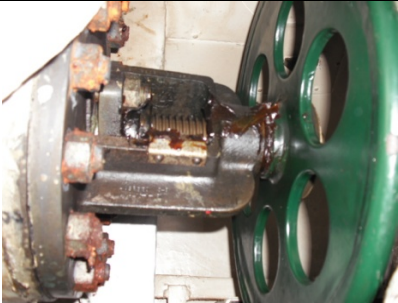
HMS Conqueror	2/011 Diesel Generator Room	Surface hydraulic fluid under hydraulic tank 2	C-4, C-3	Visual	3 litres estimate	Left over from active surface, potential leak from hydraulic tank 2

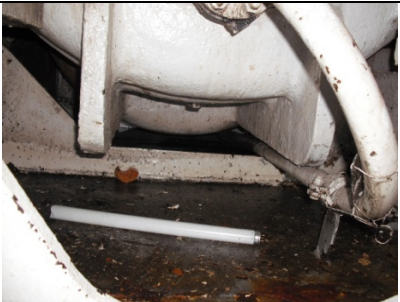
HMS Conqueror	2/013 Motor Room	Extractor fluid	C-4, C-3	Visual	Residual	Left over from active service
