Part 1.4 – FINDINGS

INTRODUCTION

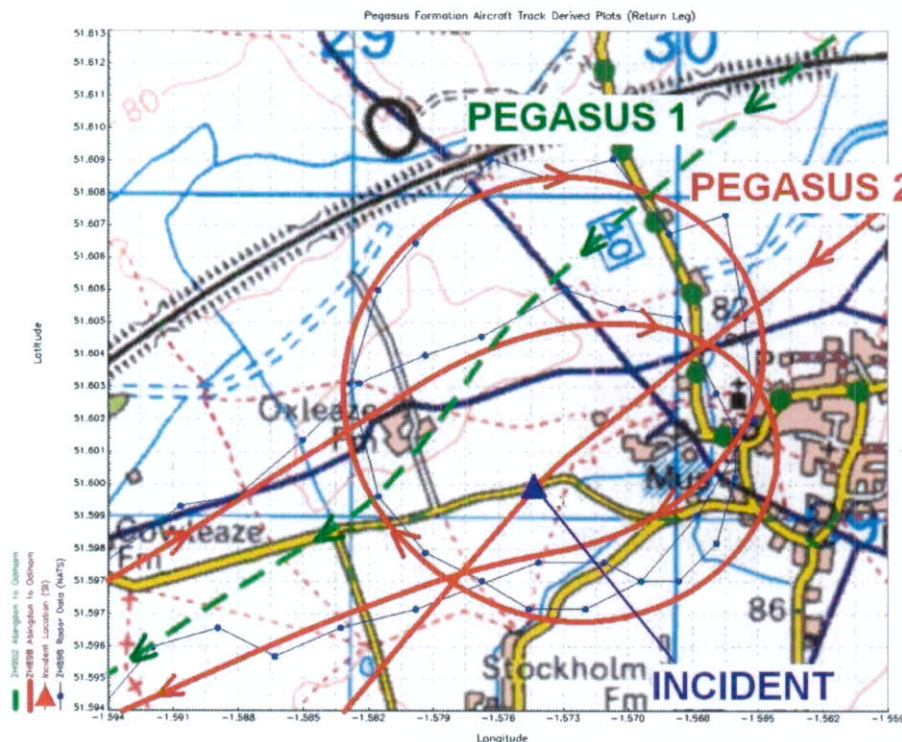
7. **Aircraft track.** The injured rider stated that a Chinook overflew her position, causing her to fall from her horse. A plot, generated by QinetiQ, using heading and air speed data extracted from the ZH898 DAPU (no GPS data is recorded), corrected for the wind on the day, placed ZH898 directly over the incident location at approximately 1454 hrs (Fig 1.4-2). The accuracy of this plot was improved by cross reference to data supplied from the Heathrow 10 radar head by the National Air Traffic Service (Fig 1.4-1). This corroborated the witness statement from the non-operating student pilot from ZH898, who saw the rider fall from her horse. The Panel therefore concluded that ZH898 was the aircraft that overflew the riders' position.

Fig 1.4-1. Plotted trace of Pegasus formation's track.

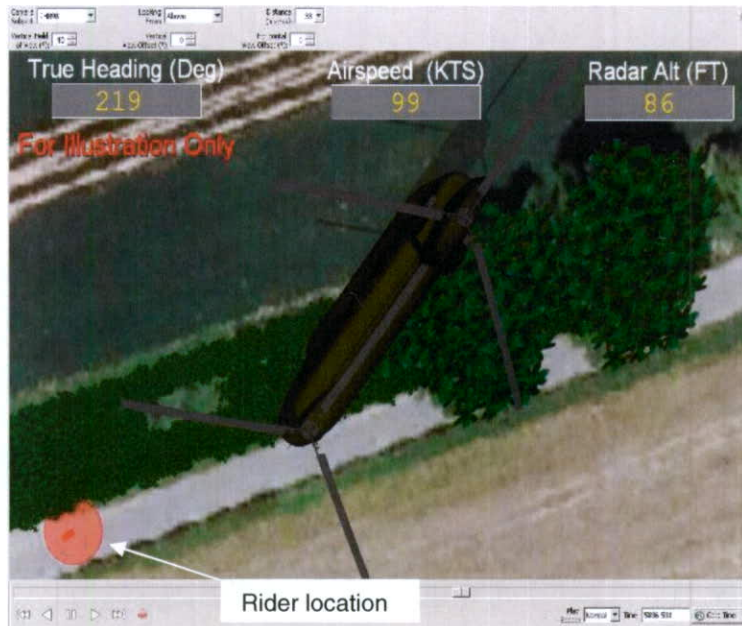
Fig 1.4-2. Overhead screen shot from QinetiQ reconstruction, showing aircraft plotted position relative to incident location.

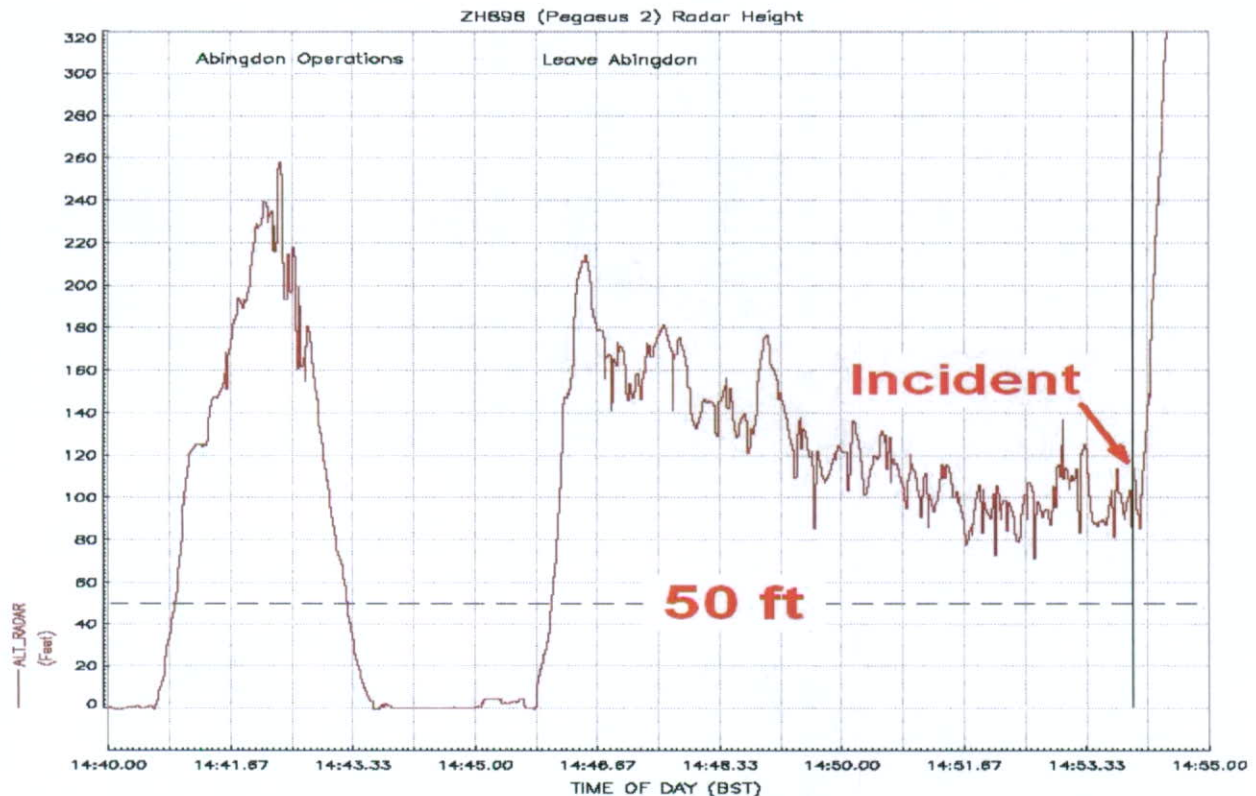
8. **Aircraft height and size.** The riders expressed concern over the height of the helicopters, stating that they assessed the aircraft height as less than 50 feet above the ground. Data retrieved from the DAPU of ZH898 showed an aircraft RADALT height of 86ft AGL (Fig 1.4-2 & Fig 1.4-3) as the QinetiQ-derived plot passed the incident location. The Panel recognise it is genuinely difficult, even for experienced observers, to estimate aircraft heights accurately from the ground. The Chinook is a large helicopter and this can add to the impression that it is flying lower than is actually the case. The riders also commented on the enormity of the aircraft suddenly appearing overhead. Though impossible to quantify, the Panel could not discount the impact the size and associated noise of the Chinook may have on a horse. The data also revealed that, with exception of take off and landing, the RADALT did not read below 50ft at any point of this LF sortie (Fig 1.4-3). The Panel found that the crew of ZH898 did not operate below 50ft AGL and 30ft MSC. The Panel found that both the aircraft height and size were **contributory factors** to the incident.

Fig 1.4-3. Trace of ZH898's RADALT. (Exhibit 37)

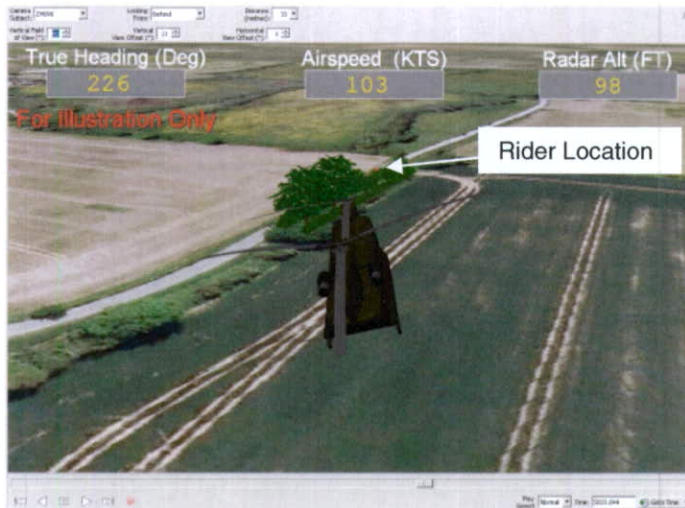
9. **ZH898 crew's awareness of riders.** The incident occurred on a minor road, bordered by a dense hedge of deciduous vegetation. To the south the hedge was up to 4ft high but to the north, the direction from which the formation approached, it contained embedded trees and extended from approximately 12ft to over 60ft. Were the riders to have been adjacent to the lowest part of the hedge (where witness reports suggest the incident occurred), the QinetiQ reconstruction suggests the lead rider's head may have started to become visible to the crew up to 5 seconds before the overflight (Fig 1.4-4). Taking into account the external view from the cockpit being restricted by the instrument panel, the pilots' window of opportunity to see the riders was further reduced to approximately 3.5 seconds. However, as the riders were advancing from the west, where the hedge extended beyond 12ft, these figures are reduced to such a level it is highly improbable any member of the crew would have seen the riders prior to overflight. Both riders corroborate this, stating that though they witnessed a Chinook 200-300m north of their position (Pegasus 1), they could not see ZH898 (Pegasus 2) through the dense hedge, stating that it appeared 'low and over my head'. The Panel found the riders' lack of warning of overflight was a **contributory factor**. Given the density of vegetation the presence of a high visibility tabard on one rider would have made very little difference on their detection range. Even if the crew, who reported they were looking out of the cockpit prior to the incident, had seen the riders at the maximum predicted range, the short distance and duration to the incident location would not have afforded them sufficient opportunity to conduct an effect avoiding manoeuvre. The Panel found the minimal chance for the crew to see the riders prior to their overflight was a **contributory factor** to the incident.

Fig 1.4-4. Pilots' line of sight view 5 seconds prior to overflight.

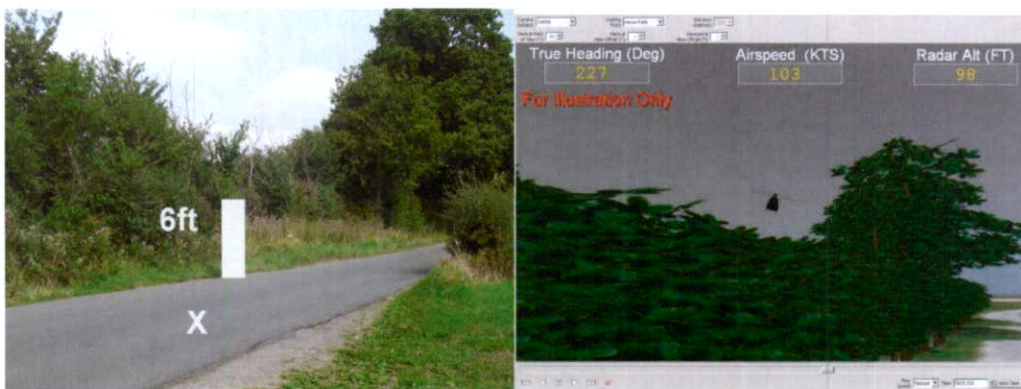
Fig 1.4-5 a, Incident location (X); 1.4-5 b, reconstruction of rider's view of approaching aircraft 3 seconds prior to overflight.

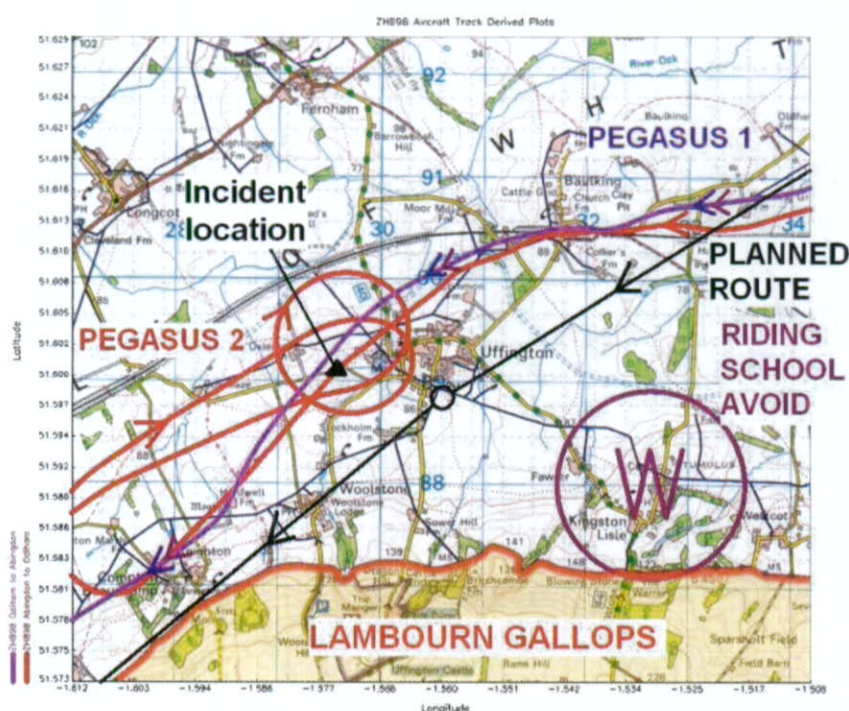
13. **Deviation from route.** The planned route involved Pegasus formation passing to the south of Uffington, away from the riders' position, but the actual routes flown were to the north of the village. The presence of a temporary avoid at Baulking Grange Riding School (0.5nm & 500ft) and the Lambourn Gallop Environmental Avoid meant there was little space for the formation to transit to the south (Fig 1.4-6). Both QHIs stated that the line drawn on the chart was a guide and they deviate from it according to the suitability of the terrain. Given the freedom of tactical manoeuvre afforded to formations, the Panel believed this minor deviation from the route was entirely reasonable but positioned the aircraft over the riders' location.

Fig 1.4-6. Actual vs planned route.

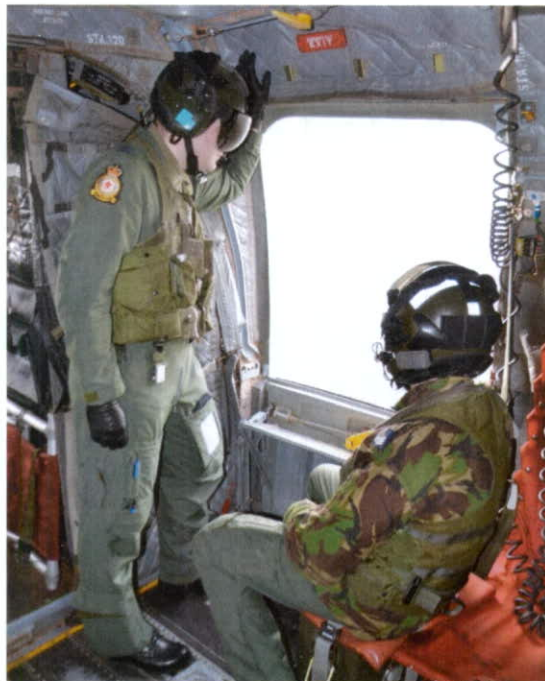
commander's seat. As a consequence, the non-operating student pilot, who would normally occupy that position, was standing in the cabin, adjacent to the starboard cabin door. With the No 2 student crewman sat at his usual position, on the oils box looking forward, the non-operating pilot's focus of attention was out to the 4 o'clock of the aircraft and down from the horizontal (Fig 1.4-7). As the aircraft's track was offset by just a few metres to the east of the horse riders they happened to pass directly through the non-operating pilot's line of sight, enabling him to witness the rider falling off her horse. Had the incident not been witnessed post incident actions would not have been initiated until 2015 hrs on 25 Aug 11, when the first flying complaint was received on station. Consequently, data from the Cockpit Voice and Flight Data Recorder (CVFDR), at the very least, and from the DAPU would have been lost as both aircraft were planned to fly again later that day.

Fig 1.4-7. Reconstruction of No 2 crewman (right) and non-operating pilot's cabin position at the time of the incident.

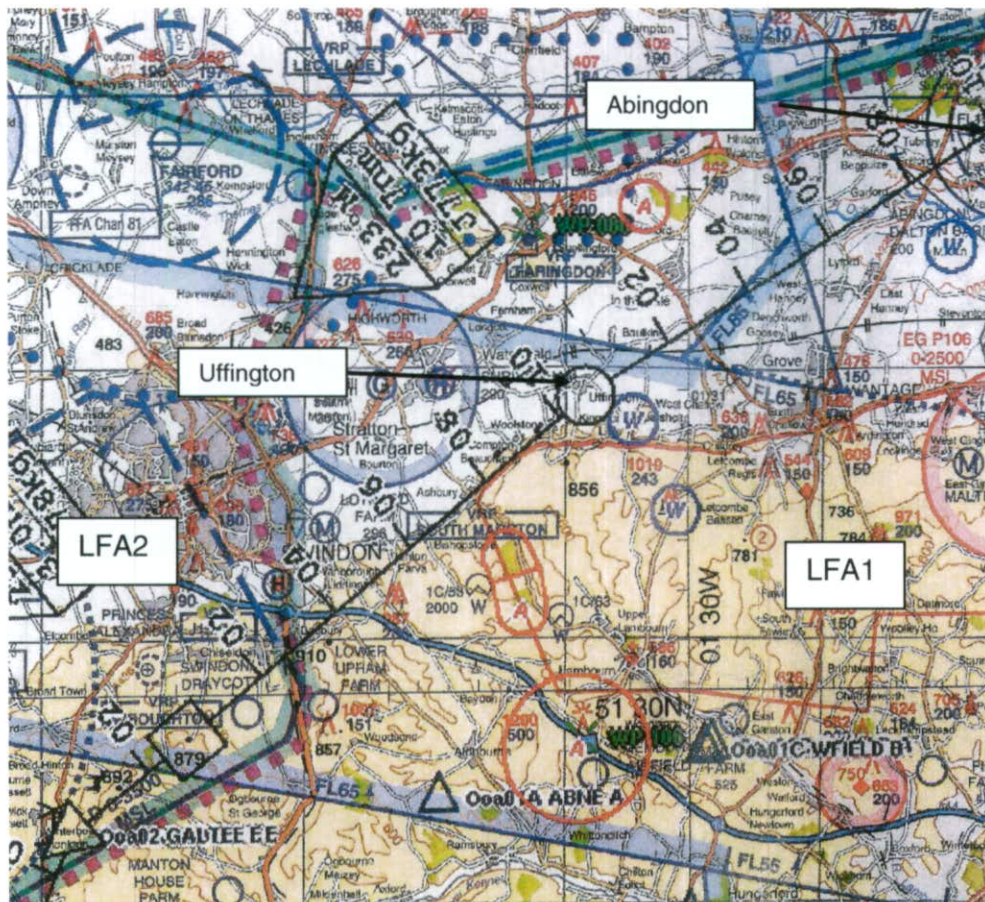
particularly illustrated in the Uffington area, which is a low level choke point between the Sandhill Farm (Shrivenham) Glider Site to the north and the Lambourn Gallops to the south (Fig 1.4-8). The Panel found that the planned low level route gave due consideration to avoiding built-up areas and high horse concentrations. The decision to reverse the route was valid based on the plan to conduct training with 2 pilots per aircraft, swapping right hand seat at Abingdon, and a balance of instructor workload verse formation practice.

Fig 1.4-8. Pegasus formation's planned route.

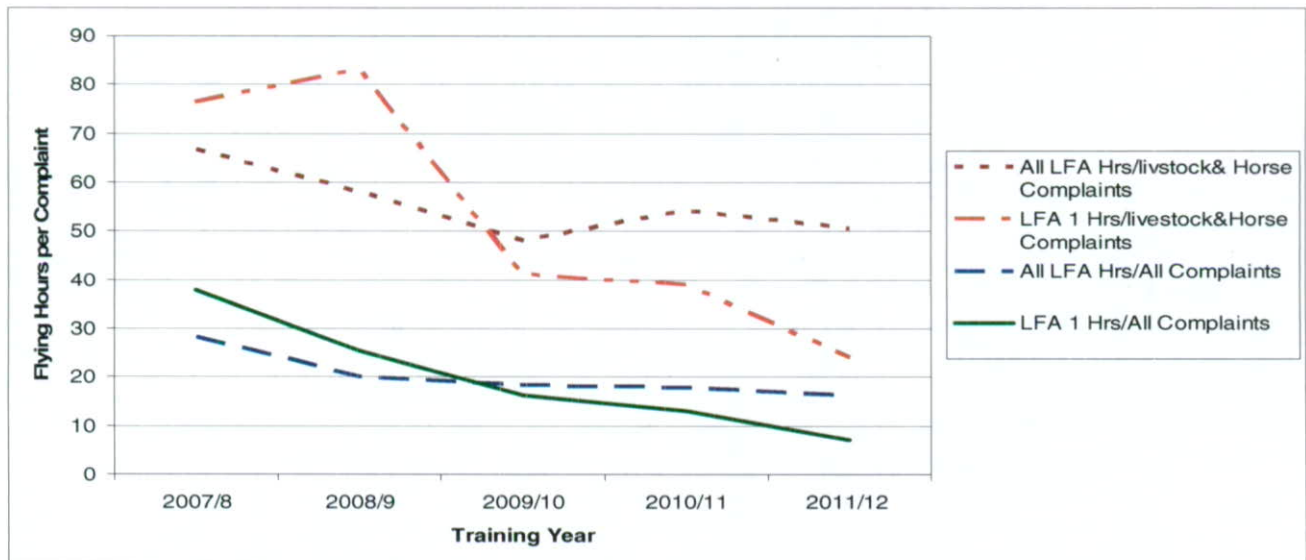
c. **Low flying Complaints and LFA Usage.** LF data shows a marked increase in the number of LF complaints per flying hour from 2007 to present (Fig 1.4-10), despite the actual number of low flying hours logged decreasing over the same period. AS LF attributed this to 2 factors. Firstly, the MOD has made it much easier for the public to complain, by increasing awareness and improving the facilities to do so. Secondly, public tolerance of military training activity is fragile at this moment in time and there is little understanding for the need for pre-deployment training. This increase in the complaints trend is apparent across all the LFAs but it is amplified in LFA 1, which has had consistently more complaints per flying hour than any other LFA over a 5 year period. This is attributed to the geographical location of the military bases within the LFA and the nature of their flying patterns. Due to the helicopters' speed and fuel capacity, they are limited to a finite range from their home base, meaning a helicopter taking off from a base within LFA 1 will generally operate exclusively within that area. The fact that this DUA has three JHC helicopter stations within its boundaries, each containing sqns that conduct pre deployment and continuation LF training, appears to be the

main factor behind the level of complaints within LFA 1 compared to others. The Panel felt this contradicted one of the findings from the 2005 review. The coroner suggested restricting LF to specific areas, either to the pre-1979 LF system or, more restrictively, just to military land. The 2005 review rejected the coroner's suggestion, on the grounds of aircrew familiarity, and advocated sharing the 'burden' of LF around as much of the country as possible. What has ultimately been the consequence of such high density of helicopter bases is a restriction in the areas used for LF. This situation is only going to be exacerbated by the addition of 14 Mk 6 Chinooks from 2013 and the relocation of assets from Dishforth and Gutersloh to RNAS Yeovilton as part of the Lynx Wildcat programme from 2014. The future basing of helicopters in the southern half of the UK is undetermined, but there is the potential that the outcome will add further users to an already over-crowded situation. Ultimately, this is likely to increase chances of a recurrence of such an incident in LFA 1.

Fig 1.4-10. Five year analysis of complaints vs LF hours. (Exhibit 53).
