Crew Handling of the Emergency

Post Accident

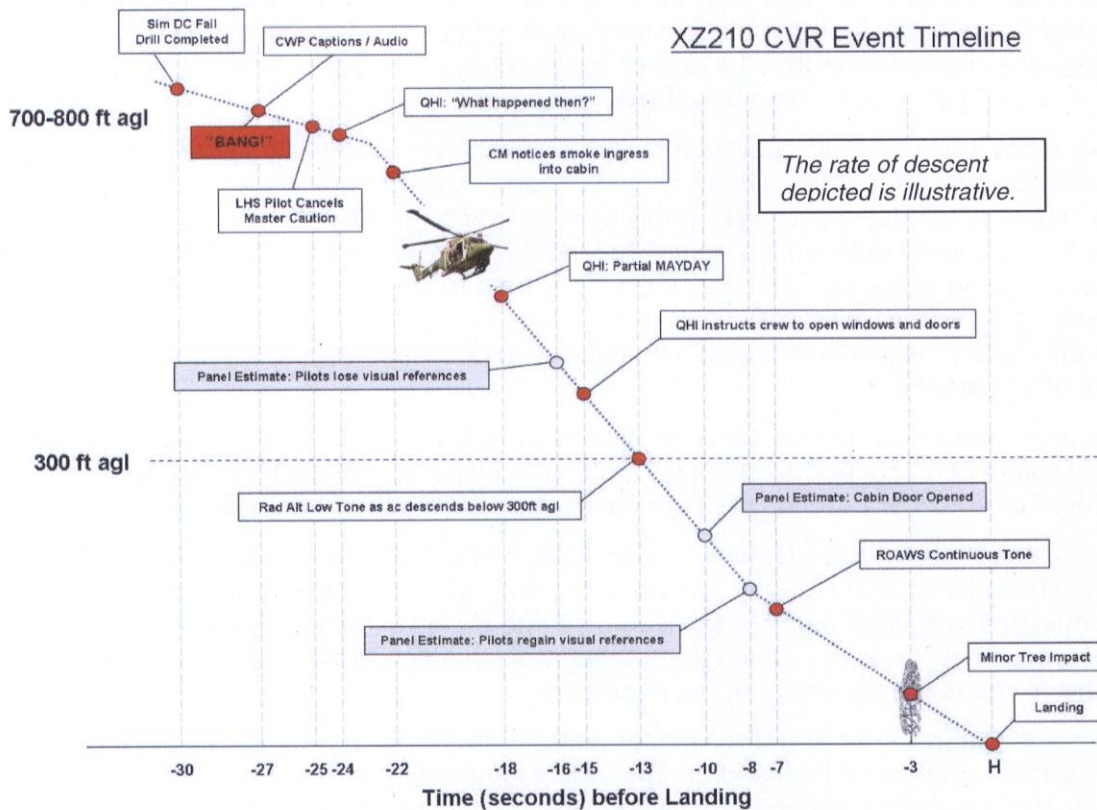
Fig 16 – XZ210 CVR Timeline

1.4.62 **Immediate Actions.** The QHI recalled that his immediate diagnosis, based on the combination of the bang, ac yaw and 'sloppiness' in the ac controls, was that something might have hit the tail rotor. Considering the potential loss of tail rotor control/drive to have been the worst case scenario, his first instinct was therefore to confirm that he still had tail rotor authority by moving the pedals. The ac response to the control input was normal and so the possibility of tail rotor malfunction was discounted. At this point the CM informed the pilots of significant smoke ingressing the cabin. The Panel noted that the Lynx Simulator only used the audio cue of a bang when initiating an engine drive shaft failure and was therefore able to discount preconditioning to audio stimulus as a result of synthetic training for the QHI's initial reaction.

1.4.63 During this time, the crew reported multiple CWP captions and associated audio warning. While the LHS Pilot and CM could recall vague patterns made by the lights, none of the crew recalled which individual warnings were activated. Although the LHS Pilot cancelled the Master Caution Audio Warning, he did not recall checking the CWP to ascertain why the attention getter had been activated. Neither pilot recalled checking the torquemeter or the triple tachometer (which indicated Nf for both engines and Nr) or noting any other dangerous indications. The Panel concluded that on the QHI's part this was as a result of his focus on flying the ac and initial diagnosis; the LHS Pilot reported an initial suspension of reality while he considered that this might have been another simulated malfunction that the QHI had somehow manufactured. By the time that this thought process had concluded, smoke had started to fill the cabin.

he called for the ac windows and doors to be opened. It was the Panel's view that his decision to interrupt the transmission was the result of suddenly losing visual references as he was making the call. It was likely that his focus then understandably shifted to ventilating the cockpit. Using the interruption of the QHI's mayday transmission to call for windows and doors to be opened as the best indicator of when he started to lose visual references, the Panel estimated that the time from the FPT failure (bang) to smoke filling the cockpit was approximately 11 secs.

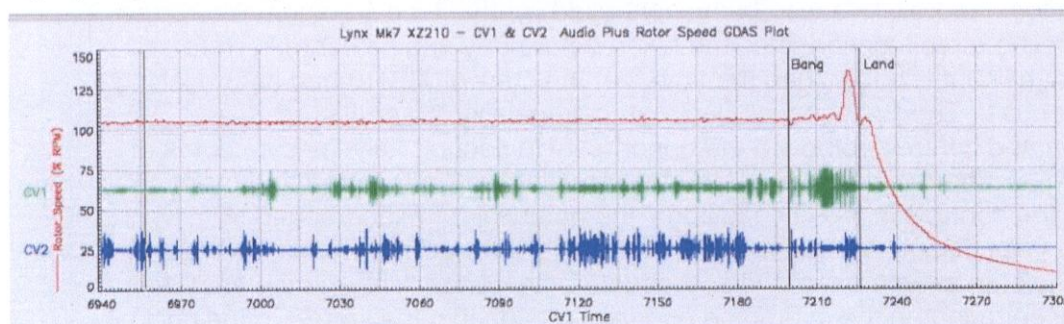
Fig 17 - CVR Visual Trace

1.4.68 **Rotor Overspeed.** Operation of the ROAWS continuous tone 7 secs before landing indicated that the ac rotor was subjected to an overspeed in excess of 115.8%. The CVR trace indicated that the Nr peaked at approx 135% (see Fig 17 below which shows Nr in red). Although the QHI did not recall making significant

1.4.69 The Panel considered what might have caused the rotor to overspeed. The possibility of a No1 engine run-away up was discounted on the basis of the Nr profile, which showed a transient peak before the rotor RPM recovered to normal as the ac landed. The Panel judged that the rapid increase in Nr was the result of the ac being flared in an attempt to arrest ac ground speed and the rapid RoD, exacerbated by manoeuvring to avoid the tree. The minor damage apparent on 2 of main rotor blades suggested that the impact with the tree branches did not have a significant effect on the ac flight path, or subsequent handling characteristics.

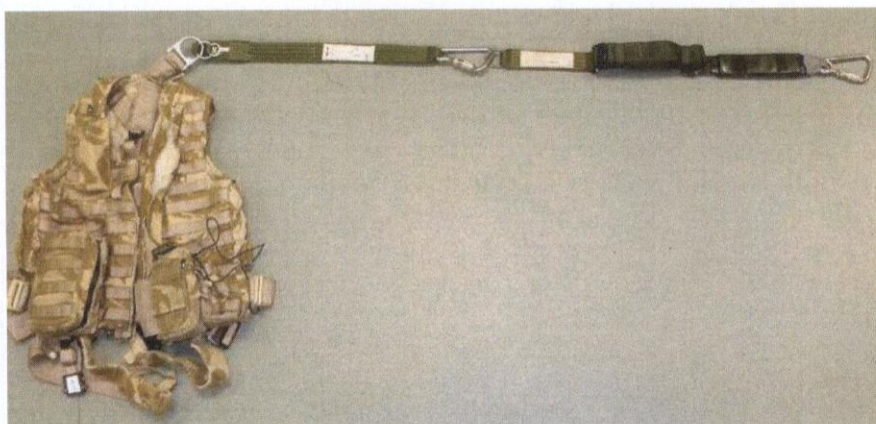
Fig 18 – Mk60 ACLP with Yoke Mounted Strop Assembly

1.4.92 The Mk 60 (CM) and 61 (pilot) Series ACLP were introduced into service to provide RW aircrew with personal body armour, survival and life preserving capabilities in one jacket, previously delivered by 3 different non-fire retardant items. The main difference for the MK60 was the new form of restraint, with the strop attached using a neck mounted "yoke" harness arrangement¹².

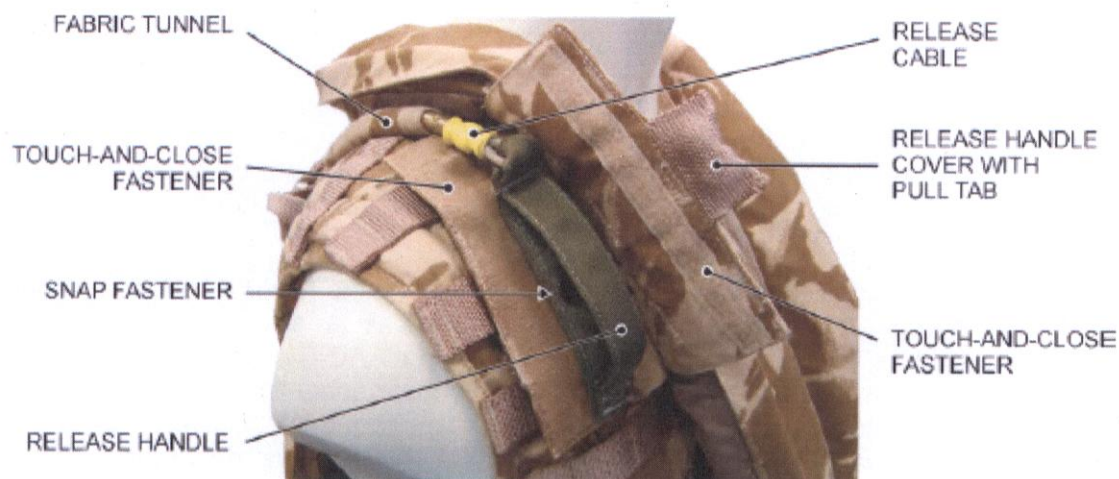
Fig 19 – Mk60 ACLP

1.4.95 The handle was protected in day-to-day operation by a flap of material, hinged on the inboard edge and secured on the outboard edge by a touch-and-close fastener (Velcro) (see Fig 19 above). The outboard edge was augmented by a locating pull tab of webbing containing 2 plastic beads. The mechanism was designed to be operated by feel, as it could potentially be required at night or even underwater.

1.4.96 In the case of the XZ210 accident, the CM made numerous unsuccessful attempts to take hold of the locating pull tab with his left hand during egress; however, he was unable to expose the quick release handle and operate the emergency mechanism. He recalled pulling the jacket in the area where he believed the pull tab was located but was unable to actually open the covering flap.

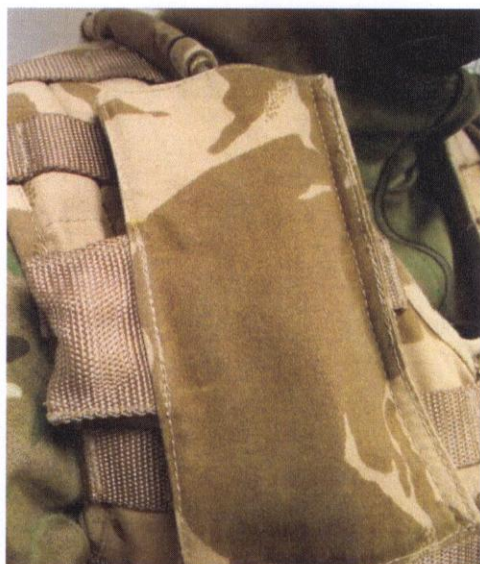
Fig 20 – Emergency Release Flap

1.4.97 Examination of the CM's Mk60 ACLP showed it to be undamaged with only minor wear consistent with normal use. The strop quick release system had not been operated and the touch and close protective tab was in place. The evidence suggested that the quick release system would have worked as designed if it had been operated by the CM.

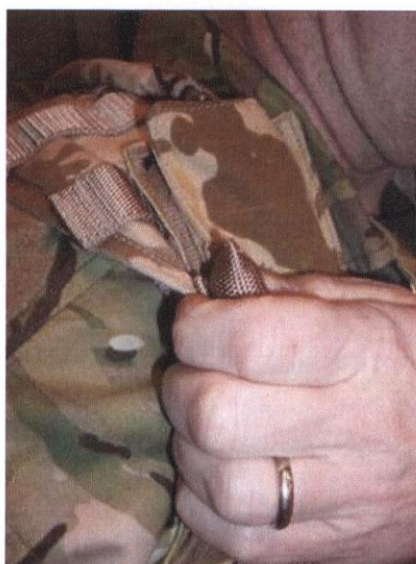
Fig 21 – Misidentification of Flap

1.4.98 During subsequent trials by RAFCAM, the standard emergency release patch on the Mk60 ACLP was found to be fit for purpose in the benign circumstances¹³ under which the testing was completed. One of the trial subjects, who had no experience with the equipment, was able to locate the patch and release in less than 6 secs in all assessments. However, the trial findings did conclude that it was possible to feel the beads, contained within the pull tab, through the fabric of the waistcoat; it was therefore possible for the wearer to inadvertently believe that they were pulling the release patch cover, whilst actually pulling the main waistcoat.

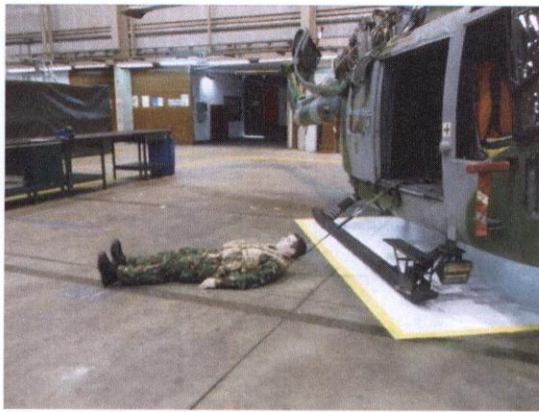
Fig 23 – Mk60 ACLP with Strop – distance away from ac achievable

1.4.103 The Panel found that a CM wearing the Mk60 ACLP with strop (at minimum length) attached to the starboard cabin floor could not reach and operate the opposite (port) cabin door with the 6 man fore-aft seat fitted. The combination of yoke mounting and floor hard points, even with the minimum length of strop, also meant that any wearer ejected from an ac could depart some distance outside the cabin before being restrained.

Fig 23 and Fig 24 above illustrate the strop assembly as worn and attached by the XZ210 CM. The images show the distance that the CM might have been ejected based on minimum strop length; however, they do not show the additional 1m of strop webbing that would have deployed in the event of shock loading as shown at Fig 25 below:

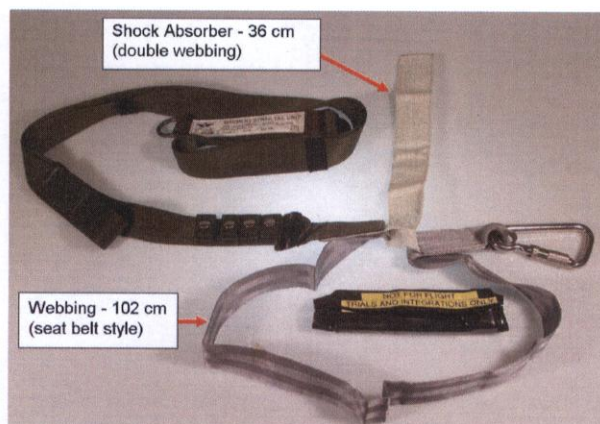
Fig 25 – Strop with shock load deployable webbing

1.4.104 The Panel was concerned that this strop arrangement did not afford the appropriate level of restraint, as set out in the Mk60 ACLP Safety Case, whereby a CM would be prevented from inadvertently falling out of an open door. It was concluded that this strop length would have allowed the CM to be thrown to a position where there was potential to be trapped beneath the ac in the event of rollover following an uncontrolled landing. The strop design (minimum strop length) was an **organisational influence** that in other circumstances might affect the outcome of another accident and was thus deemed to have been an **other factor**.
