## SAFETY ALERT

Subject: Eaton Glasgow Fuse-Switch Disconnecter 160A/200A –  
Connection Bolt Issue

Number: 01/13 version 2

Date of issue: 16 January 2013  
Corrected: 1 February 2013

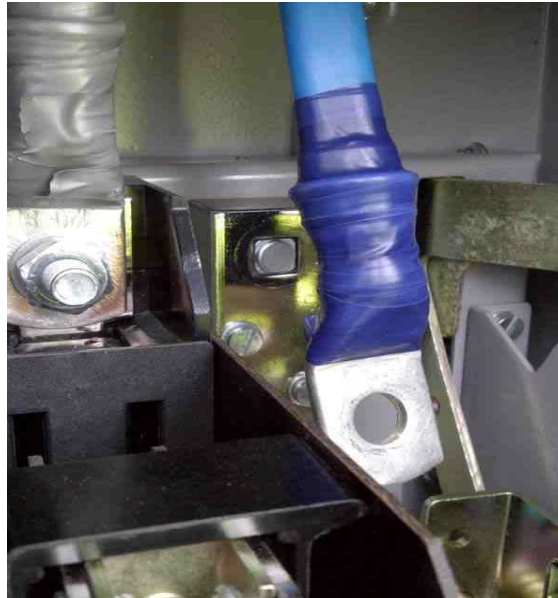
- a. An incident was reported where a terminal bolt within a Glasgow Disconnecter had fractured whilst in service. No other similar incidents have been reported.

*Fractured Terminal Bolt*

- a. Identify all Glasgow Fuse-Switch Disconnectors rated at 160A or 200A with one of the affected catalogue numbers and manufactured between the dates 1 August 2011 and 31 January 2012 inclusive.
- b. Where the Disconnector is in service:
  - a. Check for fractured terminal bolts.
  - b. Replace any fractured terminal bolts with replacements from Eaton.
  - c. Check the torque (25Nm) of all terminal bolts.
- c. Where the Disconnector is not in service return to Eaton for a replacement.

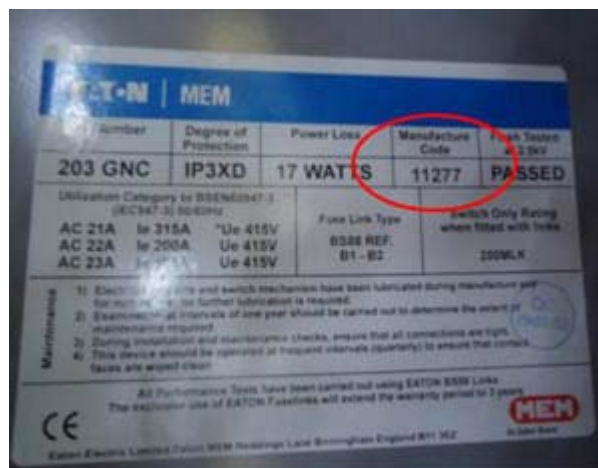
*Product Rating Label*

- b. Eaton have confirmed that the catalogue numbers of the affected products are 151GNC, 153GNC, 153GNCX, 154GC, 201GNC, 203GNC, 203GNCX, 203GNL, 204GC.
- c. The date of manufacture can be confirmed by checking the manufacturing code of the Disconnecter located on the product rating label. Codes in the range 11213 to 12031 indicate that the Disconnecter was manufactured between the dates 1 August 2011 and 31 January 2012 inclusive.
